**Preliminary Report on the Serious Incident involving a Boeing 737-400 aircraft operated by Max Air Limited with nationality and registration marks 5N-MBD which occurred between Take-off at Yola Airport Adamawa State and on landing at Nnamdi Azikiwe International Airport, Abuja Nigeria on 7th May, 2023.**

<b>Registered owner:</b>	Max Air Limited
<b>Operator:</b>	Max Air Limited
<b>Aircraft type and model:</b>	Boeing 737-400
<b>Manufacturer:</b>	The Boeing Company, USA
<b>Year of manufacture:</b>	1997
<b>Nationality and registration marks:</b>	5N-MBD
<b>Serial number:</b>	28704
<b>Location:</b>	Nnamdi Azikiwe International Airport (DNAA), Runway 22 Coordinates: 09°000'25"N, 007°15'47"E.
<b>Date and Time:</b>	7th May, 2023 at about 14:57 h <i>(All times in this report are local time, equivalent to UTC+1 unless otherwise stated)</i>

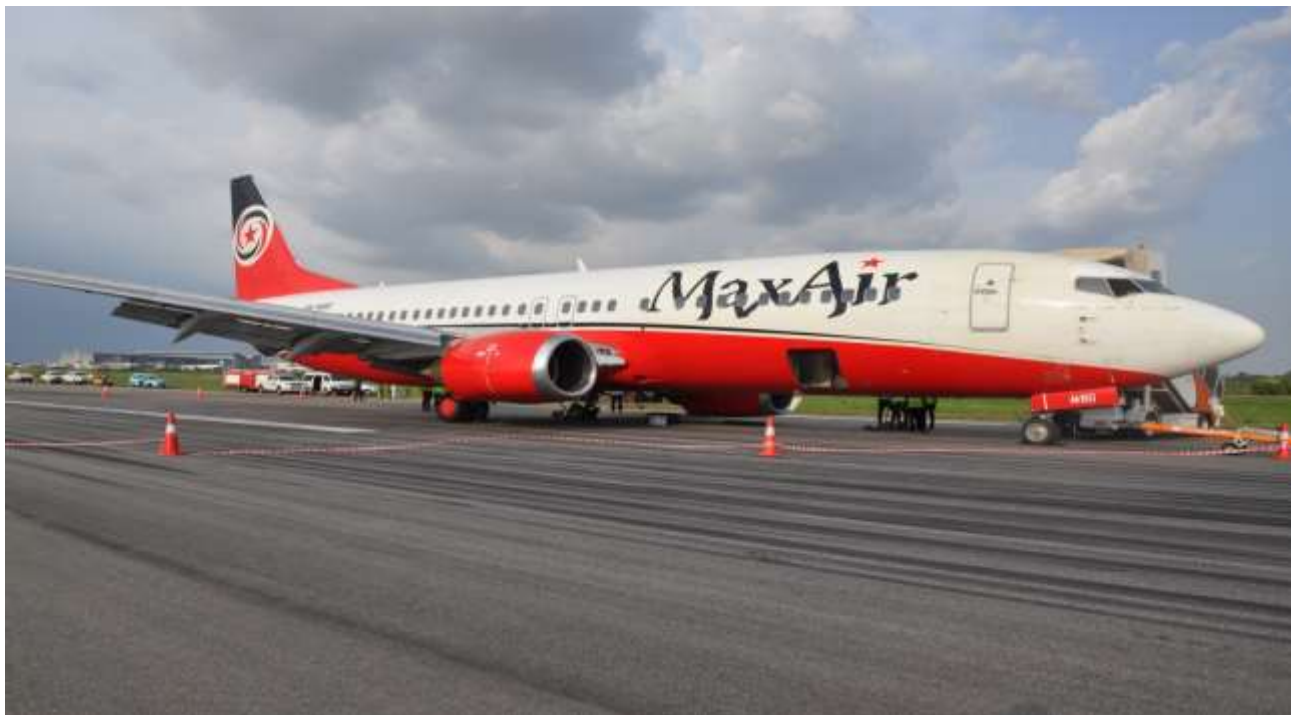
Figure 1: Boeing 737-400, 5N-MBD on the runway after the occurrence.

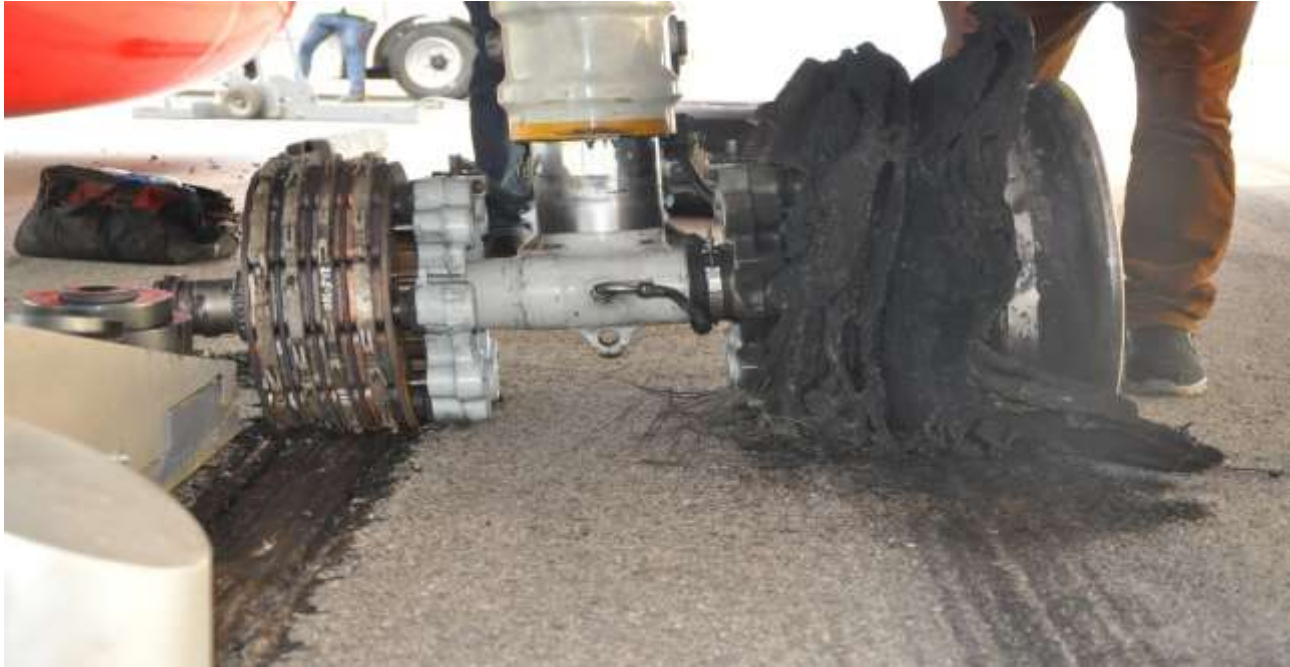
**Figure 2:** Damage to the No. 1 main landing gear wheels of 5N-MBD

14. The aircraft came to a stop between Link A5 and A6 about 2900 m from the threshold of runway 22.
15. The port wheel assembly was located by personnel of the Federal Airports Authority of Nigeria (FAAN) about 1000 m from threshold of Runway 35 Yola airport on 08th May, 2023.

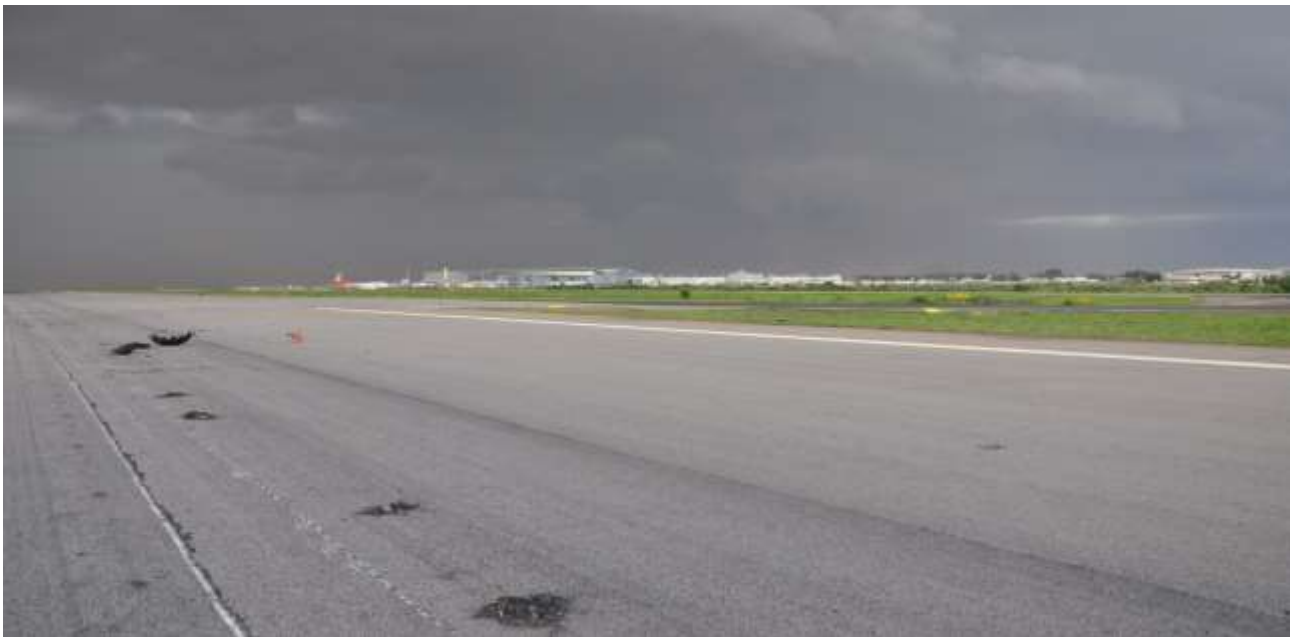
**Figure 3:** Debris of No. 2 main wheel tyre with No.2 wheel impact marks on the runway.

The aircraft landed on runway 22 and while on the landing roll, No. 2 main wheel tyre burst at about 2400 m and continued for another 100 m where No. 1 brake assembly and No. 2 wheel assembly surface contact was observed on the runway. The aircraft continued

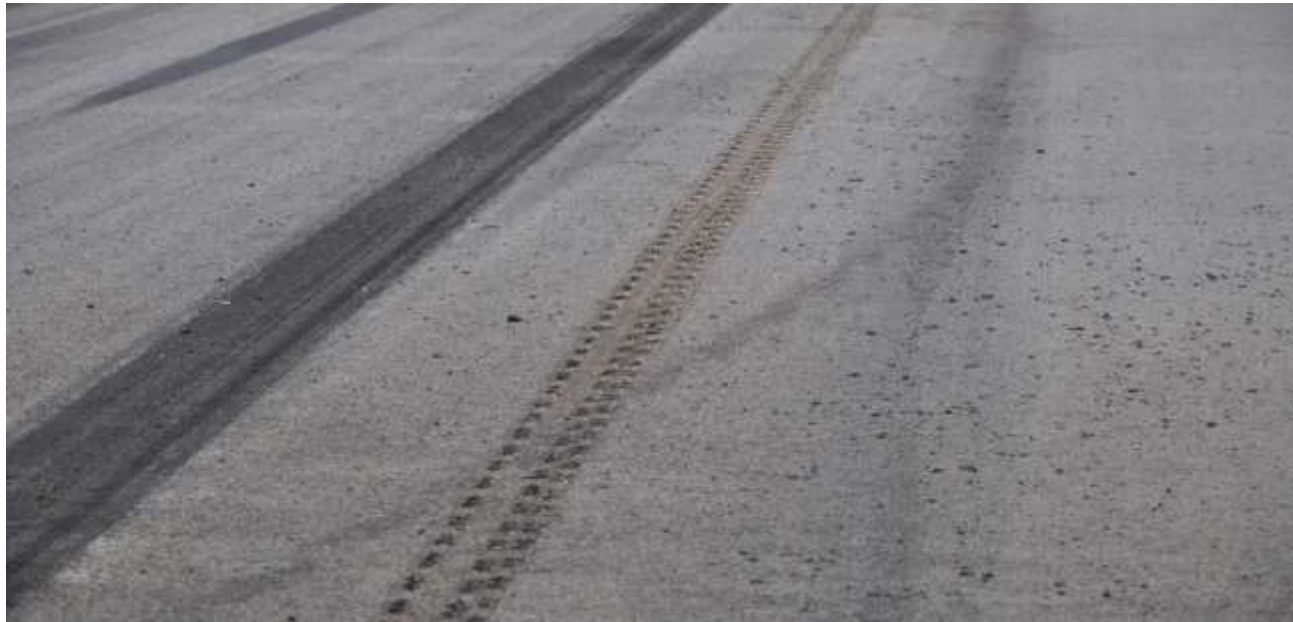
**Figure 4:** No. 1 Main brake assembly impact marks on the runway

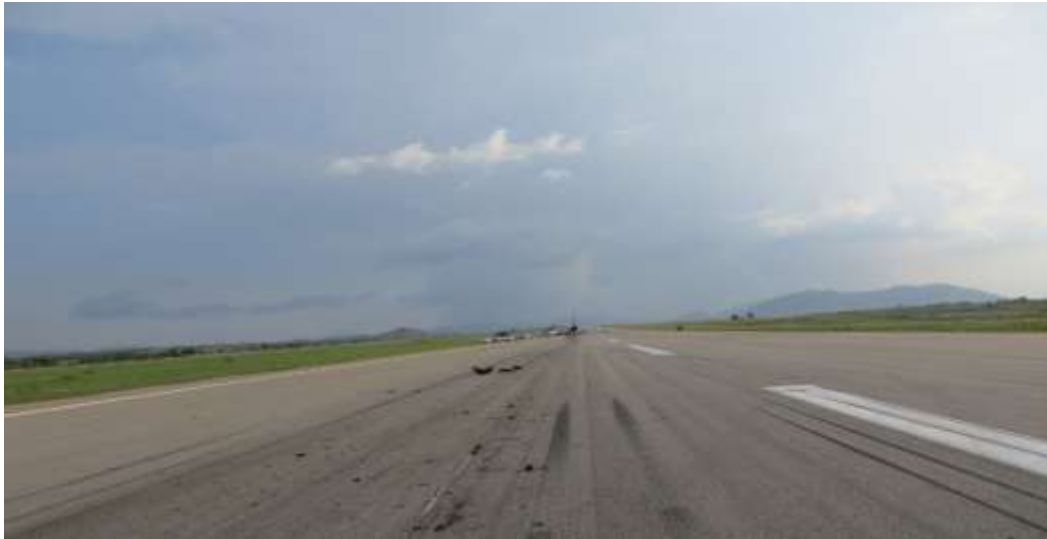
**Figure 5:** Debris of the No.2 main wheel tyre

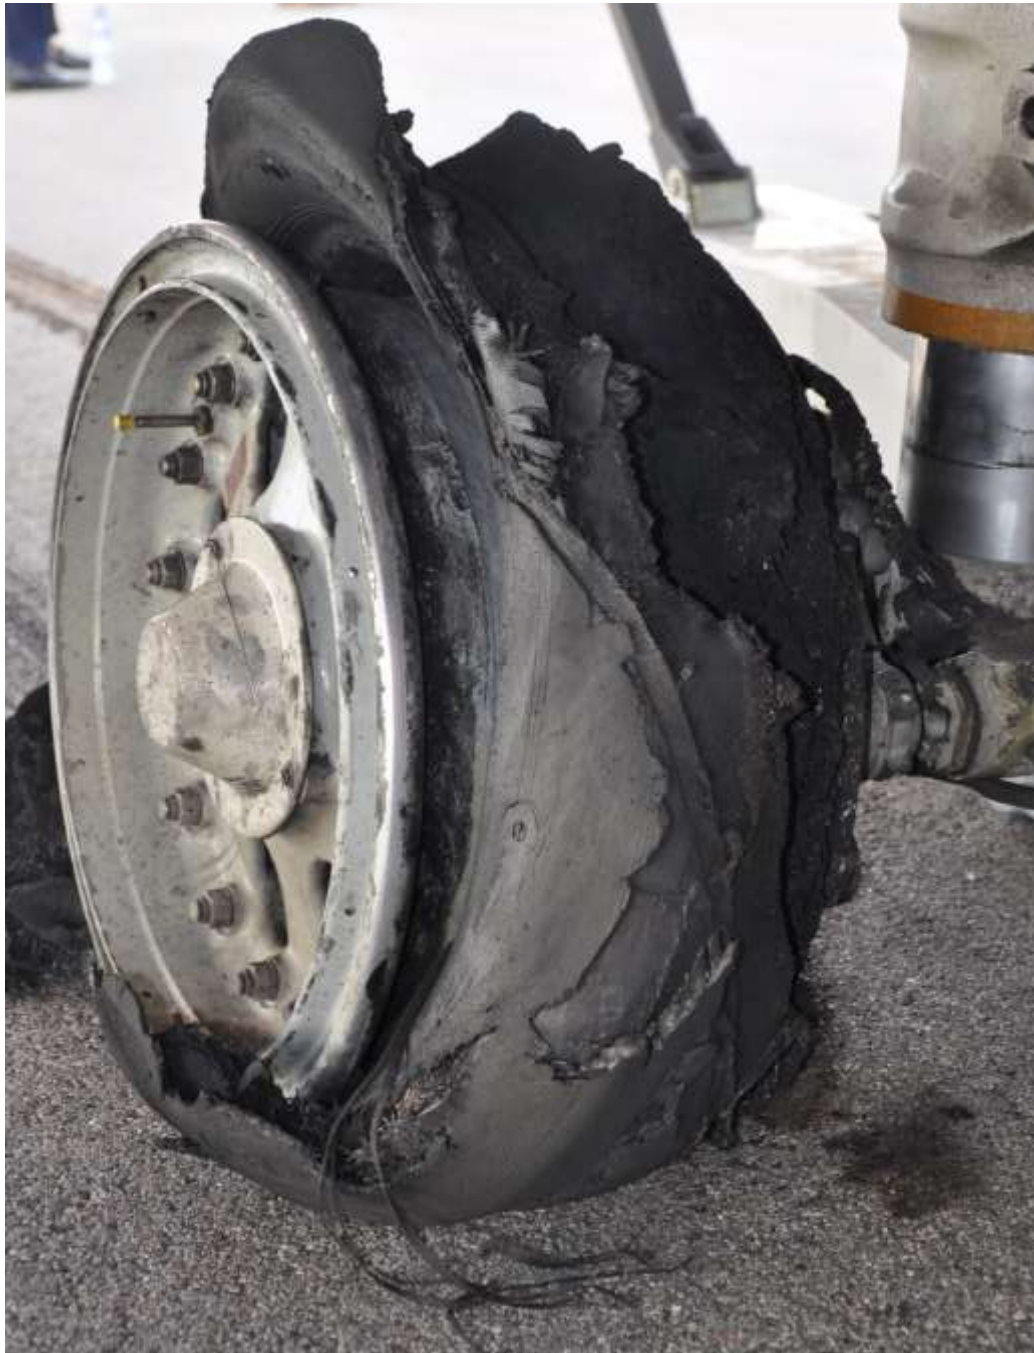
veering off to the left of centerline and stopped at about 2900 m on the runway. There was evidence of severe fire damage on No. 2 main wheel assembly.

**Figure 6:** Damaged No. 2 main wheel assembly

There was evidence of fire on the No. 2 main wheel assembly.

21. The crew did not take adequate measures to confirm the information about the missing wheel assembly.
22. There was severe fire damage on the No. 2 main wheel assembly.

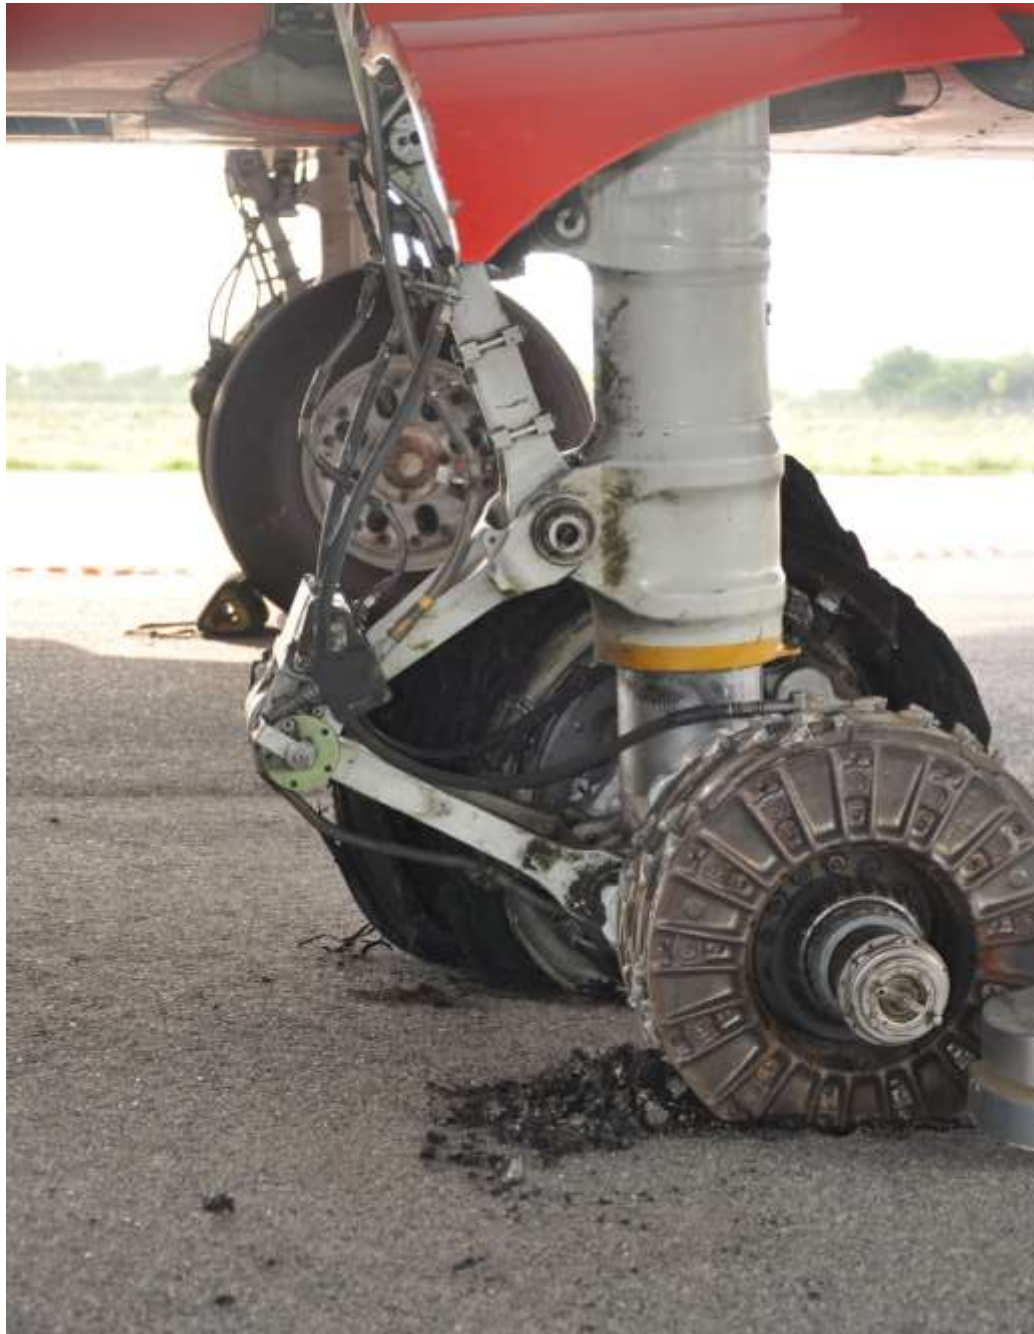
**Figure 7:** No.1 brake assembly with the roller bearings after the wheel fell off

16. The roller bearings on the wheel assembly of No. 1 main wheel had discoloration and was burnt out.
17. The CVR recording was found to be overwritten.

1. Inspection of the roller bearing and other accessories.
2. Retrieval of pertinent document from Max Air limited and other stakeholder.
3. Pertinent factors leading to drafting of the final report.
