**AIRCRAFT ACCIDENT REPORT
AERO/08/21/2010/F**

Accident Investigation Bureau

**Report on the Serious Incident involving
AERO CONTRACTORS NIGERIA LIMITED
Boeing 737-500 Registration 5N-BLE at Runway 28
Yakubu Gowon Airport, Jos, Plateau State, Nigeria
On 21st August, 2010.**

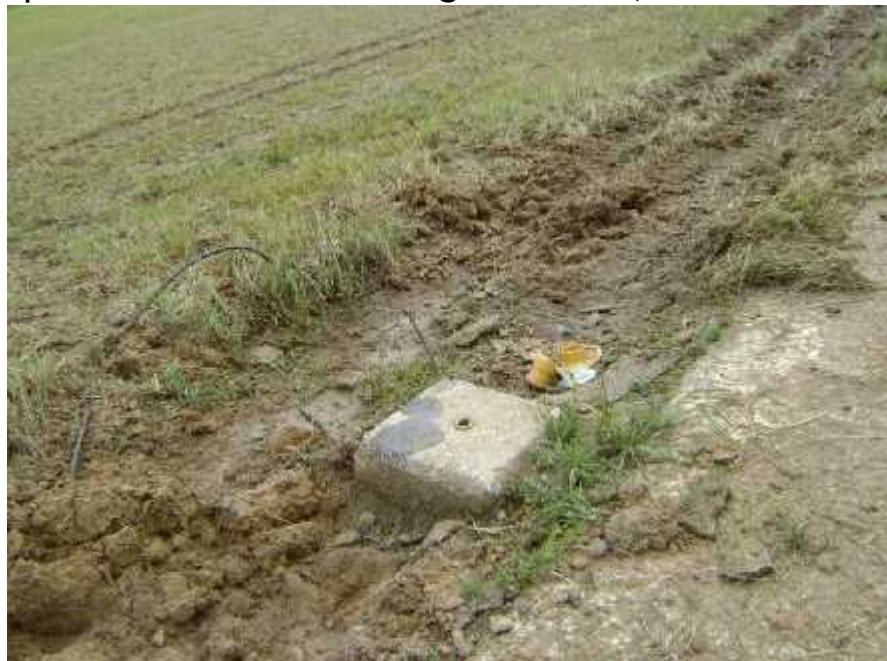
3 Runway edge lights were damaged and armored cable uprooted with cuts. See fig 1.4 below;

Fig 1.4 Damaged runway edge lights and uprooted armored cable

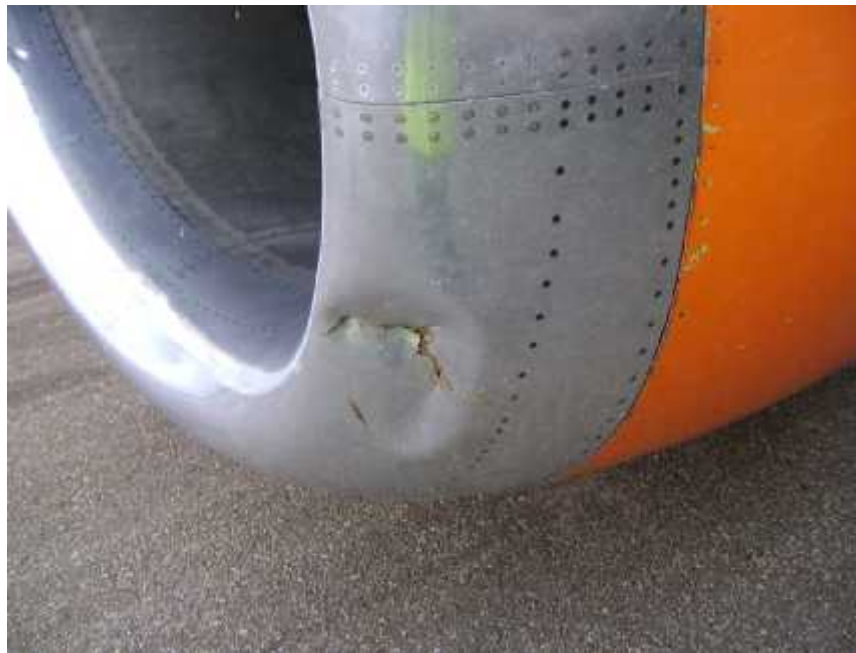
The Starboard engine made contact with the runway, damaged the lower cowling and ingested foreign objects that resulted to fan blades damage and punctures at the air intake

Fig 1.12a Picture showing damaged lower cowling

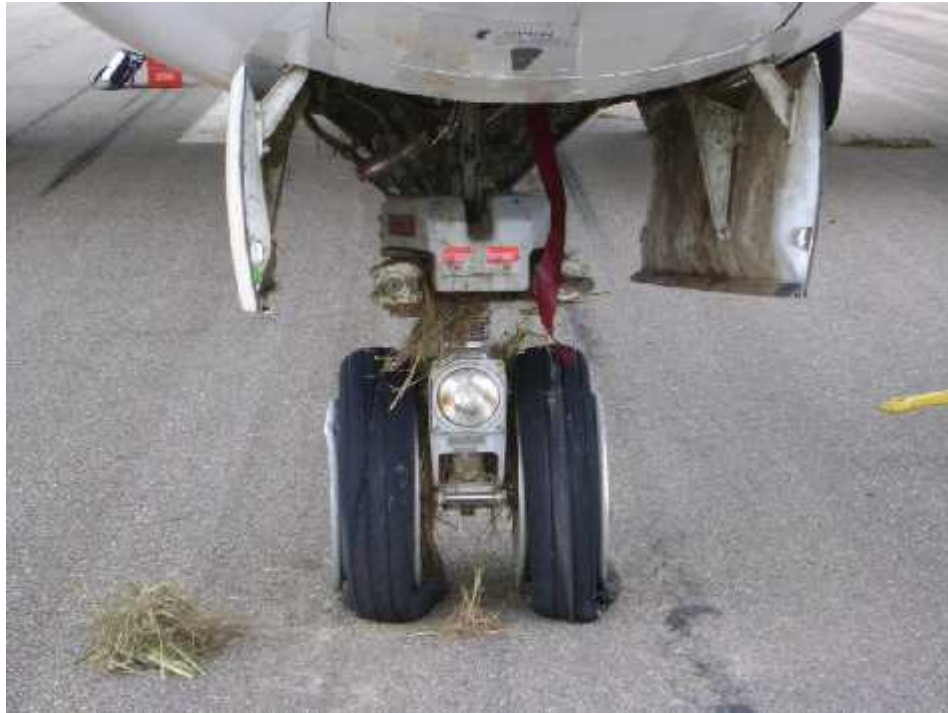
The aircraft recovered from the grass area back to the centre line of the runway and came to rest 2000 metres from the threshold of runway 28. The Nose gear shock strut collapsed and the two nose wheel were damaged and deflated. See fig 1.12a-g below;

Fig 1.12b Picture depicting nose landing shock strut collapse with burst tires

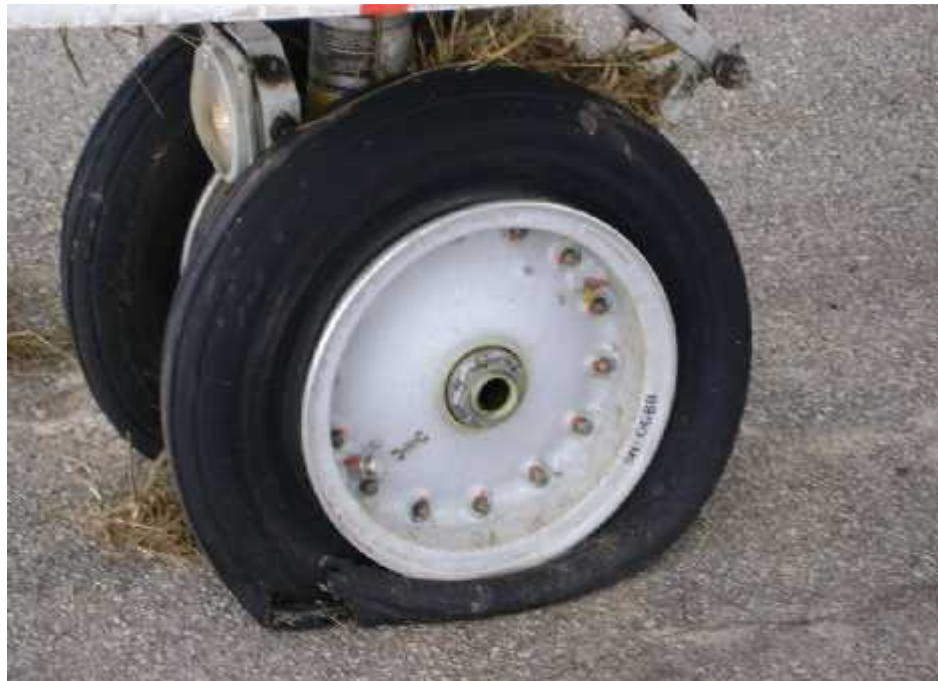
Fig 1.12c Picture showing nose landing gear with burst tires

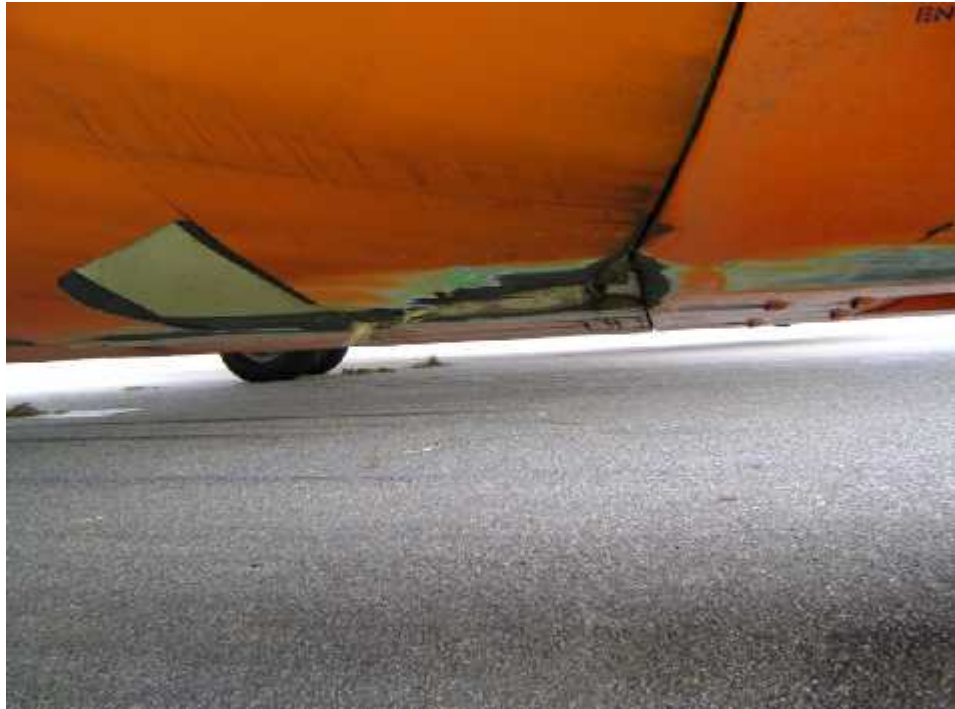
Fig 1.12d Picture showing under fuselage damaged

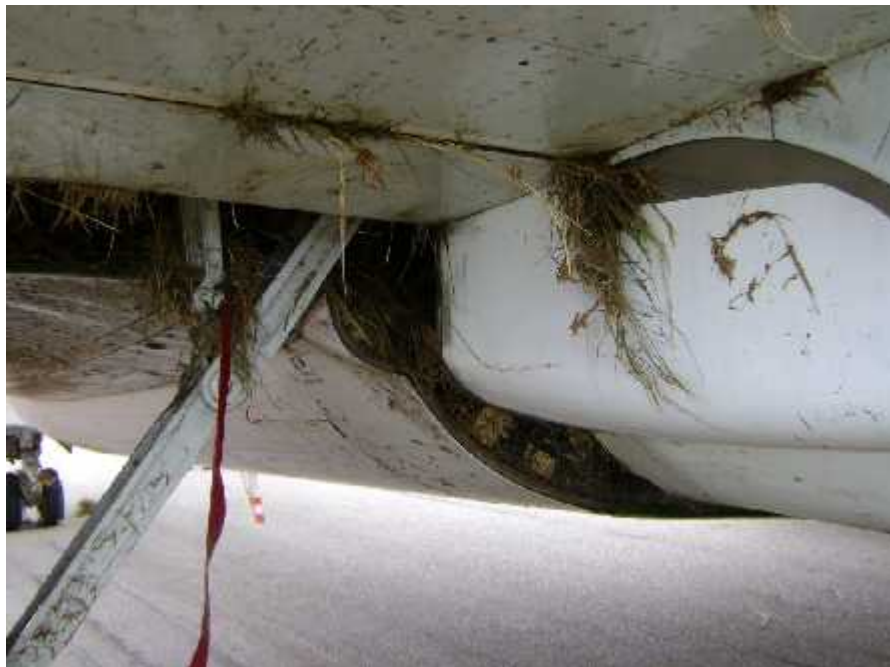
Fig 1.12e Picture showing engine cowling with ingested materials and lip damages

The Starboard engine made contact with the runway, damaged the lower cowling and ingested foreign objects that resulted in fan blades damage and punctures at the air intake section of the engine.

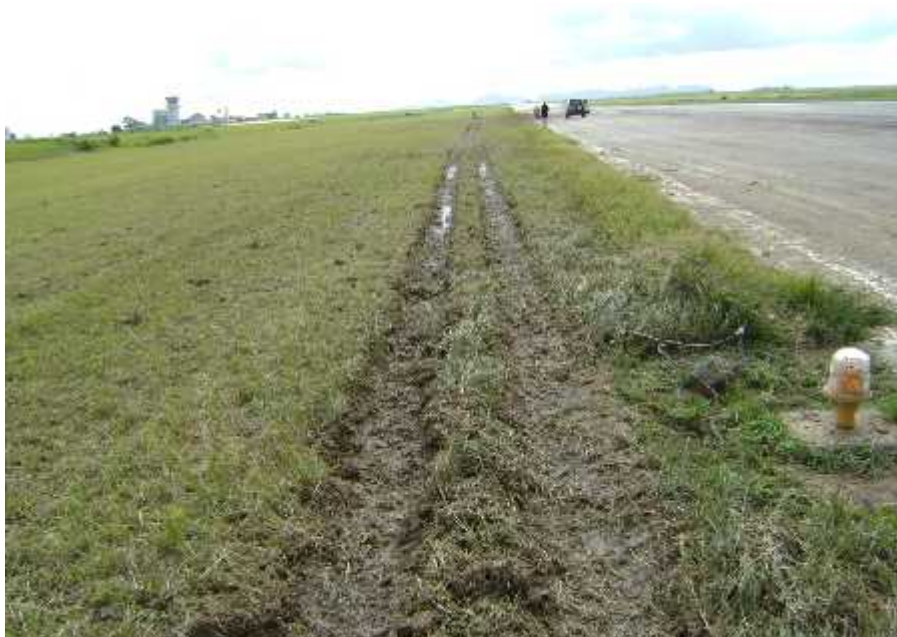
The aircraft touched down with the Right Main wheel 135 metres from the threshold, skidded off the runway to the left into the grass area, damaged three runway lights and uprooted the armored cables.

Fig 1.12f Picture showing tyre marks of aircraft veered off the runway 28

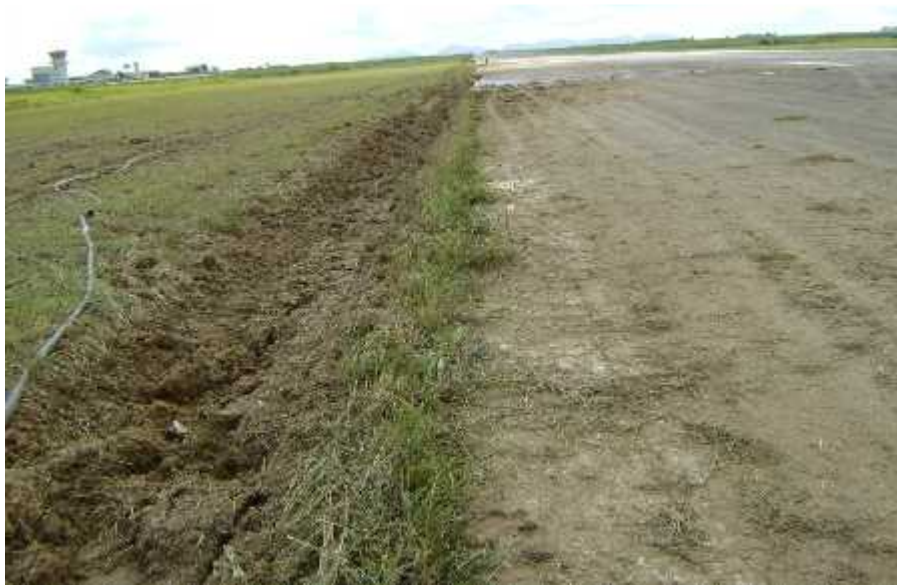
Fig 1.12g Picture showing tyre marks of aircraft veered off the runway 28
and up-rooted armored cable
