AIRCRAFT ACCIDENT REPORT

AERO/2016/04/09/F

**Report on the Serious Incident involving a B737-500
aircraft operated by Aero Contractors Company of Nigeria
Limited with Nationality and Registration Marks 5N-BLG
which occurred on Runway 18R, Murtala Muhammed
International Airport, Ikeja, Lagos
On 9th April, 2016**

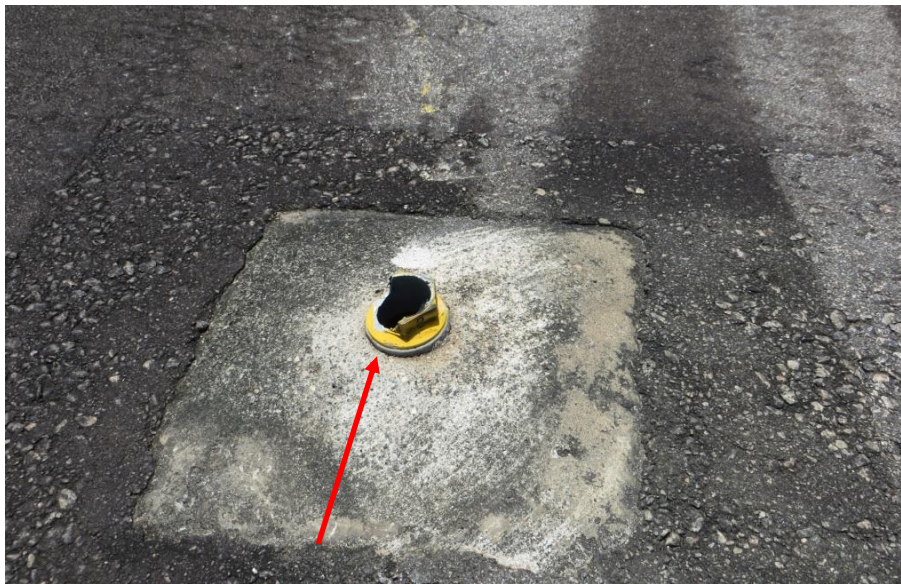
Four runway edge lights were broken.

Figure 1: A broken runway edge light fixture base

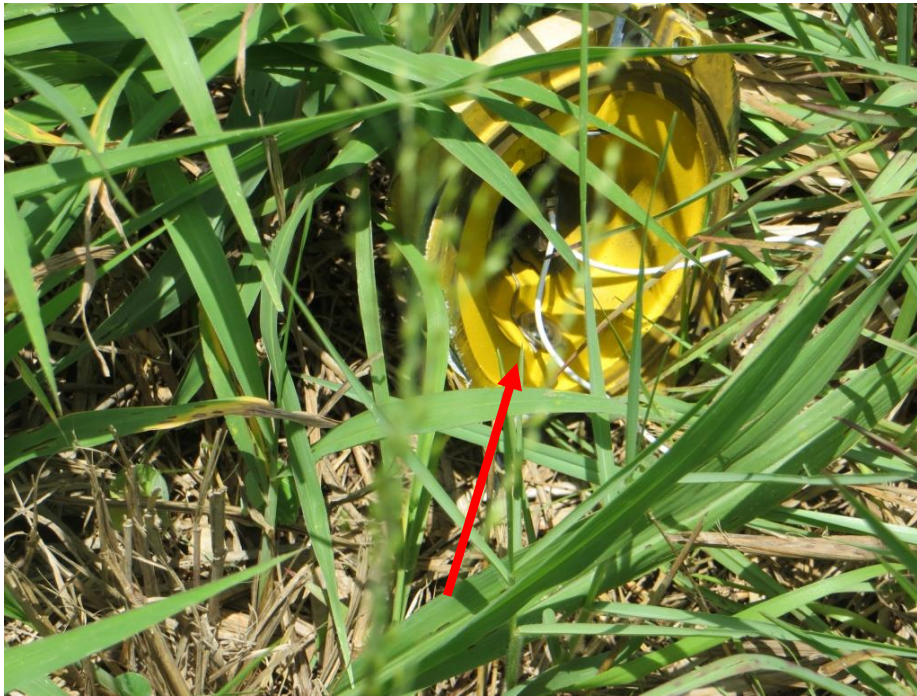
Figure 2: Photo of the broken runway edge light fixture

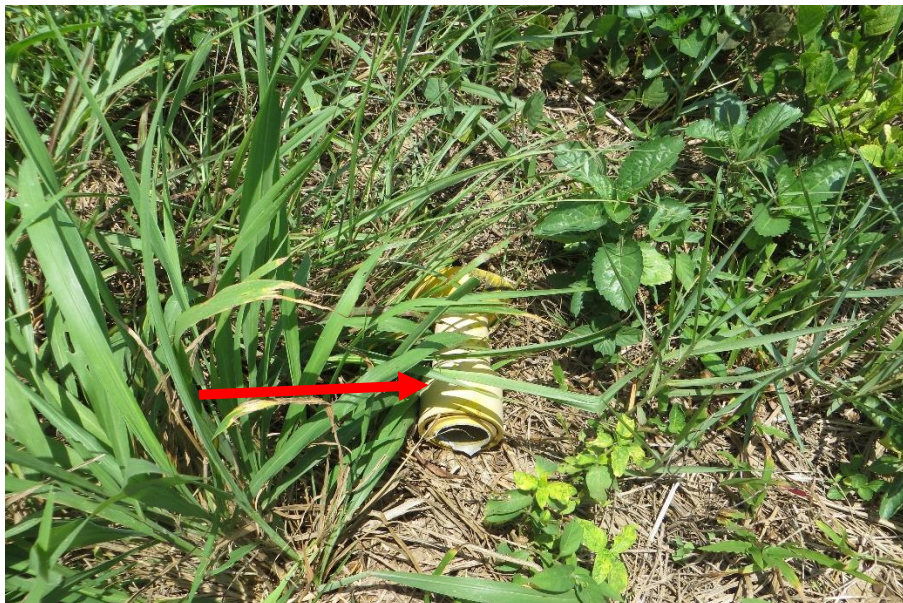
Figure 3: Photo of the broken runway edge light fixture

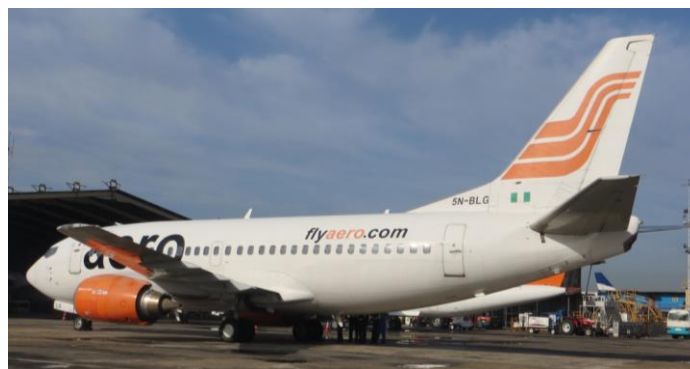
Figure 4: Photo of the aircraft after the incident

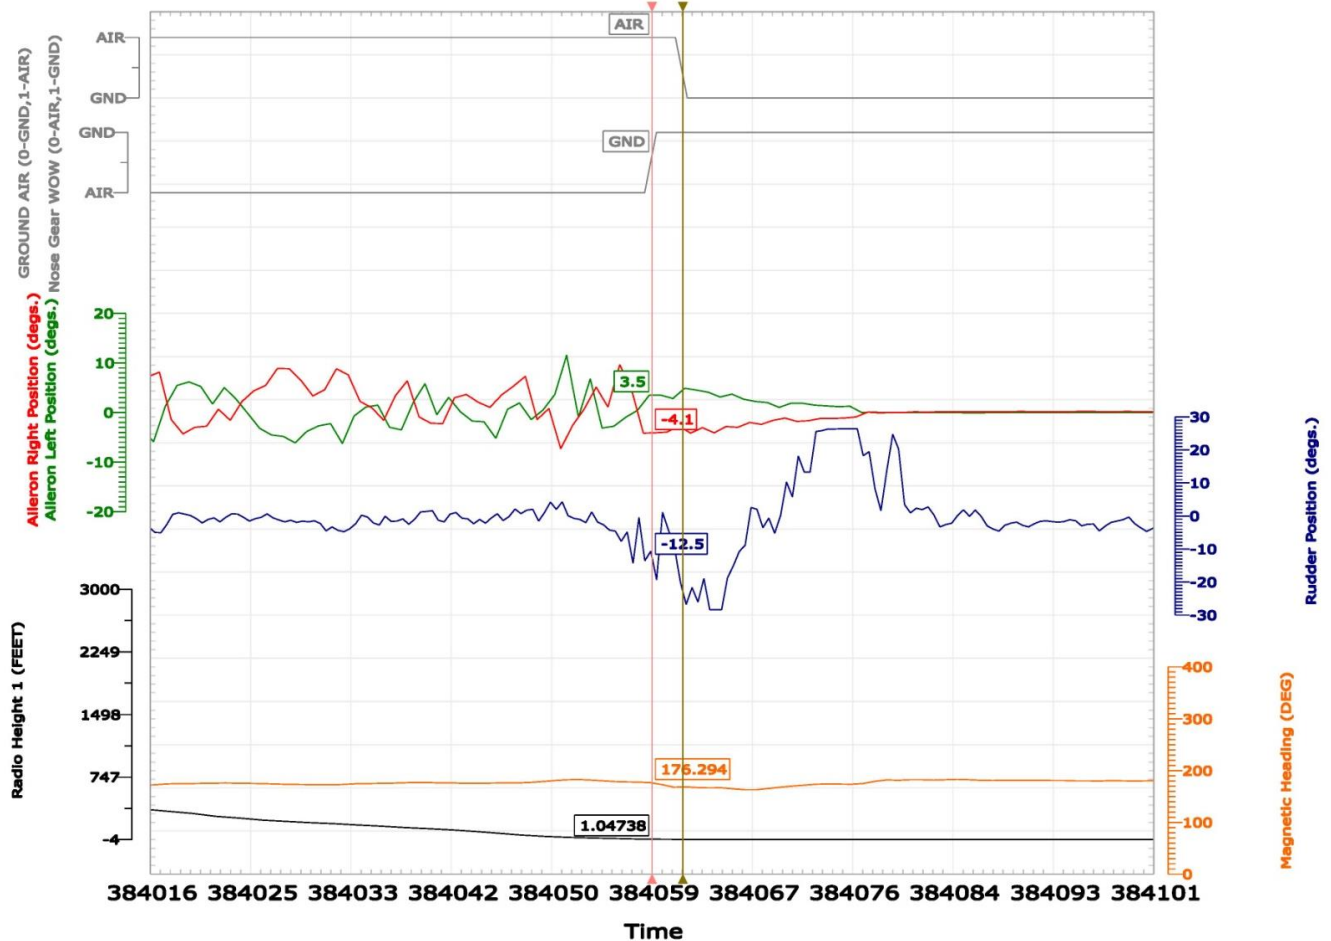
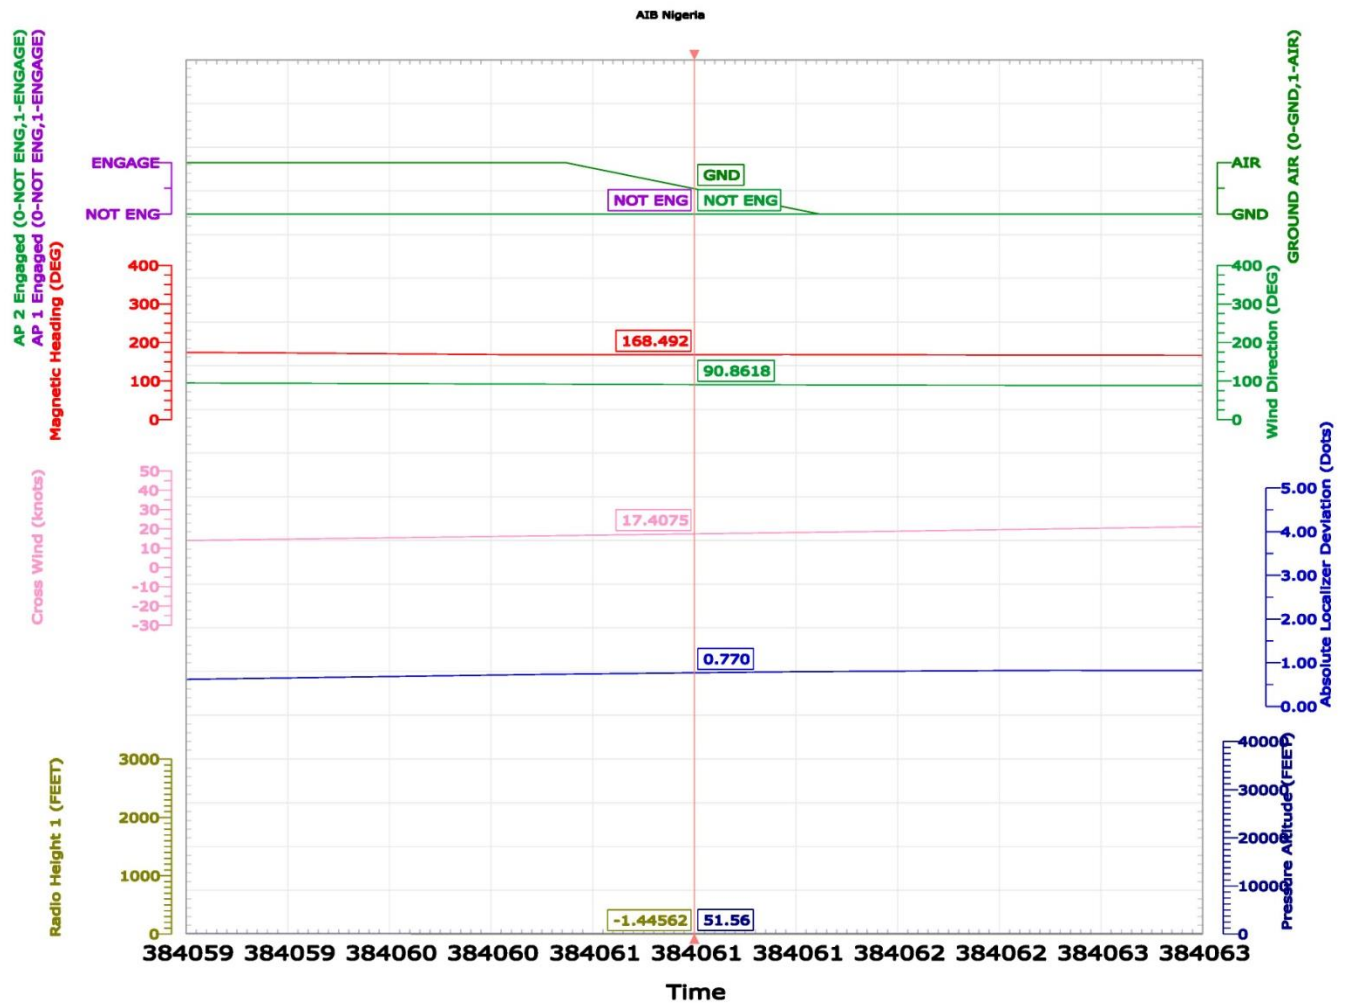
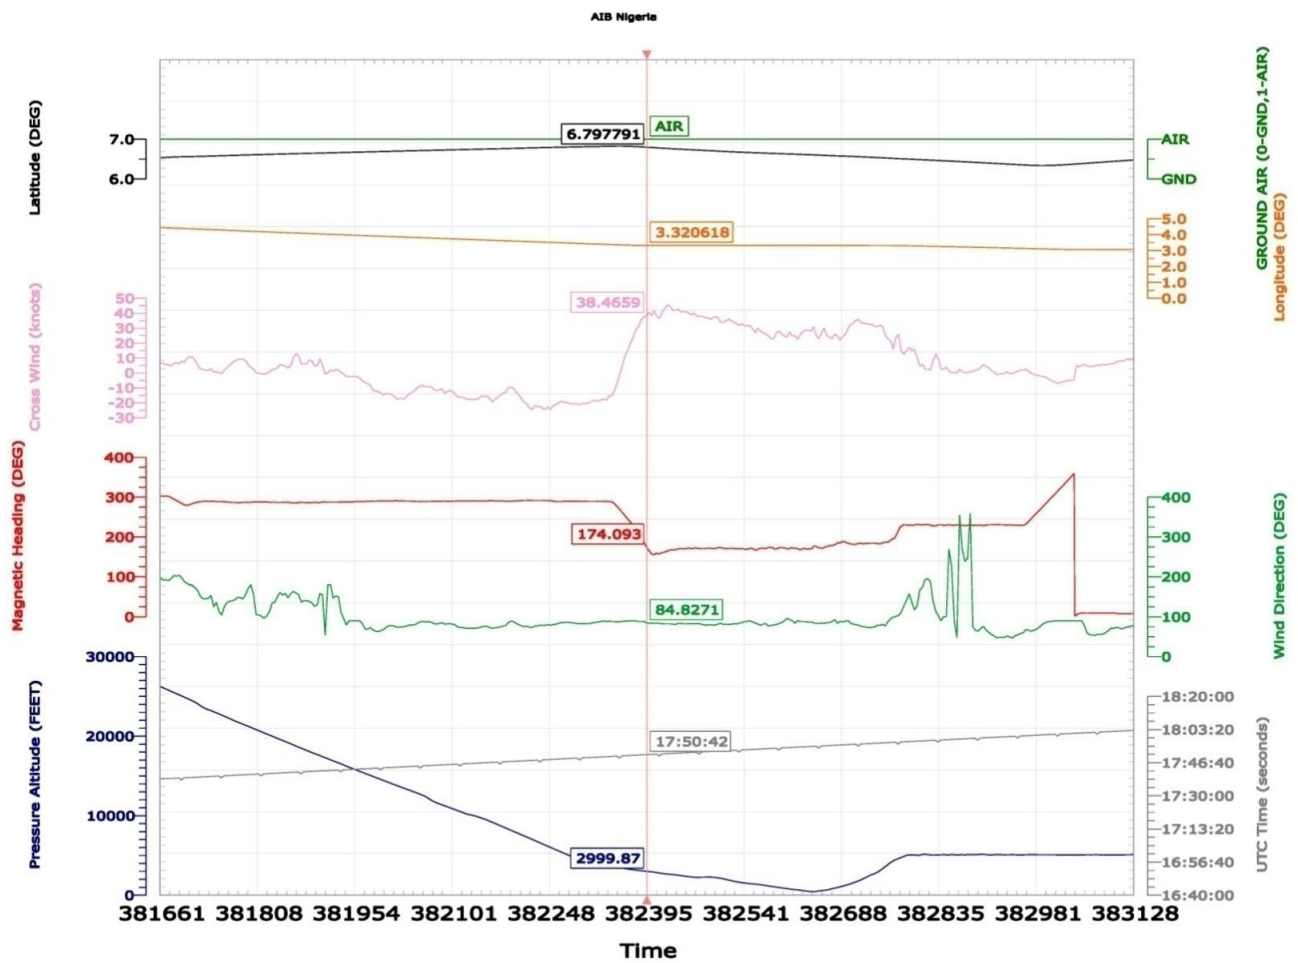
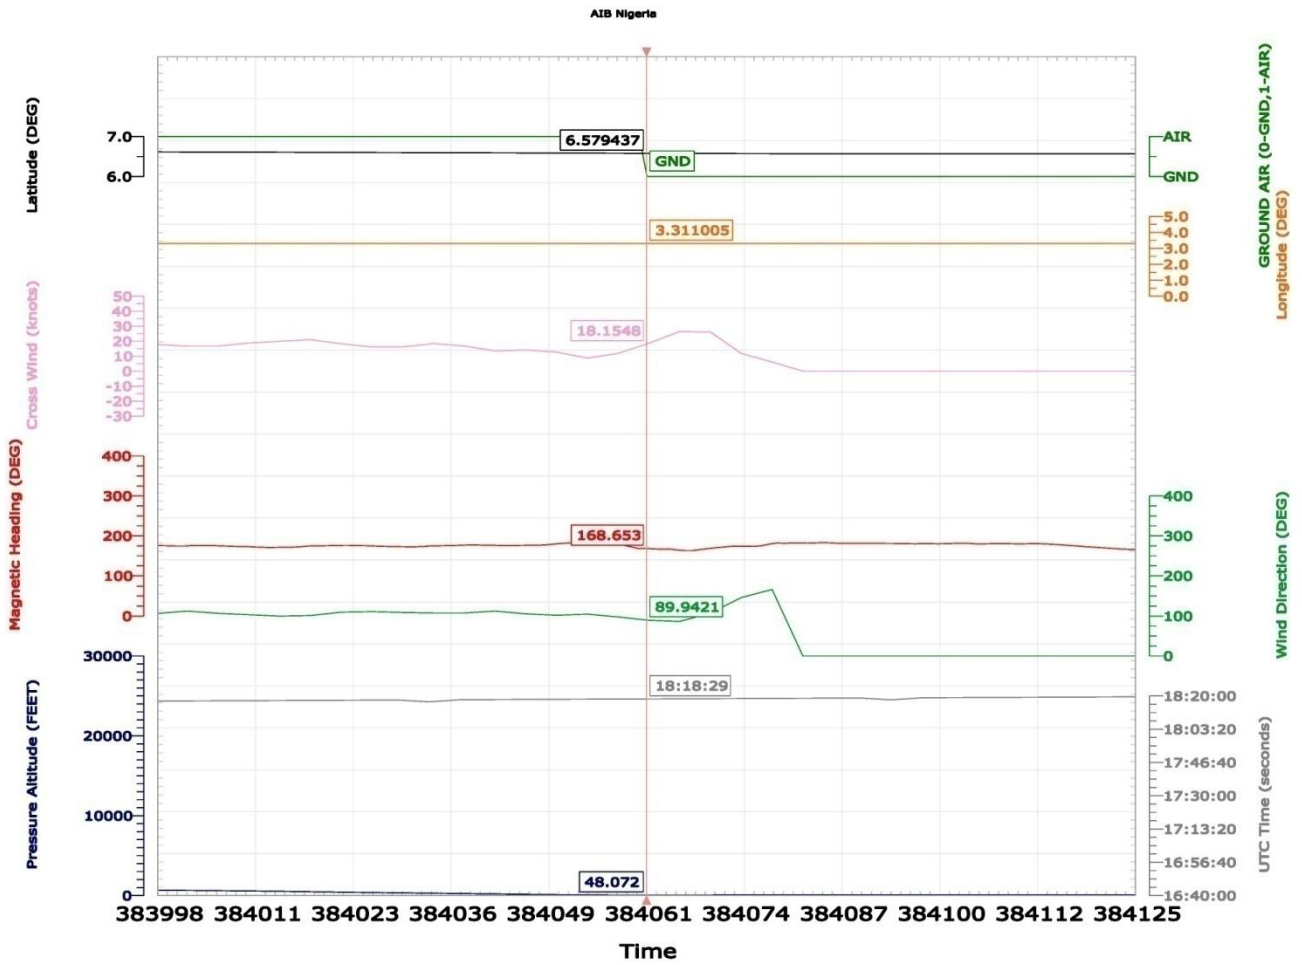
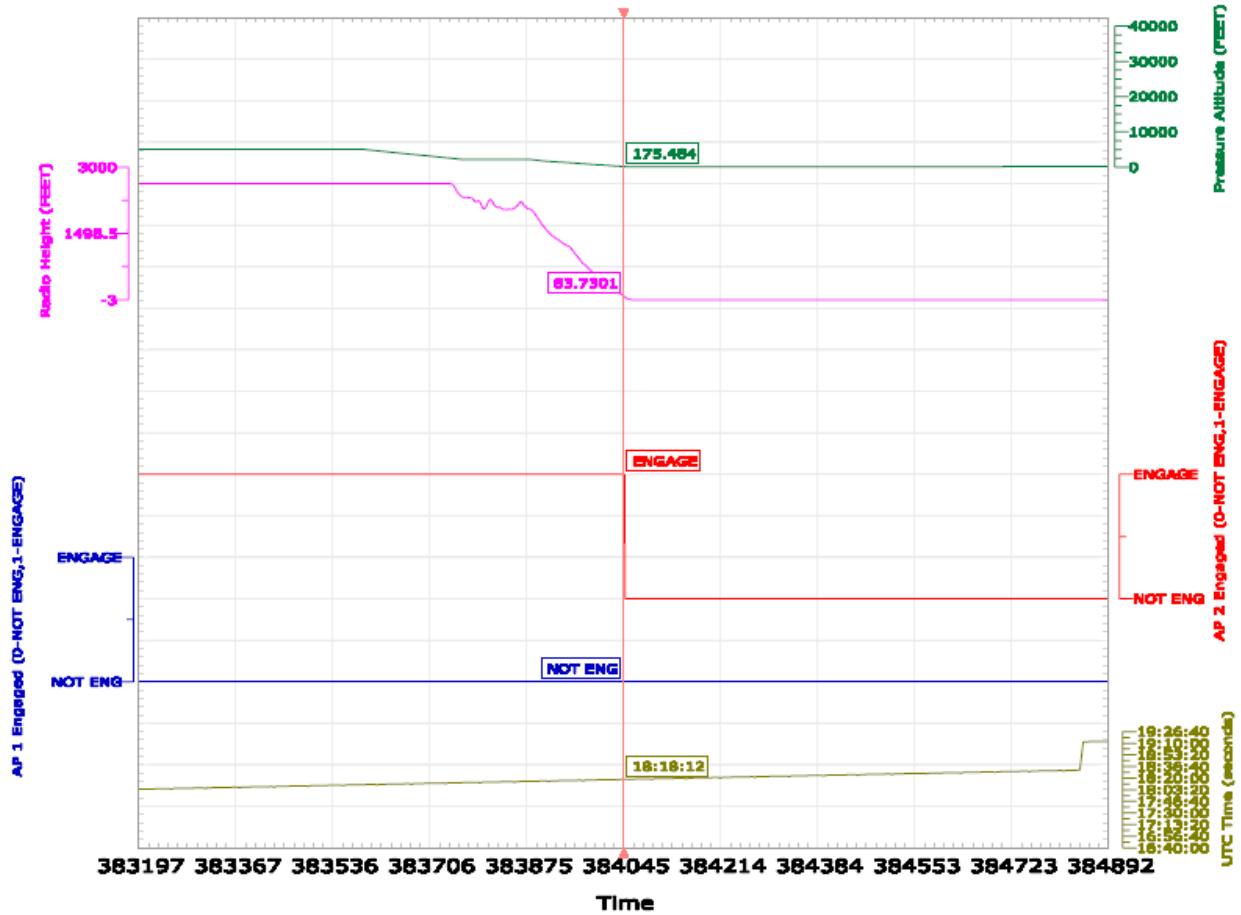
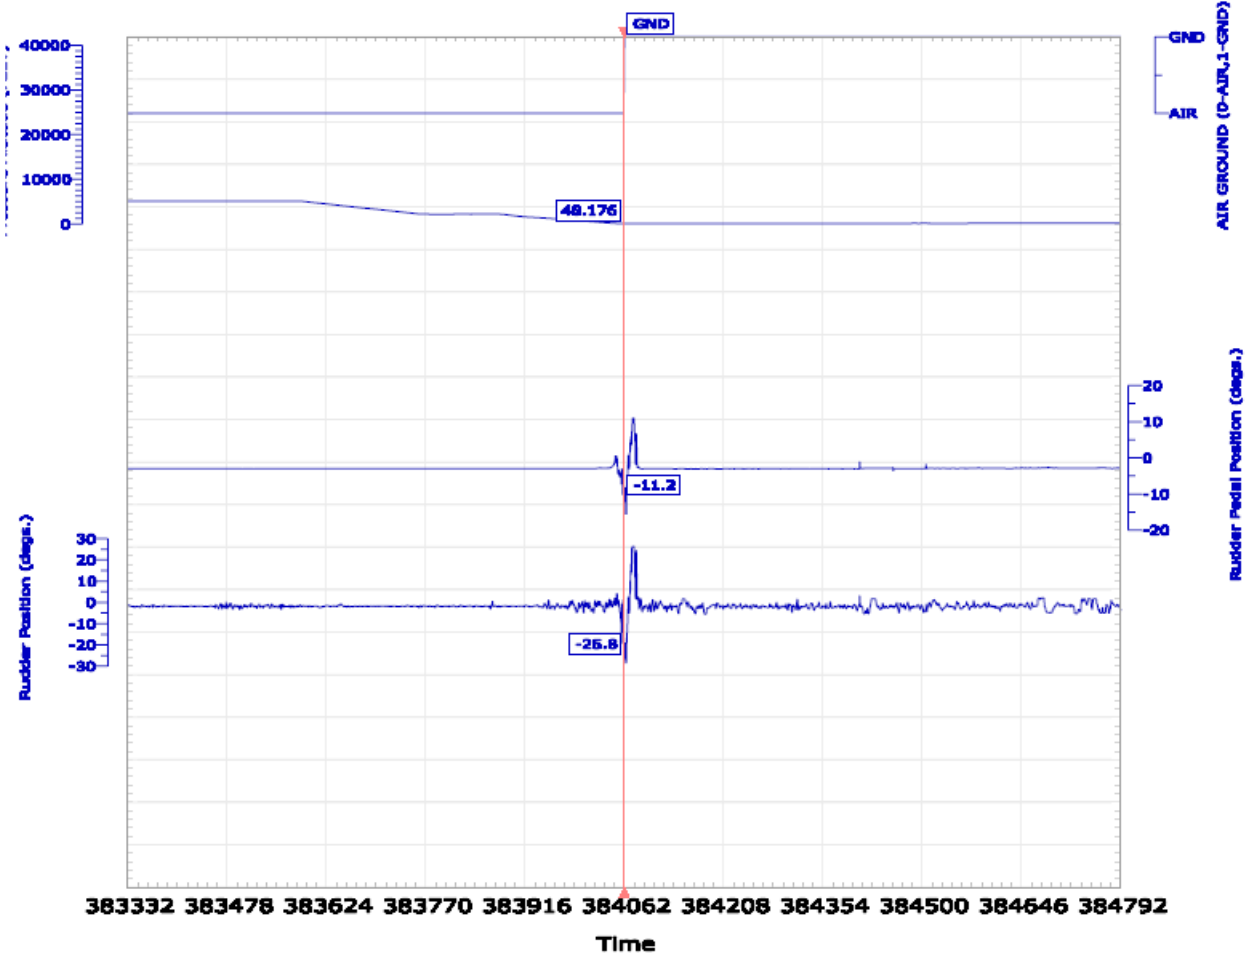
From the FDR analysis, the aircraft was on localizer and afterwards carried out a missed approach due to crosswind of 38 kt and magnetic heading of 174°. Before touchdown on second approach to runway 18R, the aircraft was crabbing to the left with a magnetic heading of 176.5°. The autopilot was disengaged at radio altimeter height of about 83 ft when the aircraft was on ILS approach.

The FDR plots indicate that the autopilot disengagement and touchdown occurred within seconds at 18:18 h (making the approach resemble an “auto land / approach” gone wrong).

The FDR plots also showed that the PF applied the rudder pedals prior to touchdown - the PF began a right rudder command input, likely to initiate a de-crab¹ manoeuvre. Shortly after touchdown the PF's right rudder command reached 11.2 degrees to the right of the datum with an associated deflection of 25.8 degrees of the aircraft rudder

tail plane to the right which corresponds to the aircraft veering to the right of the runway centreline and excused into the grass verge.

Aero Contractors Company of Nigeria Limited should lay more emphasis during flight crew simulator trainings, on the effects of excessive rudder application at high speeds during landing roll, particularly on wet/contaminated runways.

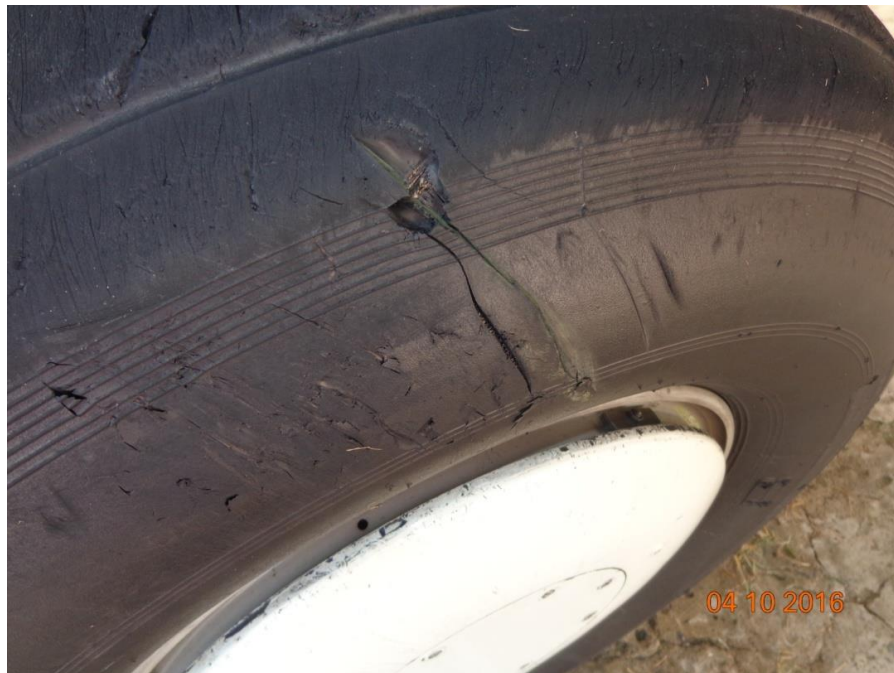
Post-occurrence inspection revealed deep cuts, dents and abrasions to the No. 1, No. 2 and No. 4 Main Landing Gear (MLG) tyres as well as No. 1 Nose Gear (NG) tyre. Grass was also found collected in the main wheel well, right main wheel axle and flap tracks.

Figure 11: Photo of a deep cut on No. 4 main wheel tyre

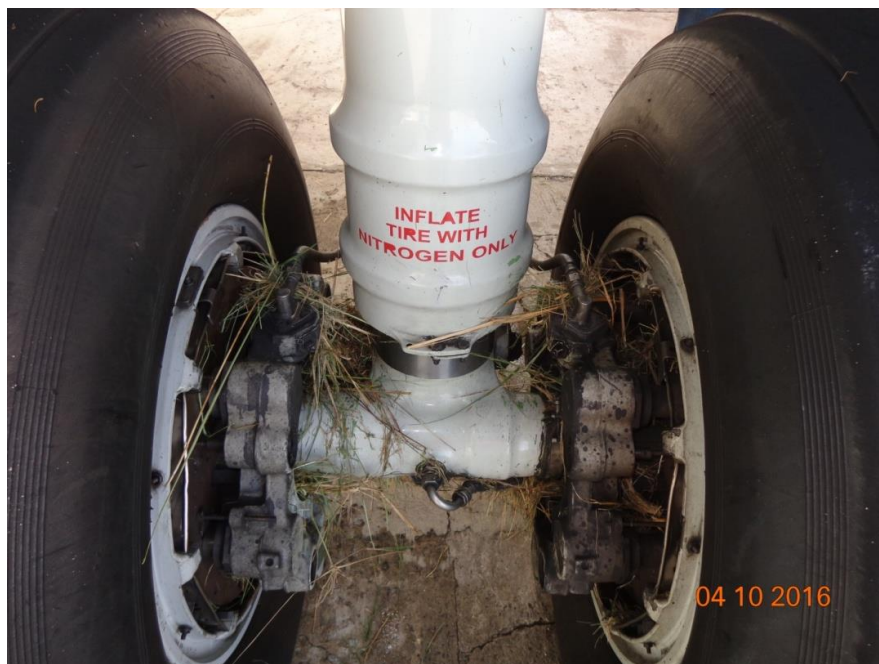
Figure 12: Photo of grass on right MLG assembly axle

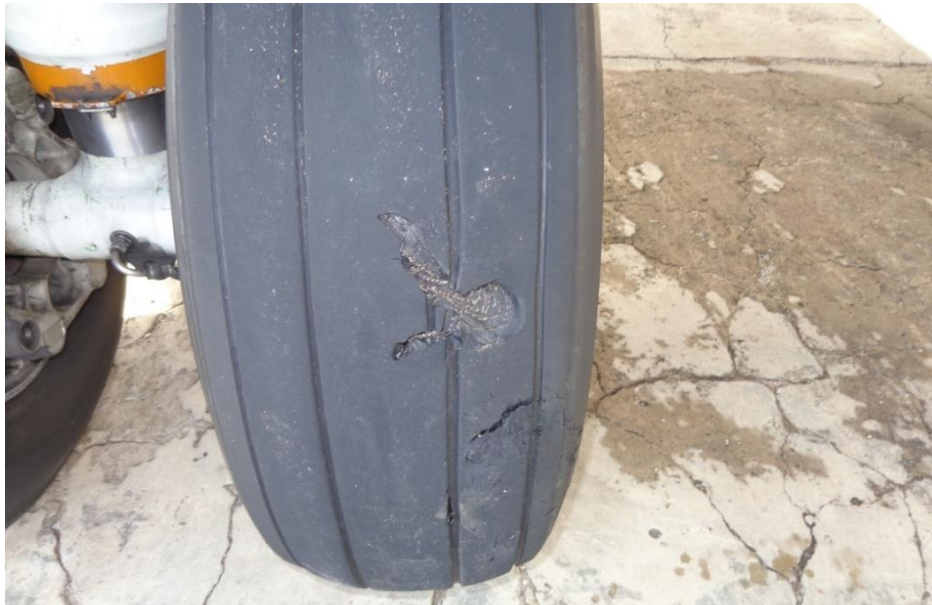
Figure 13: Photo of cuts and flat spots/abrasion on No. 2 main wheel tyre

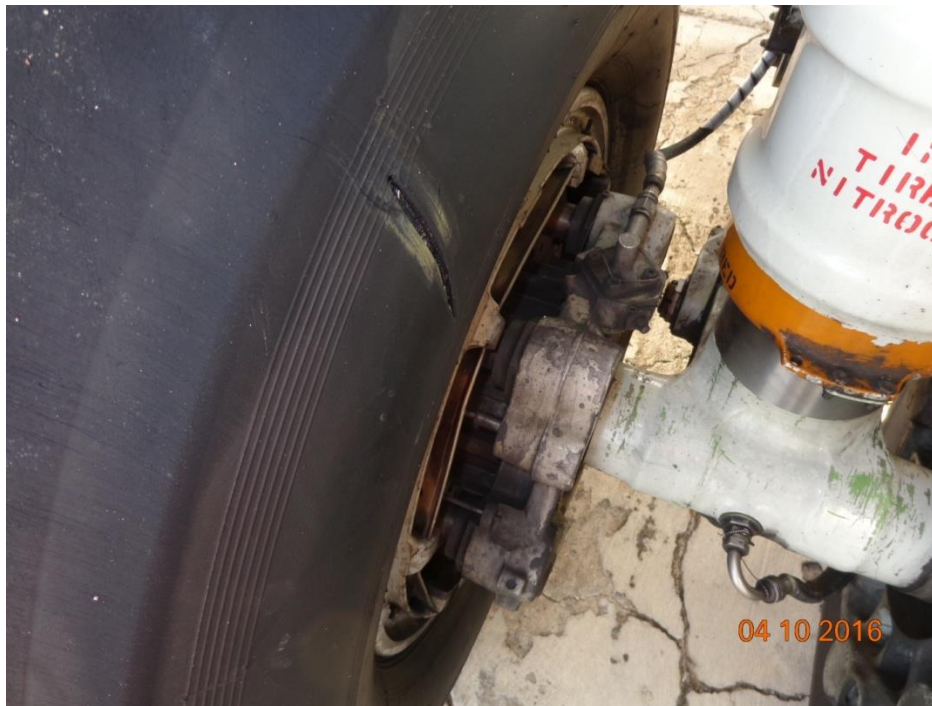
Figure 14: Photo of abrasion on No. 1 main wheel

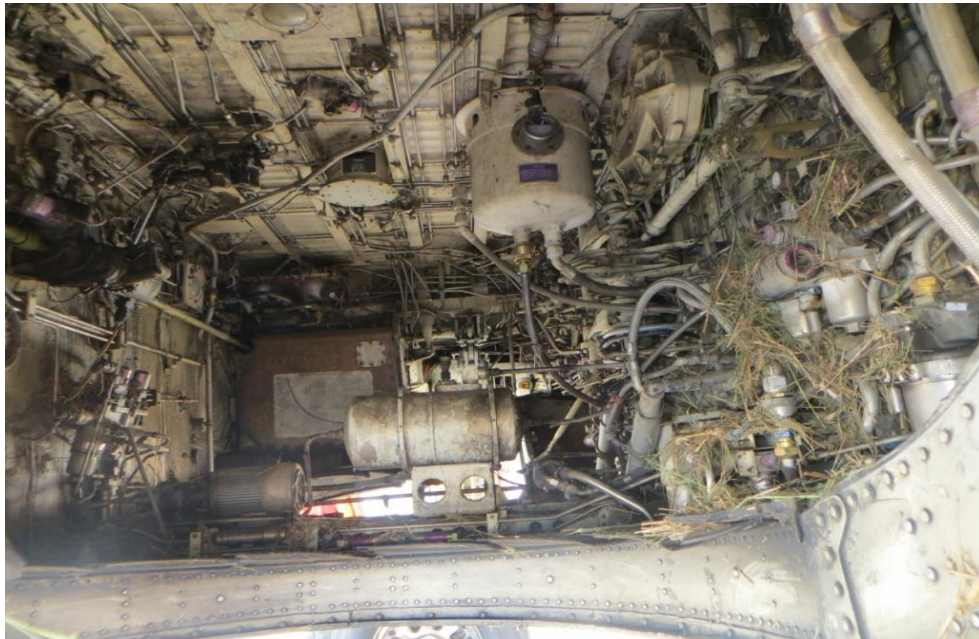
Figure 15: Photo of grass ingestion in the wheel well area

9. Grass was found in the right main wheel well.
10. Grass was found in right spoilers and flap tracks.
11. One of the runway cable trenches was destroyed.

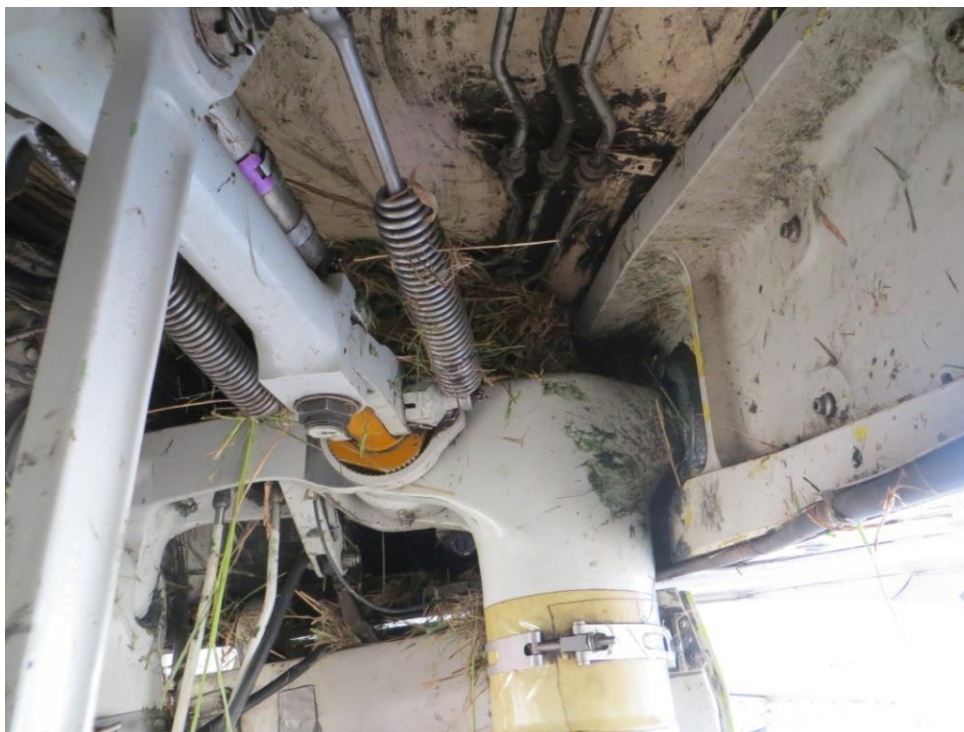
Figure 16: Photo of grass on right main landing gear attachment area

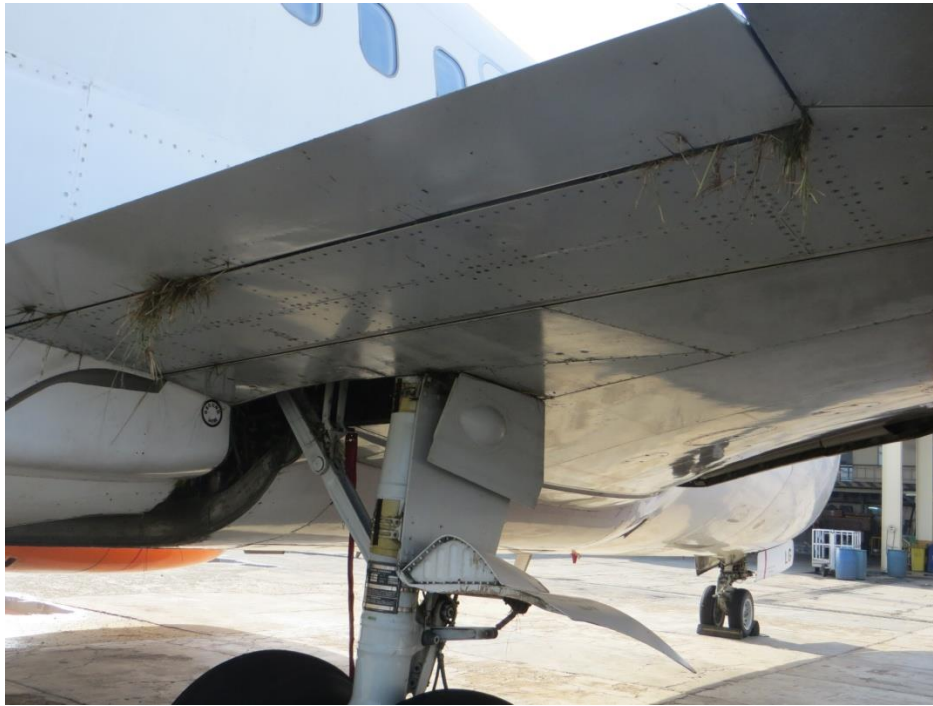
Figure 17: Photo of grass in the right inboard flap tracks
