# AIRCRAFT ACCIDENT REPORT

AERO/2017/04/18/F

**Report on the Serious Incident involving Bombardier  
DHC-8-Q400 aircraft owned and operated by Aero  
Contractors Company of Nigeria Ltd. with nationality  
and registration marks 5N-BPU which occurred at  
FL240, 80 NM to Lagos  
On 18th April 2017**

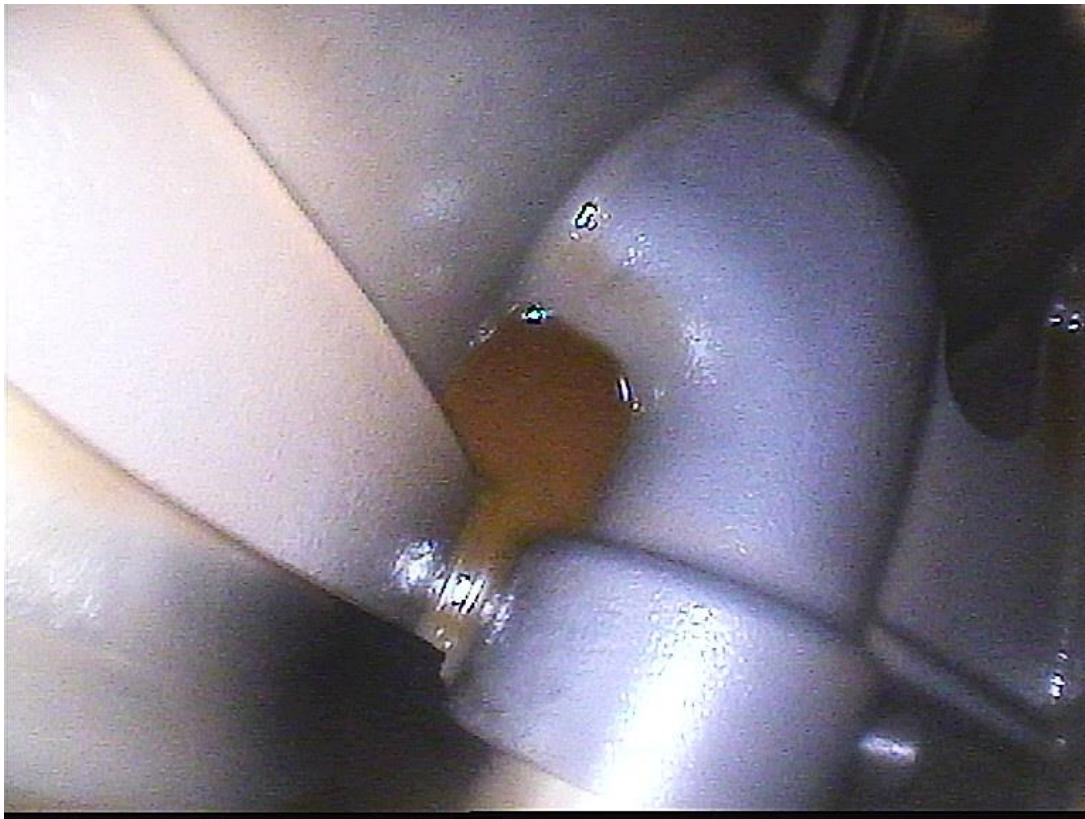
**Figure 2:** Photo of a pool of oil inside engine No. 1 discovered during borescope inspection

1. A collection of oil seen in the Compressor Inner Support (CIS) section of the engine
2. Visible oil stains and wetness at different sections in the gas path: inner compressor, Low Pressure 1<sup>st</sup> Stage Compressor Blades, High Pressure 4<sup>th</sup> Stage Axial Compressor, Inter Turbine Vanes, Accessory Gearbox and Inter Compressor Case.
3. Traces or random light oil stains were found on the blades and vanes in all other sections of the engine.

Borescope Inspection on Engine No. 1 showed traces of oil around the Low Pressure Compressor stage 1 blades, Inter-Compressor-Case (ICC), Inter-Turbine Vane Struts and Gas generator area of the engine. Wetness was found at the Gas Generator Case, PT Stage 1 case and Low Pressure Turbine (LPT) blades. The bleed air for the air conditioning system is extracted from stage 5 or 9 of the compressor (as the case may be) through a bleed valve and mixes with hot air for the required temperature to achieve passenger comfort. The presence of smoke in the cabin and cockpit area can be attributed to this conditioned air.

The result of the Borescope inspection carried out by the Aero Contractors Company Ltd revealed that the source of oil leakage from No.1 engine could not be ascertained at the conclusion of the borescope inspection but the oil found in the shaft area of the compressor interchange CIS was suggestive of failure of either CIS carbon seal or any of the internal oil supply tubes. The pool of oil leak mixing with the engine bleed air resulted to smoke in the aircraft cabin, cockpit and lavatory/cargo compartments which contaminated the Air Conditioning system of the aircraft. The smoke had no smell or odour, was not irritating to the eyes and did not cause cough.

Nigerian Civil Aviation Authority should ensure that operators utilize the New Oil Analysis Technology made available by Pratt & Whitney Canada in order to identify impending failure of the carbon seals on PW150A engines that are yet to comply with SB 35342R1.

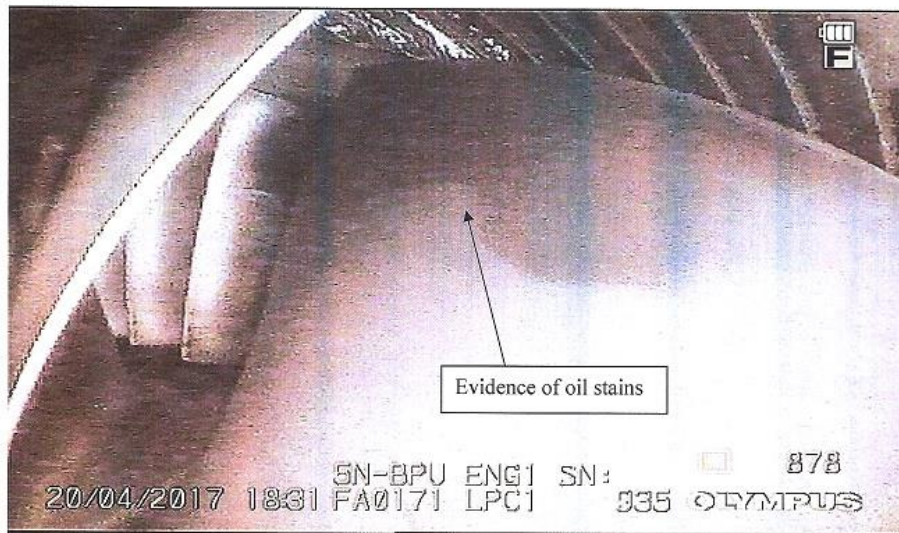
#### LPC STAGE 1 BLADES

Location	Ea	Findings:
		Evidence of oil stains found on several blades.
In Accordance with:	72-00-00	Sign & Stamp:

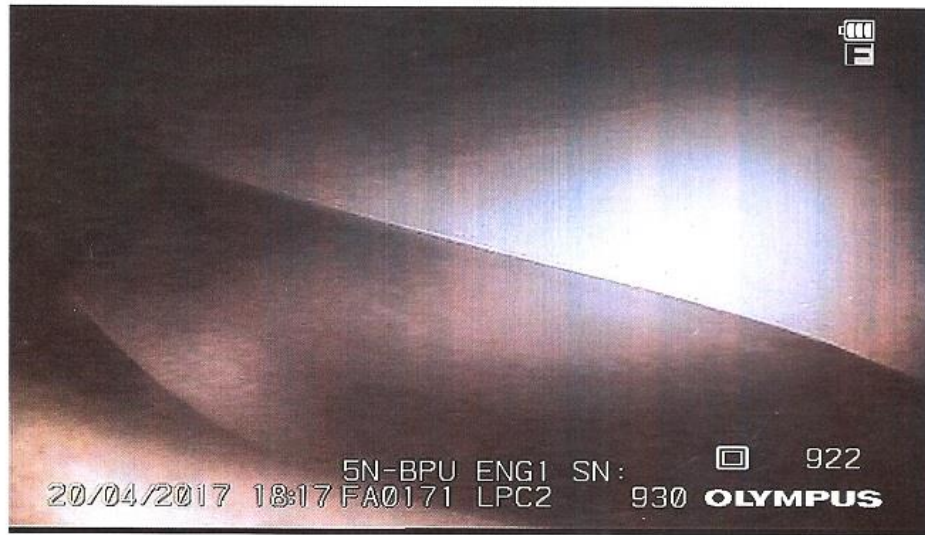
### LPC STAGE 2 BLADES

Location	Ea	Findings:
		No visible discrepancy.
In Accordance with:	72-00-00	Sign & Stamp:

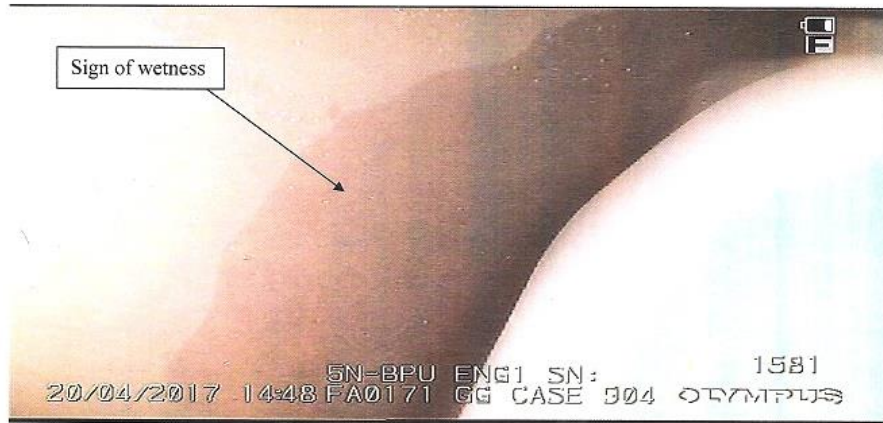
**GAS GENERATOR CASE**

Location	Ea	Findings:
		Sign of wetness
In Accordance with:	72-00-00	Sign & Stamp:

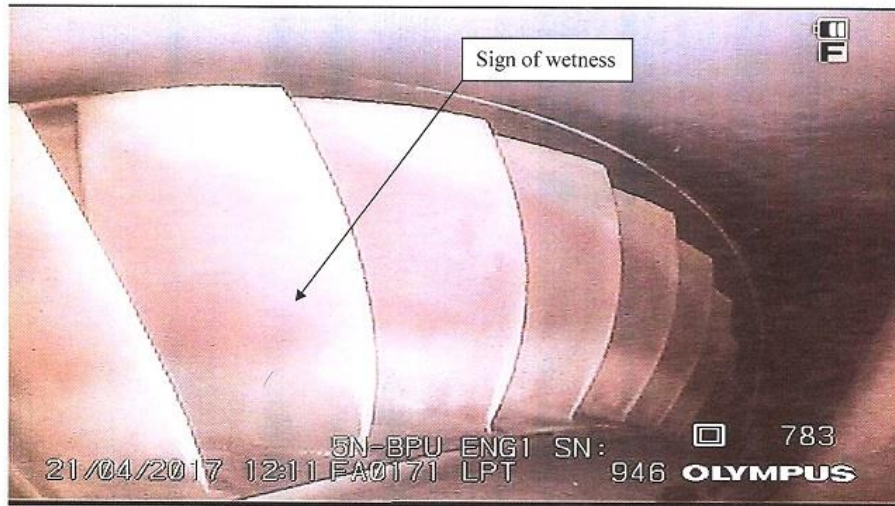
### LPT BLADES

Location	Ea	Findings:
		Sign of wetness
In Accordance with:	72-00-00	Sign & Stamp:

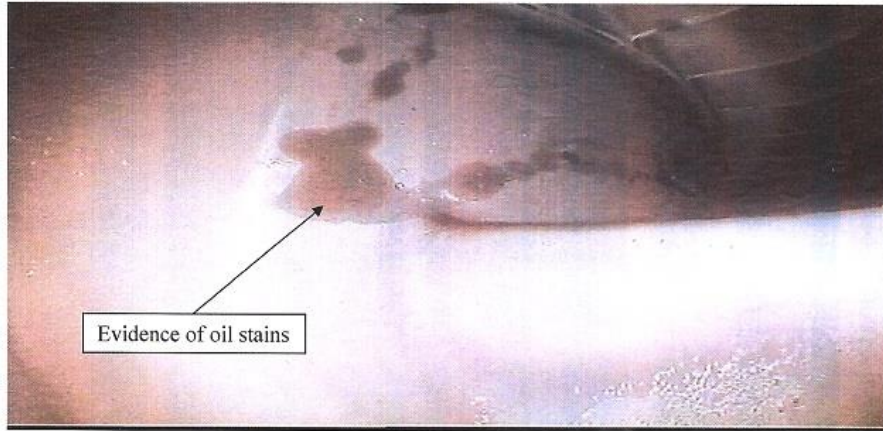
### INTER TURBINE VANE STRUTS

Location	Ea	Findings:
		Evidence of oil stains
In Accordance with:	72-00-00	Sign & Stamp:

Evidence of oil stains

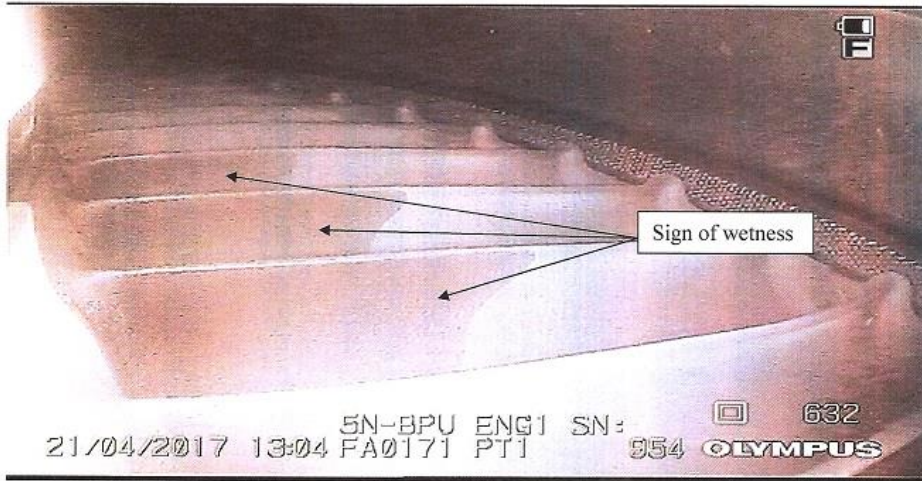
PT STAGE 1 BLADES

Location	Ea	Findings:
		Sign of wetness
In Accordance with:	72-00-00	Sign & Stamp:

Sign of wetness
