AIRCRAFT ACCIDENT REPORT

AIB/DHL/2006/09/07/F

**Report on the Accident Involving
DHL, Registration ZS - DPF,
at Murtala Muhammed International Airport,
Ikeja, Lagos. Nigeria
On 7 September 2006**

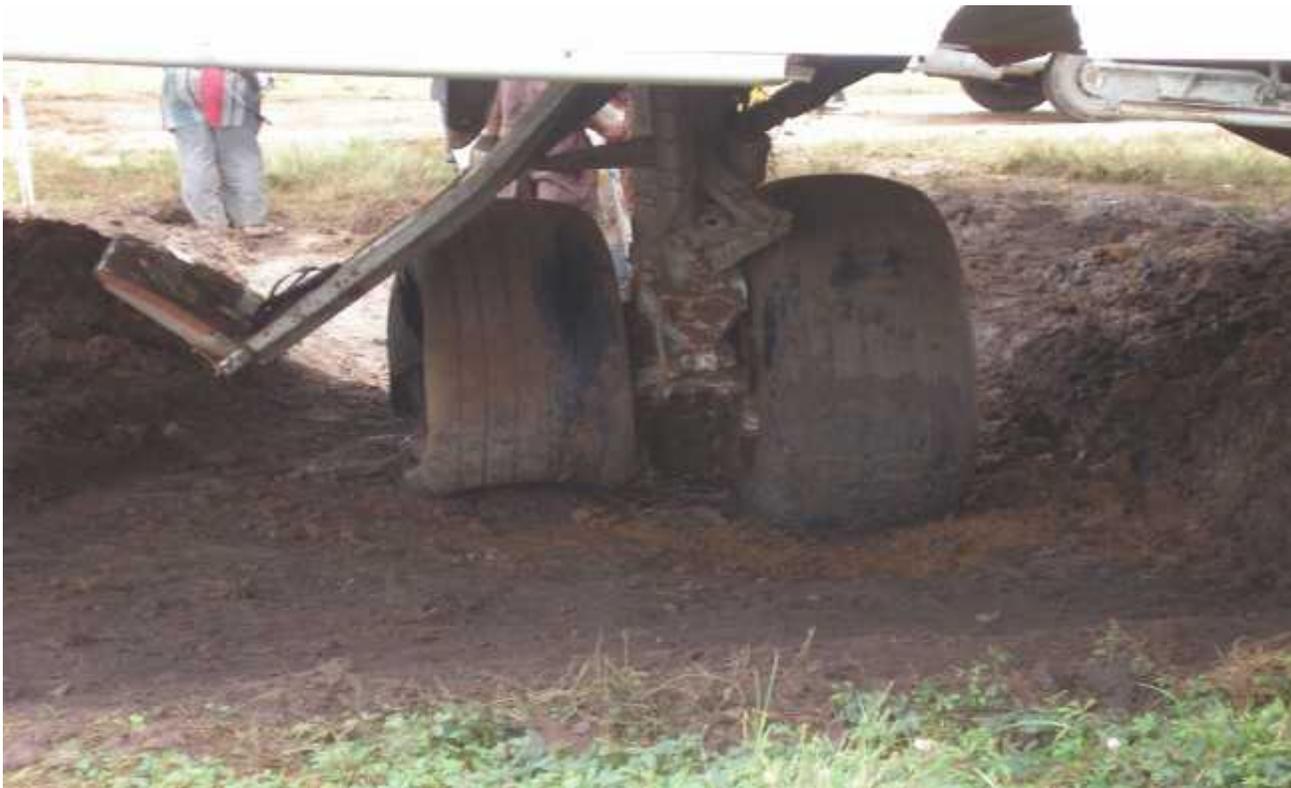
- (i) Nose wheel (sheared off)
- (ii) Nos. 1 and 4 main wheels
- (iii) Left wing leading edge devices.

Fig 1.3a Damage to Main gear assembly

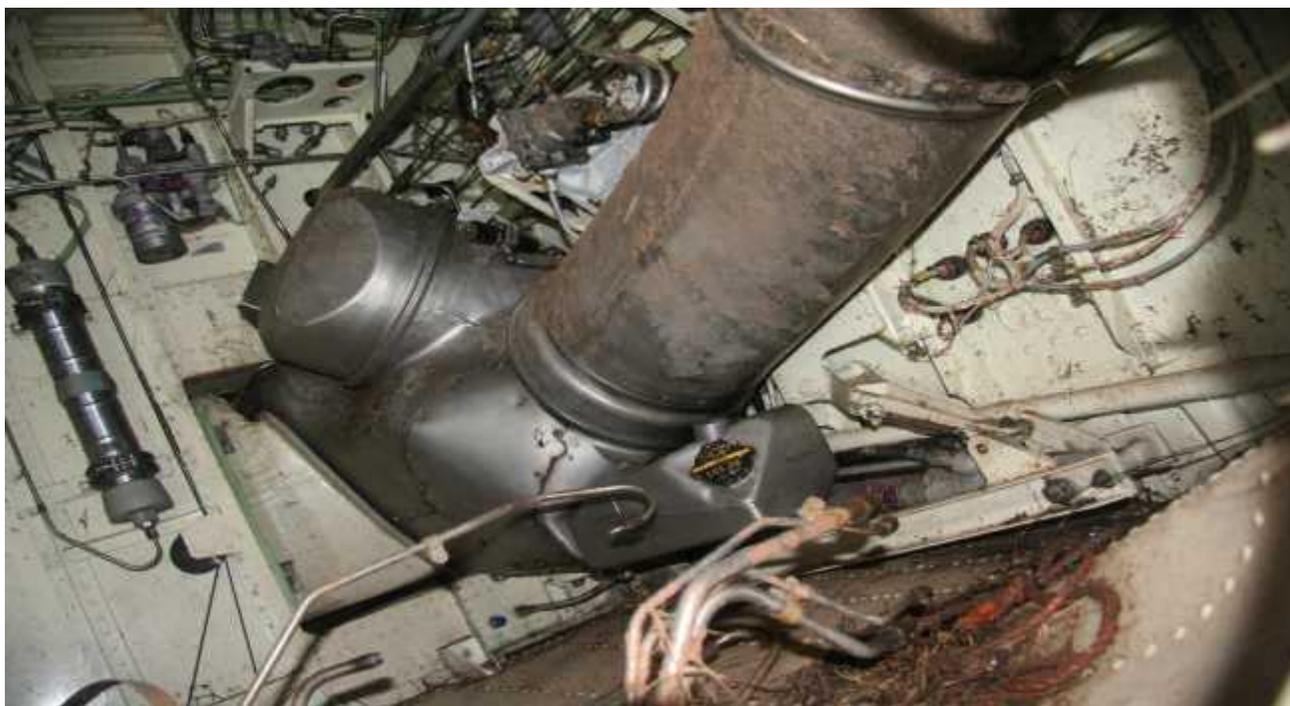
Fig 1.3b Wheelwell damage

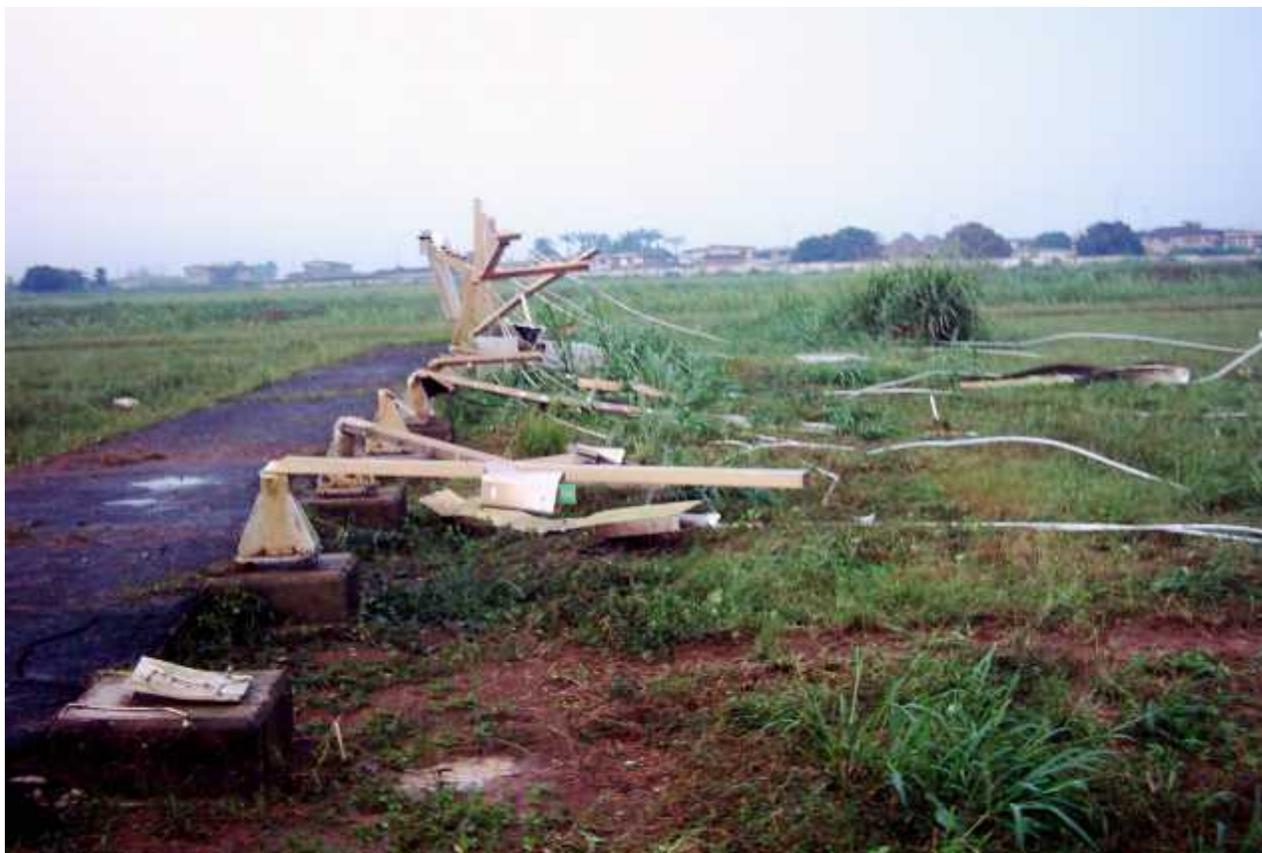
Runway 18L localiser antennae and runway end lights were damaged (See fig 1.4).

Fig 1.4 Damage to NAV aids

The aircraft overshot the runway and in the process broke some runway end lights and ILS antennae leaving high voltage armoured cables exposed which constituted hazard to personnel.

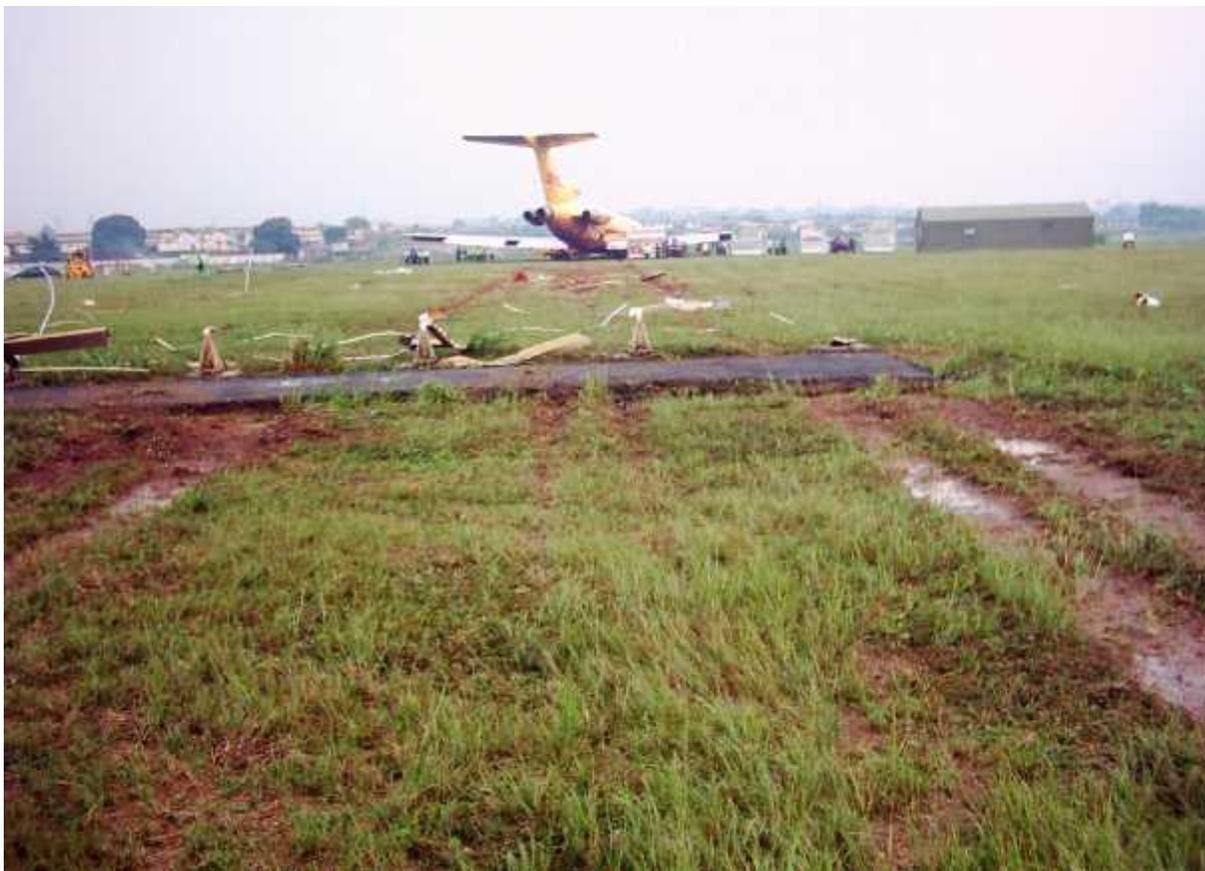
The aircraft landed and overshot the runway into the grass area. The nose wheel landing gear sheared off. The No. 1 and 4 wheels were damaged. The left wing leading edge devices were damaged. The impact also damaged the runway 18L ILS antennae and the runway end lights (See fig. 1.12a-b).

Fig 1.12a Wreckage scene

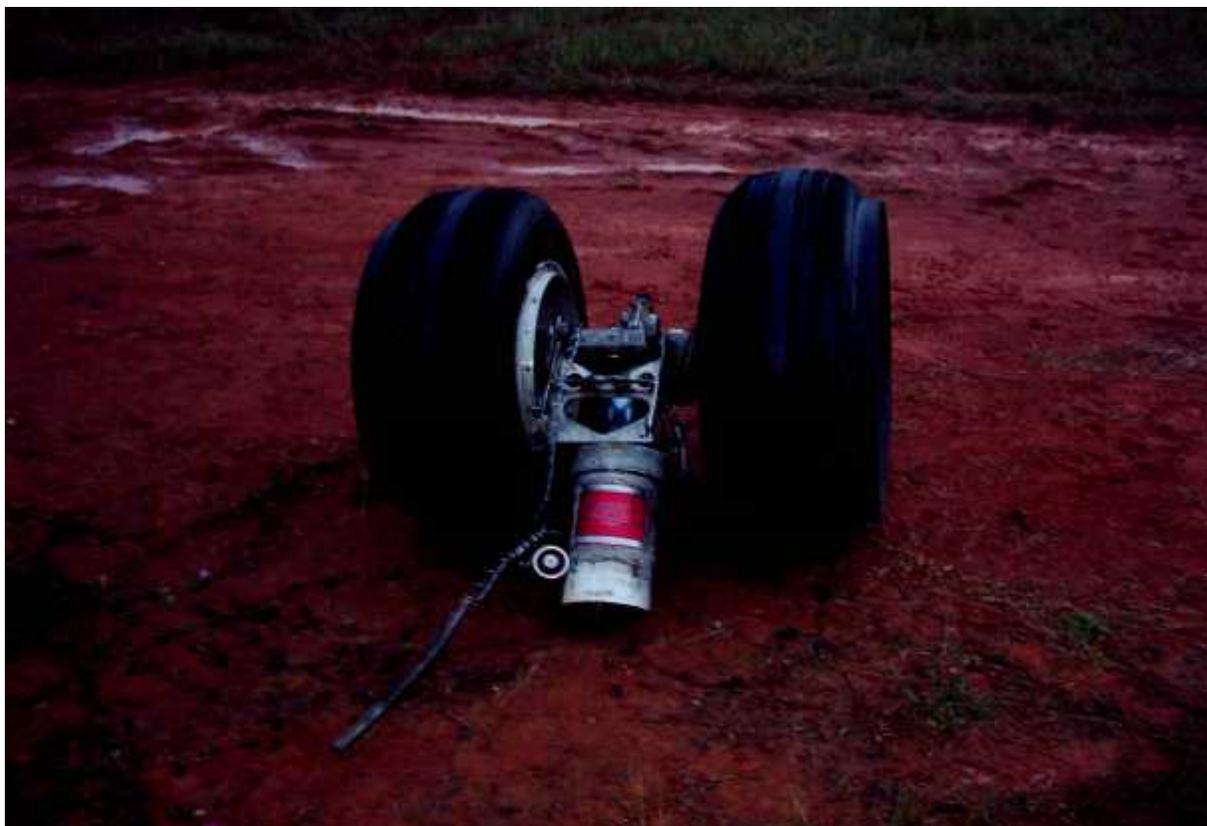
Fig 1.12b Sheared Nose gear assembly

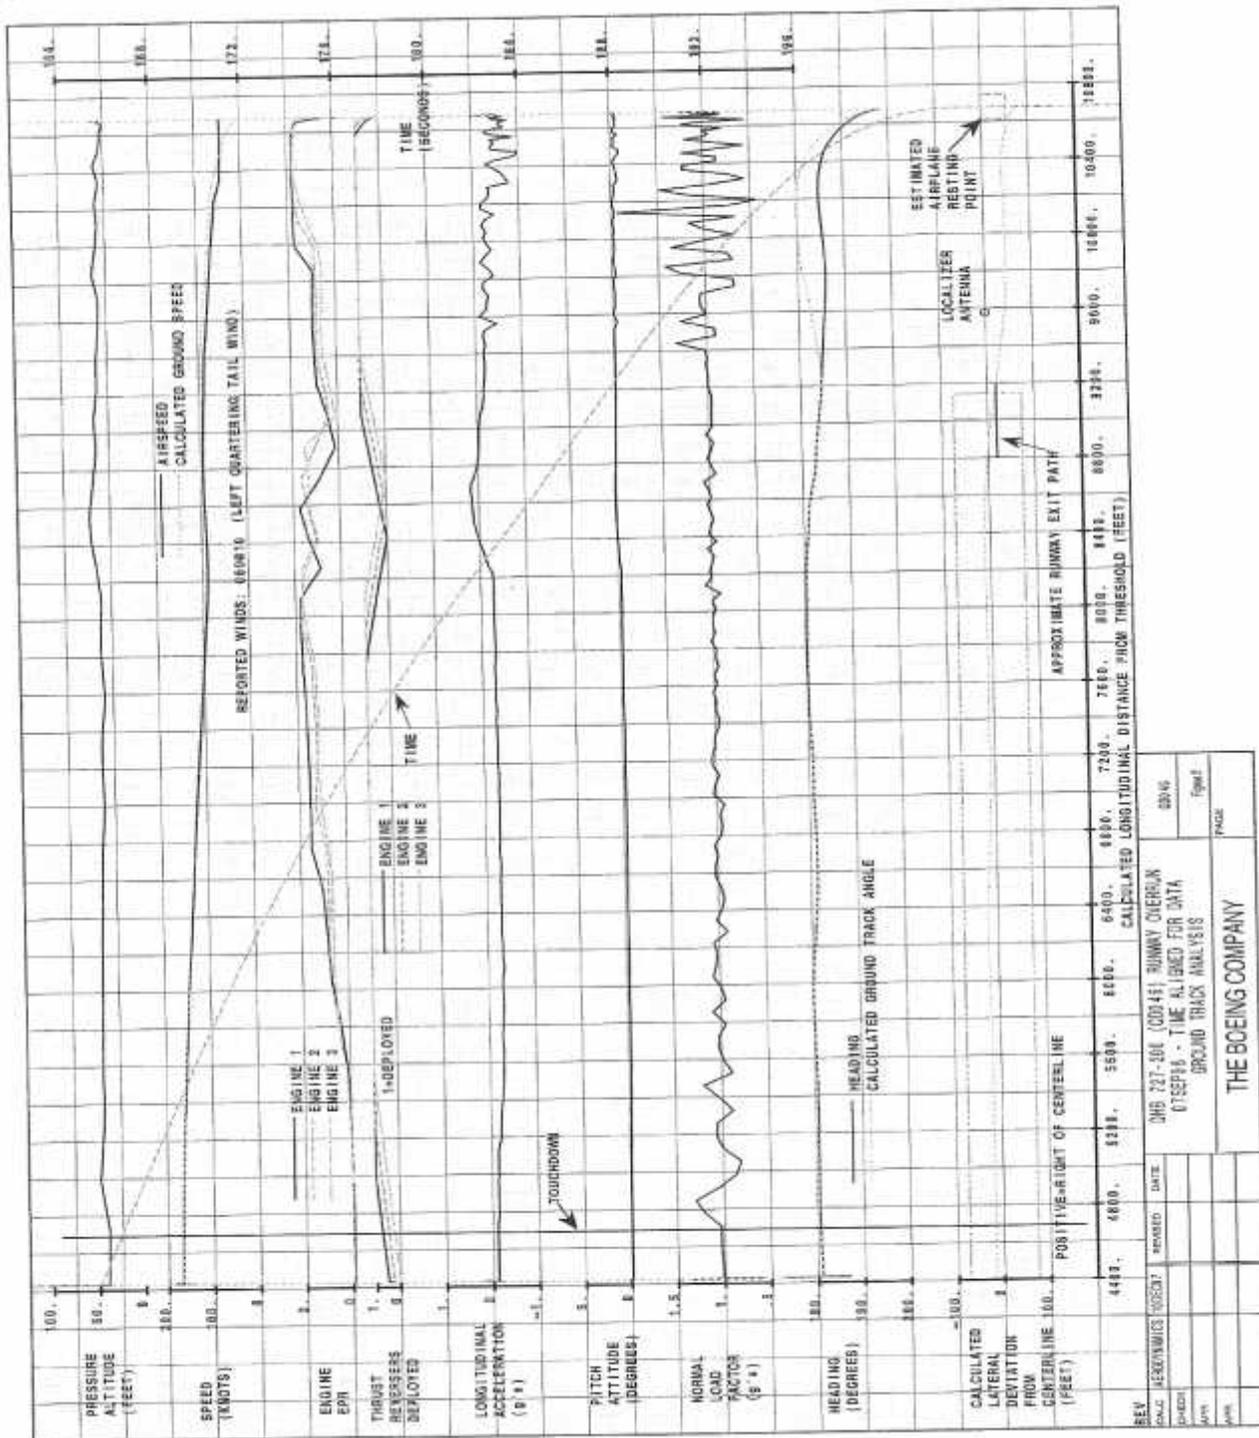
Figure 1 identifies three key events during the landing based on the change in character of the recorded normal load factor and longitudinal acceleration, 1) the touchdown, 2) the runway departure, and 3) the full stop. In order to provide a touchdown point and speed it was necessary to compute the ground track shown in Figure 2. The process for computing a ground track relies on the aircraft ground speed which, as noted above, was not available. A ground speed was estimated by integrating the longitudinal and normal accelerations, in conjunction with the recorded pitch angle, and constraining the solution by anchoring it to the point at which the aircraft came to a stop. Normally, a kinematic analysis is performed in order to determine the typical accelerometer bias that must be applied to correct for known sensor and mounting errors. In this case, the limited data does not allow for the development of an accurate kinematic analysis. As such, a bias is applied to the longitudinal acceleration so that the slope of the ground speed approximately matches the slope of airspeed between the runway departure and recorded airspeed of 60 knots. Figure 2 shows the calculated ground track angle required to achieve a track consistent with the runway exit path observed on site. It can be seen that the point at which the aircraft exits the runway does not correlate to the change in character of the load factor data. While the change in the character of the load factor data most likely indicates runway departure, this cannot be confirmed without additional on-site ground track evidence. Due to these discrepancies, the accuracy of the touchdown is believed to be no better than ± 500 feet.
