PRELIMINARY REPORT ON THE SERIOUS INCIDENT INVOLVING A BOEING 737-500 AIRCRAFT WITH NATIONALITY AND REGISTRATION MARKS 5N-BUJ OWNED AND OPERATED BY AIR PEACE LIMITED WHICH OCCURRED ENROUTE SAM MBAKWE AIRPORT, OVERRI ON 5TH NOVEMBER, 2019

| Aircraft Accident Report No.: | AIRPEACE/2019/11/05/D |

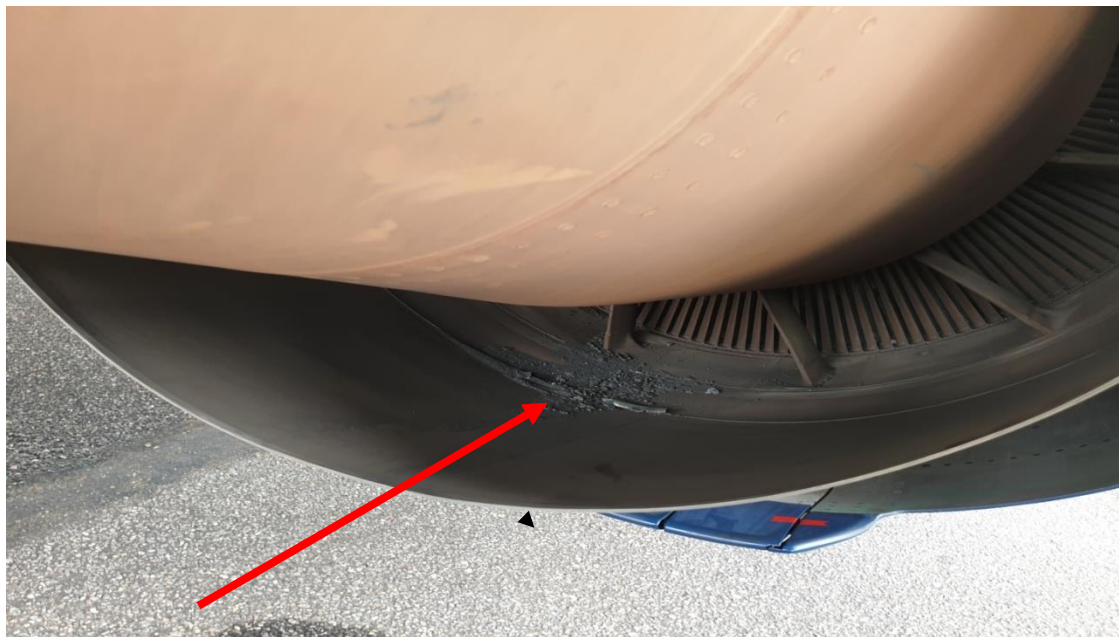
Figure 2: Photo of metal debris from the malfunctioned No. 2 engine

Metal debris were found around the tail cone of No. 2 engine during post-occurrence inspection.

10. Metal debris were found around the tail cone of No. 2 engine during post-occurrence inspection.
11. The Time Since Repair (TSR) and Cycles Since Repair (CSR) of Engine S/N 720461 was 586.29 h and 655, respectively at the time of the occurrence.
