# AIRCRAFT ACCIDENT REPORT

**Nigerian Safety Investigation Bureau**

**Final Report on Serious Incident involving Embraer  
EMB-145LR with nationality and registration marks  
5N-BVD operated by Air Peace Limited which  
occurred at Kaduna Airport, Kaduna on 14th January,  
2021**

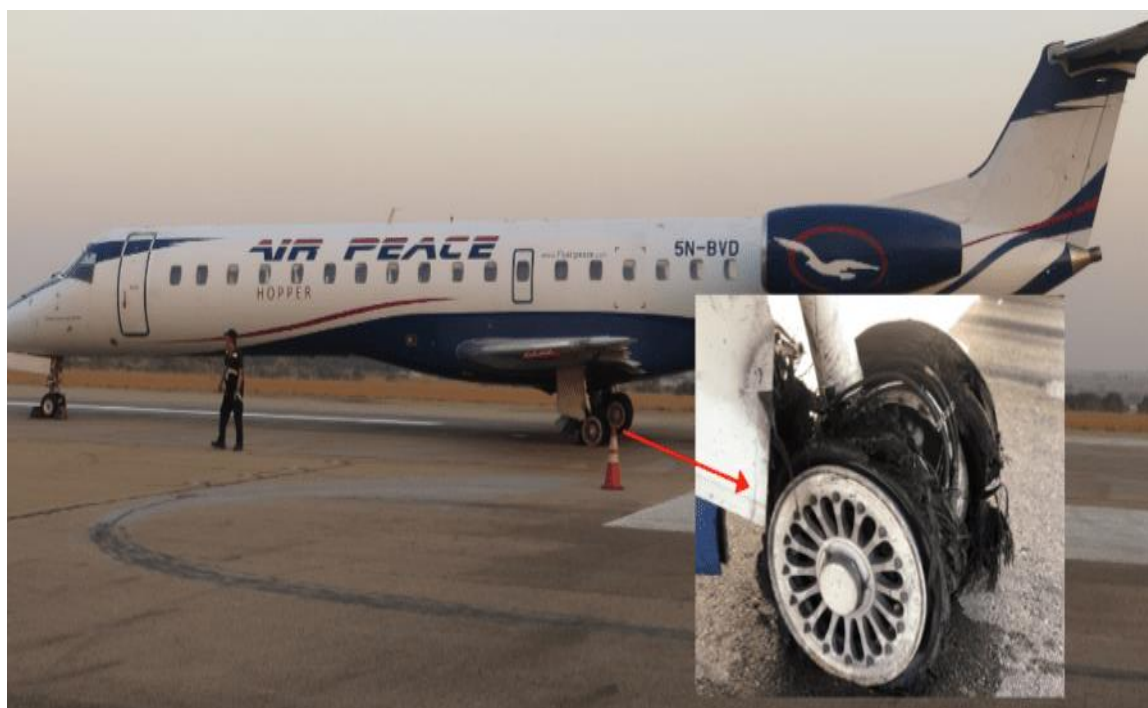
**Figure 1:** EMB-145 LR with registration marks 5N-BVD showing the condition of the No.1 main landing gear wheel assembly after the occurrence

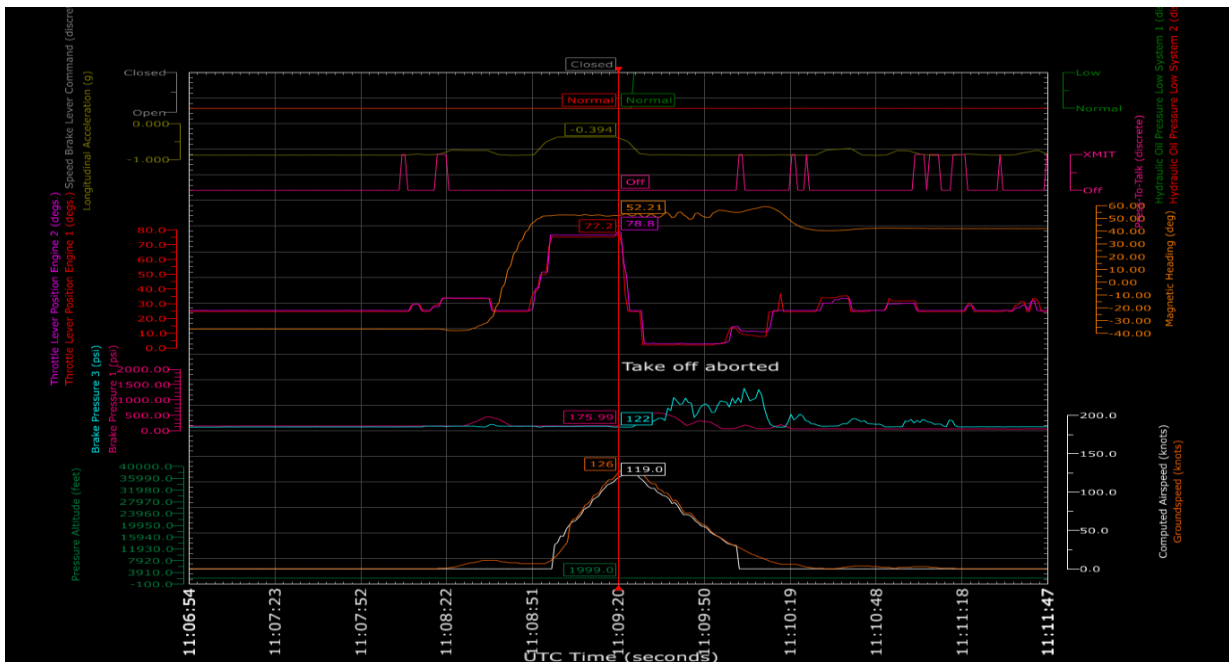
The FDR showed that the take-off was aborted at a computed airspeed of 119 kt. Thereafter, the Number 1 Thrust Reverser did not deploy and hydraulic fluid pressure for Number 1 system became low. Brake pressure was applied to bring the aircraft to a stop.

**Figure 9:** Relevant flight parameters at point of initiation of the rejected take-off 1

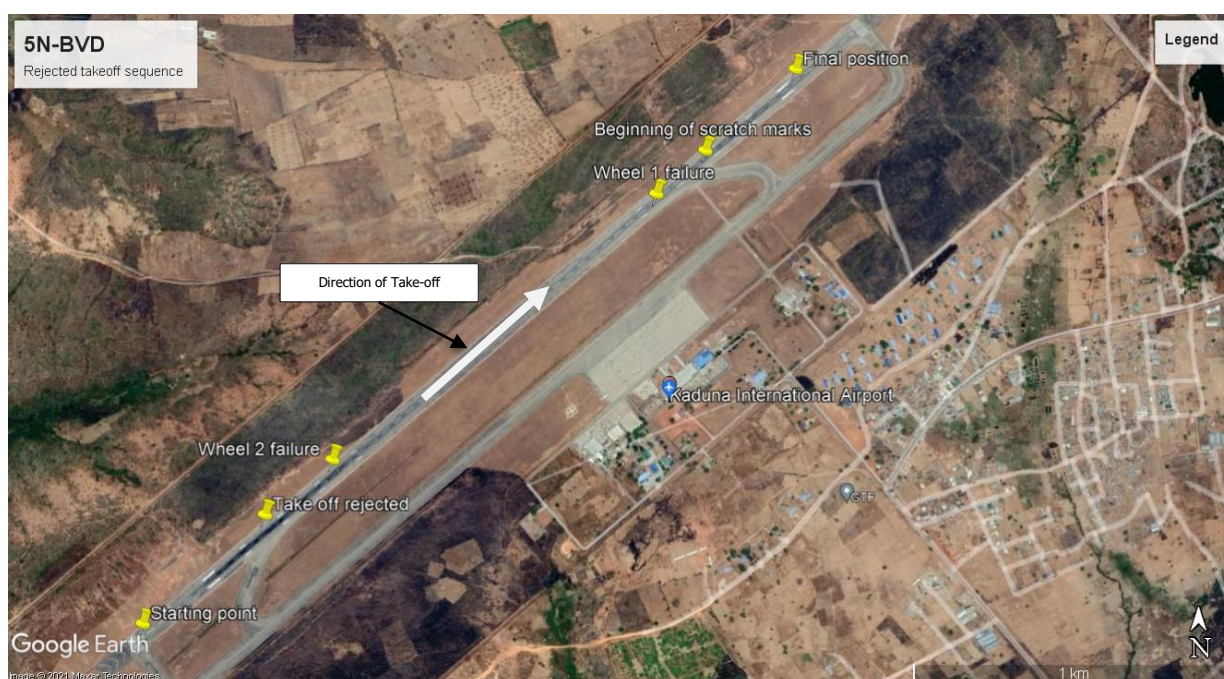
Witness marks on the runway indicated that during the take-off roll, at about 756 m from the threshold of RWY 05, the number 2 main wheel tyre burst (inboard left main wheel) and the aircraft continued for a distance of about 1300 m where the number 1 left main wheel tyre burst (outboard left main wheel). The aircraft continued for another 200 m (2256 m from RWY 05 threshold) where runway to metal contact was observed and thereafter moved in a ground loop pattern for 460 m.

The aircraft finally stopped 284 m to the end of RWY 05 at a magnetic heading of 031°, four meters left of the runway centreline. The aircraft rested on the left main landing gear wheel hubs with hydraulic fluid spillage underneath.

**Figure 10:** Sequence of events during the rejected take-off

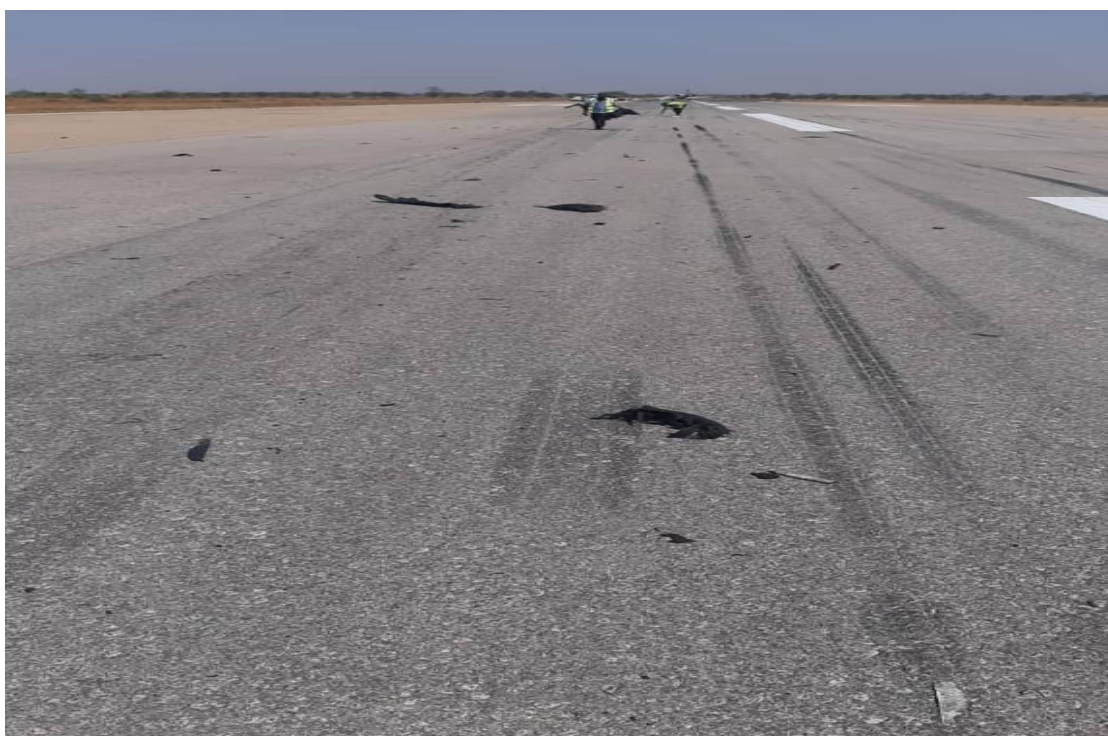
**Figure 11:** Tyre debris being cleared from the runway

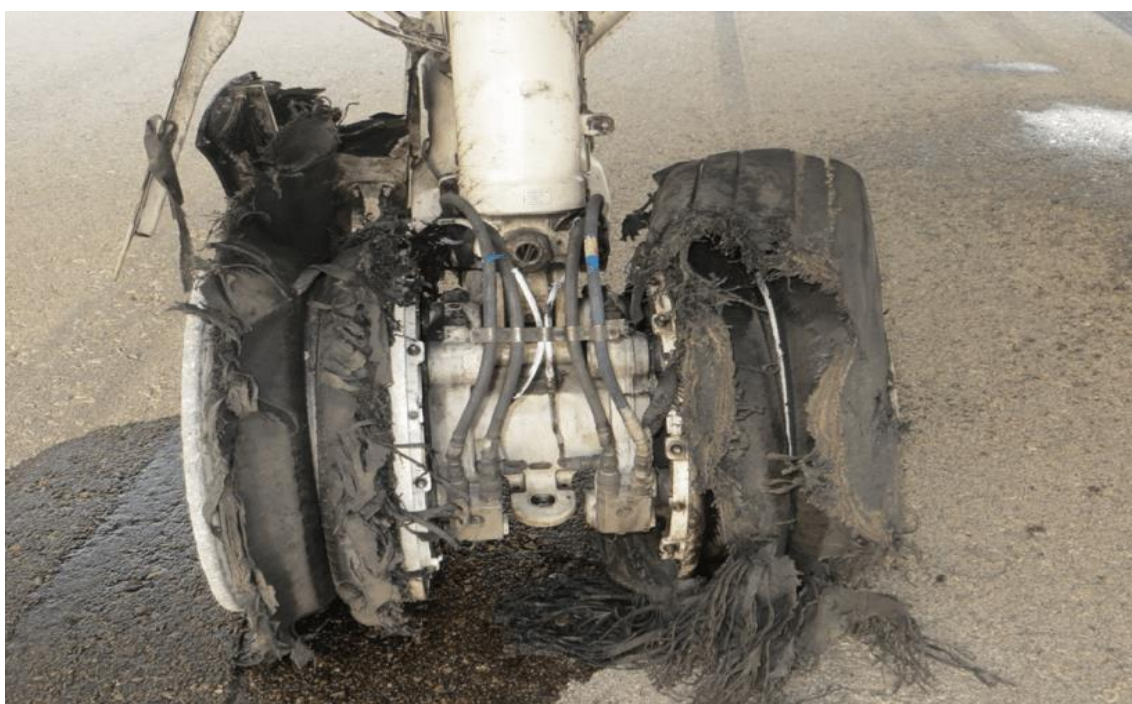
1. The plies of the Number 1 tyre were shredded and the beads remained on the flange.
2. Number 2 tyre had flat spot and portions of the plies were shredded; the beads were not detached from the flanges.
3. The flanges of the two left main wheel hubs were abraded.
4. Left main landing gear door fairing was torn.

**Figure 12:** Damaged number 1 and 2 tyres with hydraulic leakage

The failure of number 2 tyre transferred the shared weight of the aircraft to number 1 tyre hence causing its eventual failure at about 1300 m from the point where tyre number 2 failed as evidenced by marks on the runway.

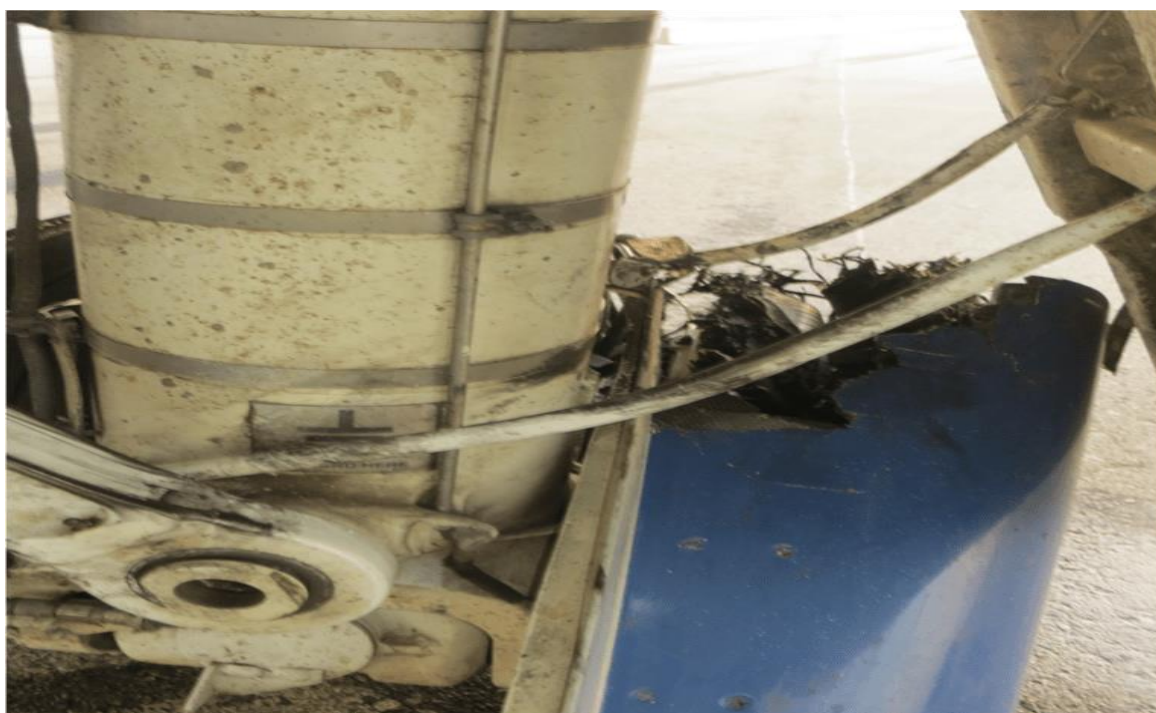
**Figure 13:** Torn left main landing gear door fairing

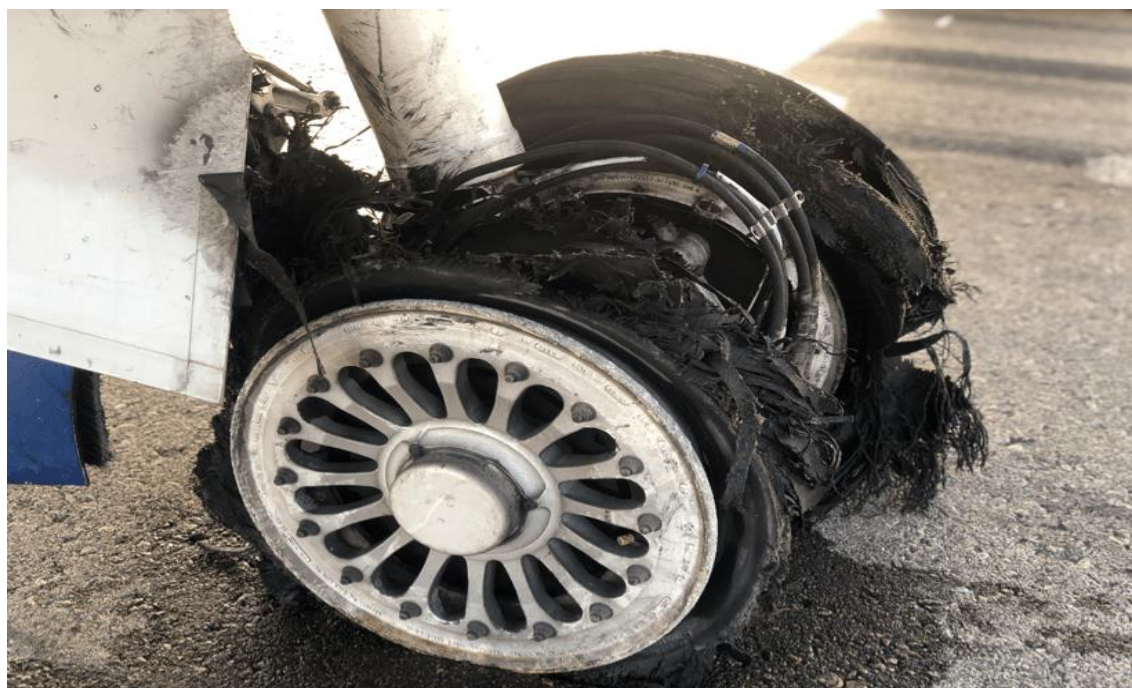
**Figure 14:** Abraded number 1 left main wheel hub
