AIRCRAFT ACCIDENT REPORT

BHNL/2009/11/12/F

Accident Investigation Bureau

**Final Report on the Serious Incident involving two
Bristow Helicopters (Nig.) Ltd aircraft, Bell 412
helicopters with Registration numbers 5N-BGS, and
5N-BDD, at the Addax Base Helipad, Calabar, Cross
River State, Nigeria on 12th November, 2009.**

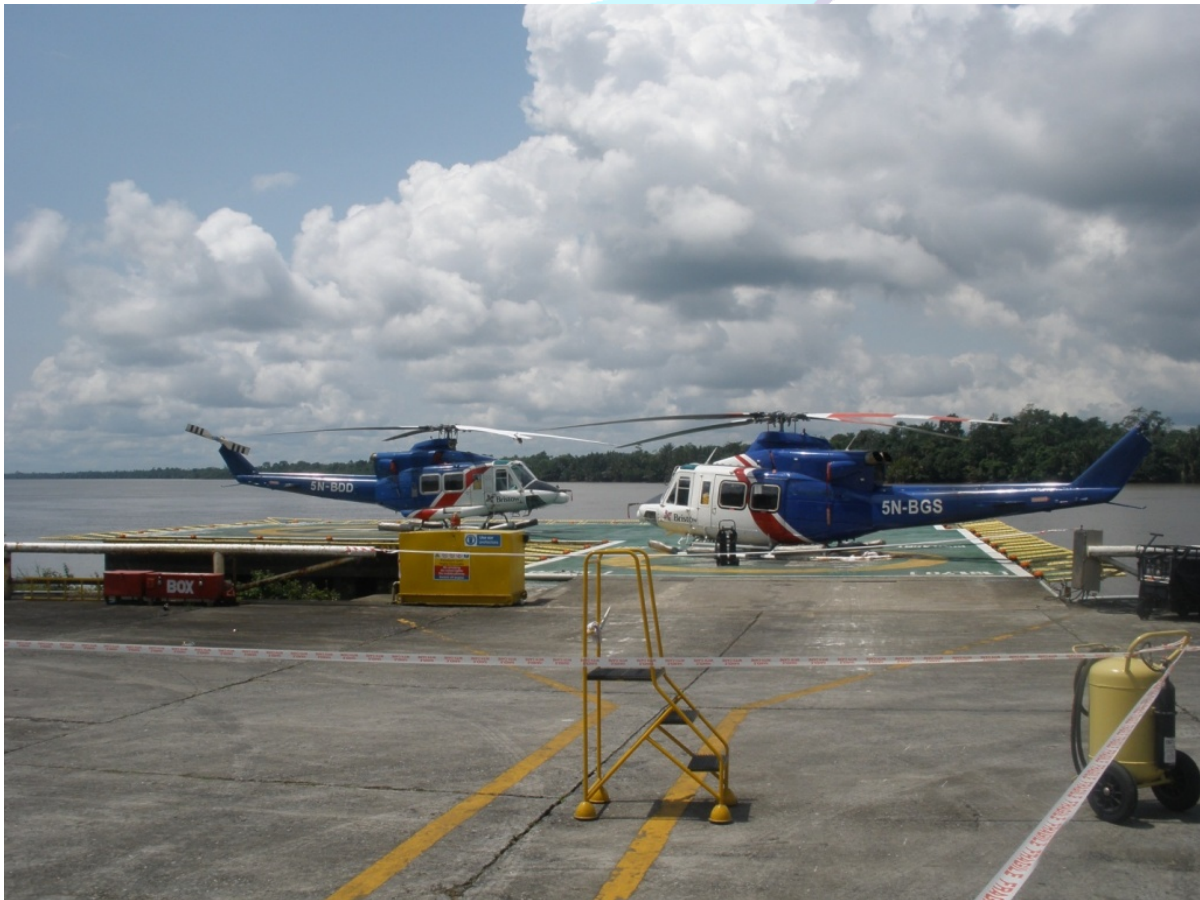
5N-BGS and 5N-BDD were both substantially damaged.

Figure 1: The relative positions of 5N-BGS and 5N-BDD after the incident

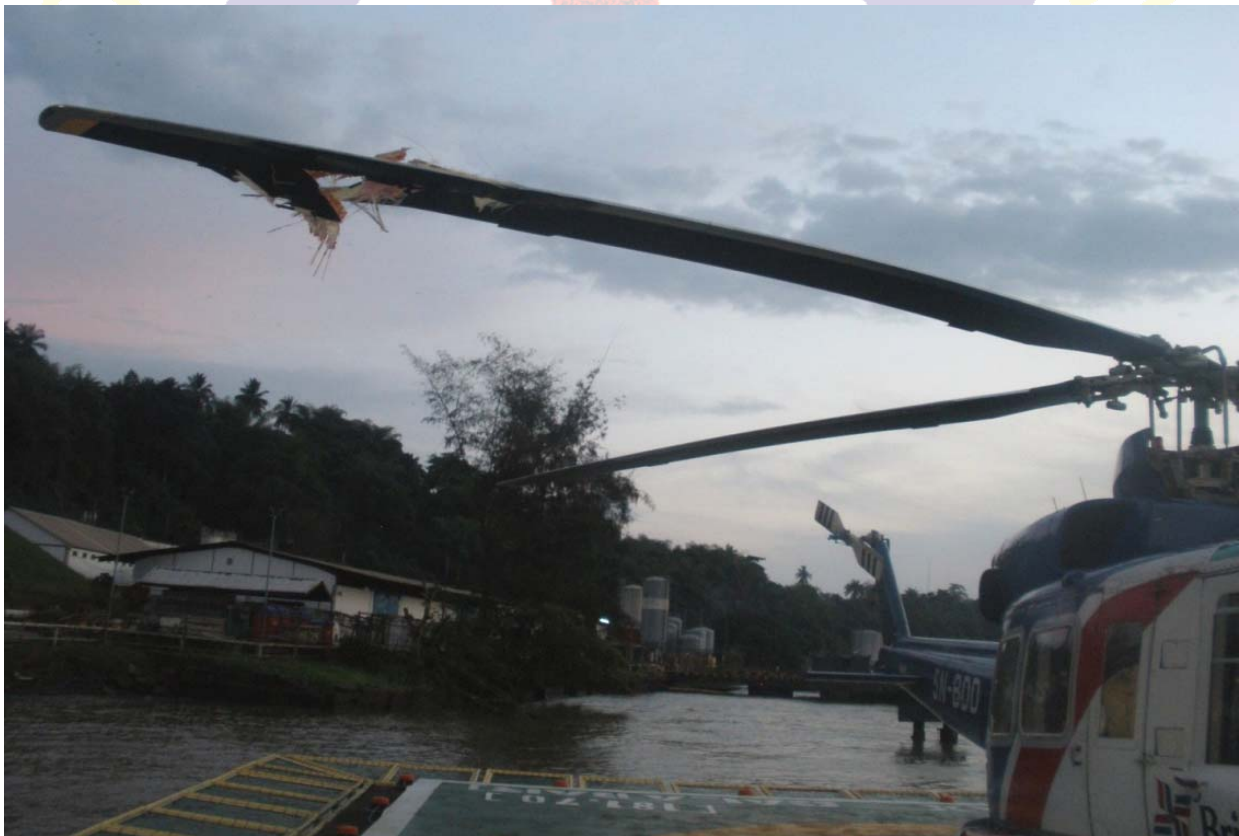
The parked aircraft, 5N-BDD sustained substantial damage to one of the Main Rotor Blade.

Figure 4: The damaged Main Rotor Blade of 5N-BDD

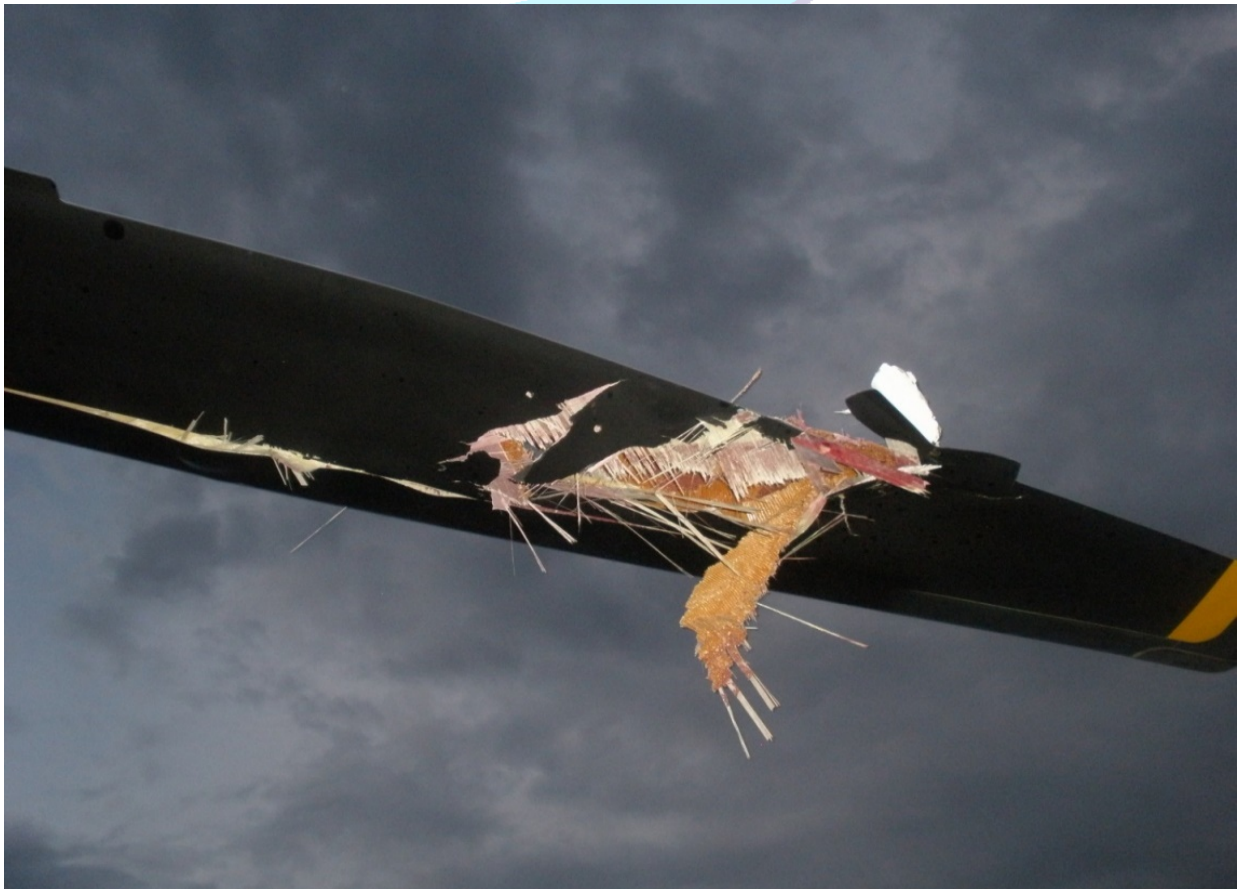
Figure 5: The close-up view of the damage on 5N-BDD Main Rotor

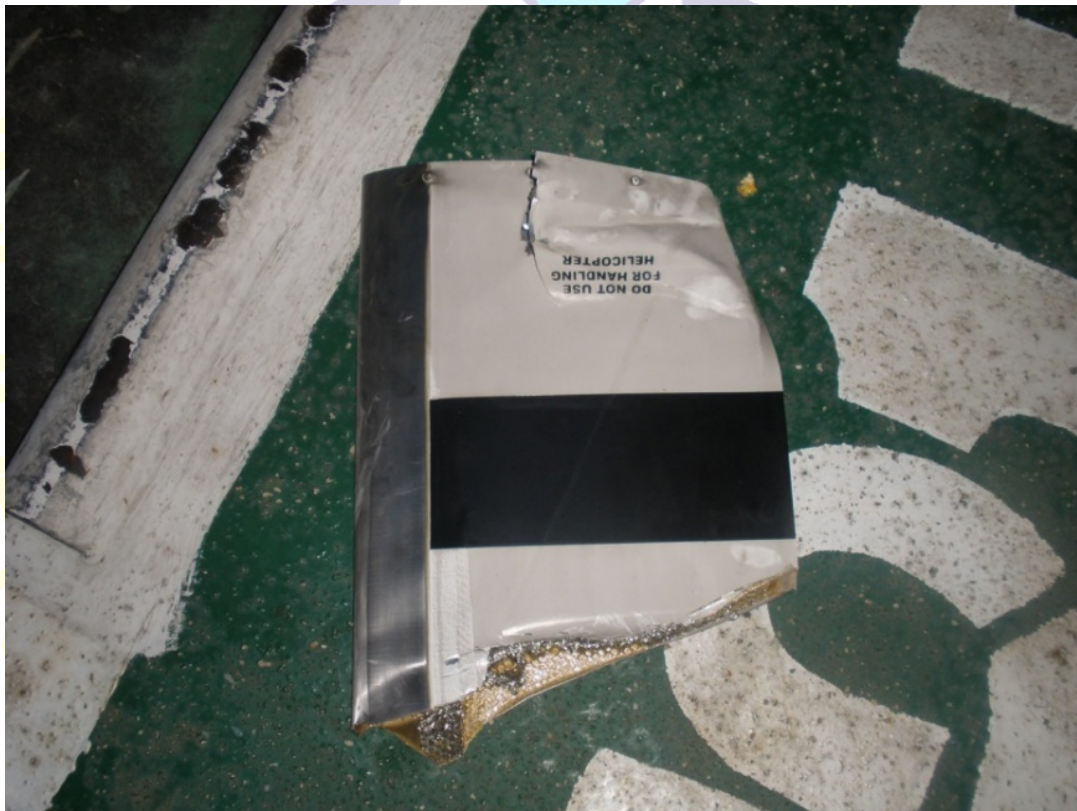
Figure 8: The stump of sheared Tail Rotor blade of 5N-BGS on the Helipad

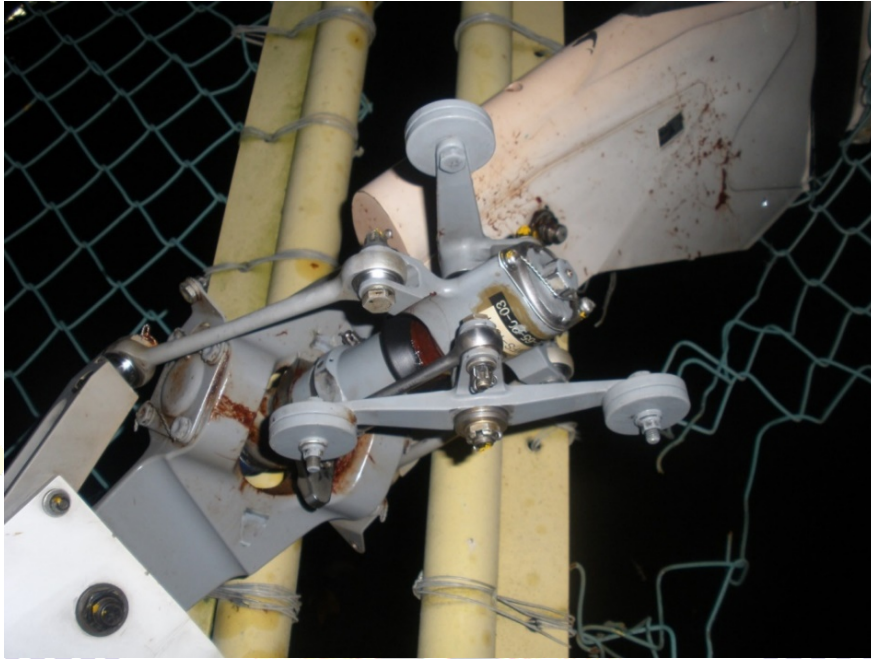
Figure 9: The sheared off Tail Rotor Assembly of 5N-BGS on the helipad

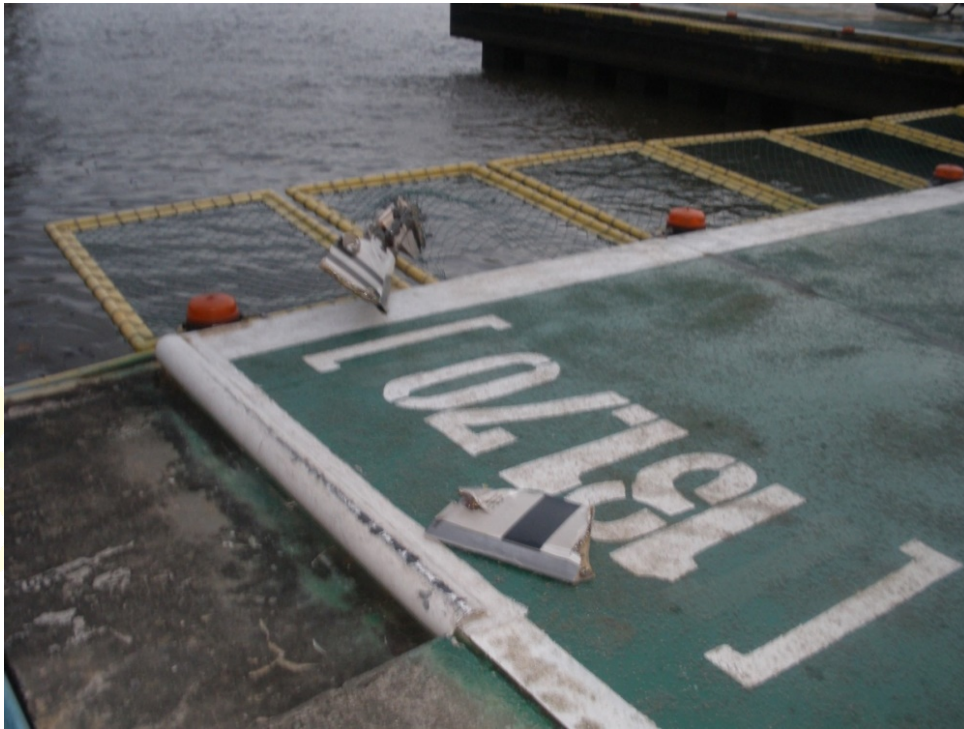
Figure 10: The detached and broken Tail Rotor blade assembly of 5N-BGS on the Helipad

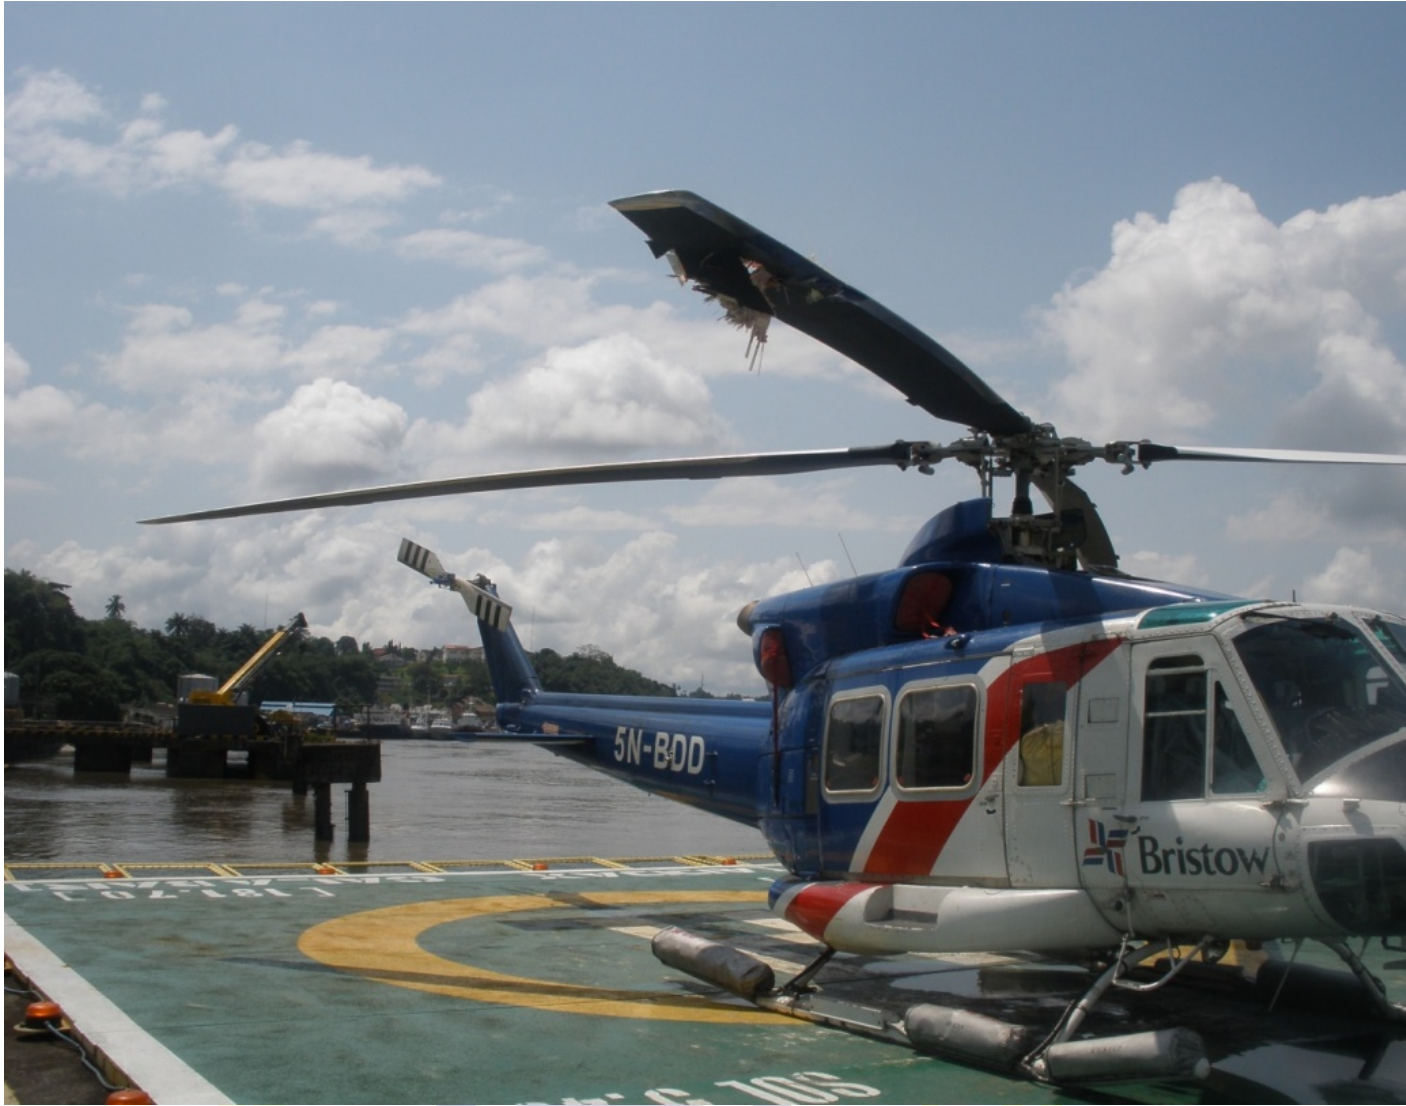
Figure 11: The damage on one of the Main Rotor blade of 5N-BDD on the parking circle

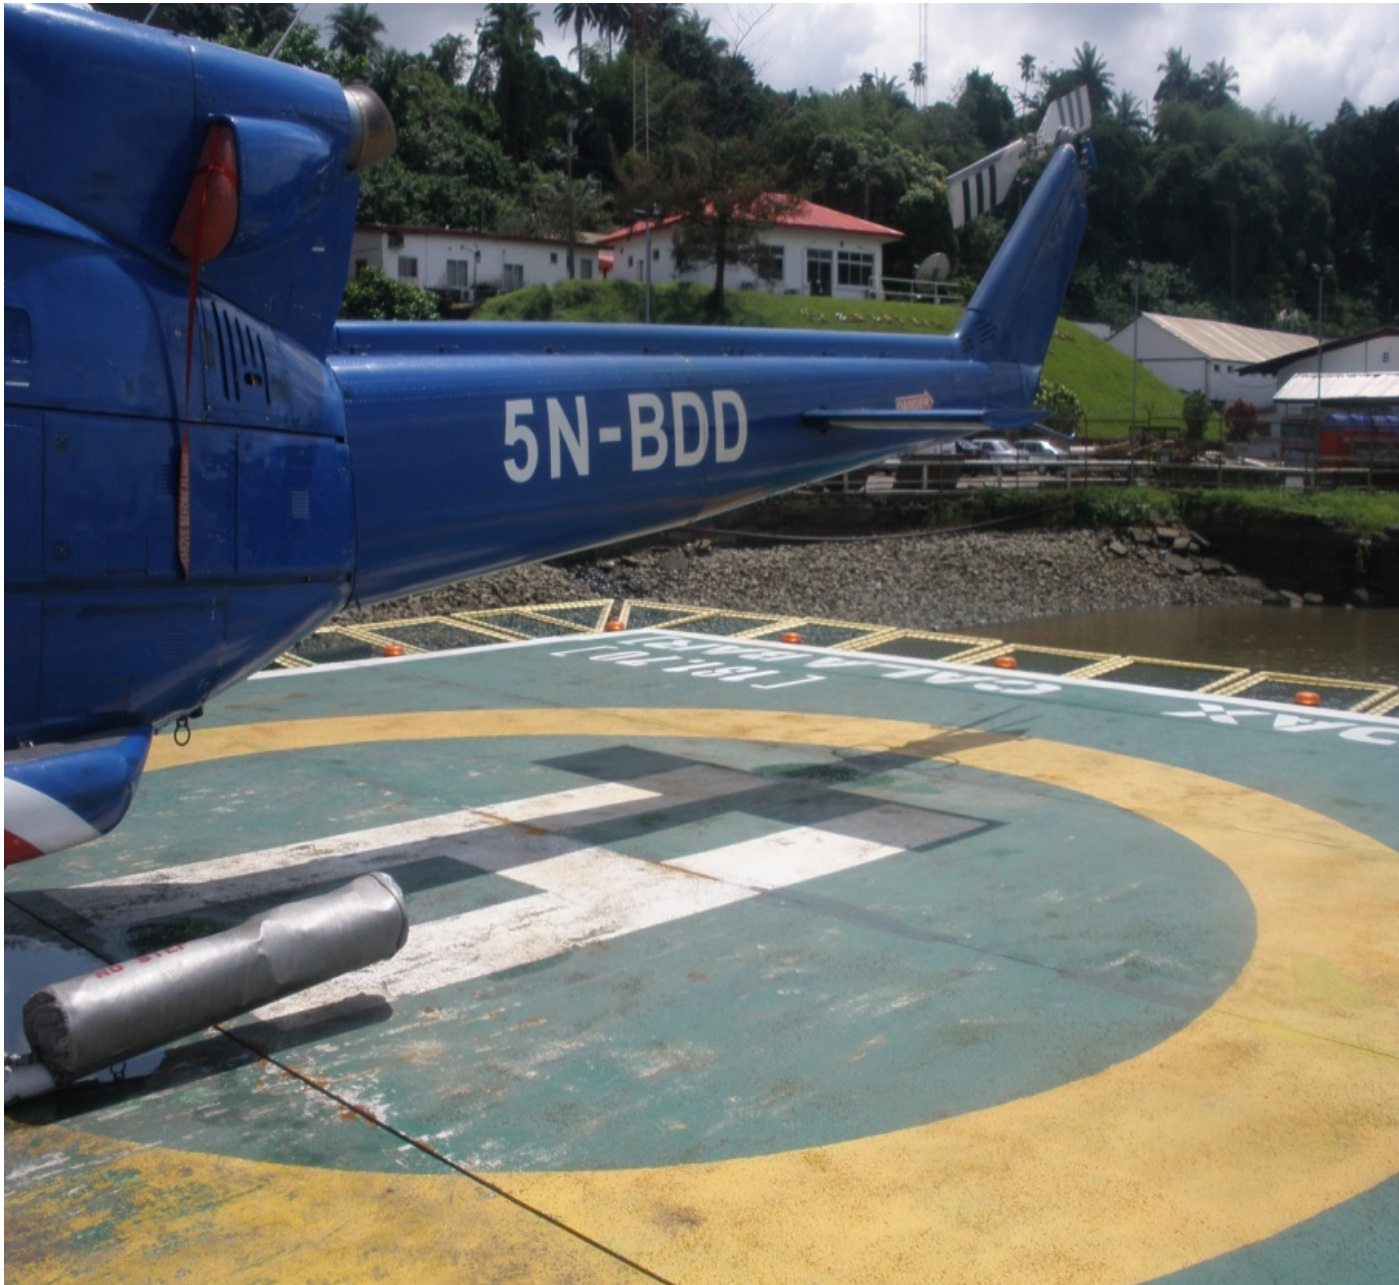
1. Parking of the aircraft 5N-BDD outside the designated parking area.
2. Inadequate pre-flight inspection.
3. Poor Airmanship.

Figure 12: 5N-BDD positioned almost outside the parking circle on the Helipad
