AIRCRAFT ACCIDENT REPORT

2/2009 (BLV 2005/10/22/F)

Accident Investigation Bureau

**Report on the Accident involving
Bellview Airlines Ltd B737-200 Reg. 5N-BFN
at Lisa Village, Ogun State, Nigeria
On 22 October 2005**

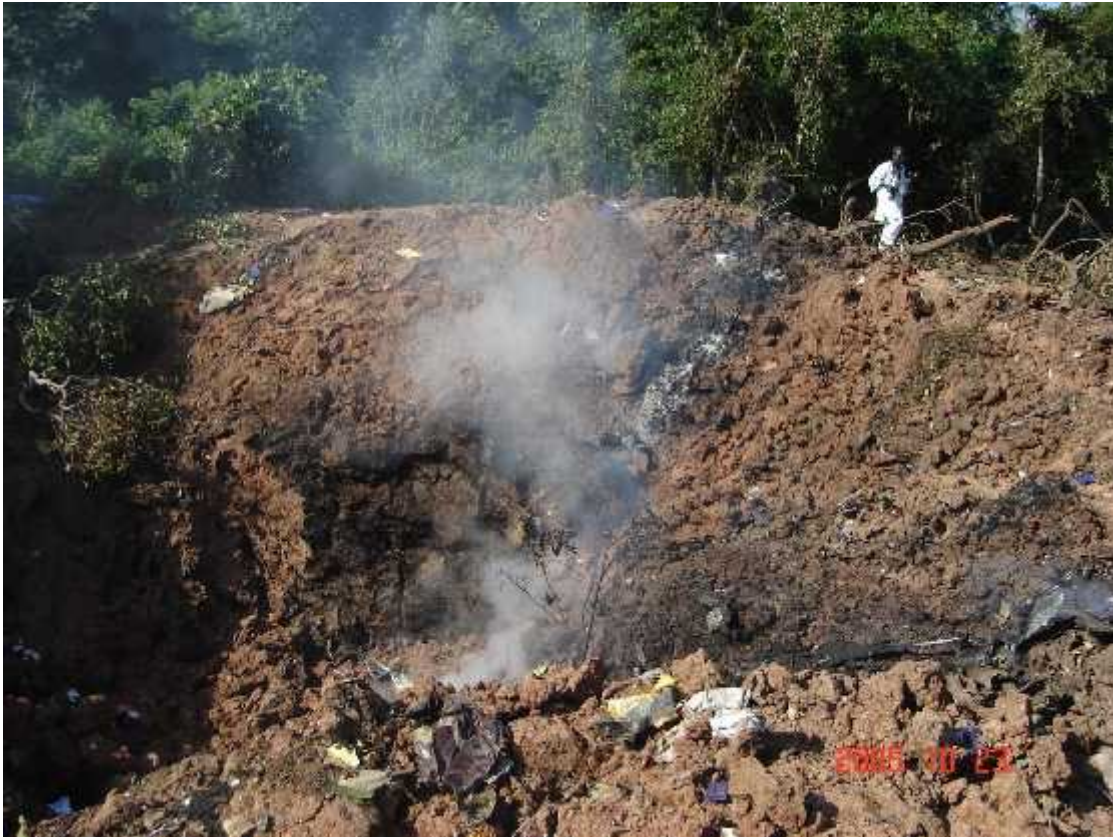
Fig 1.12c: Crater in the Forest

Different metal pieces were found scattered all over the wreckage site, some trees were trimmed while few were uprooted by the aircraft pre-crash impact. Smoke emanated profusely from the crater while the excavation was on-going (See fig 1.12c-d).

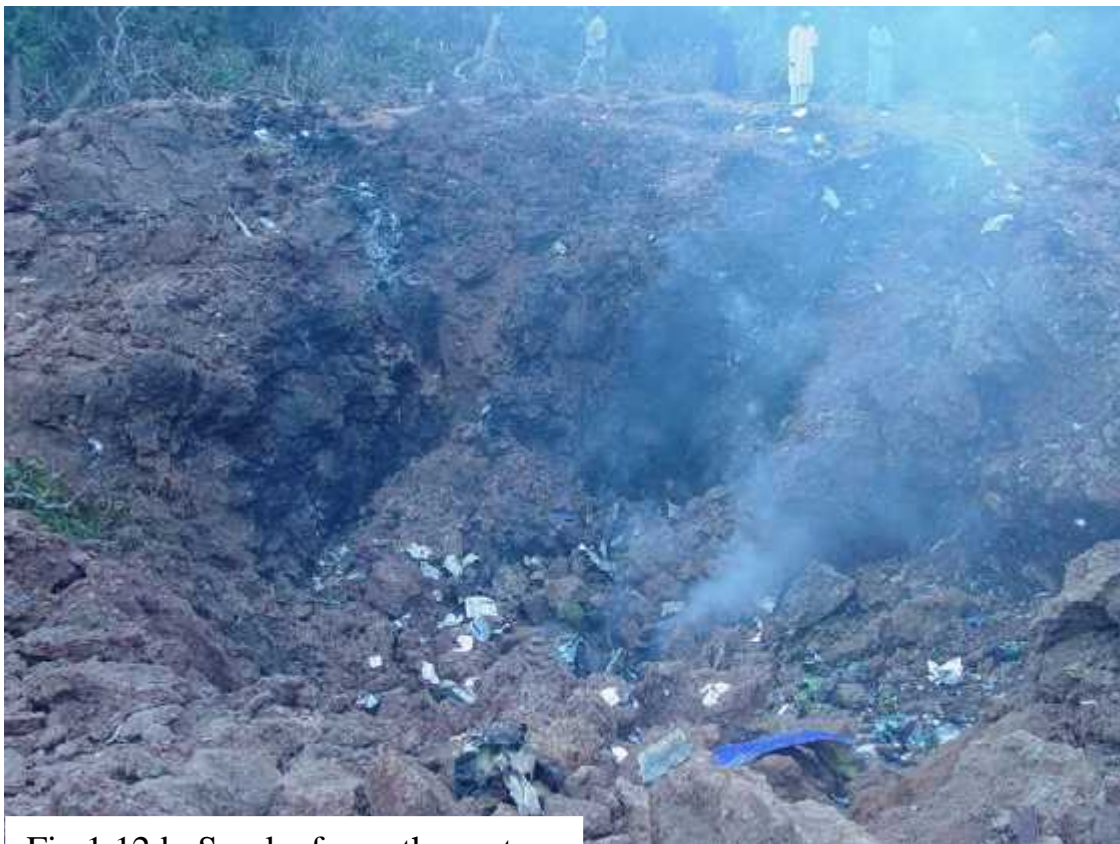
Fig 1.12d Smoke from the crater

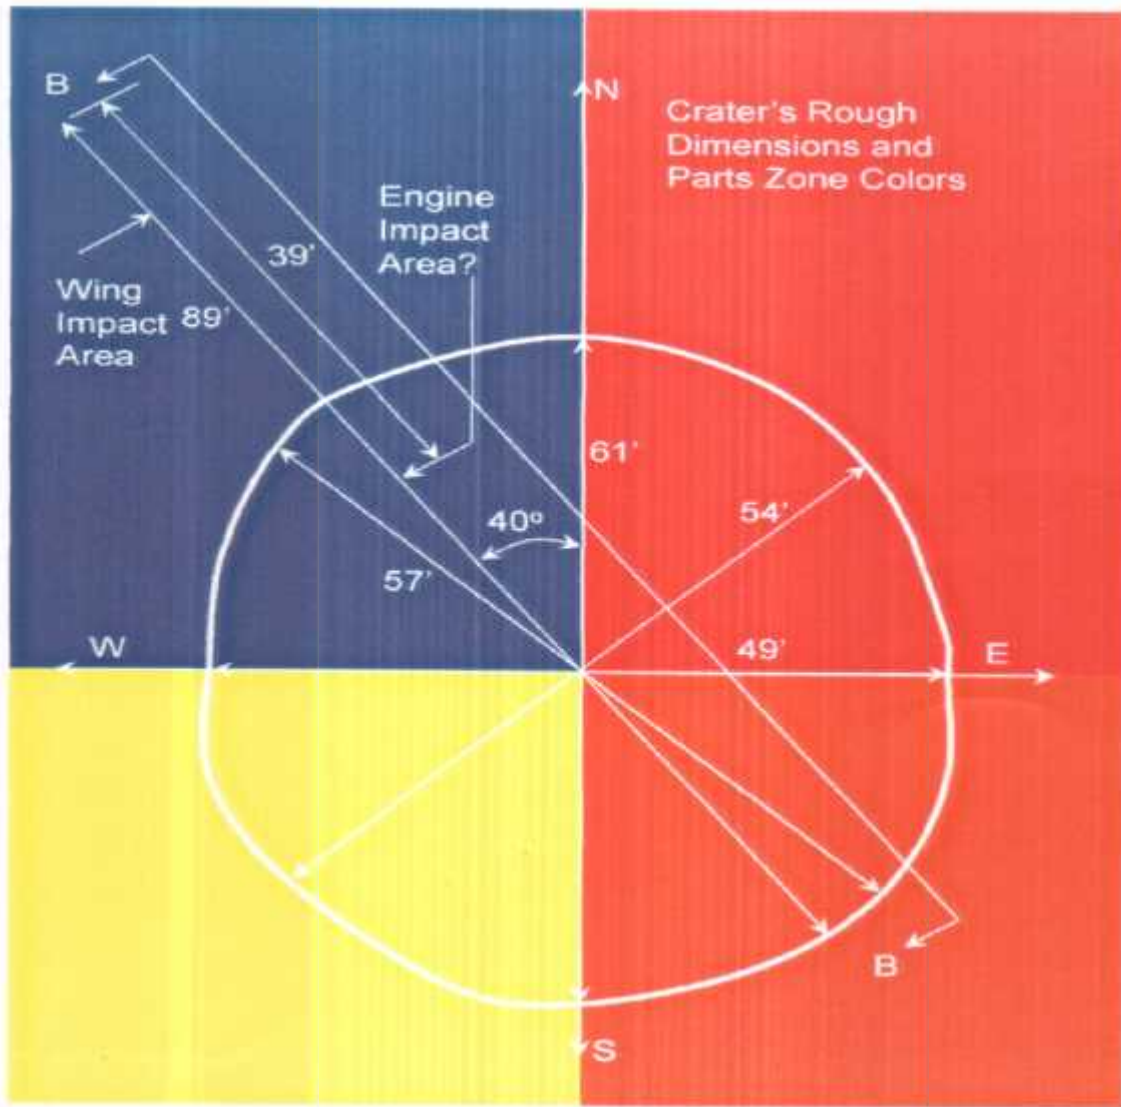
Plan view of the impact crater

Fragments of engine parts were recovered in the area outside the crater between 3 and 6 O'clock positions, including one fractured fan blade, oil cooler, fuel de-icing heater, low compressor blades, stator vanes, fan case, intermediate case and turbine case.

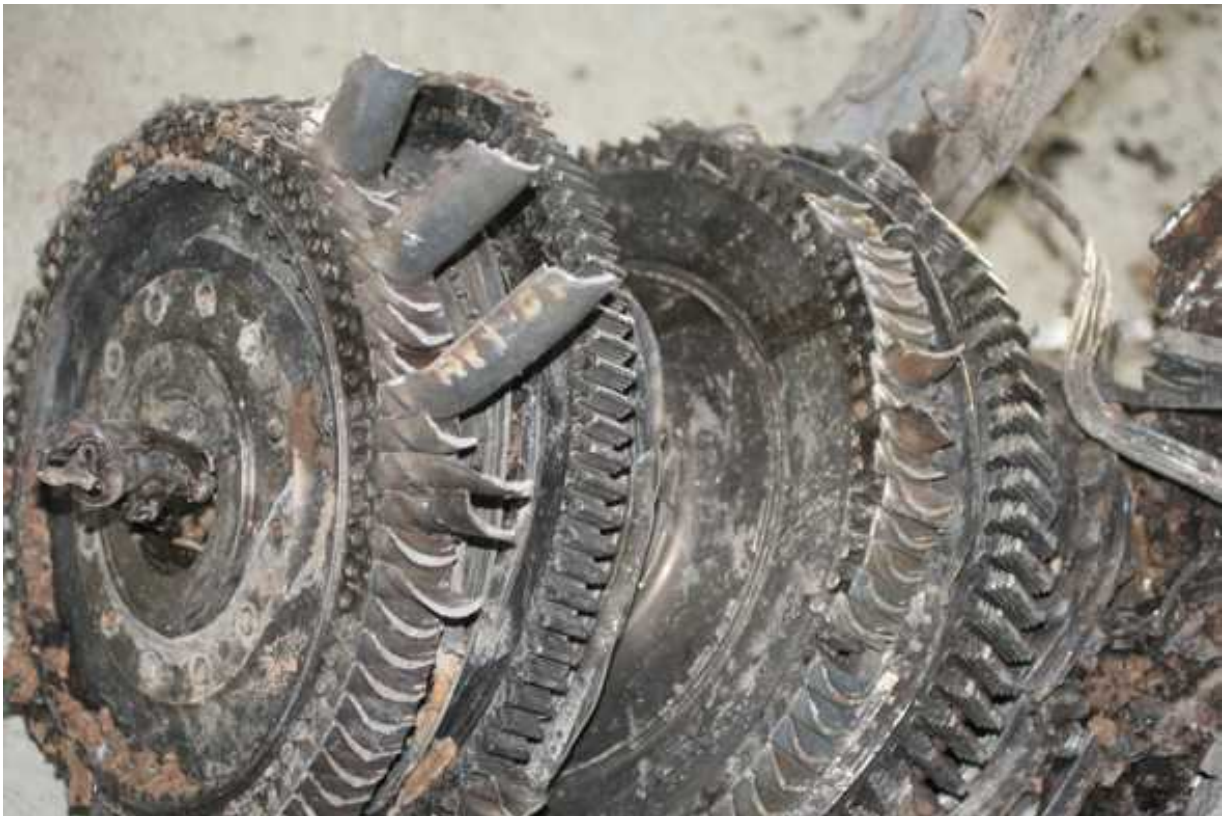
After excavation, at the engine imprint location between 10 and 11 O'clock position of the main crater, heavily damaged engine components were recovered, including 1st and 2nd stage compressor (Low Pressure Compressor (LPC)), High Pressure Compressor (HPC) and turbine rotors. All compressor blades were corn-cobbed, except one 1st stage fan blade. The cases of the engine were compressed axially.

Heavily damaged components from the other engine were recovered at approximately 3 O'clock position of the crater, including one HPC and turbine disks. Several 1st stage turbine blades fractured inboard of tip shroud, and all other blades were corn-cobbed.

The characteristics of the damage on both engines appear consistent with a high speed impact with engines rotating and producing power (See fig 1.12b).

Fig 1.12b An impact damaged engine

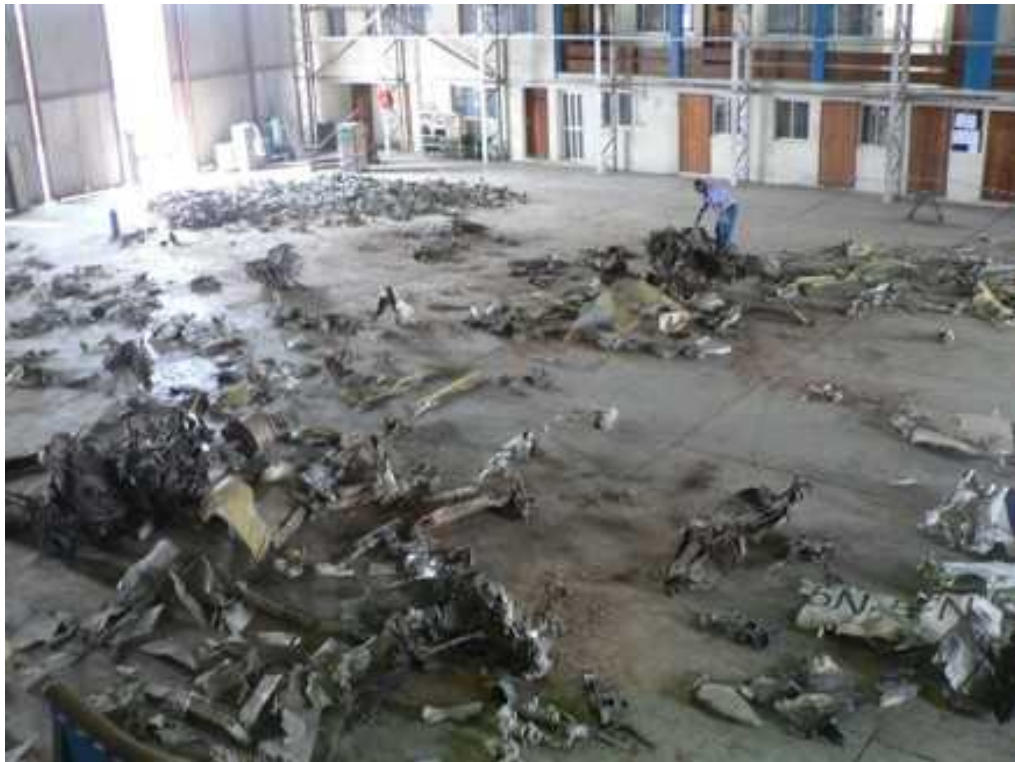
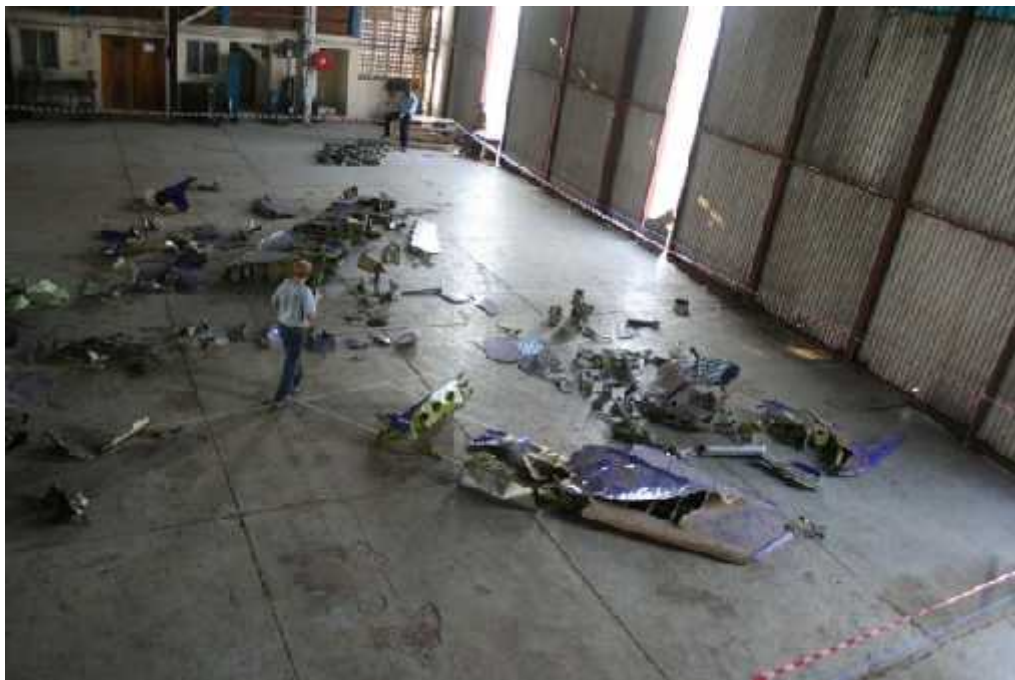
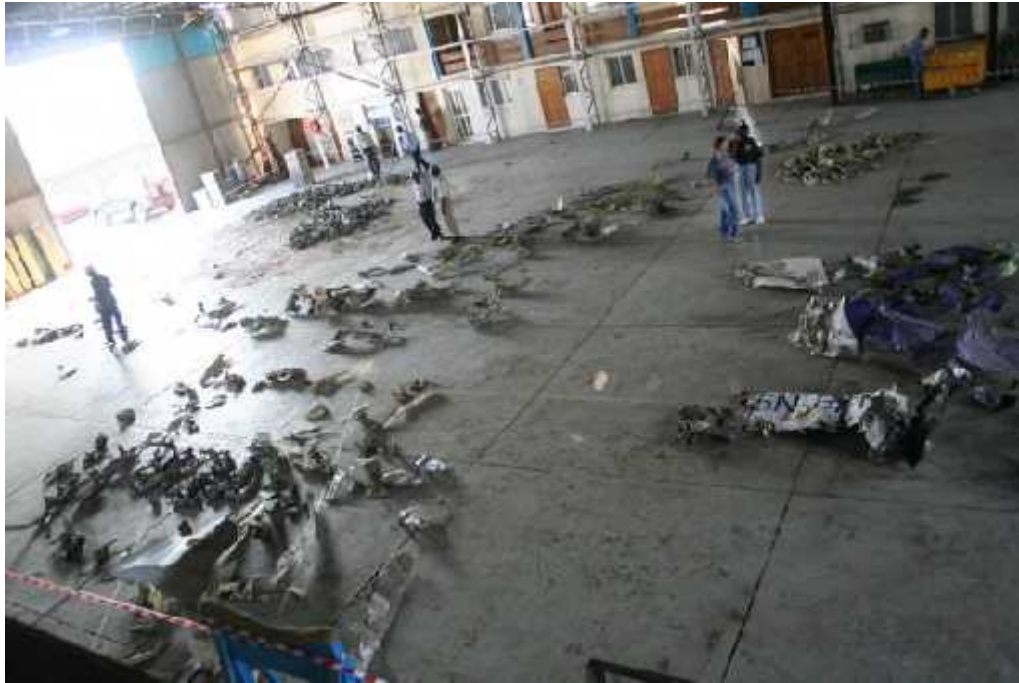
2-Dimensional wreckage layout

A two dimensional layout or reconstruction of the wreckage was performed to permit a detailed examination of the various wreckage pieces and an analysis of the various components of the aircraft. A reconstruction is an assemblage of the various pieces of the wreckage in their relative positions before failure.

The reconstruction revealed that about 60% of the aircraft wreckage was recovered and the structure sustained high impact damage. Localized fire damage was also discovered during the examination.

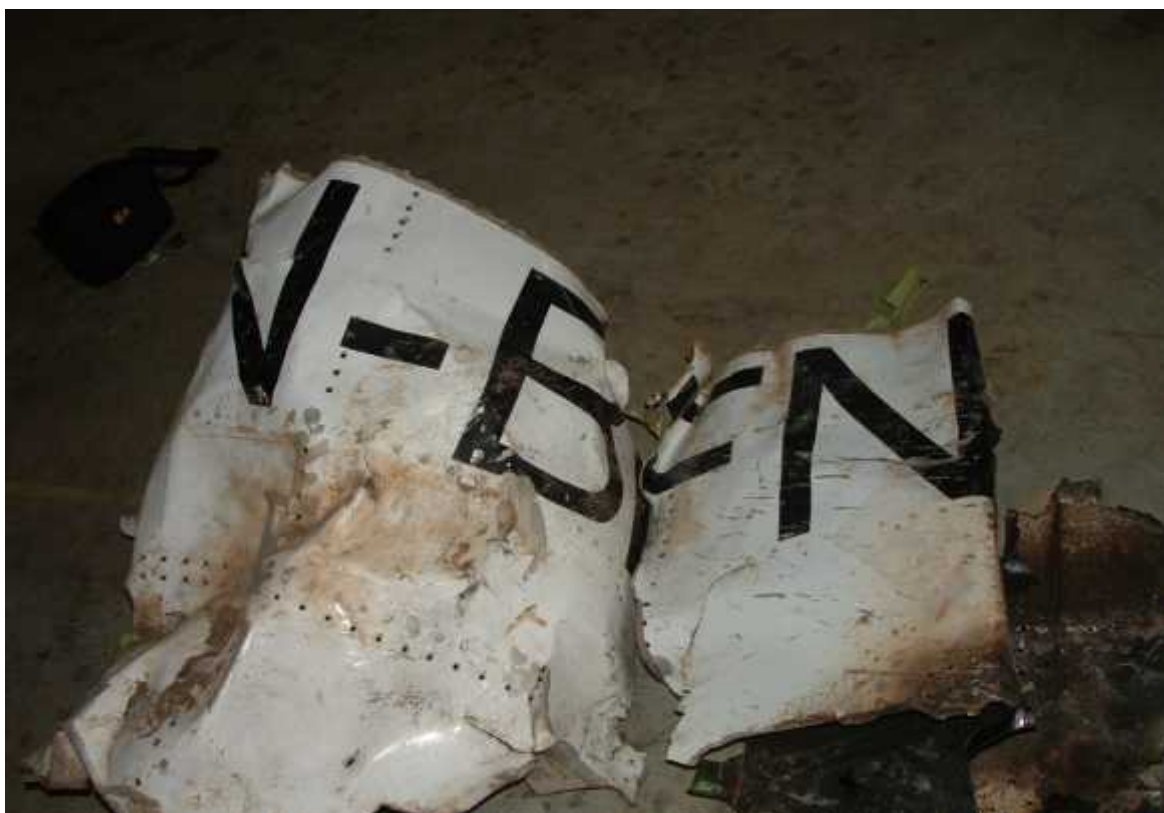
Burnt fuselage parts of the left side of the underbelly of the aircraft near the cargo hold area were recovered from the wreckage. These pieces were found approximately 100 feet away from the crater created by the impact of the aircraft with the ground. The burnt parts contained a portion of the registration number and another section of the skin with the other part of the registration number. The two pieces matched and were suspected to emanate from the left side of the fuselage. The nature of fire damage to this section raised the suspicion of an explosion. The Nigerian State Security Services (SSS) and the United States of America Federal Bureau of Investigation (FBI) were invited to examine the burnt parts. The US FBI took a piece of the burnt part, swabs from the inner and outer surface of the burnt piece and an electronic part found within the folded section of the piece of interest, back to their facilities for laboratory analysis and screened for presence of explosive residue. The results of the tests were negative i.e. no explosion.

Physical examination of the wreckage and explosive residue testing showed no evidence of high explosives. There was clear evidence of fire but no conclusion could be reached as to whether the fire occurred prior to the crash or only as a result of the crash.

Fig.1.6.1 Two piece match from the left side of the fuselage.

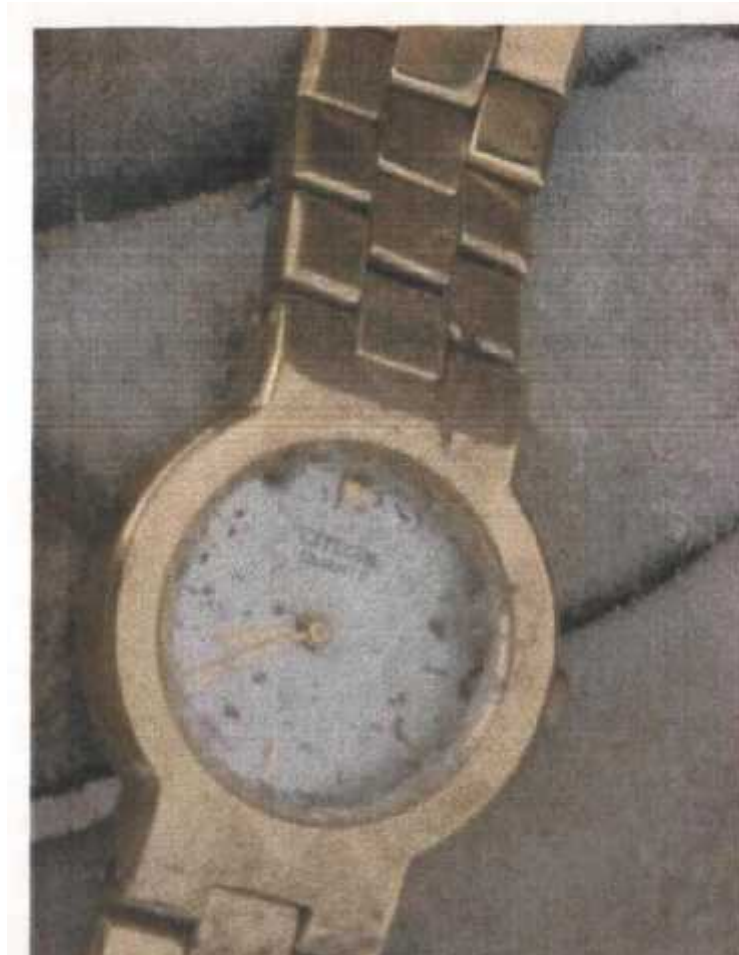
Same clearance given to similar aircraft to make a right turn to Abuja usually takes about 3mins to LAG. Further 7nm north which was the crash site will take an additional 2mins at an assumed speed of 240kts, adding the calculated 5mins to departure time at 1935 UTC will take the crash time to 1940 UTC. This was corroborated with the time on the wrist watch found at the wreckage site which stopped at 2040 hrs (1940 UTC) (See fig 2.10).

Fig 2.10 wrist watch recovered from the wreckage site

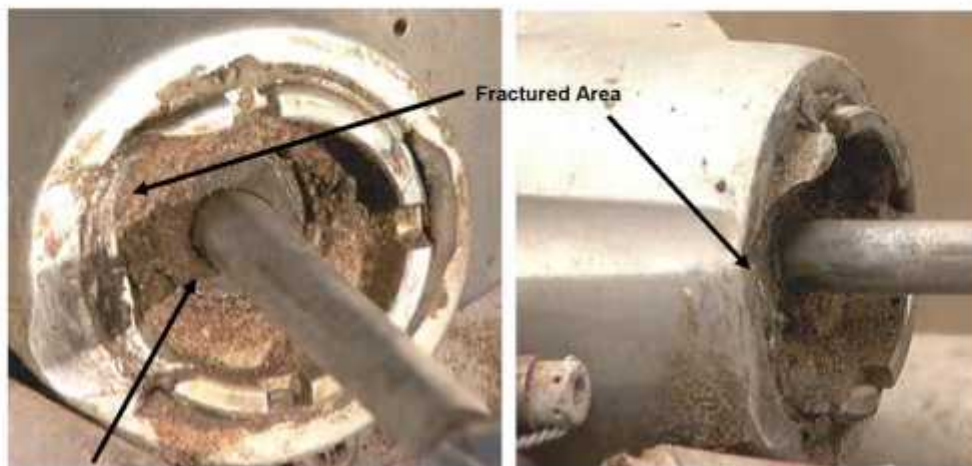
Figures 10 – 16 document the anomalous features of the piston rod at the **AFT** end of the subject PCU. Note that the bend and fracture (cup/cone tensile type) are at the attachment point. Note also in Figures 14 and 15 that the mating surface of the fracture shown in Figures 12 and 13 appears to be recessed in the (gland) nut.

"Recessed" aft piston rod
Figure 15

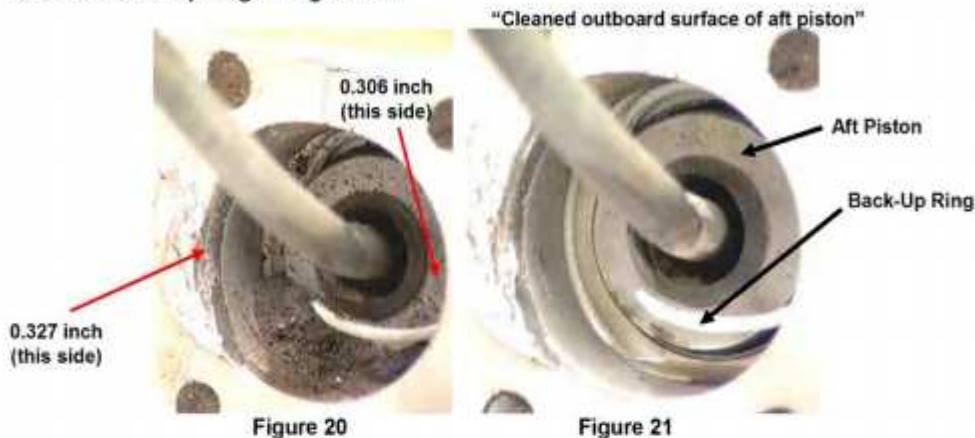
As shown on Figures 20 and 21, the aft piston had over-traveled in the retract direction. Over-travel is defined as the distance from the top of the piston surface to the edge surface of the bore. The distances were measured on each side of the bore (0.327 & 0.306 inch). Figure 20 documents the measurements. Note also the extruded back-up ring in Figure 21.

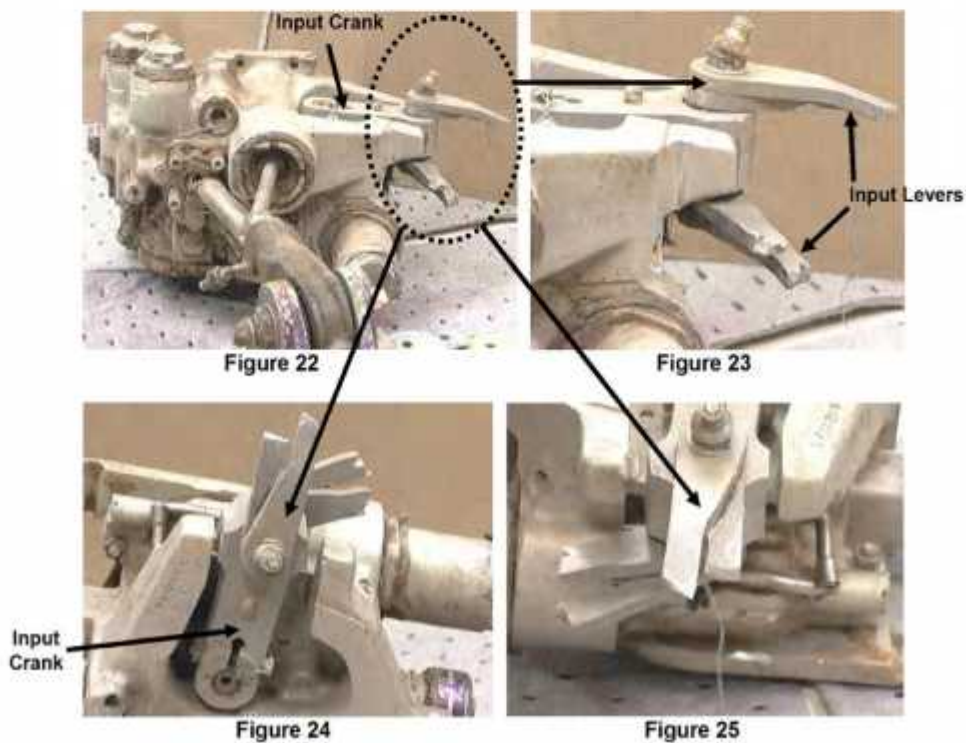
Figures 22 – 25 show the fractured input levers, which were characterized, predominantly as tensile failures.

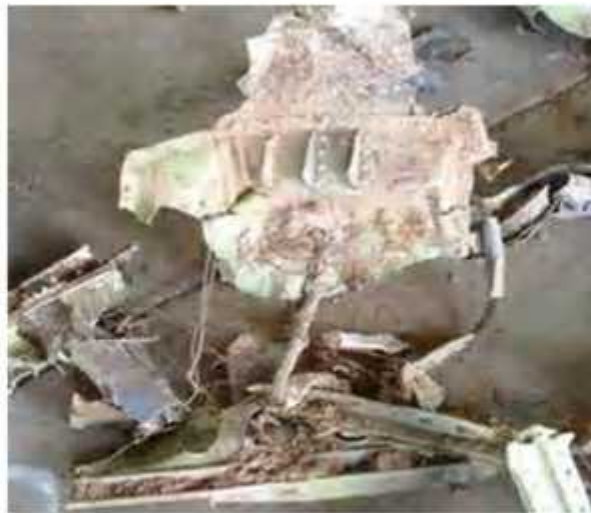
A portion of the BS 1016 aft pressure bulkhead was found, three pieces of the outer Y-chord with stringers and small section of web attached. The largest piece was the lowest portion of the bulkhead, which includes section of web where the control cables penetrate, including intercostal just aft of bulkhead.

FIG 4 - Aft Pressure Bulkhead Lowest Portion

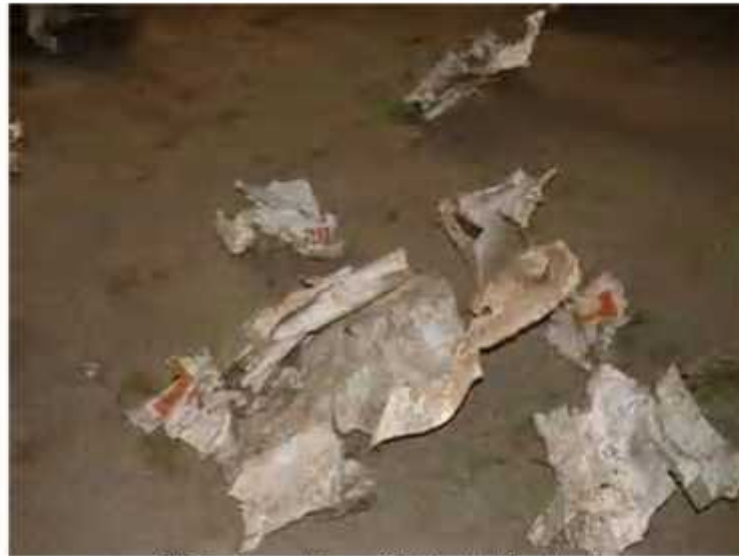
The only other left hand skin with distinctive markings is that section marked “cut here” (so marked for emergency crews as an acceptable location to cut through the structure for access) in the forward crown area. There are three pieces that make-up a portion of this area.

FIG 7 – Forward Upper Skin Marked “Cut Here”

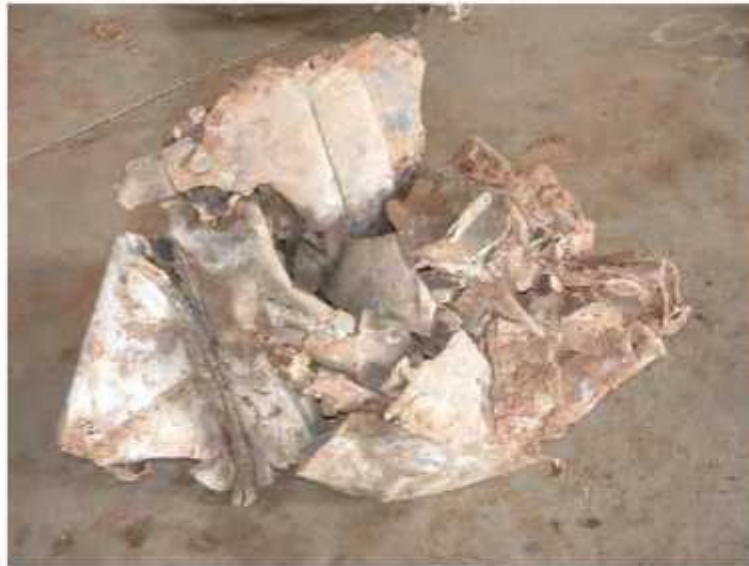
The only major section from the right hand side is the forward cargo door cutout. This piece is crumbled into a ball as seen in figure 8 and was found in bottom of the impact crater.

FIG 8 – Fwd Cargo Door Cutout Lower Sill Area

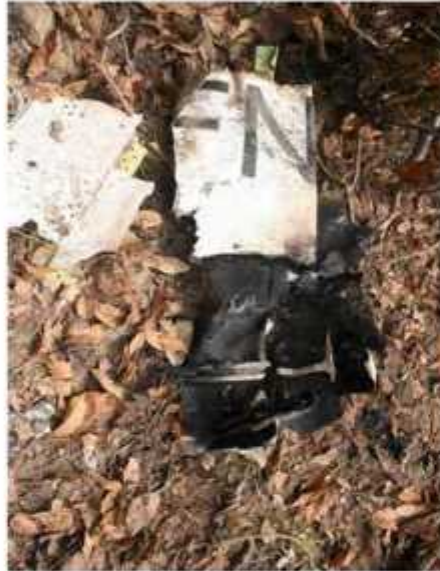
During the examination of the impact site, a number of parts were noted to have evidence of burn damage (actual heat and sooting). A section of recovered fuselage skin from approximately body station 940 to 980, left side (below the windows and on the backside of the body registration number) appeared to display an unusual burn/sooting pattern. As noted on the accident site, the part was folded twice, the outside against outside and inside against inside. The burn/sooting pattern appears to stop along the fold line. The level of expertise available at the site could not make a determination of pre- or post- impact fire damage.

FIG 13 – Burned Skin Part at Site

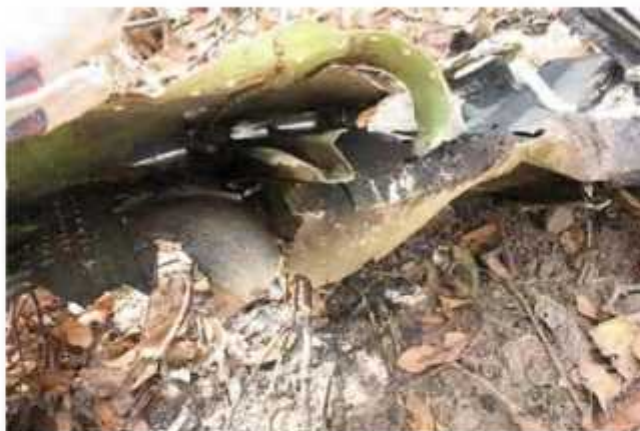
FIG 13B – Burned Part Looking at Inside Fold.
Note fire/soot damage stopping within the fold

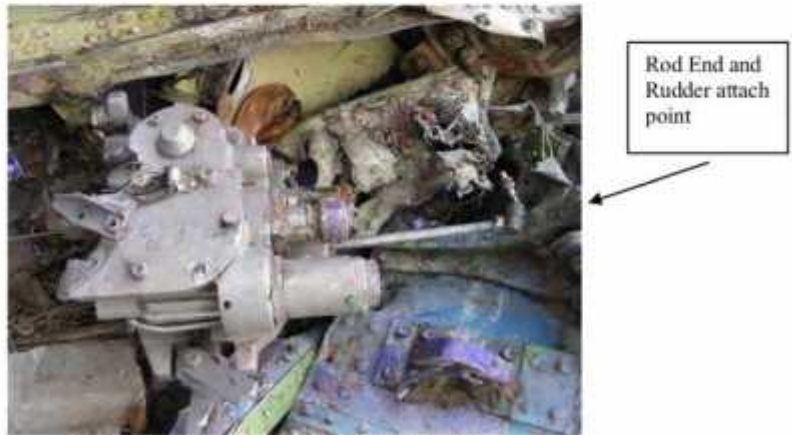
- Rudder System (Main Rudder Power Control Unit (PCU))
 This unit, shown in figure 14 (as documented in the field), is missing the front portion of the attach arms which provide support to the vertical stabilizer rear spar. The inner portion of the concentric dual piston remains attached to the rod end; this, in turn, remained attached to a portion of the rudder front spar. Figure 15 shows the unit in the hanger with a recovered portion of the attach arms.

FIG 14 – Main Rudder PCU (at impact site)

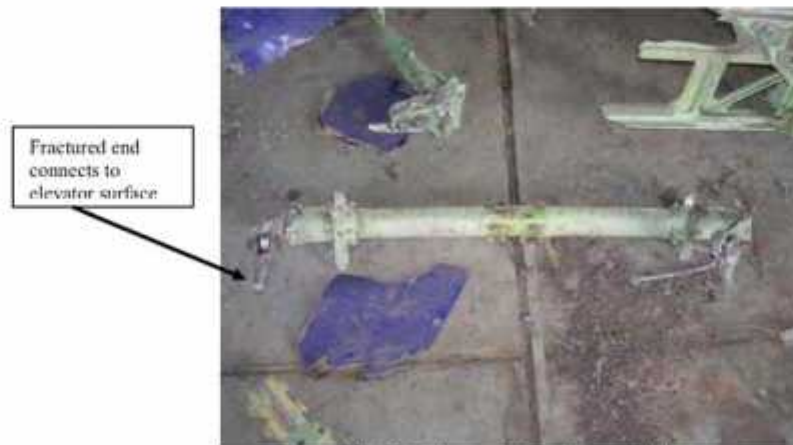
Small portions of the STA 1156 elevator control and actuation system were recovered as shown in figures 17 and 18 below. Figure 19 shows the normal relationship on these components and their location in the airplane. The main elevator drive torque tube is largely intact (and bent); the elevator connecting rods are fractured.

FIG 17 – Elevator Upper Torque Tube

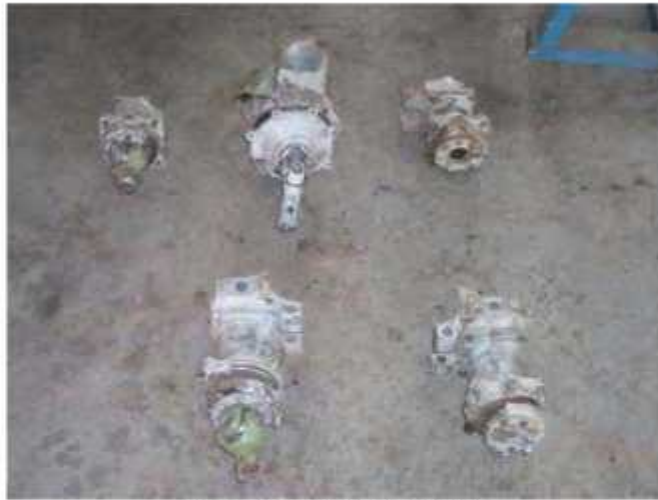
Figure 21B shows the 5 recovered TE flap transmissions. Examination notes that transmissions #1 and #8 (outboard flap, outboard transmission), #3 and #6 (inboard flap, outboard transmission), and either #2 or #7 (outboard flap, inboard transmission) were recovered. Both #4 and #5 (inboard flap, inboard transmission) were not recovered.

FIG 21B – TE Flap Transmissions

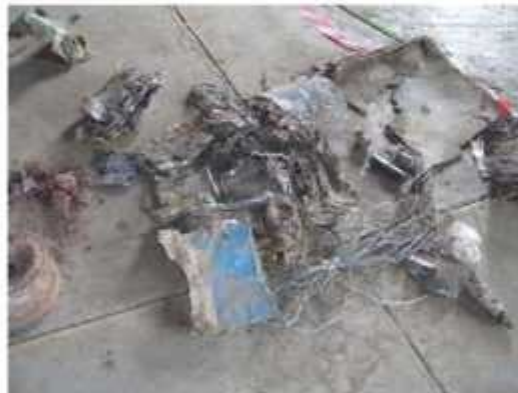
A number of electronic aviation boxes were also recovered. They were damaged to a degree that it is not possible to identify them. See figure 23.

FIG 23 – Electronic Boxes

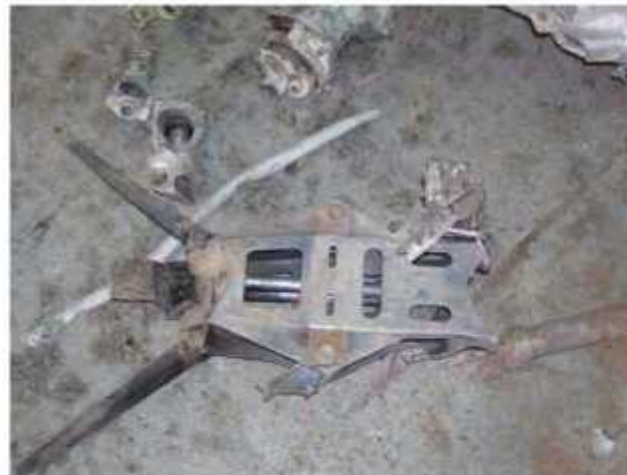
Portions of all four actuation mechanisms were recovered. These portions consist mainly of the links and driver assembly. One partial cylinder (of 4) hydraulic actuators was found.

FIG 25 – One of four recovered TR actuation mechanisms

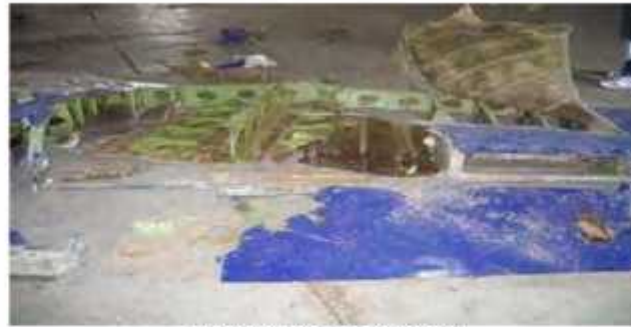
Aft spar from inboard to SSta 193.90 is missing. Front spar was attached to the leading edge however, broken in pieces.

FIG 30 Aft View of Stabilizer

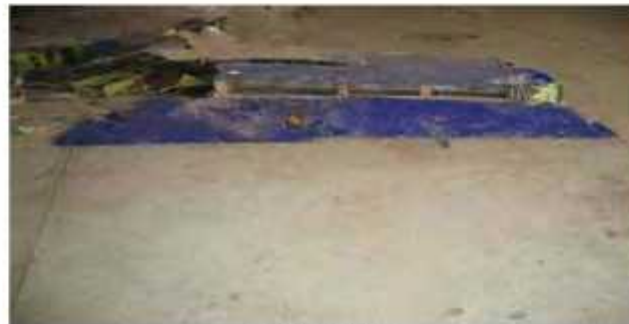
Two large pieces of elevators were recovered. The inboard section from outboard tab cutout location to inboard section of elevator is missing. All attachments of elevator to stabilizer were broken.

FIG 31 Elevator

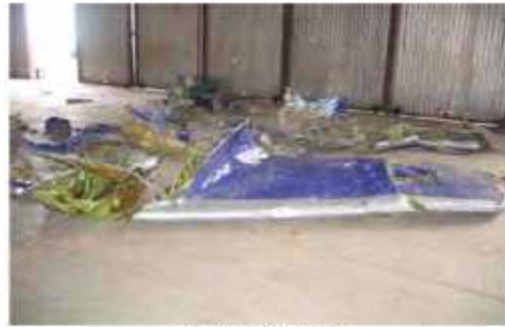
The inboard section of the stabilizer is missing (approximately 1/3 of stabilizer). The mid section crushed and tangled.

FIG 32C Stabilizer

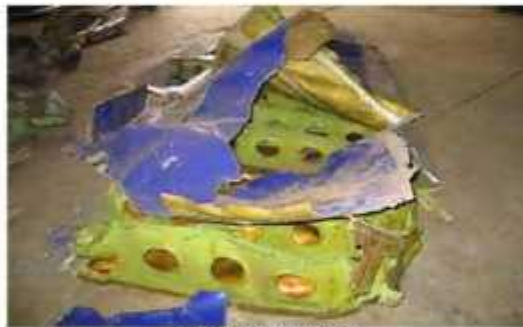
Upper and lower skin has a number of cracks and tears with ribs attached to them.

FIG 33 Upper Skin

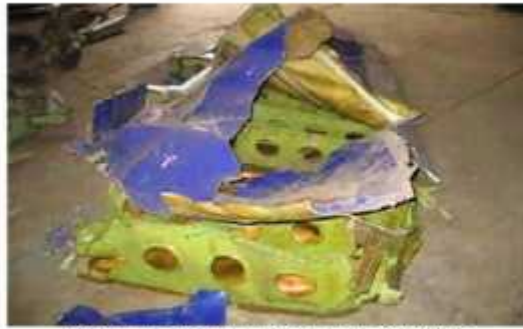
Ribs at the 2/3 outboard section of horizontal stabilizer were damaged and within the stabilizer box.

FIG 34 Inboard View of Damaged Stabilizer

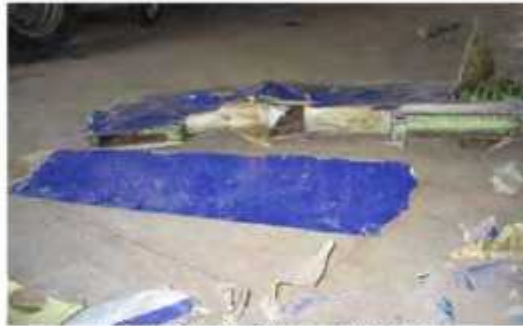
Most of trailing edge box was missing.

FIG 35 Aft End of Horizontal Stabilizer

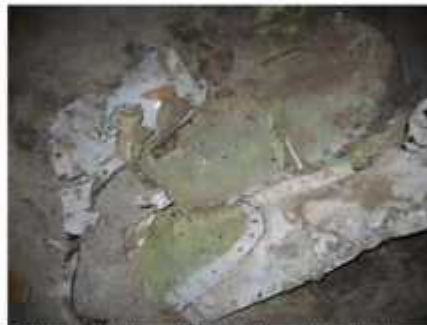
FIG 47A Folded out View LH logo light fairing missing.

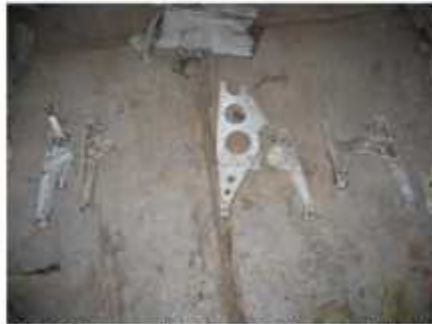
FIG 52 Ship set of the 4 outbd flap - track fairing support fittings broken as shown

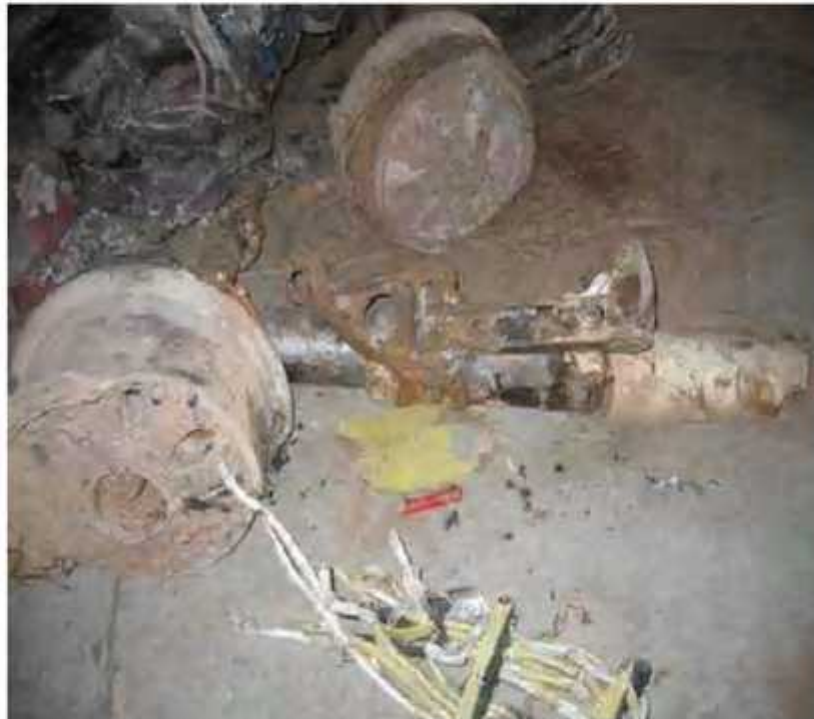
FIG 58 LH lower main landing gear assy shows evidence that the tires, wheels, and struts were subjected to fire

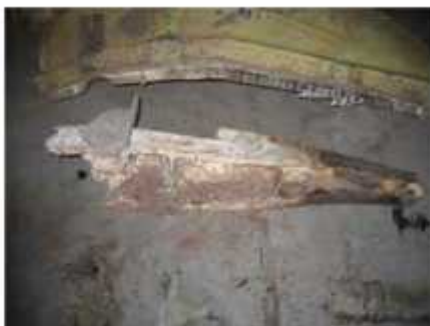
FIG 60C RH main landing gear support beam outbd end.
Smoke and/or heat damage on the outbd end.
