*AIRCRAFT ACCIDENT REPORT*

*CIVIL AIRCRAFT ACCIDENT REPORT NO. CIA 129 ON  
AIRBUS A-310  
AT PORT-HARCOURT AIRPORT  
PORT-HARCOURT*

16th February, 1988.

This mishap involves Airbus A-310 model 221, serial numbered 329 with registration mark of 5N-AUG. It was operated by Nigeria Airways Limited as flight WT 104 and crashed in the landing phase on September 8th, 1987 at approximately 1756 hours UTC at Port-Harcourt International Airport, Rivers State.

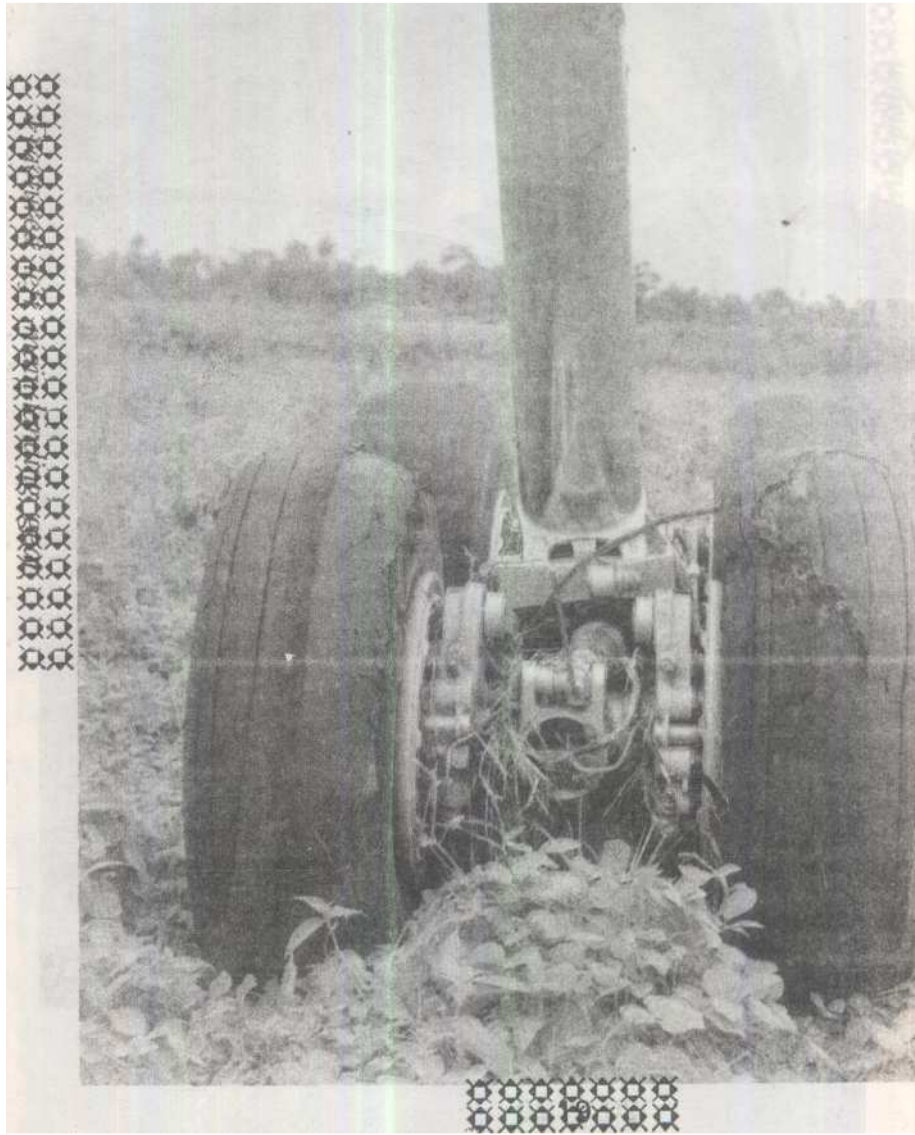
*Plate No. 2*

The trench alongside runway 21 did the most devastating impacts to the aircraft. The accident became more disastrous when the Left main gear first ran into the ditch and fractured the strut. The nose gear also broke off. Port side engine impacted with the ground, crushing the fan-blade shroud and eventually the High Pressure compressor chamber.

Engine number one suffered an irreparable damage. The airplane came to rest 640 metres after initial touchdown, with its left wing in contact with ground because the left gear had been completely severed off earlier in the disastrous landing roll. (Please see attached plate Nos. 2- 5)

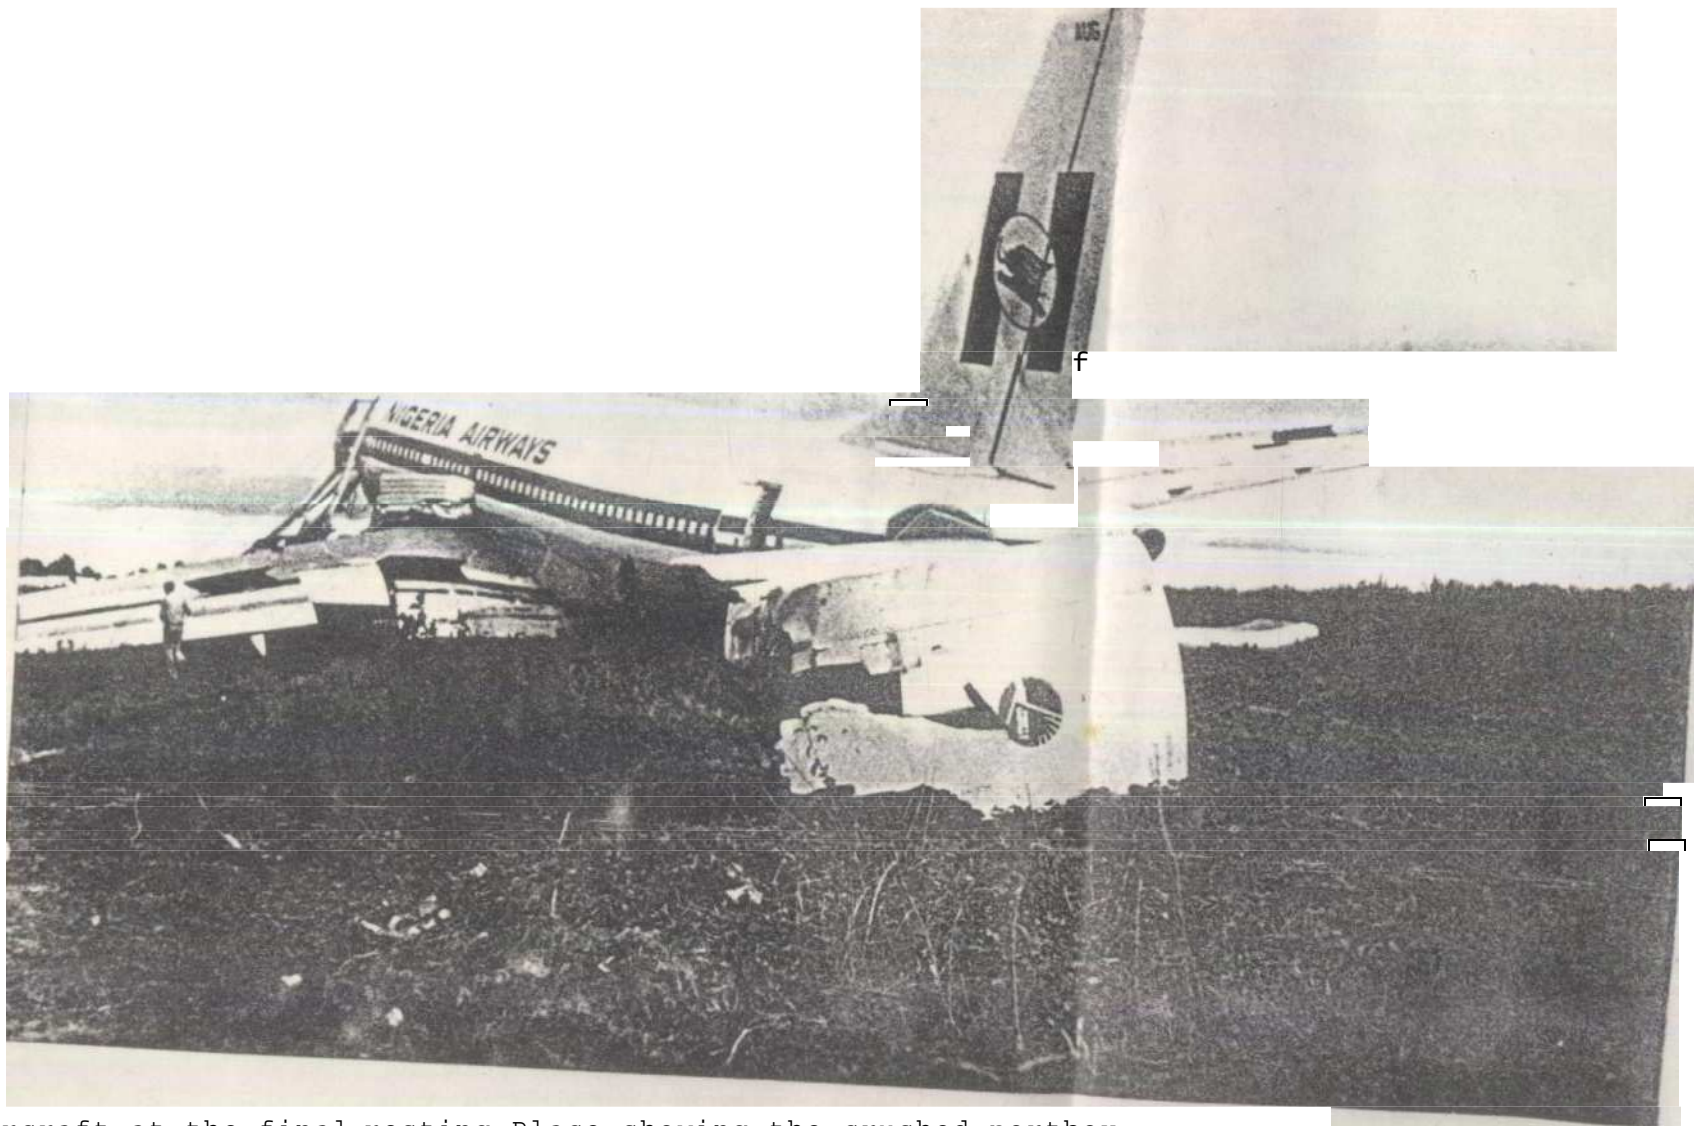
*Fractured left main-landing gear 19*

aircraft at the final resting place showing the crushed portbox

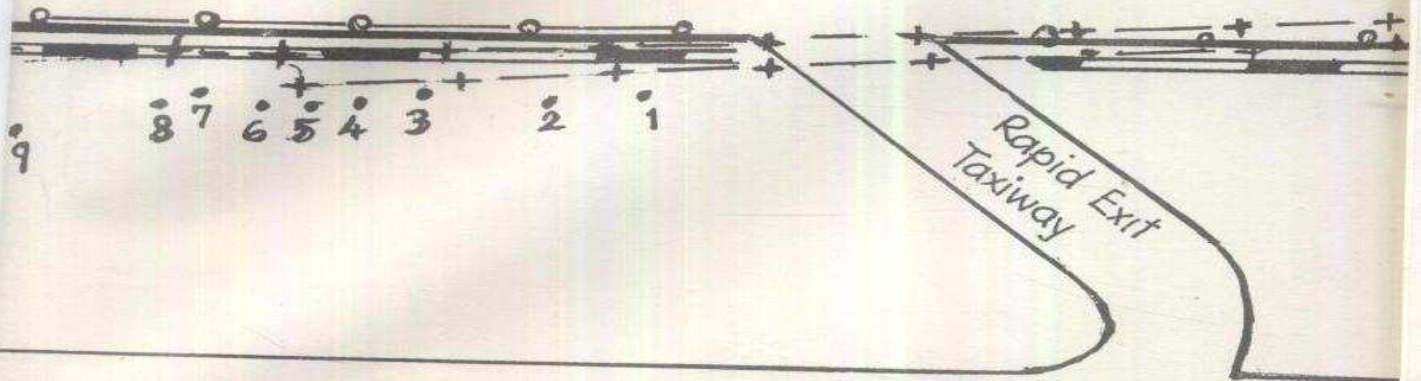
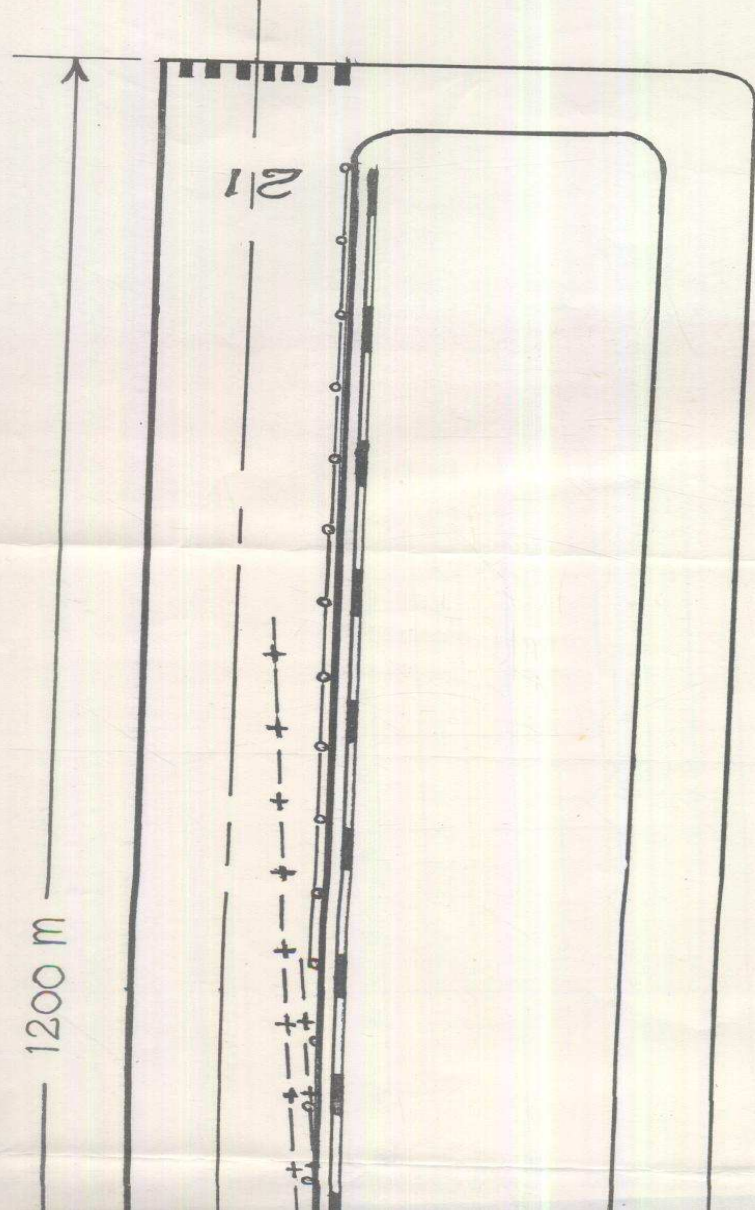
1200 5N-AUG WRECKAGE

**1.10.4** There are open wide and deep trenches very close to the left side of runway 21 - These trenches are about one metre from the edge of the runway, on the immediate shoulder. They are about one metre deep and half a metre wide (see plate No. 1) from the beginning of runway 21 and continuing towards the beginning of runway 03

Along the wreckage trail, (appendix 1) are engine intake cowl, fan blades, compressor blades, thrust reverser parts, left main gear struts, wheels and brake assembly, Nose gear wheel assembly, brake line hoses, and engine acoustic linings.

The trench at runway 21 should be filled immediately and the surface be brought to the load bearing status which the runway design specifies.
