**CIVIL AVIATION
ACCIDENT REPORT**
NO CIA 161

REPORT ON THE ACCIDENT TO
BRISTOW HELICOPTER (NIG.) LTD
HELICOPTER REGISTERED 5N-AJY
AT EKET OFF-SHORE ON THE
24TH FEBRUARY 1991

**Final Report on the Accident to the
Bristow Helicopter Bell - 212 Aircraft
Registered 5N-AJY at Eket Off-shore Near
BOP Oil Rig_ on the 24 February 1991**

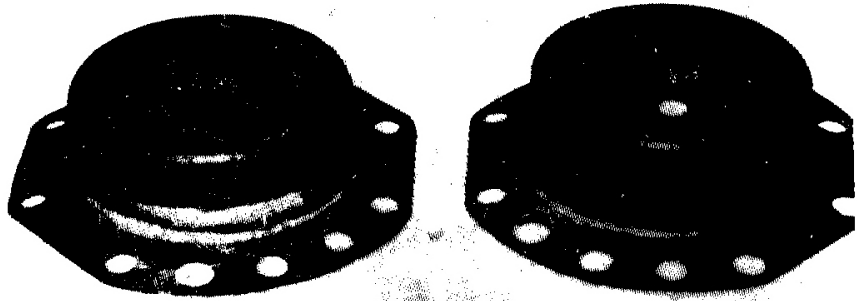
APPENDIX 2B A

3.1.7 Bleed Valve Serial Number A4316 on the No.2 engine was found to have its diaphragm rolled up and kinked, therefore not permitting full up and down travel motions of its piston.

This malfunction could have caused the problem of compressor surge resulting to the type of bang sound that the captain claimed he heard

The pinched diaphragm on the left - In comparison with a normal one on the right.

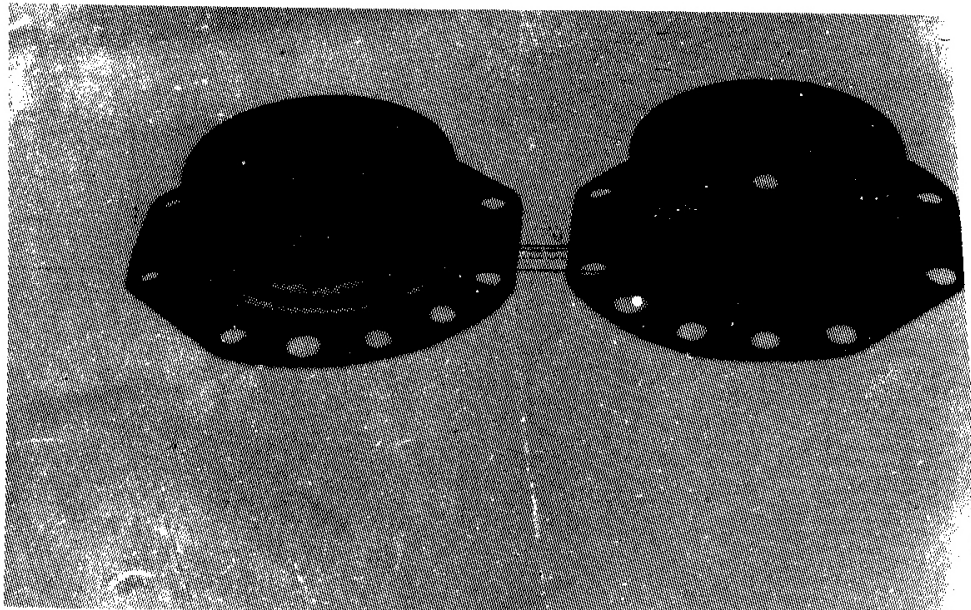
B

Another angle of the damaged diaphragm.
