CIVIL AVIATION ACCIDENT

REPORT NO CIA 171

*REPORT ON THE ACCIDENT TO THE PMAS
DO-228 201 AIRCRAFT REGISTERED 5N-ARI
AT EKET AIRSTRIP, AKWA IBOM STATE
ON THE 26TH FEBRUARY 1992*

CIVIL AIRCRAFT ACCIDENT REPORT NO. CIA 171

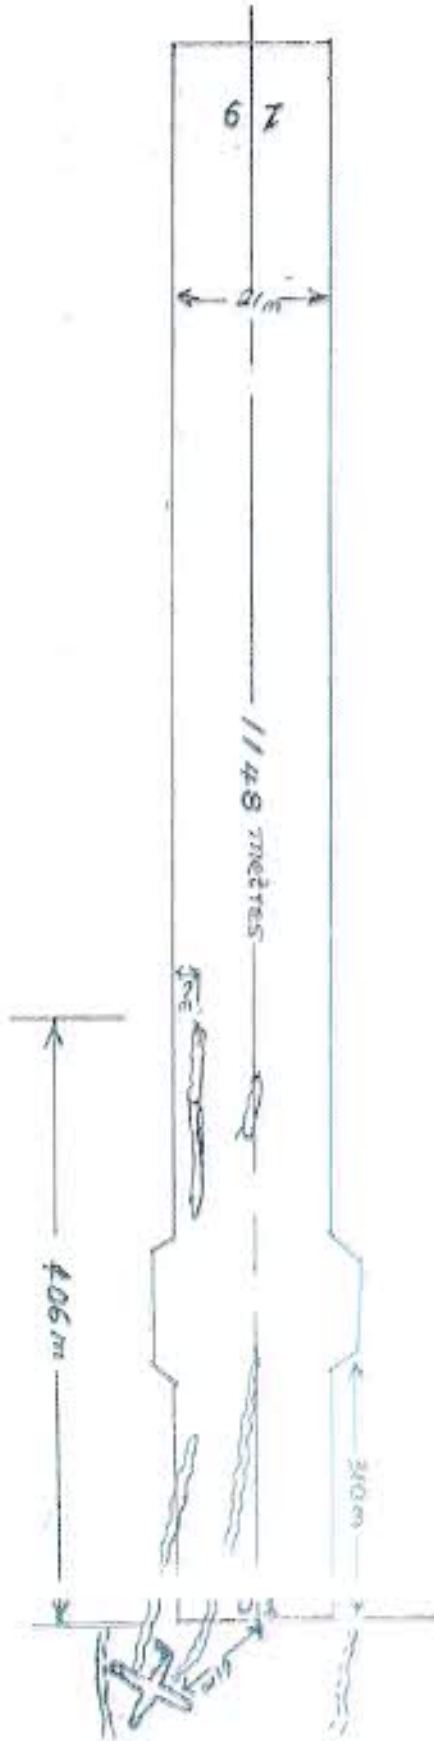
EKET AIR-STRIP

The aircraft remained intact at the final resting place at the end of the runway. Please see the accident trail diagram on appendix 2.

The result of the hurried descent OVER THE RUNWAY was that the aircraft touched down on one gear first at a point 742 metres upstream, leaving only 406 metres for the landing roll. The aircraft's touching down on one gear for some distance within the remaining available landing roll distance indicates that the aircraft was not yet firm on the ground for effective deceleration devices to take effect, which further more consumed some of the available 406 metres.

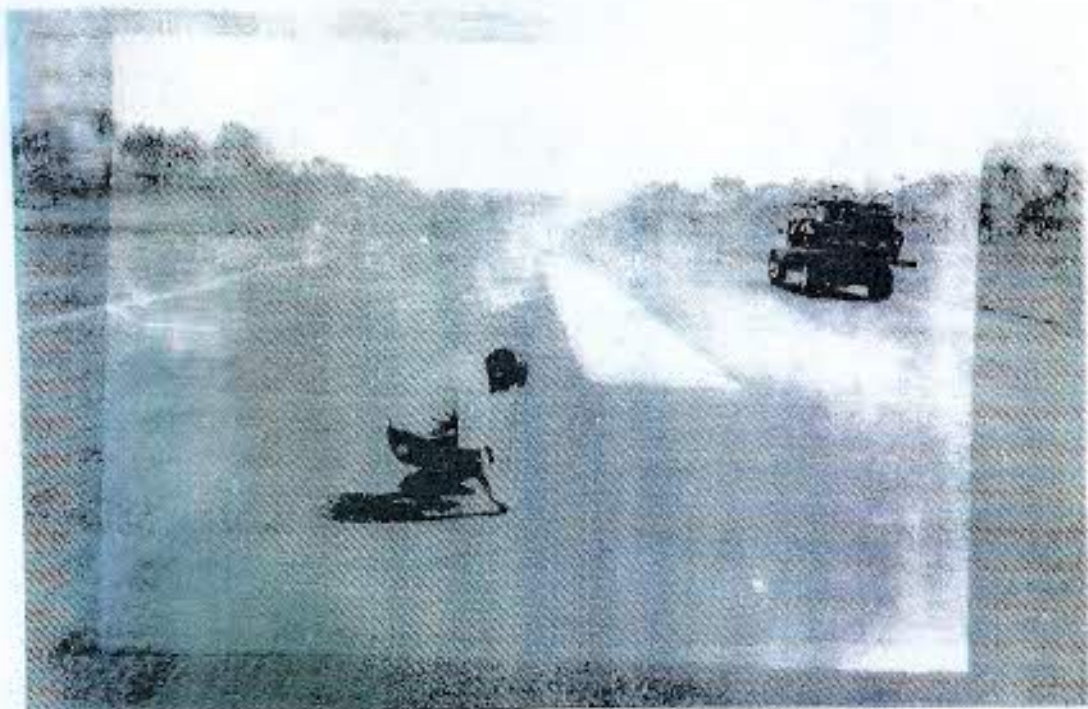
APPENDIX 3 A

Ray picking the left hand wheel touchdown marks on the runway.

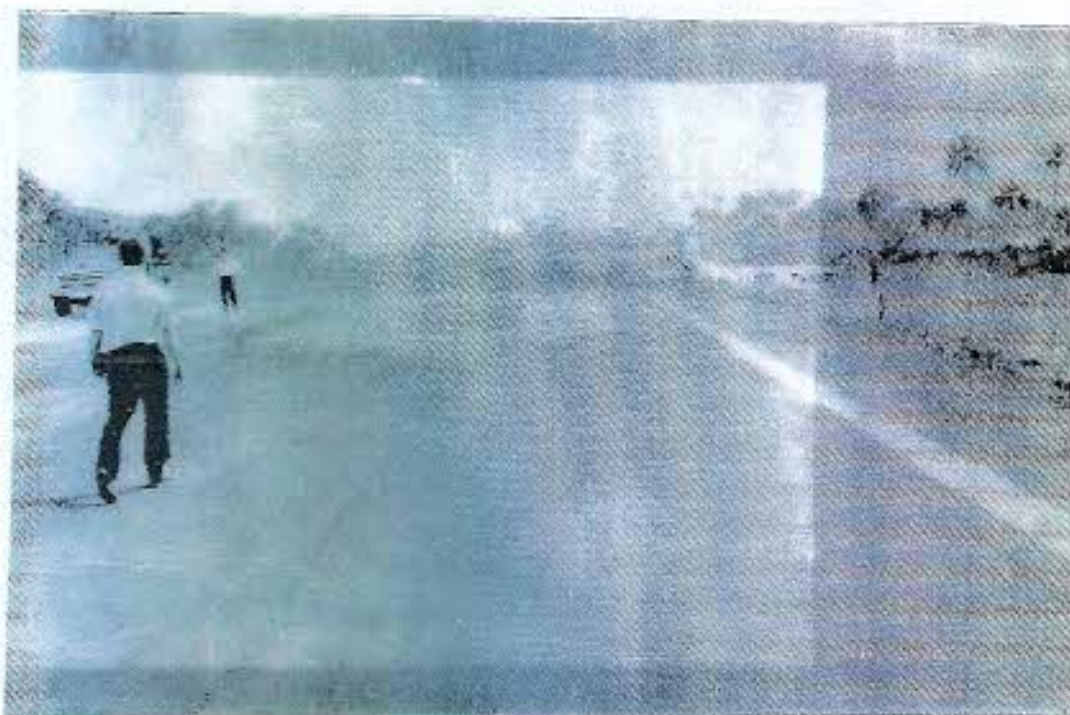
B

So, all the maximum reverse thrust, all the braking and all the skiddings were just the resultants of a panic measure, which could not stop the aeroplane successfully, except if the crew had an infinite runway distance ahead of them but which they did not. Hence this accident.

Ray following the main gear wheel panic braking marks to the end of the runway.

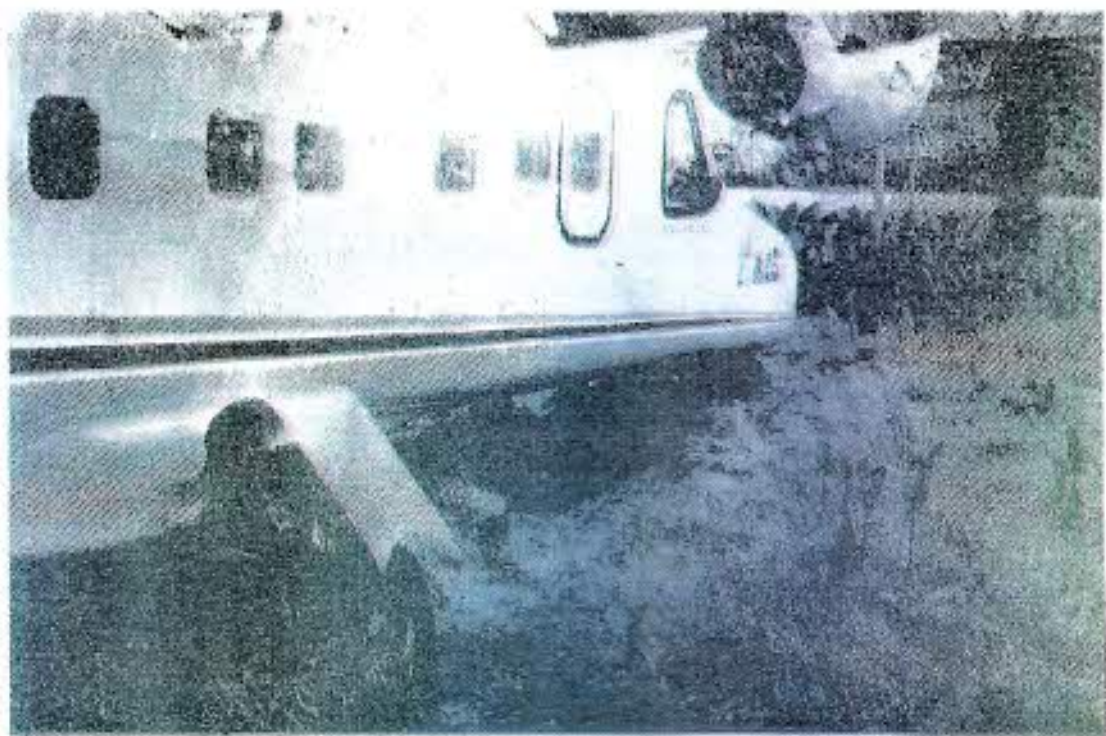
APPENDIX 4. A

The nose wheels were observed to be partially damaged but the gear itself looked apparently unaffected though was buried into the soil.

Extent of ground work done by the nose gear.

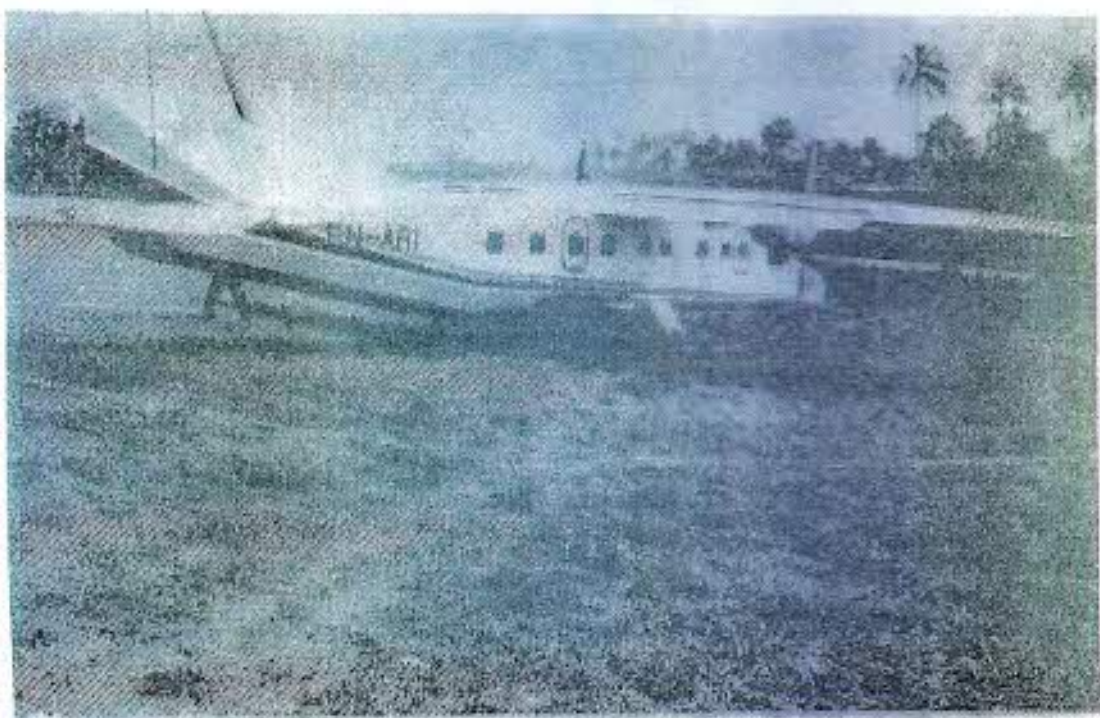
B

The accident started at the touchdown point and the aircraft was brought to an abrupt halt on the clearway about 60 metres from the end of the paved threshold.

SN-ARI at its final resting place.

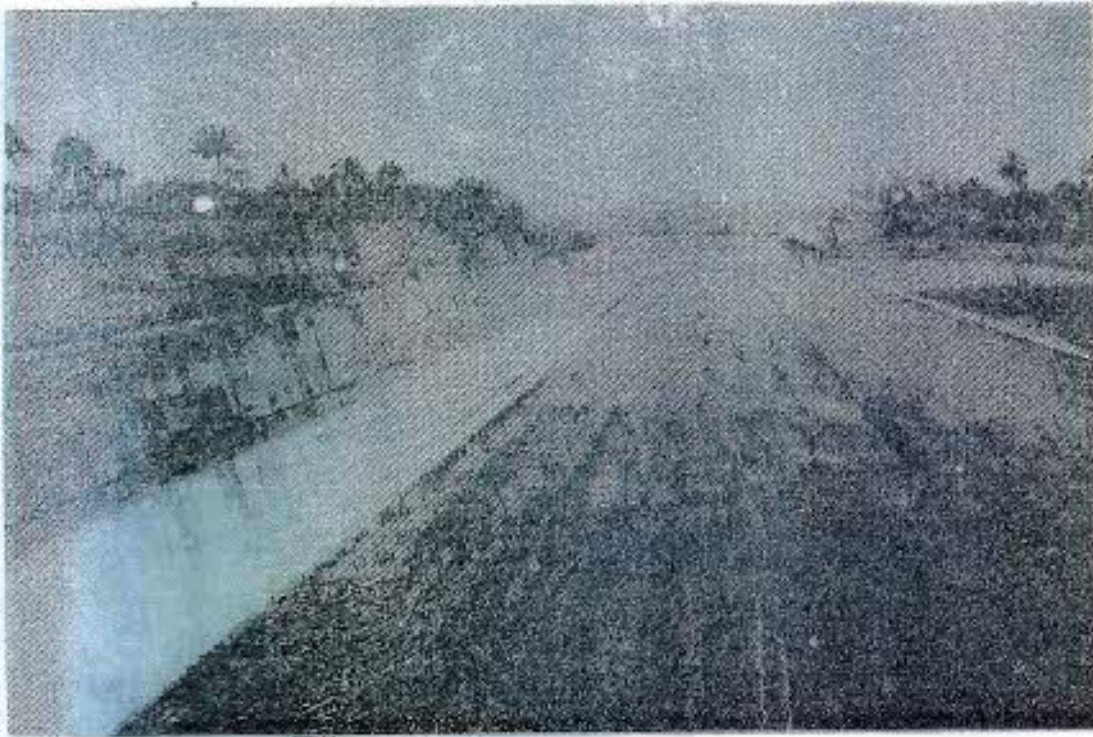
APPENDIX 5 A

".....Right hand wheel touched down almost level with the 'edge' of the 'turning circle'" - statement by an onboard passenger.

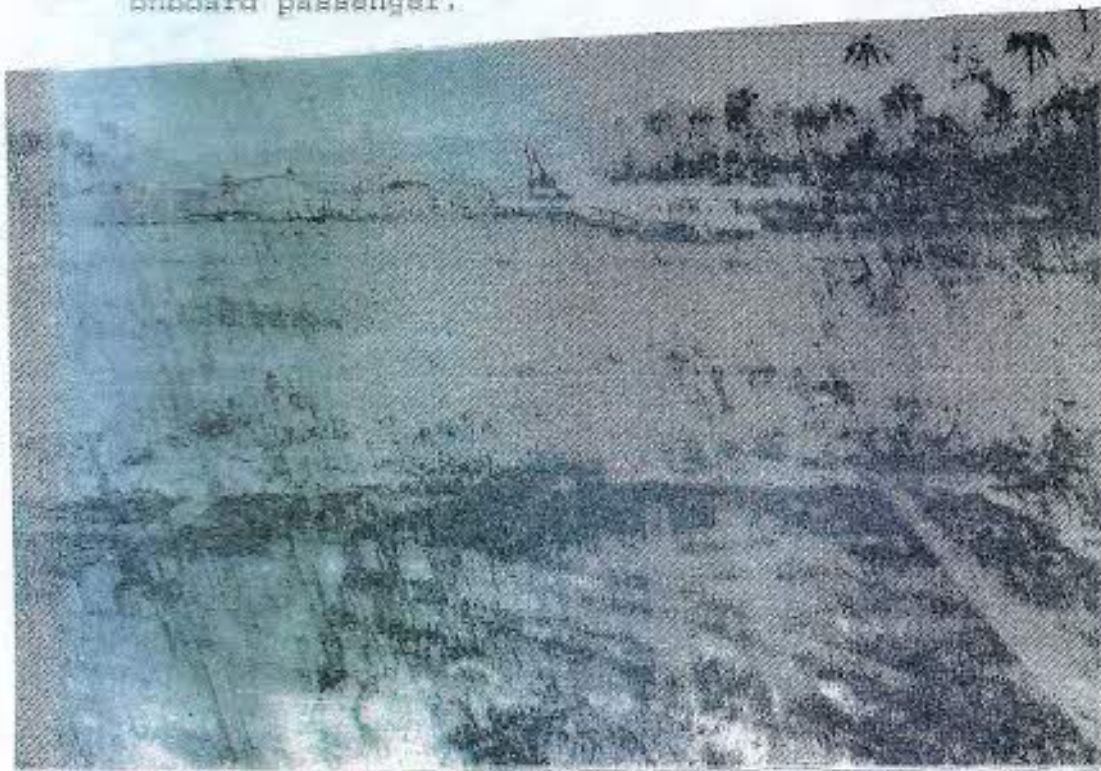
B

- 3.1.14 The touchdown point was too short to contain the landing roll; hence the overrun was imminent and no desperate action could prevent it.

Overrunning the paved way end.

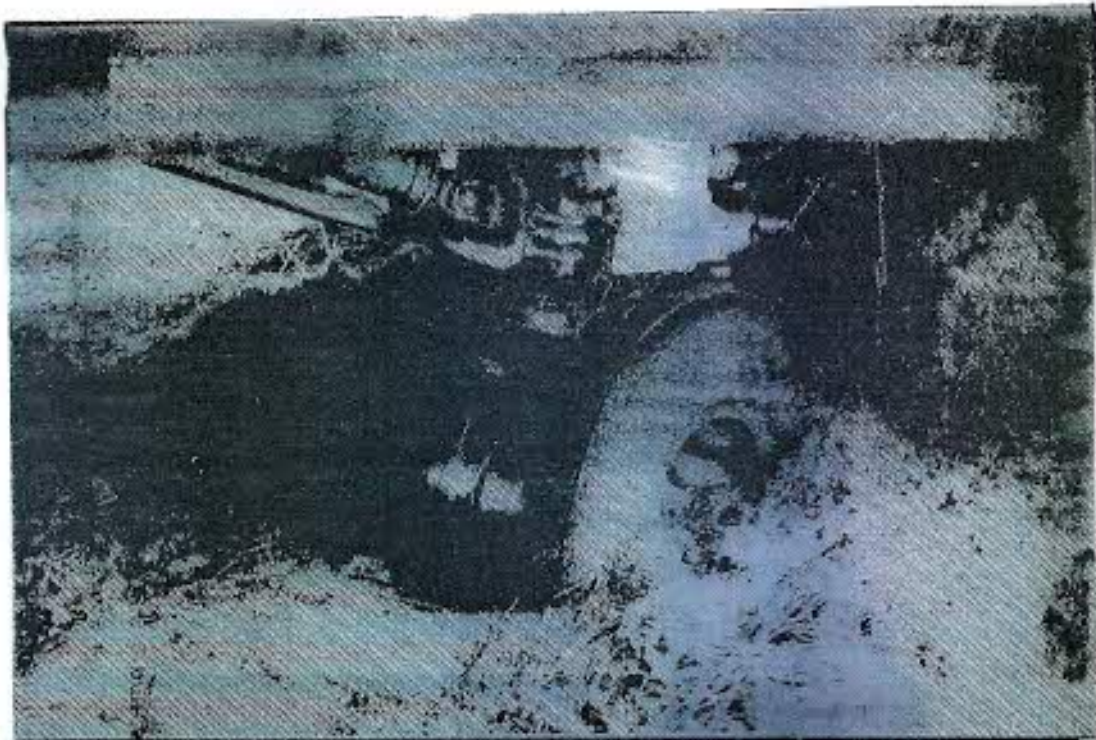
APPENDIX 6 A
Damage to the nose gear wheels

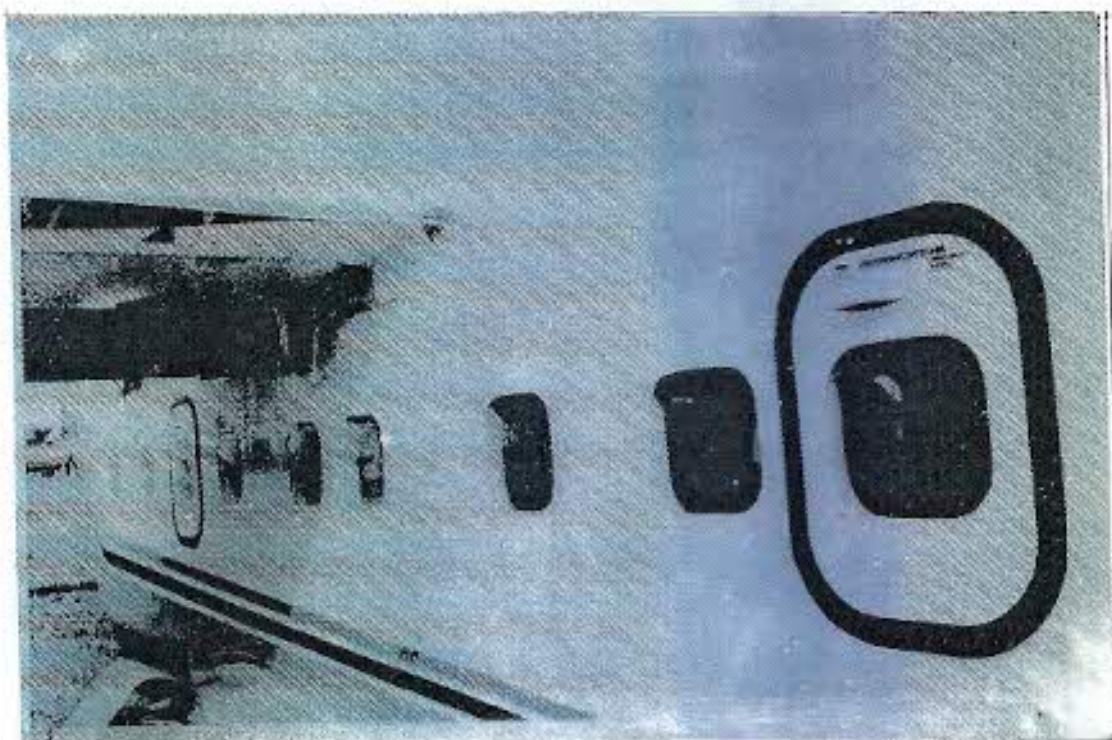
There was an observable skin buckling on the fuselage top just forward of the left wing leading-edge and also at the fuselage/wing rear attachment point. The bucklings might be indicative of probable fuselage/wing distortion, which might also affect the dihedral angle of the main plane. Also the right hand side of the fuselage had bucklings at the forward section.

B
Damage to the fuselage structure.
