AIRCRAFT ACCIDENT REPORT

DANAL/2019/01/23/F

**Final Report on the Serious Incident involving a Dornier
328-100 aircraft with nationality and registration marks
5N-DOX, operated by Dornier Aviation Nigeria AIEP
(DANA) Limited, which occurred at Port Harcourt Military
Airport On 23rd January, 2019**

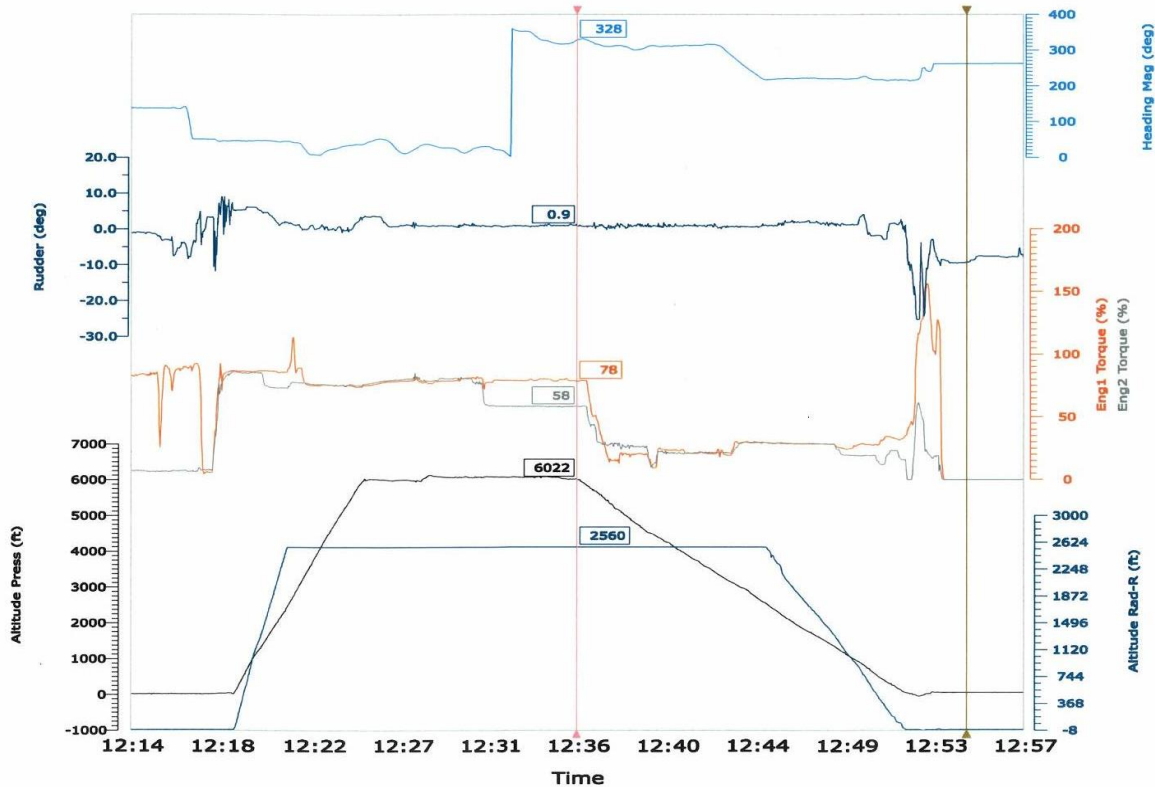
Figure 2: FDR Plot

1. The FDR showing a torque disparity of 20% (78/58) at 6,000 ft pressure altitude 23 minutes to DNPM.
2. The FDR showing initial rudder deployment of 26° right of the runway centreline immediately after touchdown.

The disparity in engine torque according to the FDR had occurred at 6,000 ft, which became more pronounced at touchdown to a value of 300% disparity as shown on the FDR plot. However, from the crew statement, these values were missed. Because they missed the true nature of the problem, they were not able to execute the correct checklist to arrest the situation.

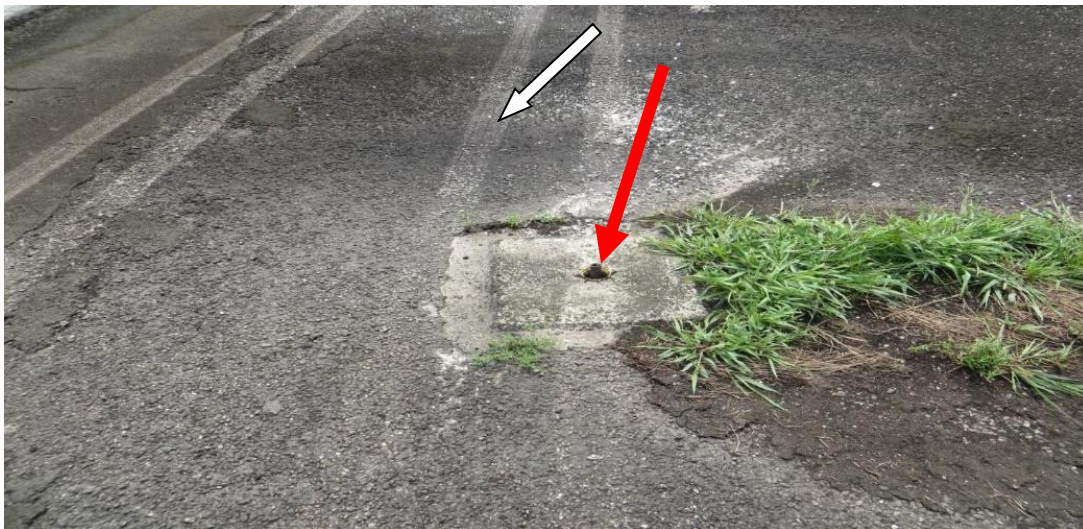
One runway edge light was damaged.

Tyre marks on the runway showed that the aircraft exited the runway at a distance of 1,190 m from the threshold of runway 22. It further travelled on the runway shoulder for a distance of about 105 m. At a distance of approximately 98 m of its movement on the runway shoulder, the No. 4 right main tyre broke a runway edge light. The aircraft further veered off the runway shoulder and continued on the grass verge. It covered a distance of about 262 m on the grass verge. The aircraft travelled an additional distance of 259 m on the apron and came to a complete stop at about 3 m to the perimeter fence by the Aero Contractors ramp.

Figure 3: The main wheel tyre marks on the runway right shoulder (white arrow) and a damaged runway edge light (red arrow)

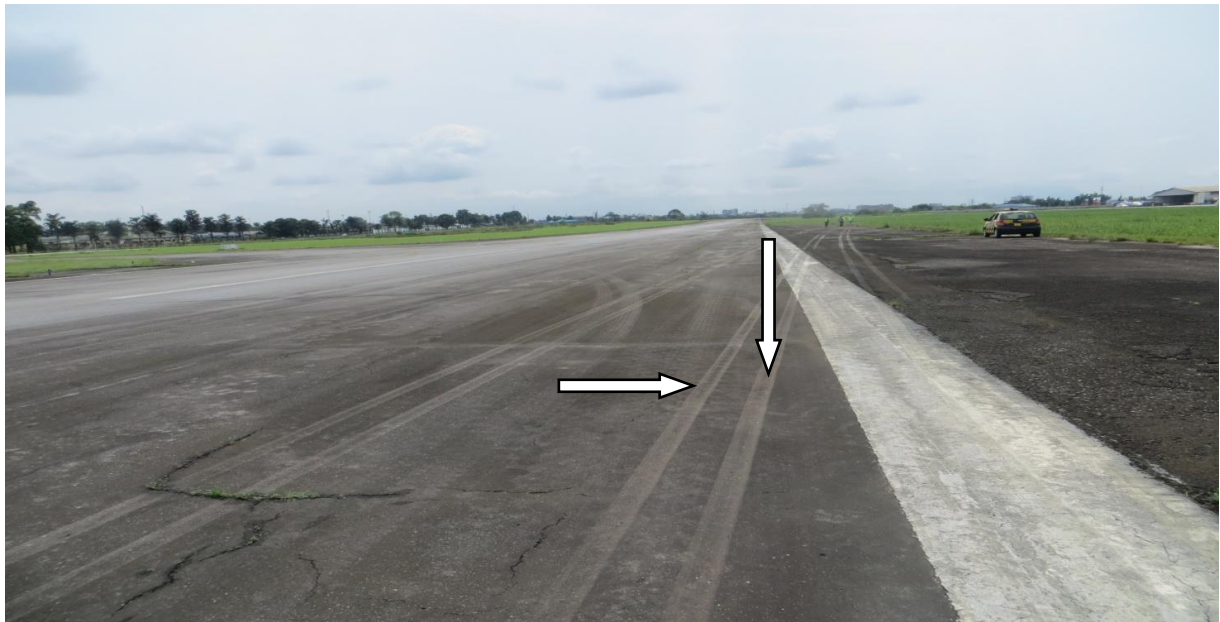
Figure 4: The aircraft main wheel tyre marks on the runway and the runway right shoulder

The tyre tracks showed that the aircraft landed right of the runway centerline and veered further right into the grass verge. This indicates the effect of a propeller torque asymmetry coupled with excessive rudder input of -30° as revealed by the FDR plots especially after touchdown which the crew were unable to arrest.

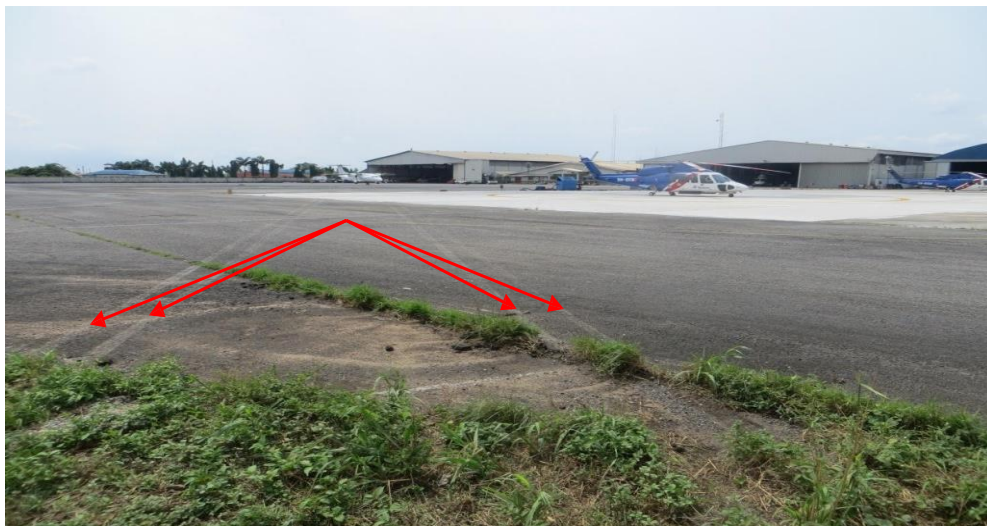
Figure 5: The aircraft's tyre marks on the Apron

The investigation believed that there was a delayed application of Emergency brakes considering the distance travelled by the aircraft before it finally stopped.

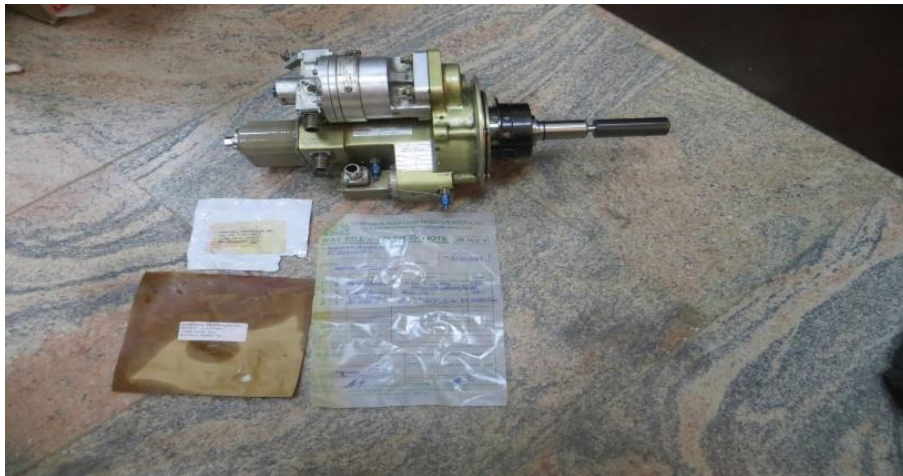
The PCU failed the incoming ATP because of low pressure at the 400 pound relief valve. Pressure at the relief valve should be 470+/-30 psi.

After disassembly, the filter was found to be full of a black silt-like substance.

Visual inspection of the remaining part including the Coupling/Tube Assembly and Volume Exchange Unit exhibited signs of normal wear. No dimensional inspections have been performed at this time.

Figure 6: The defective left engine PCU

The disparity in the left and right propeller torque values is an indication of failure of the propeller control unit (PCU) of the number 1 engine. This is evident from the crew account that the engine number 1 torque value at about 6.2 NM to touchdown and at landing, did not agree with the corresponding power lever settings.

- "L/H engine propeller will not come out of feather."
- "L/H PCU replaced IAW DO328 MM 61-21-04. OPS, Rig Check, Leak Check, OK".
