AIRCRAFT ACCIDENT REPORT

GAL/2020/09/10/F

Accident Investigation Bureau

**Final Report on the serious incident involving
BAe 125-800B aircraft with nationality and registration
marks 5N-B00 operated by Gyro Air Limited which
occurred at Osubi Airstrip, Warri, Nigeria On 10th
September, 2020**

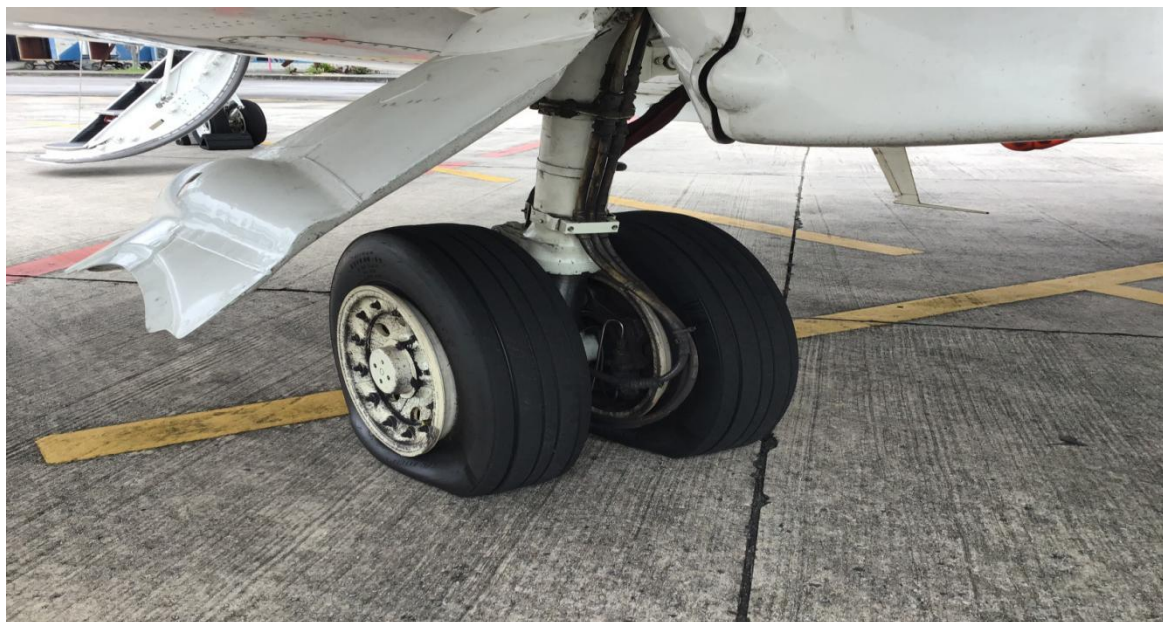
the apron. The crew disembarked normally and discovered the left main wheel tyres (No.1 and No.2) had deflated.

Figure 1: The left main wheel tyres (No.1 and No.2) deflated

After the rejected take-off, the crew taxied back to the apron to await the stipulated brake cooling time but discovered that the left main wheel tyre (No.1 and No.2) had deflated. The investigation revealed that, the very high thermal load imposed by the maximum braking action during the rejected take-off, might have caused the temperature in the wheel assembly to rise to 177°C or 199°C which led to the melting of the fusible plugs. This excessive heat causes the nitrogen pressure within the tyre to eject the piston and fused material from the plug. The fusible plugs are installed as a safety mechanism to avert a high-speed tyre burst that can lead to loss of directional control and runway excursion.

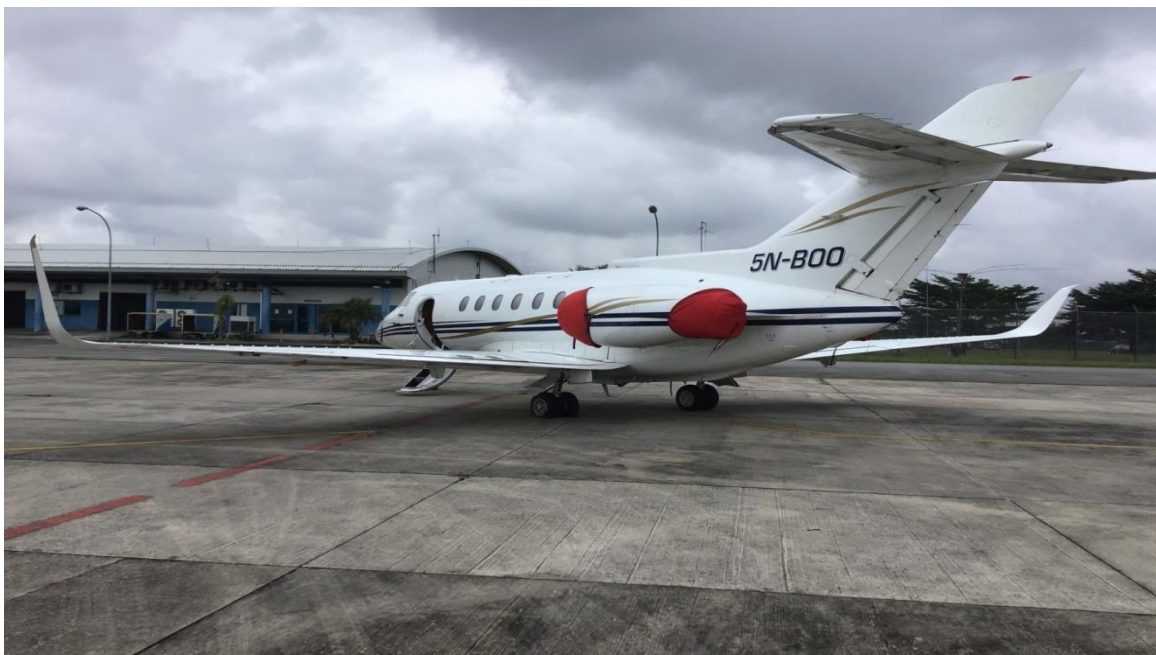
Figure 2: 5N-B00 parked at Osubi apron after the incident

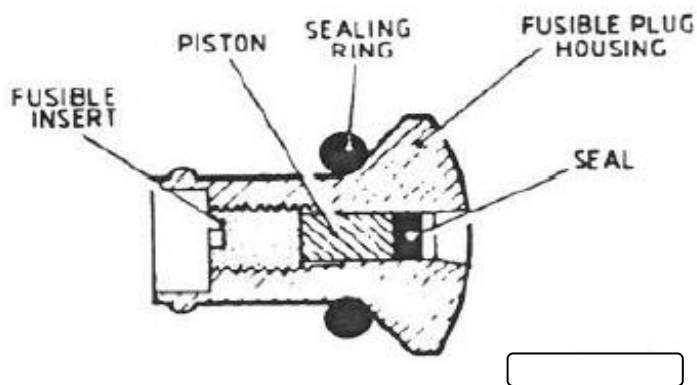
When excessive heating occurs the insert fuses at 177 degrees Celsius or 199 degrees Celsius (Mod.253089) and the nitrogen pressure within the tire ejects the piston and fused material from the plug.

Figure 4: Fusible plug assembly and O-ring
