PRELIMINARY REPORT ON THE SERIOUS INCIDENT INVOLVING BOEING 747-400 AIRCRAFT OPERATED BY MAX AIR LIMITED WITH NATIONALITY AND REGISTRATION MARKS 5N-DBK WHICH OCCURRED AT MINNA INTERNATIONAL AIRPORT ON 7TH SEPTEMBER, 2019

Aircraft accident report number:	MAL/2019/09/07
Registered owner and operator:	Max Air Limited
Aircraft type and model:	B747-400
Manufacturer:	The Boeing Company, USA
Date of manufacture:	1996
Nationality and registration marks:	5N-DBK
Serial number:	26403
Location:	Runway 05, Minna Airport
Date and time:	7 th September, 2019 at 04:17

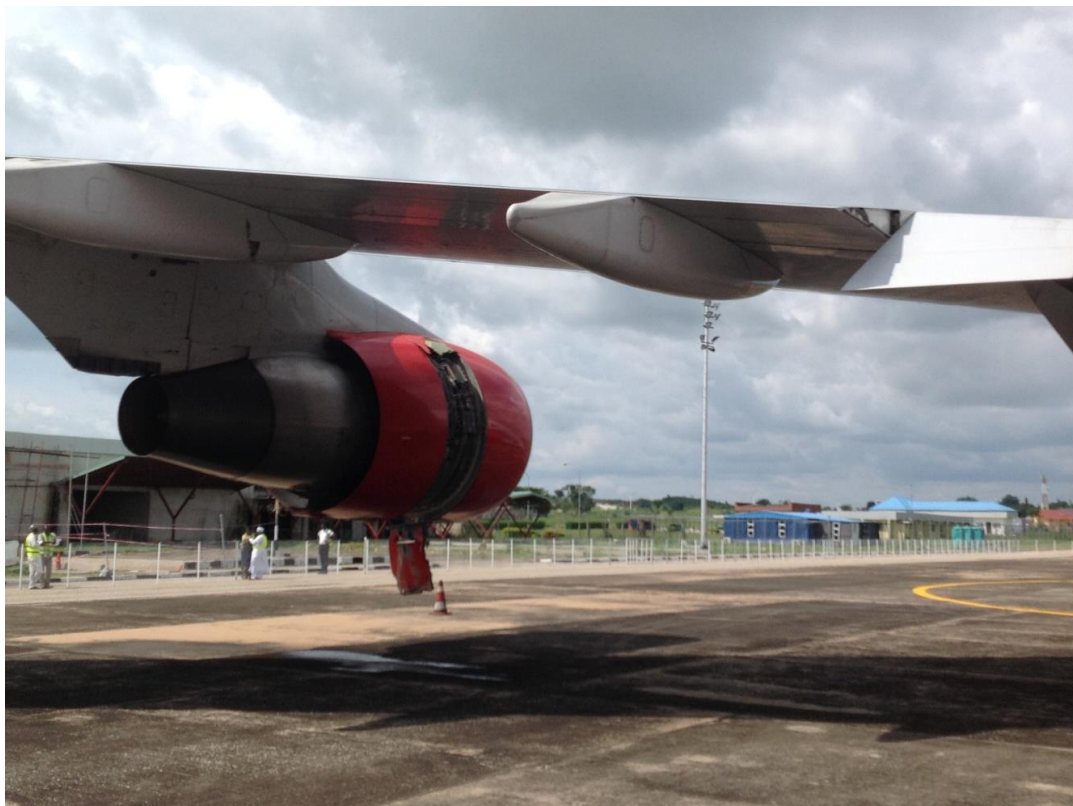
On examining the number one engine, the bottom surface of the nacelle was abraded, thereby releasing the cowl latches resulting in the fan cowls being blown off the engine by the slipstream.

Figure 1: Damage to the right cowling of engine number one

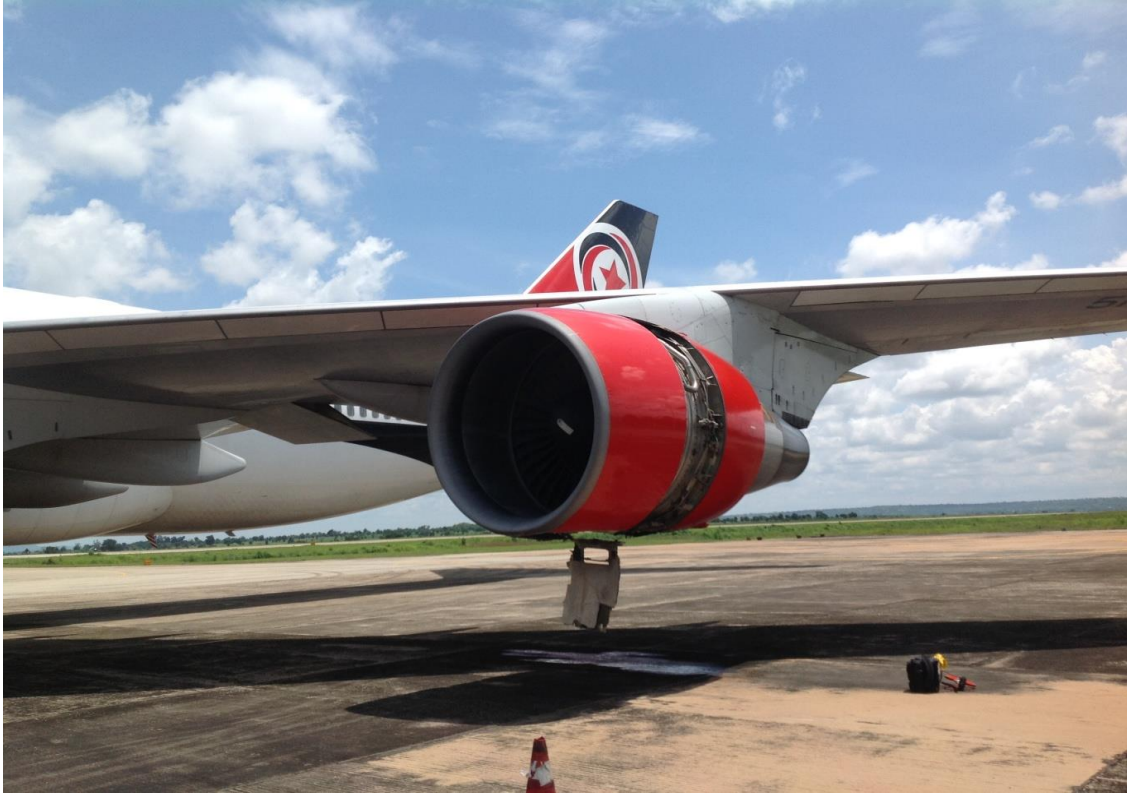
Figure 2: Damage to the left cowling of engine number one

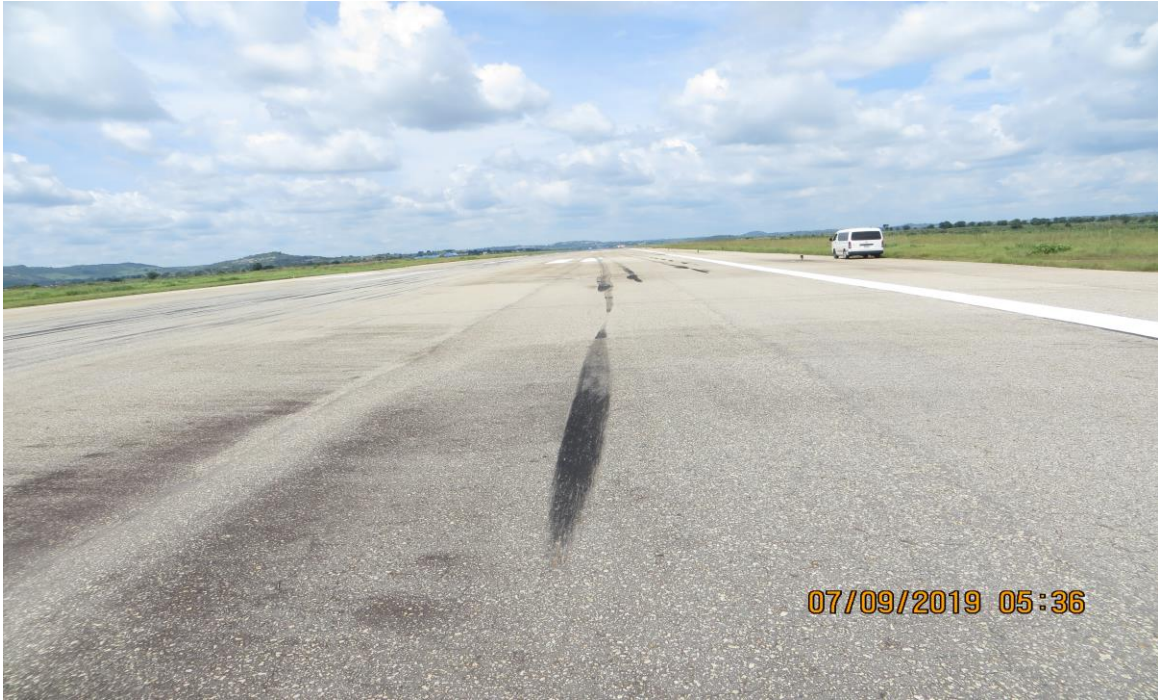
wheels. The touchdown point was 203 m from the threshold on the right side of the runway centreline, the aircraft gradually steered to the centre line.

Figure 3: Tyre marks indicating the touchdown point

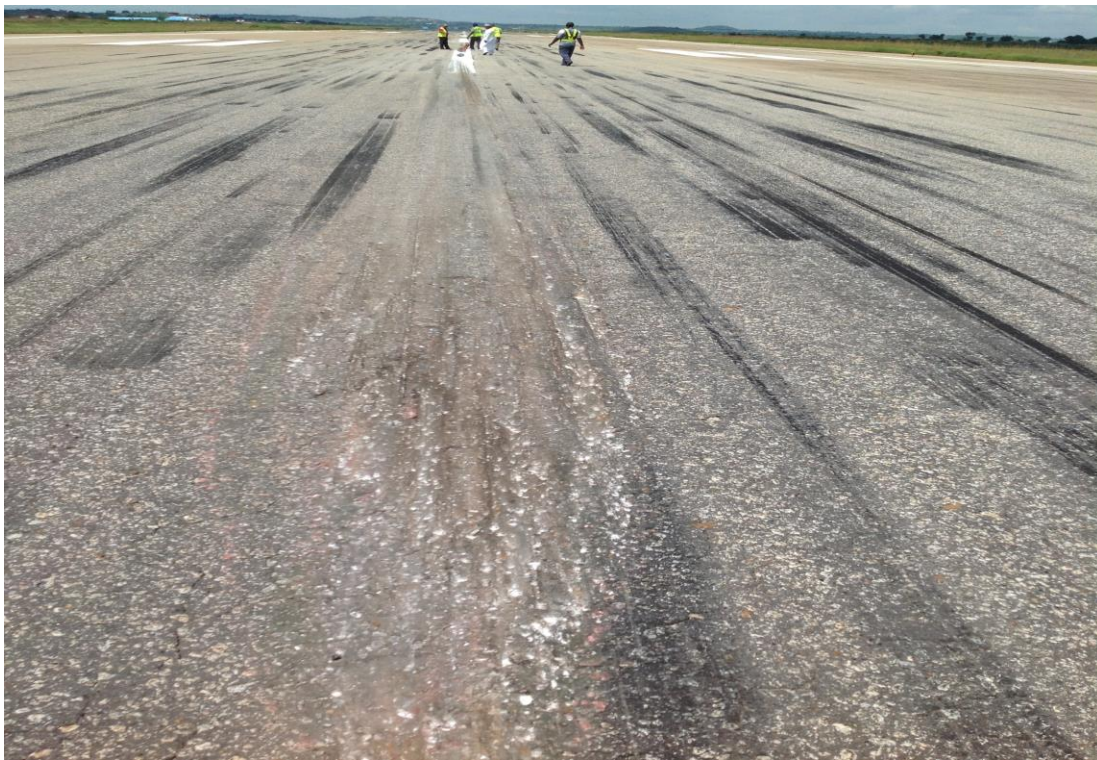
Examination of the marks on the runway revealed the following; The aircraft crossed the threshold right of centre line, was in a left bank, the left main wheels touched down and the number one engine nacelle contacted the runway on the centre line, 203 m from the threshold, and was dragged on the runway along the centre line for approximately 44 m. The body wheels touched down, followed by the right main

Figure 4: Impact marks of engine number 1 on runway centerline

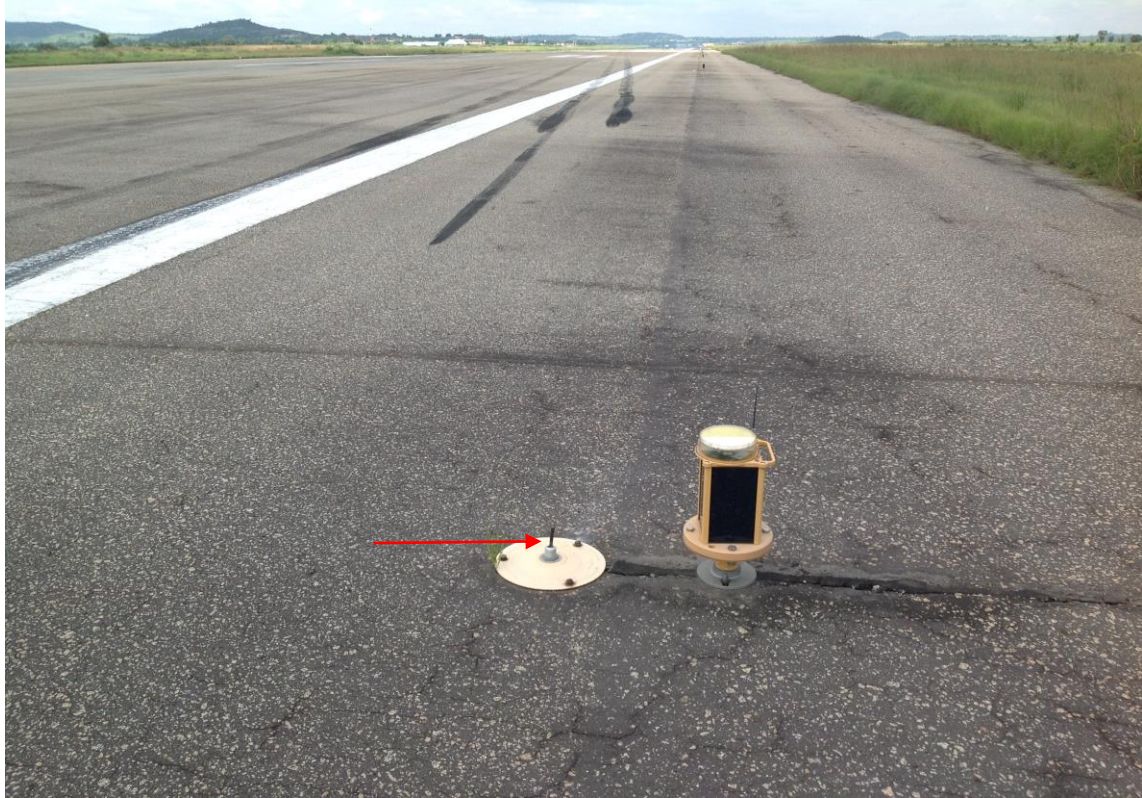
One runway edge light was damaged.

Figure 5: Damaged runway edge light

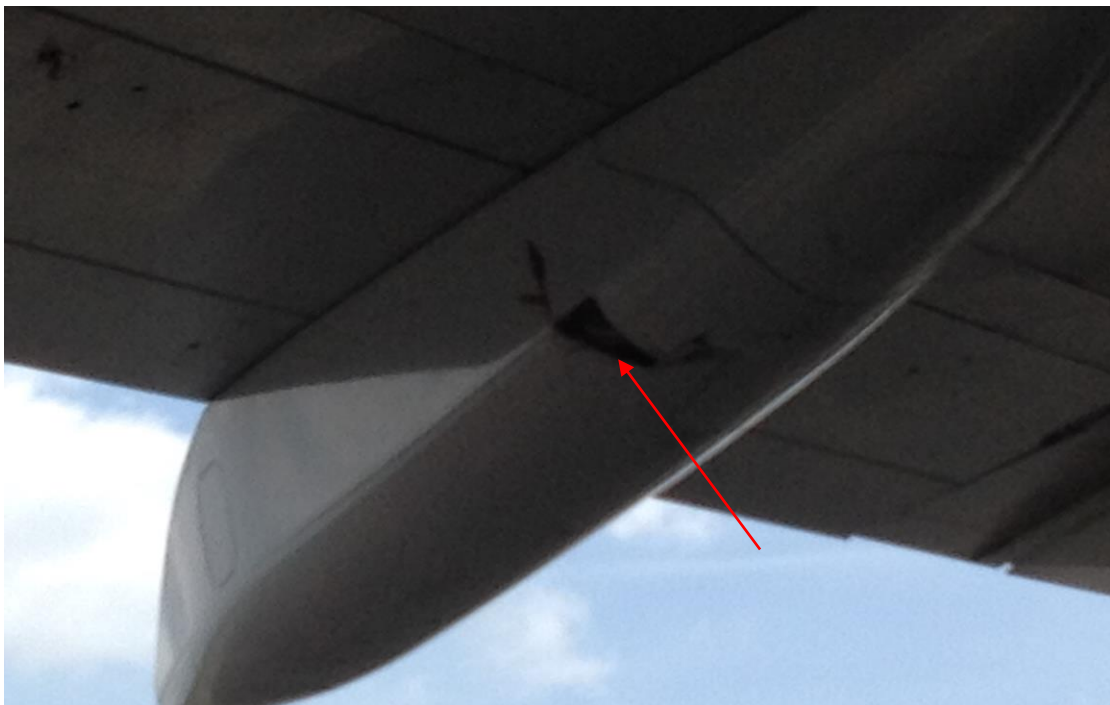
Figure 6: Punctured flap fairing on the left wing

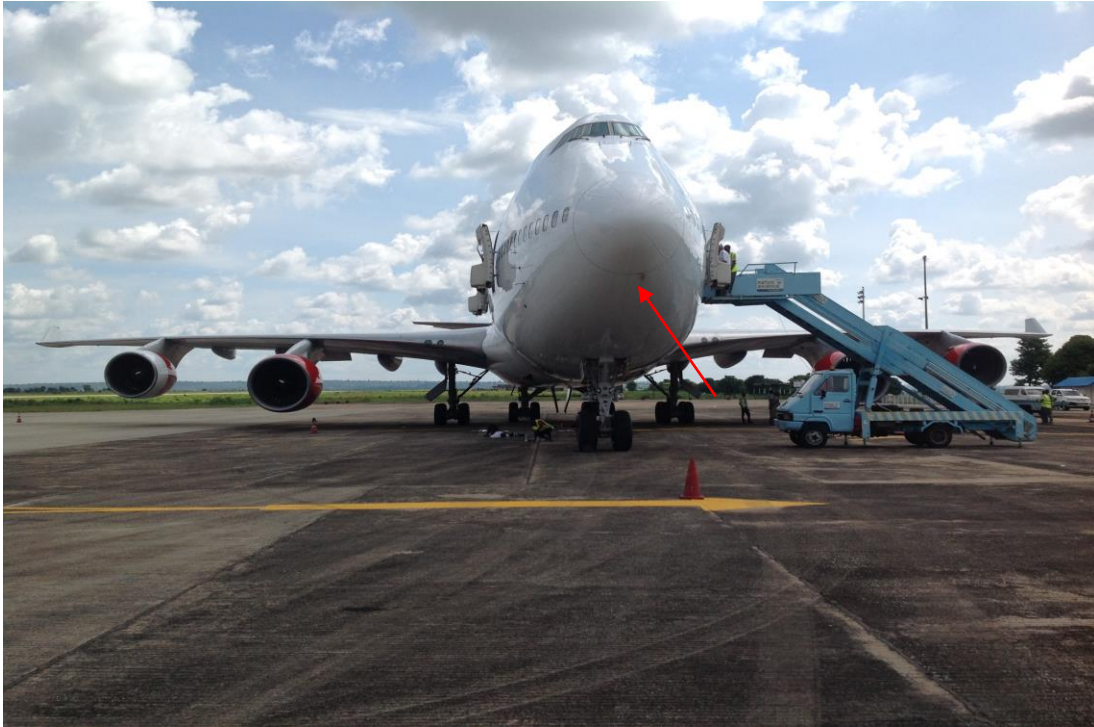
Figure 7: Bird strike at the edge of the radome

1. NAMA should ensure that the Navigational Aids installed at all the operating airports in Nigeria are calibrated in accordance with the AIP Supplement S 38/2019 dated 10th September, 2019
2. FAAN should always ensure that there is effective control of birds and wild life during airport operating hours at Minna Airport
