INTERIM STATEMENT

Accident Investigation Bureau

**Interim Statement on the serious incident involving
Boeing 747-400 aircraft with nationality and
registration marks 5N-DBK operated by Max Air
Limited which occurred at Minna Airport, Nigeria on
7th September, 2019**

AIB REPORT NUMBER: MAL/2019/09/07/INTR/01

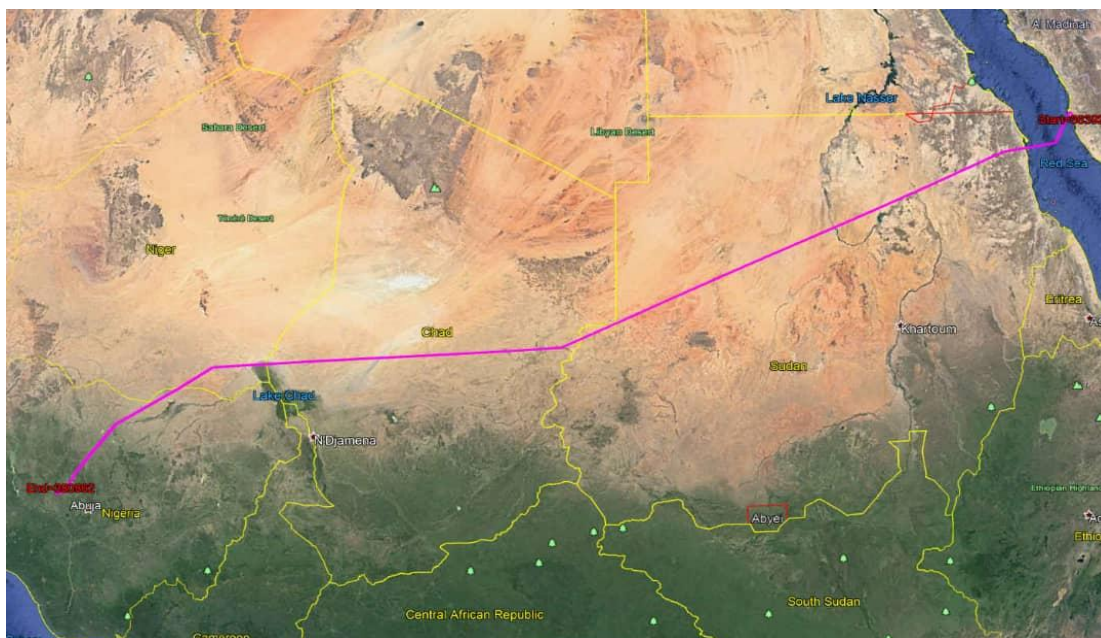
Figure 1: Flight track for NGL2092 imposed on Google Earth

At 03:46:55 h, NGL2092 further reported to Minna Tower that there was an accumulation of storms on the final approach path, then requested to deviate left and extend the downwind leg of RWY 05. Minna Tower acknowledged and instructed NGL2092 to report when clear of weather.

At 03:50:23 h, NGL2092 reported RWY 05 in sight, established on the localizer (LOC) 05 and also clear of the accumulated storm on the final approach path of RWY 05. Minna Tower cleared NGL2092 to land RWY 05 with a reported prevailing wind of 030°/ 07 kts.
