# AIRCRAFT ACCIDENT REPORT

MAL/2022/04/26/F

**Nigerian Safety Investigation Bureau**

**Final Report on the ground collision incident involving an EMB-135BJ aircraft operated by Max Air Limited with nationality and registration marks 5N-BXK and a parked ATR 42 aircraft operated by Nigerian Air Force registered NAF 930 which occurred on the apron of the General Aviation Terminal of Nnamdi Azikiwe International Airport Abuja; Nigeria on 26 April, 2022.**

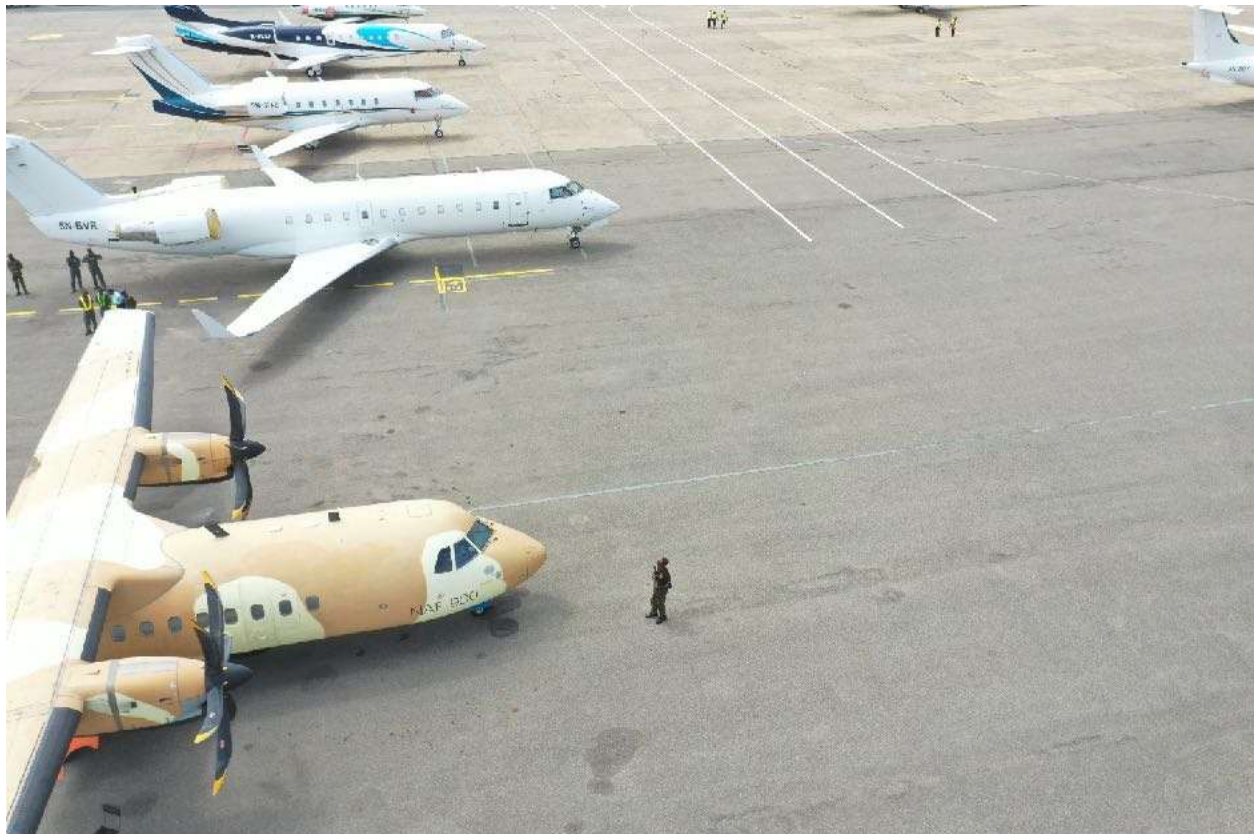
**Figure 1:** NAF ATR 42 Parked at unmarked spot beyond the last designated parking position

NAF930 was not properly parked in accordance with the lateral and longitudinal parking alignment relative to the other parked aircraft at the apron. The protrusion of NAF930 constituted a serious hazard that was readily discernible. However, the crew of NAF930 asserted that it was not obvious to them when they carried out the post-flight walk-around. It seemed sufficed that their aircraft was aligned with the other aircraft that was parked across the taxi lane. It is however worth noting that aligning an aircraft with another in the opposite bay without considering its alignment with the aircraft parked adjacent to it might bring about a protrusion of the tail as observed in this scenario. Furthermore, the alignment should also take into consideration the forward limits of the bay and the apron taxi lane.

Nigerian Air Force should adhere to the procedures, instructions, safety rules and guidance established by the airport authority in its relevant manuals, including Section 6.5 of the Airfield Operations Manual of Nnamdi Azikiwe International Airport for appropriate guidance and allocation of parking bay in the congested GAT/Cargo Apron to avoid safety hazards and to make the most efficient use of the limited parking space.

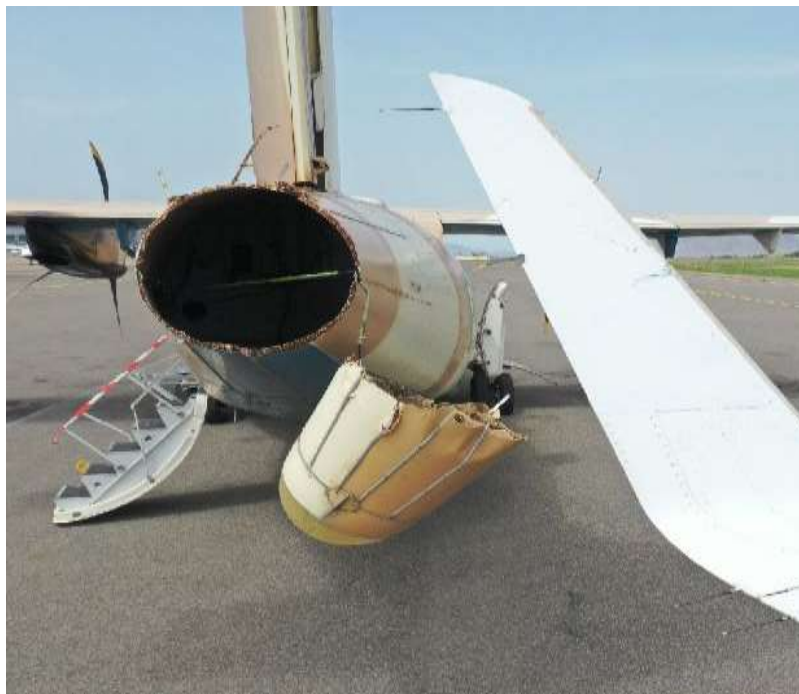
A section of the Tail Cone of the parked ATR 42 (NAF 930) sheared off.

**Figure 2:** Sheared off section of the Tail cone of the parked ATR 42 (NAF930)

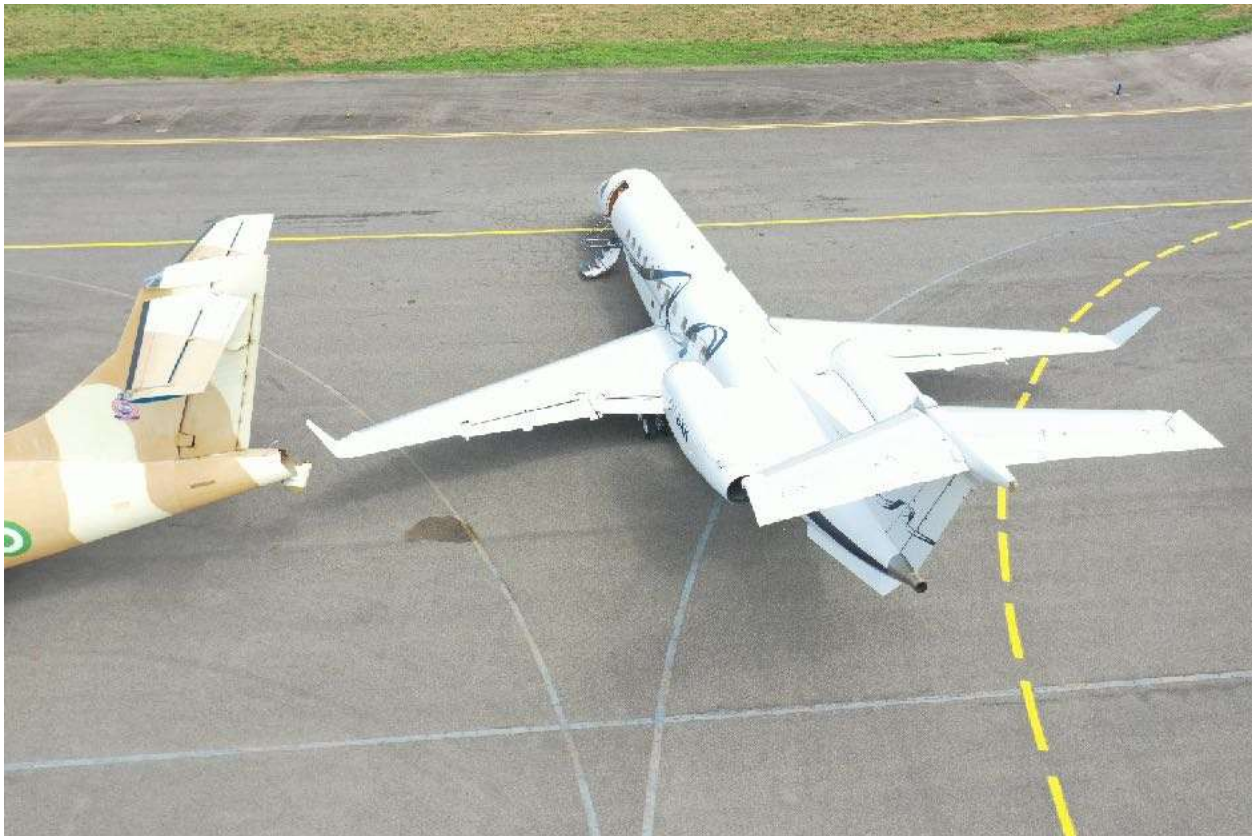
**Figure 3:** Post occurrence aerial view of 5N-BXK and the parked ATR 42 (NAF930)

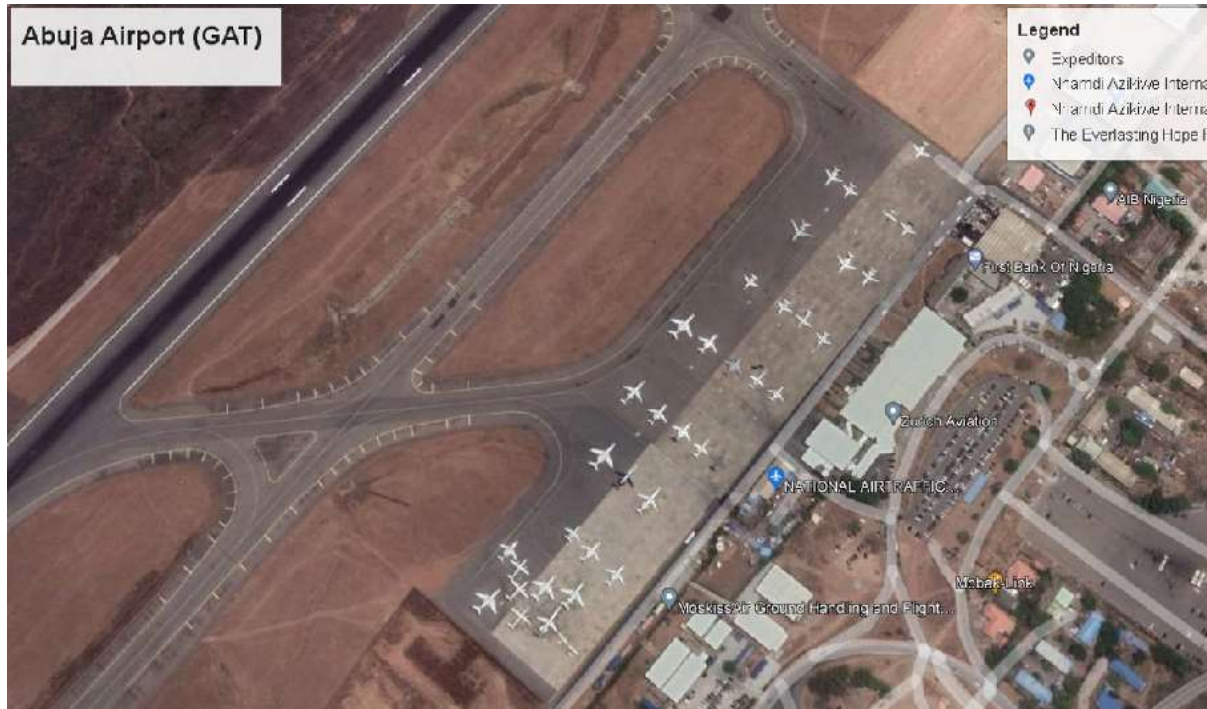
**Figure 4:** Aerial Satellite Imagery of the Congested GAT/Cargo Apron on a Typical Day (Not the Day of the Occurrence)

Federal Airport Authority of Nigeria (FAAN) should adhere to Section 3.6 of Nnamdi Azikiwe International Airport Safety Management System Manual to ensure the implementation of all the outstanding Risk Control measures contained in its Hazard and Risk Register, including the timely completion of the GAT/Cargo Apron expansion project to ensure additional parking space is made available to reduce the congestion of the apron.

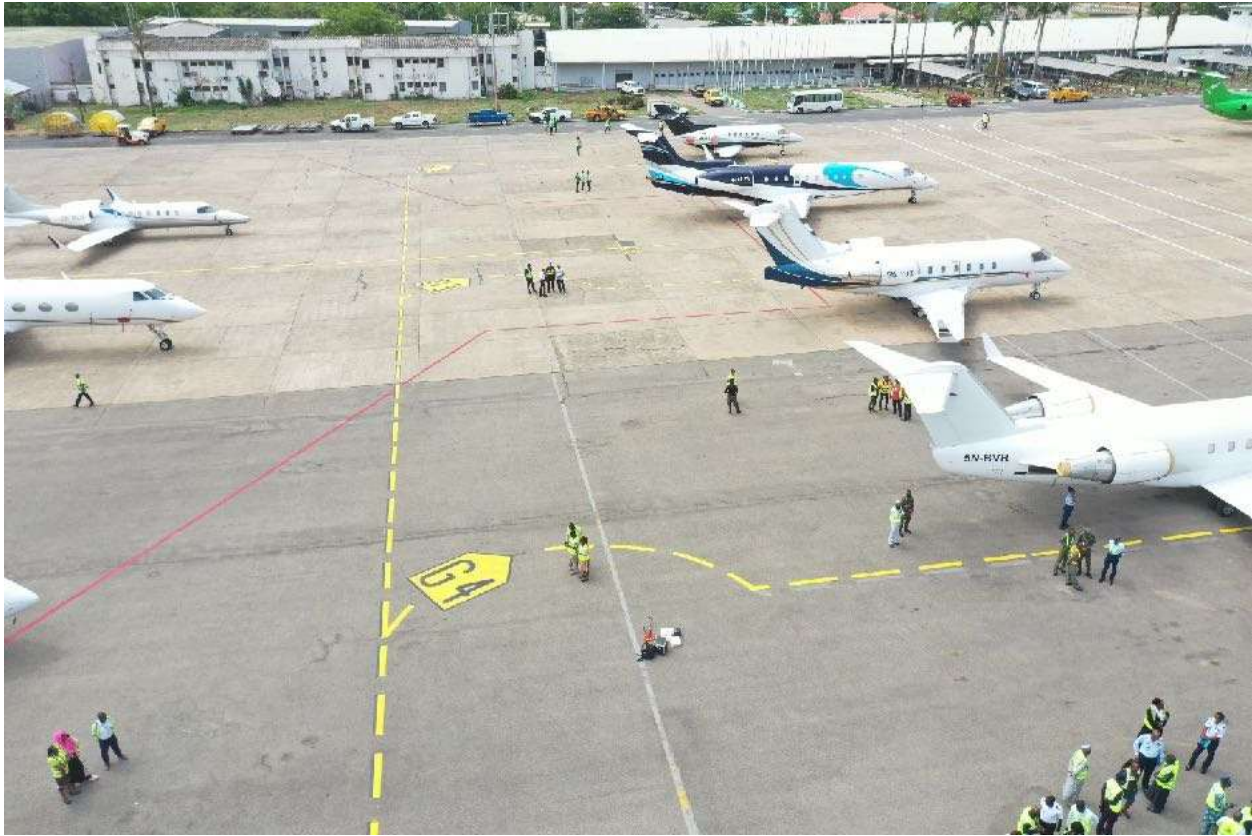
The requirement to park aircraft at approved parking stands was not followed. Aircraft are marshalled by the Federal Airports Authority of Nigeria (FAAN) Marshaller on duty to park at approved parking stands and also to park at unmarked spots on the GAT/Cargo Apron.

All the aircraft marshalled by FAAN Marshalls to their respective parking places on the GAT/Cargo Apron were found to be maintaining adequate wingtip clearance (7.5 m) and properly aligned with one another where consideration was given to each aircraft length and wing span.

**Figure 5:** Aerial view of congested GAT/Cargo Apron with aircraft parked at marked positions and at unmarked spots on both sides of the Apron Taxi Lane used by 5N-BXK.

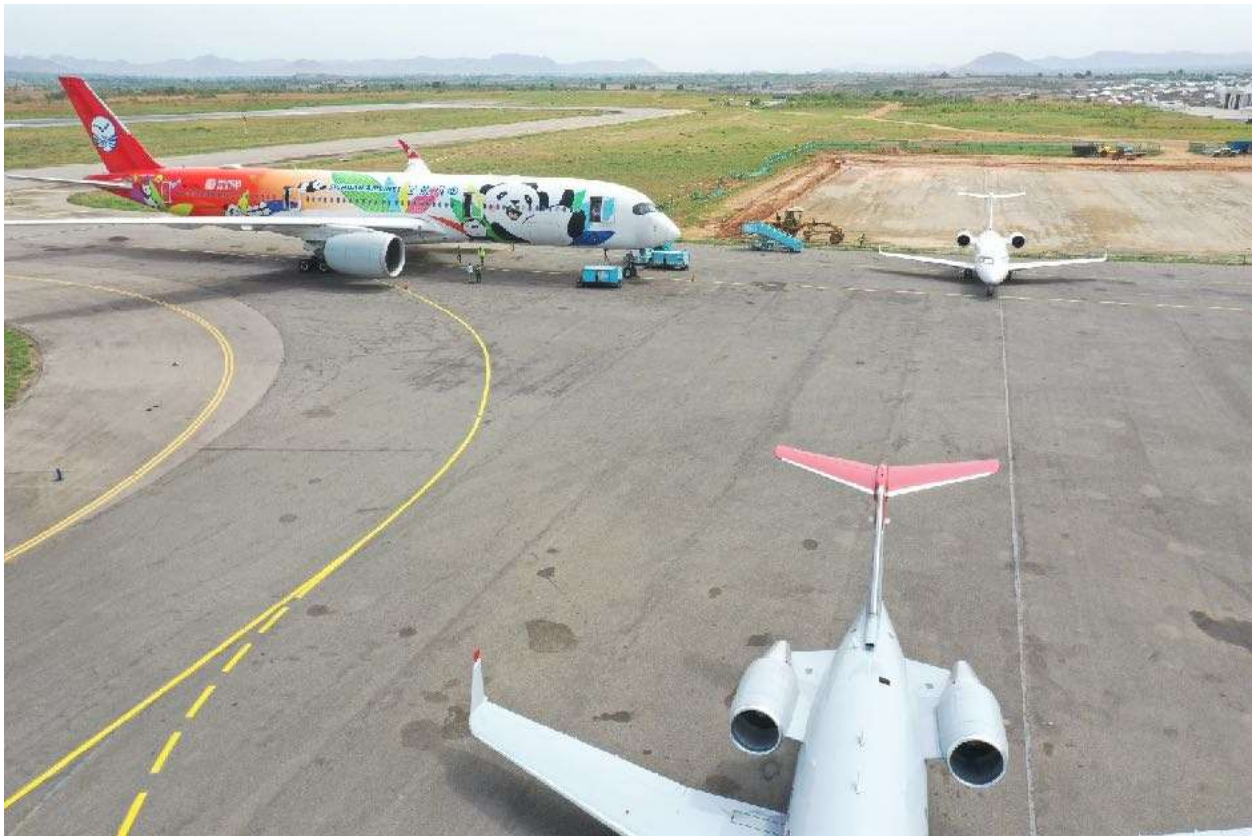
As at the time of the occurrence, Link A2 which would have been normally used to taxi out to runway 22 was blocked by a parked large body aircraft (Airbus 350) on a Special Parking provisions.

A construction project to expand the GAT/Cargo Apron was ongoing as at the date of the incident.

**Figure 6:** Left- A350 blocking Link A2. Right- GAT Apron Expansion Construction Site

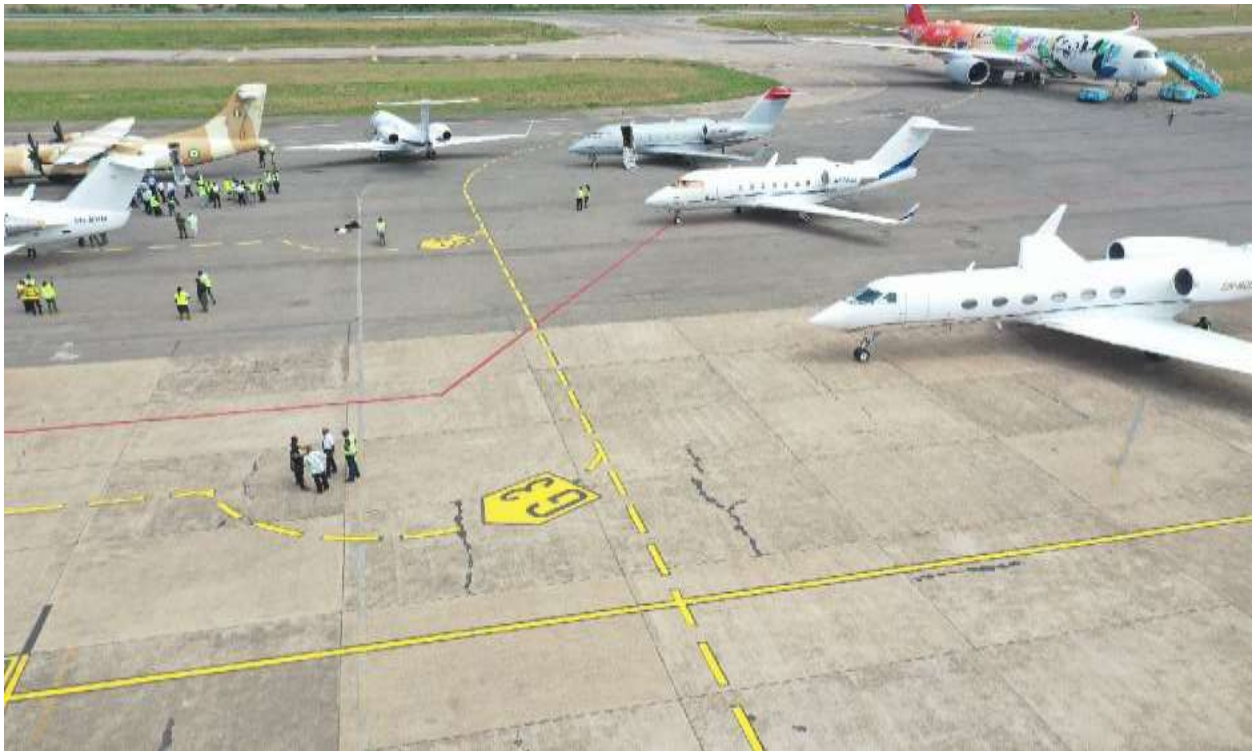
**Figure 7:** NAF ATR 42 parked at unmarked spot with its Tail Section protruding into the Apron Taxi Lane used by 5N-BXK. Other aircraft parked at unmarked spots on the GAT/Cargo Apron right side of 5N-BXK

12. The ATR 42 was not properly parked in accordance with the lateral and longitudinal parking alignment relative to the other parked aircraft at the apron. The protrusion of NAF930 constituted a safety hazard that was readily discernible.

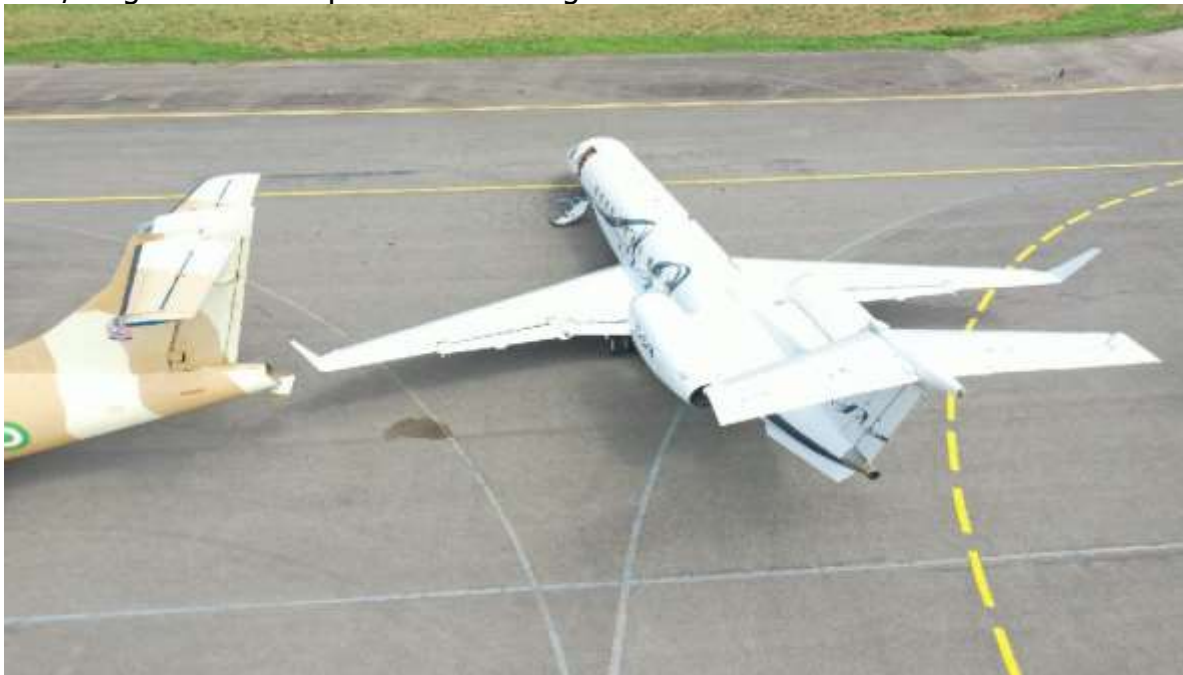
**Figure 8:** Post occurrence aerial view of 5N-BXK and NAF ATR 42 (NAF930)

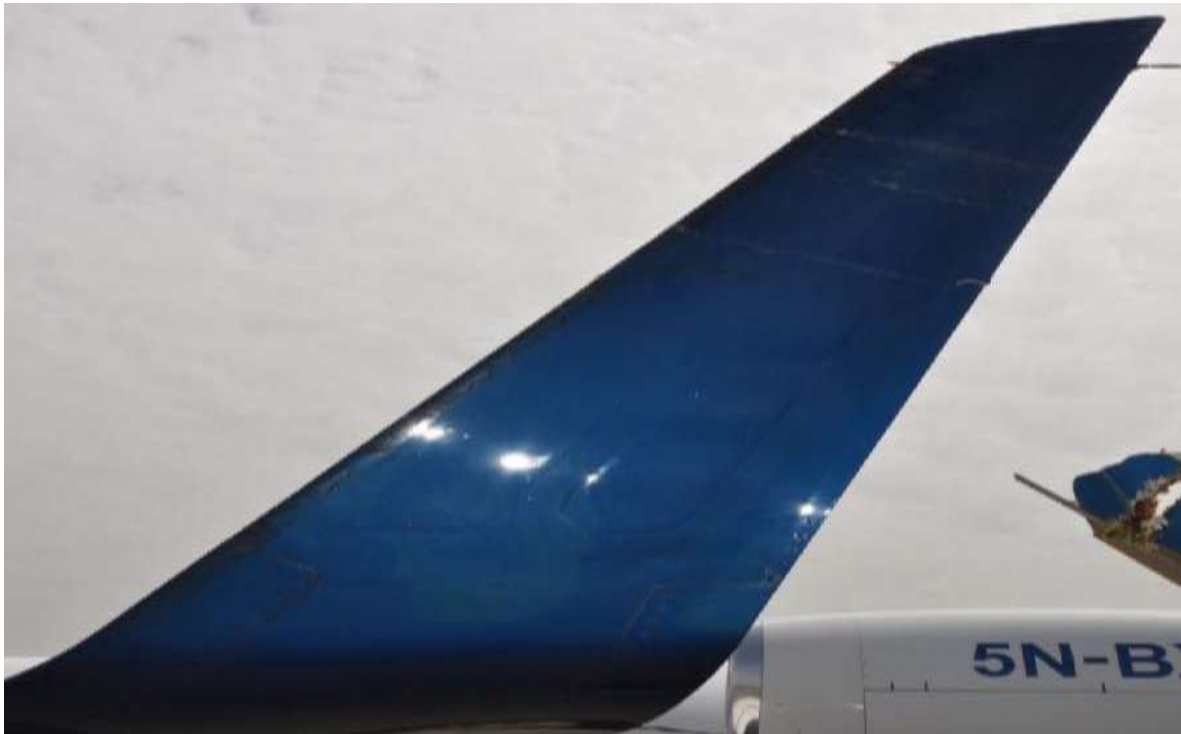
The aircraft was slightly damaged.

**Figure 9:** 5N-BXK Winglet abrasion and the broken discharge wick position

- 1) Performed detailed visual inspection (DET) in affected regions (winglet area) and surroundings in accordance with (IAW) Aircraft maintenance manual (AMM) 57-52-00 Part II and EMBRAER case number [EEJ-0442047]. No major damage or abnormality, found only abrasions, abrasion cleaned, and new winglet leading edge erosion tape installed.

- 2) Performed DET in the wing-to-fuselage fairings IAW AMM 57-52-00 Part II and EMBRAER case number [0442047]. No damage or abnormality on fairings and seals.
- 3) Missing static dischargers recovered, inspected and found satisfactory. Static dischargers reinstalled IAW AMM 23-60-01-04 Part II.

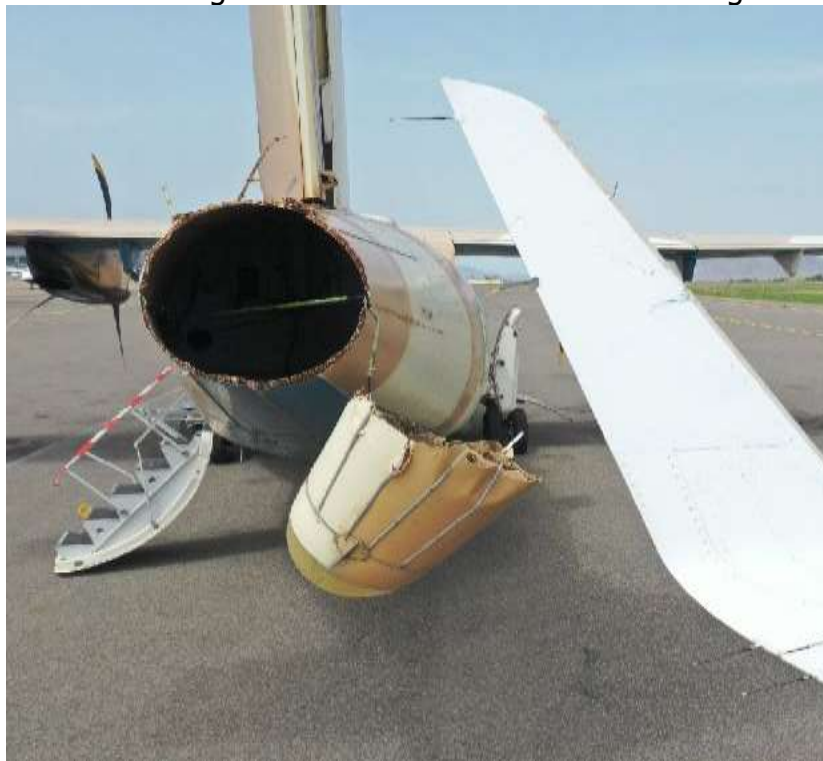
**Figure 10:** Damaged Section of the Tail Cone of ATR (NAF930)
