AIRCRAFT ACCIDENT REPORT

NCAT/2022/12/31/F

Nigerian Safety Investigation Bureau

Final Report on the Serious Incident involving Beech Baron 58 aircraft operated by Nigerian College of Aviation Technology (NCAT), Zaria with nationality and registration marks 5N-CAG which occurred on runway 05 at General Hassan Usman Katsina international Airport, Kaduna Nigeria on 31 December, 2022.

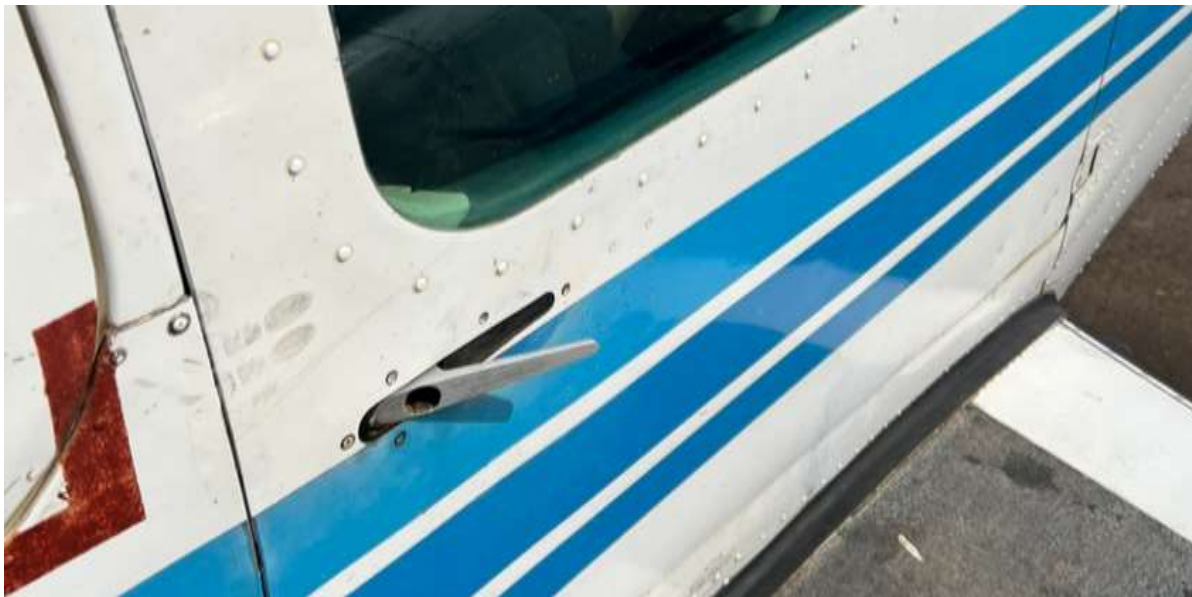
During the site inspection, the Bureau observed that with the cockpit door closed and locked from the inside, indicating LOCKED, the door handles outside did not latch.

Figure 2: The unlatched starboard door handle

During the site inspection, the Bureau observed that with the cockpit door closed and locked from the inside, indicating LOCKED, the door handles outside did not latch. The Beech baron 58 was not designed with a light or aural sound to indicate when the door is closed or open and latched from the cockpit. This would have alerted the flight crew that the door was not closed and locked before the flight.

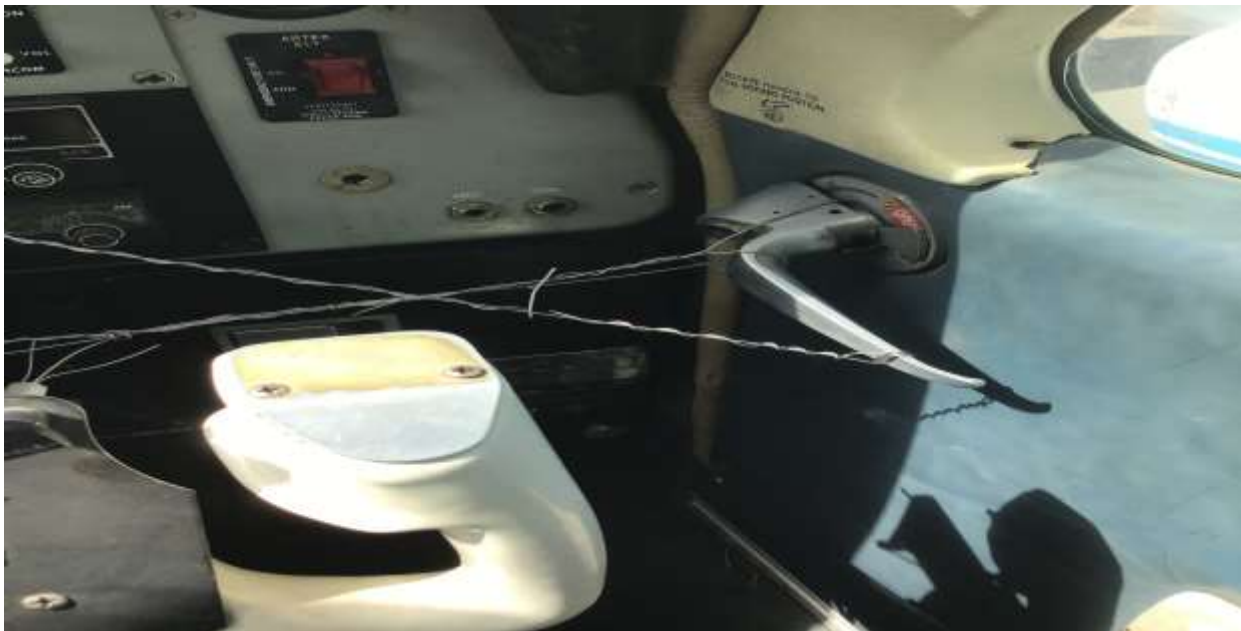
Figure 3: The starboard door locked from inside the cockpit

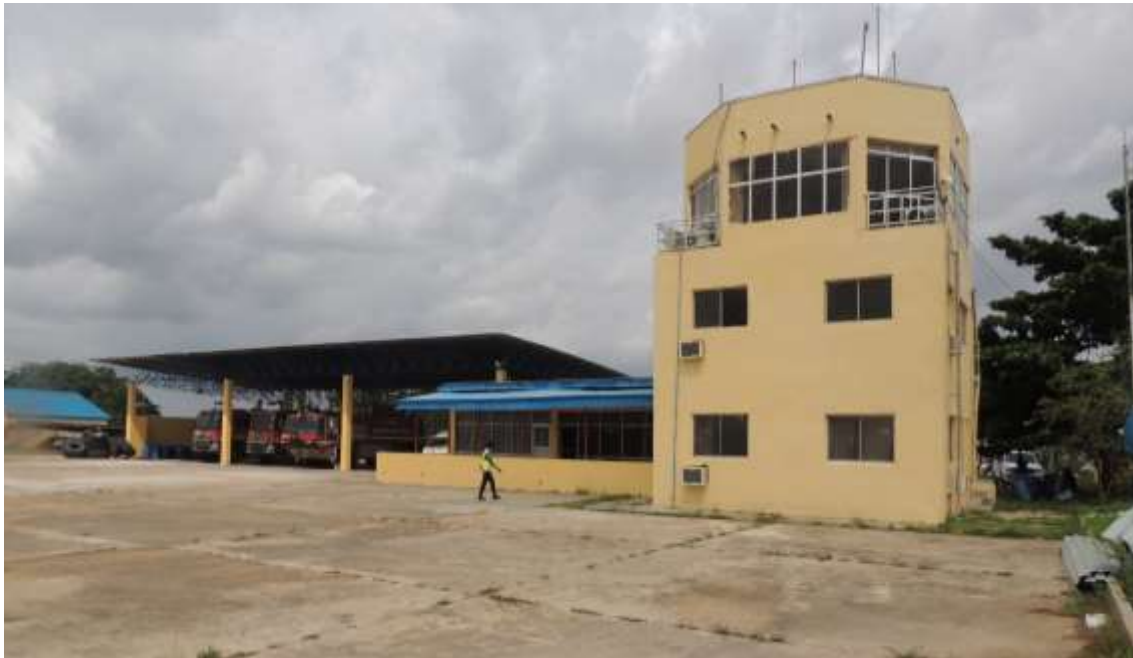
The control tower at (DNKA) was temporarily located at the Aerodrome Rescue and Fire Fighting services (ARFFS) watch room at the time of the occurrence. The watch room provides limited viewing of the extreme end of runway 05.

Figure 6: ARFFS Watch room/ATC Tower

The control tower in DNKA is temporarily located at the ARFFS watch room at the time of occurrence. The watch room provides limited view of the end of runway 05. This contravenes section 14.1.1 (a), (b), (c) and (d) of the Nig. CARs 2015.

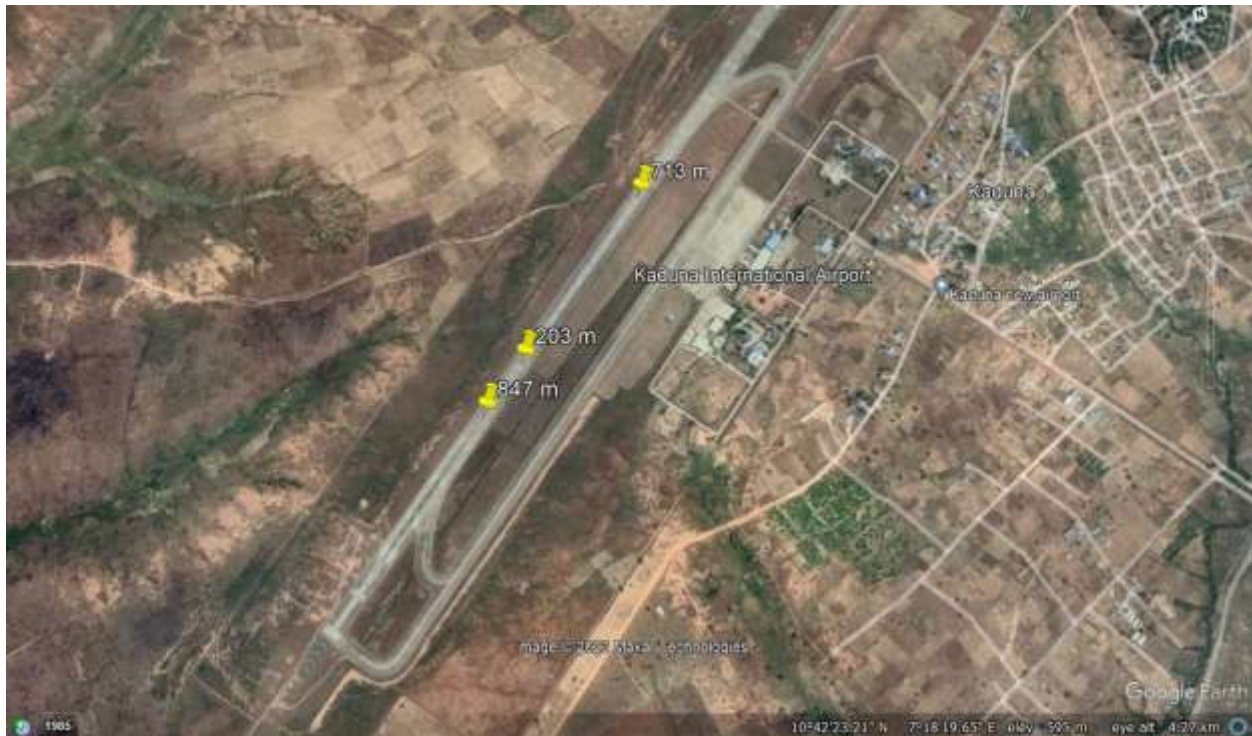
On the safety investigators' arrival at the scene of the occurrence, it was discovered that the aircraft had been moved away from its final position to another location 713 m along the runway after the occurrence.

The distance from the threshold of runway 05 to the point where the right main landing gear sheared off is 847 m.

The distance from the point where the right main landing gear sheared off to the aircraft's final position is 203 m.

Figure 8: Area view of General Hassan Usman Katsina international Airport Kaduna showing distance the aircraft was moved

The DATCO on duty reported that he did not grant permission to remove the aircraft from the incident site. There was no evidence that the Bureau permitted the removal.

On arrival of the safety investigators to the scene of the occurrence, it was discovered that the aircraft was moved from its final position to another location 713 m along the runway after the occurrence. The Bureau is responsibility for determine the cause and circumstances surrounding the occurrence. This can be successfully achieved with proper preservation of evidence. This is very important as it enables the investigators to gather relevant and crucial evidence that can aid in the investigating the occurrence. Recall that, the propeller blades' tips struck the runway surface. The investigation could not identify where the blades struck the runway because the incident site was compromised. The investigations revealed that; the aircraft stop at the edge of the runway with the left wing deep into the runway after the occurrence. Hence, the runway was closed at 10:14 h and the relevant stakeholders were informed.

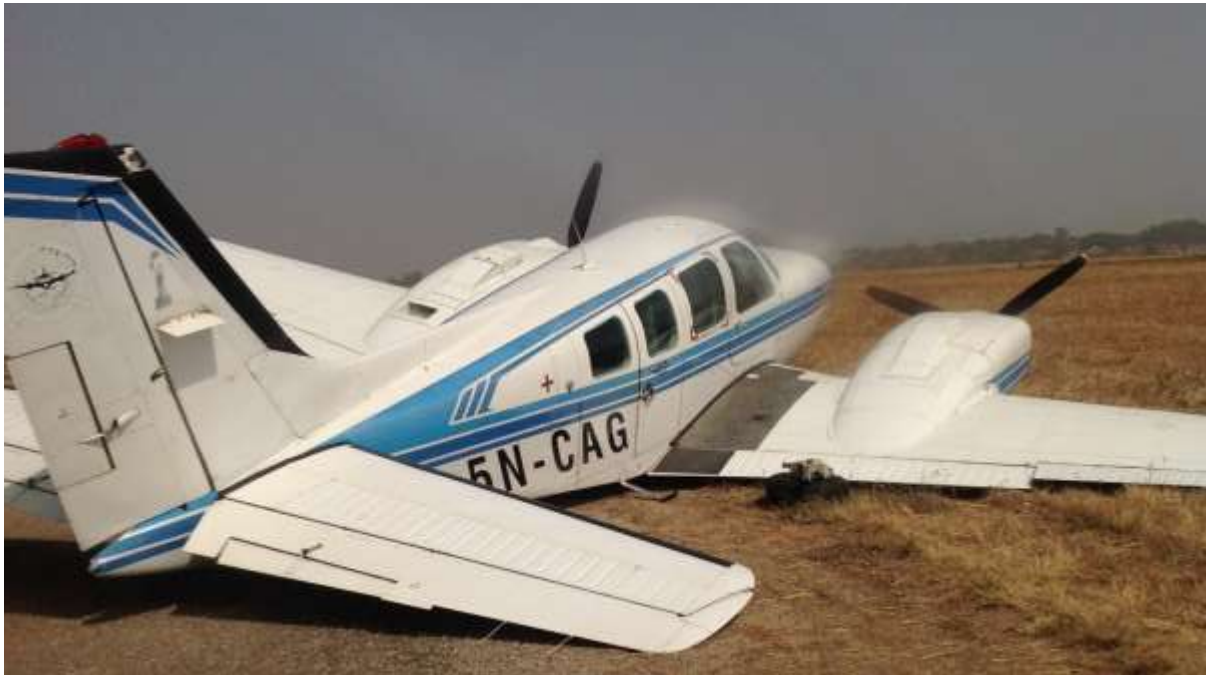
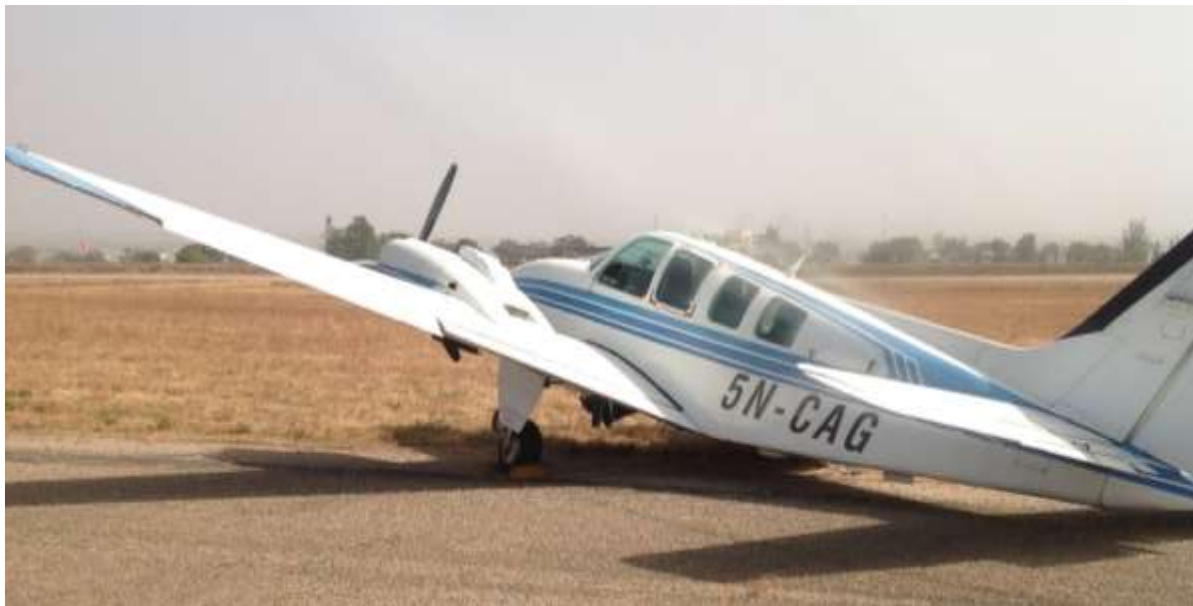
During take-off and after lift-up the right hand cockpit door opened. The FI closed engine power and landed the aircraft. This resulted in the hard impact of the right main landing gear on the runway surface and the right main landing gear sheared off.

Figure 9: The aircraft after the occurrence

Figure 10: The aircraft after the occurrence

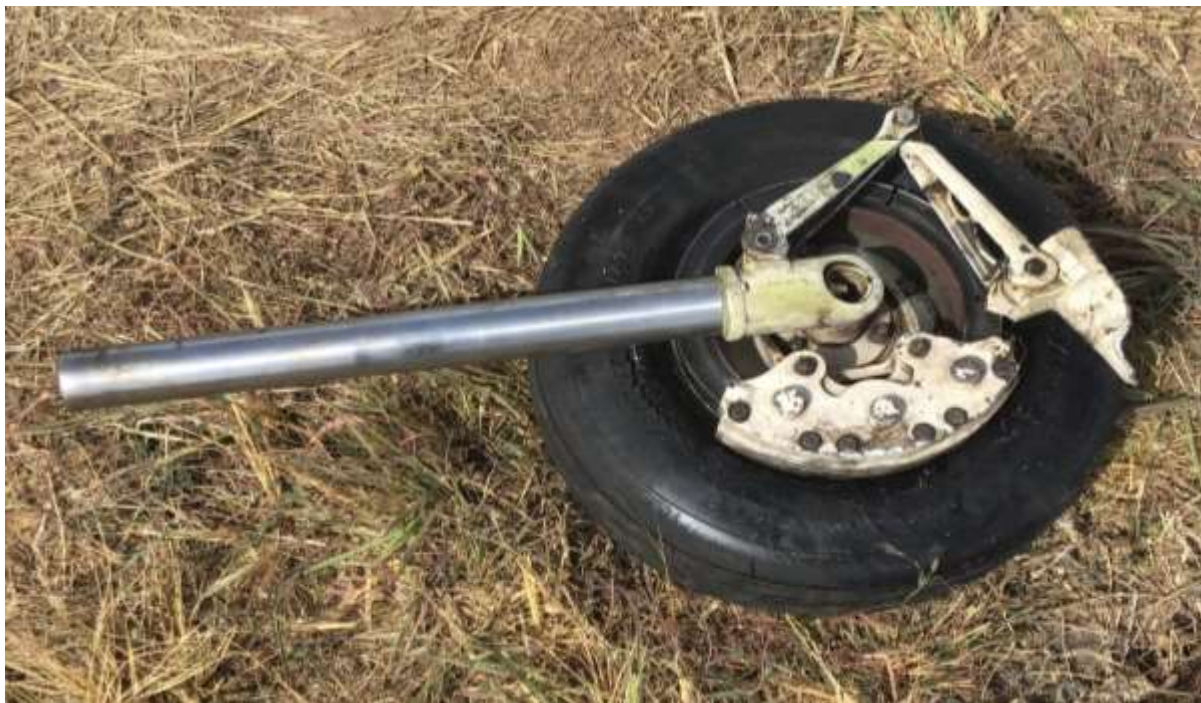
- The right main landing gear torque link sheared-off

- The right main landing gear inner cylinder separated from the outer cylinder
- The right wing lower section of the tank tore-off
- Two of the propeller blades of the right engine bend outward and the other bends rearward
- The aircraft's right door step broke-off

Figure 11: The sheared right main landing gear

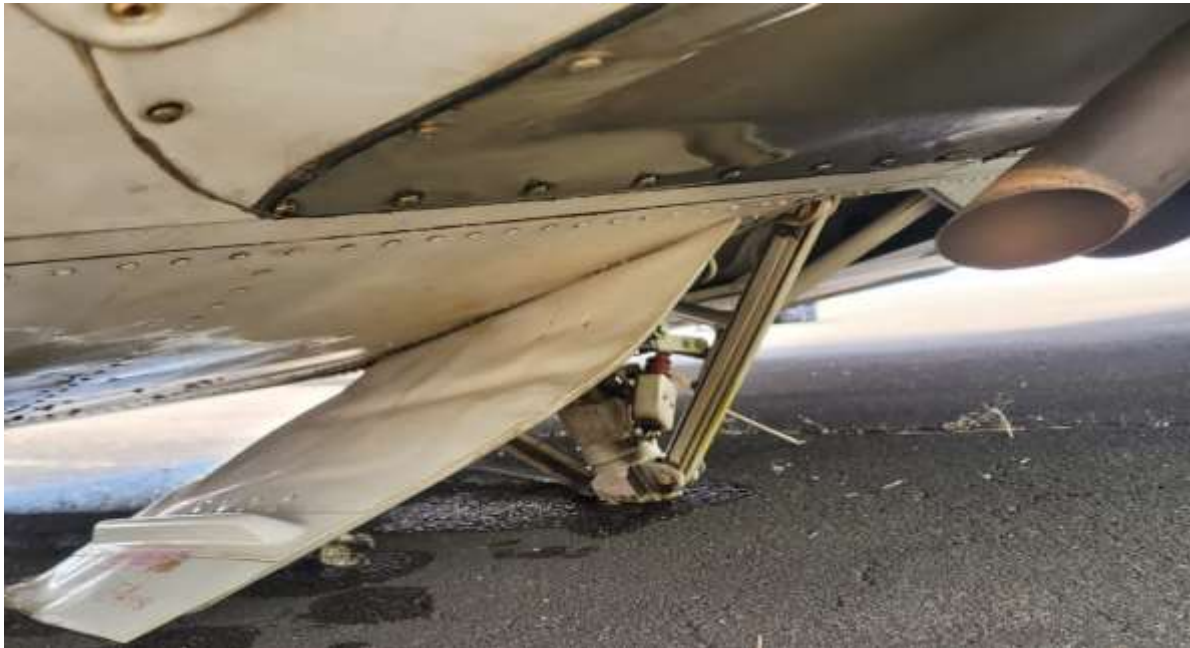
Figure 12: The remaining part of the landing gear attach to the aircraft

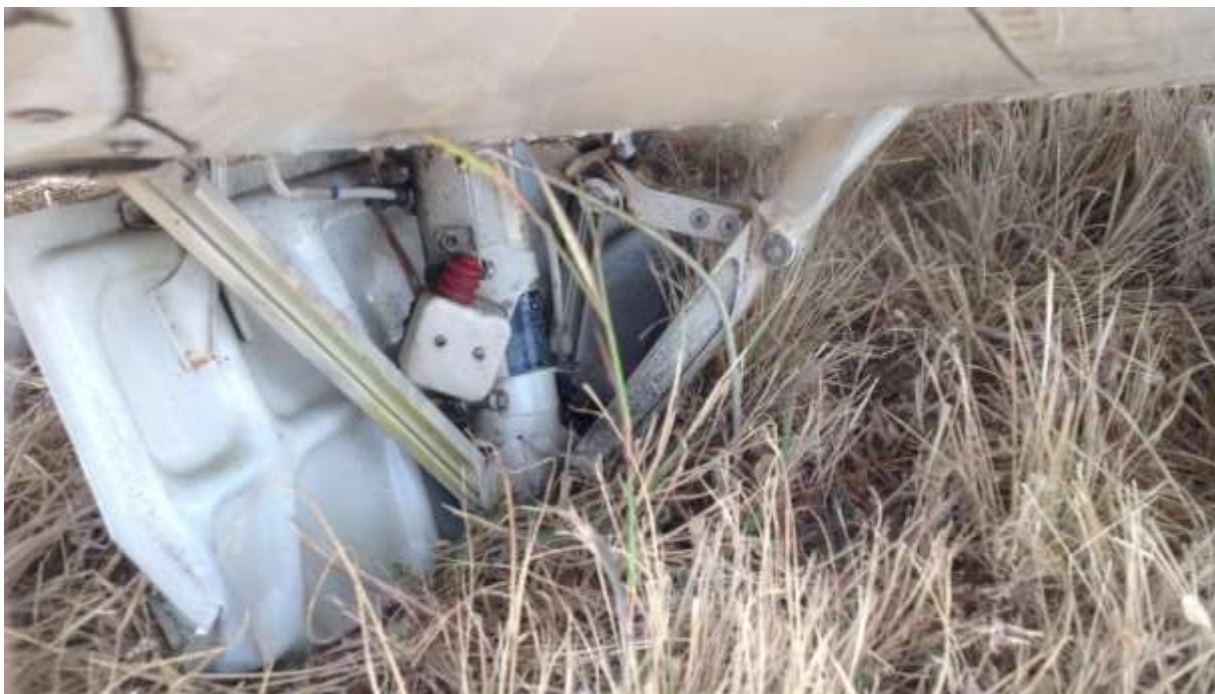
Figure 13: The remaining part of the landing gear attach to the aircraft after it was moved

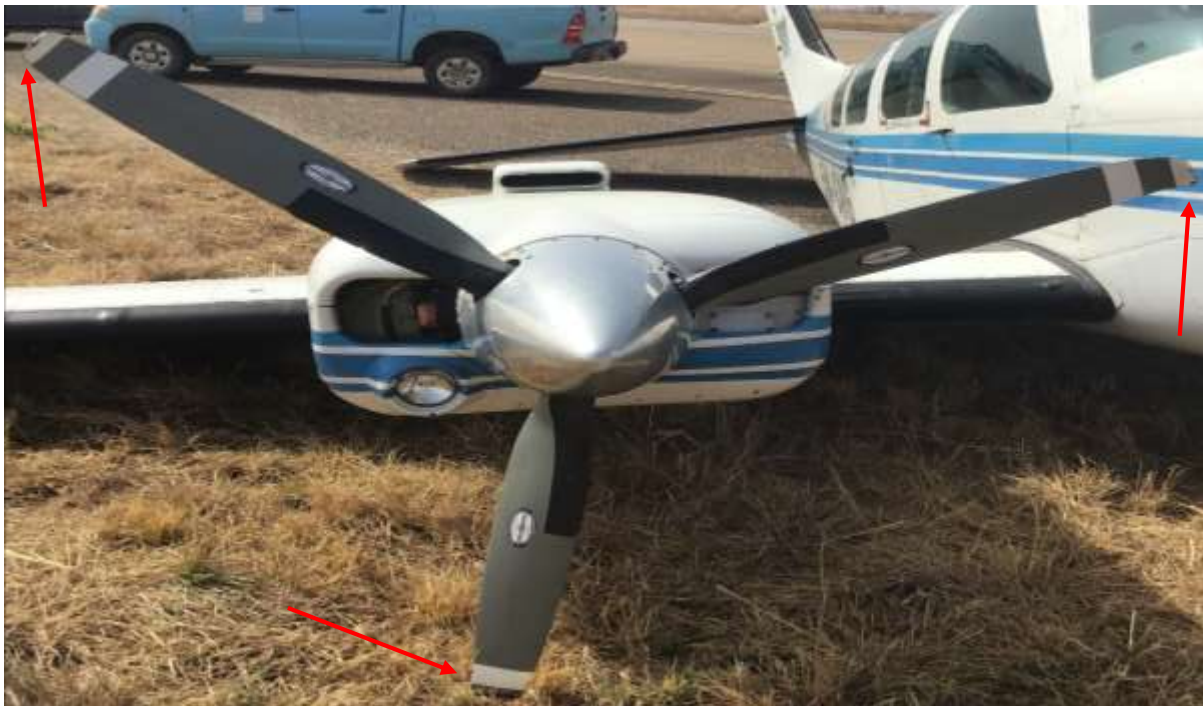
Figure 14: Bent propeller blade at the tip

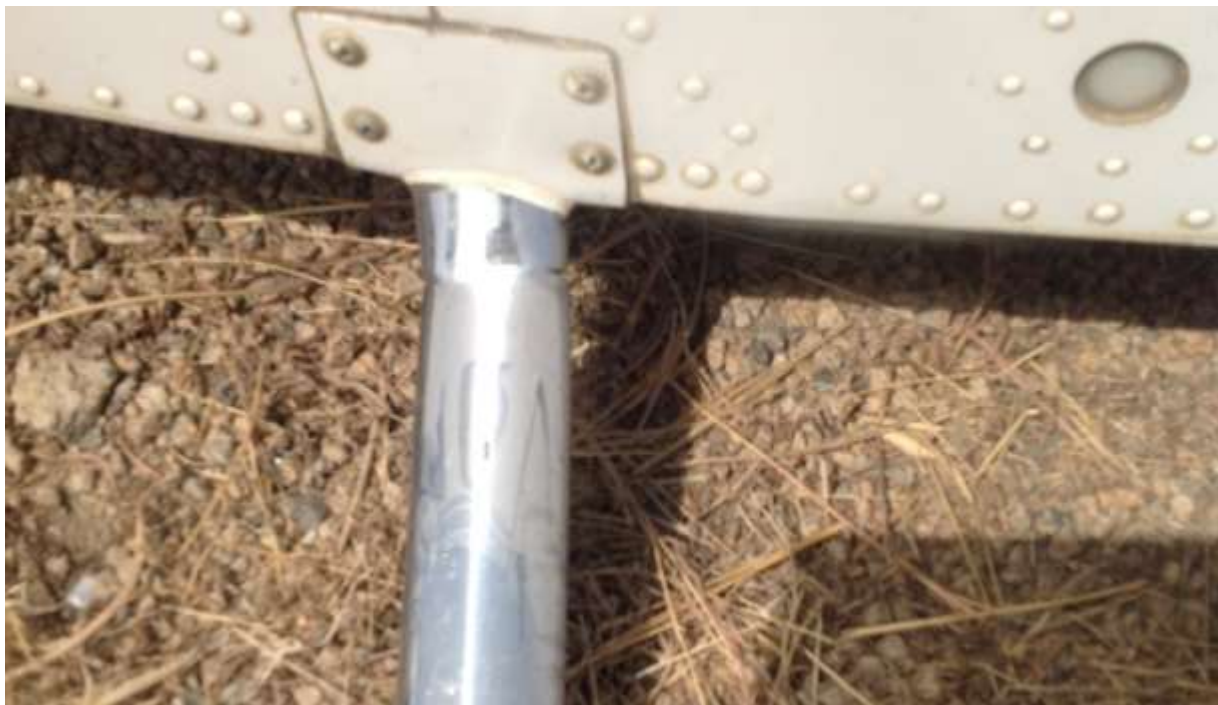
Figure 15: The broken right door step

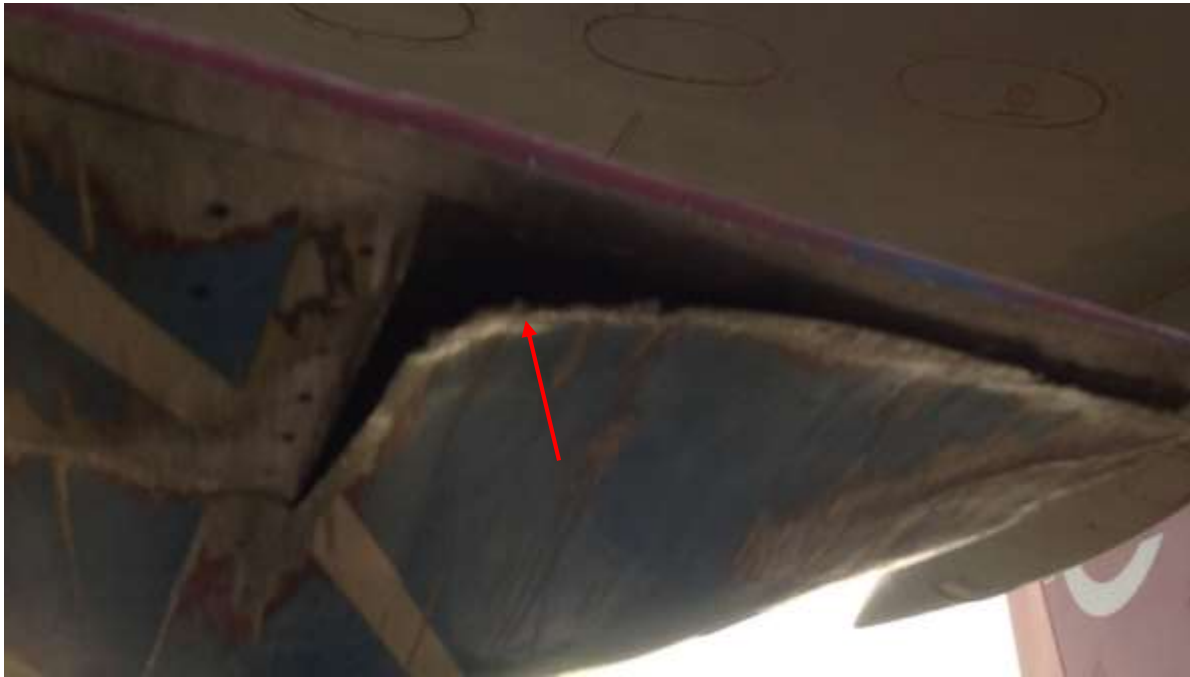
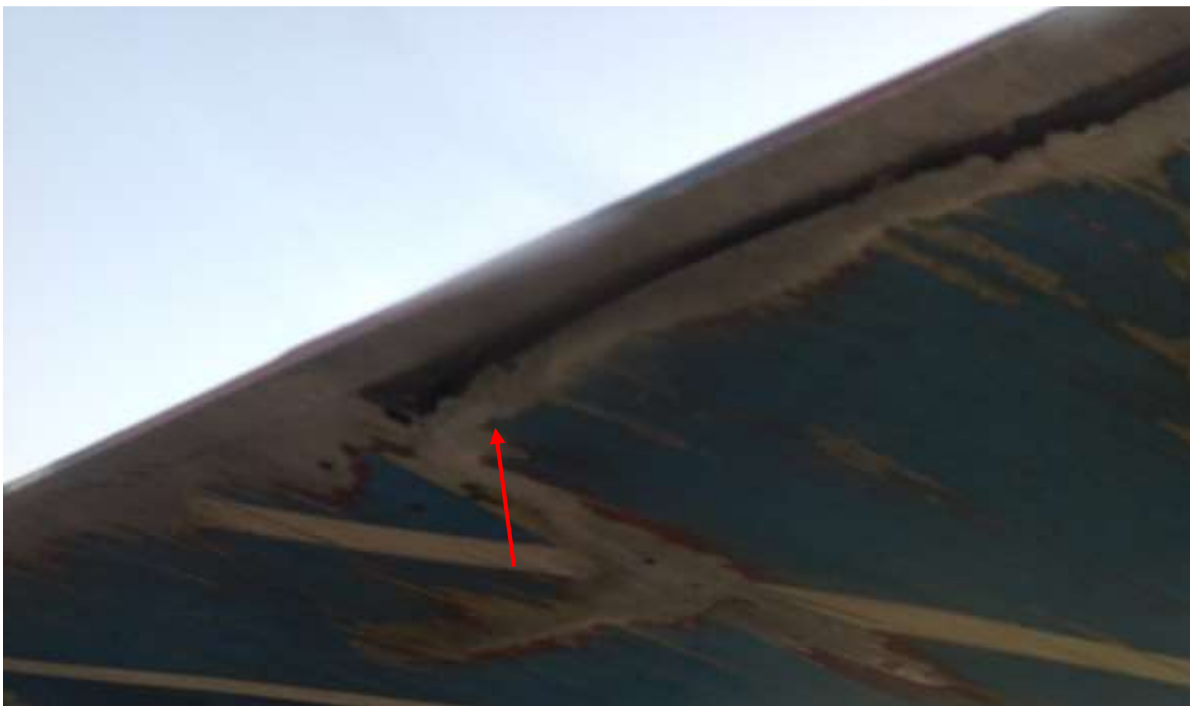
Figure 16: The ruptured right tank from the bottom

Figure 17: The ruptured right tank from the bottom

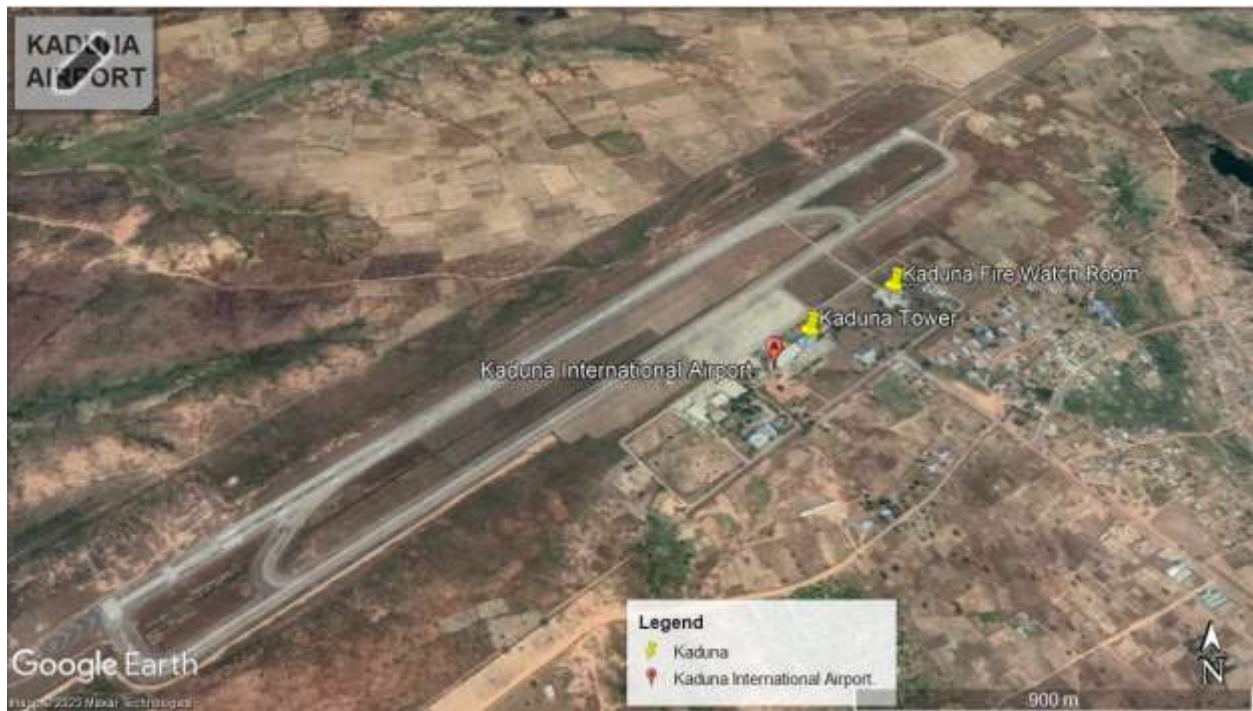
Control tower is responsible for aircraft on the maneuvering area, active runway, departing, landing and all aircraft airborne within the designated airspace. The current position of the tower does not permit the DATCO to perform his duty effectively. The DATCO should be able to scan the runway's full length and keep aircraft in sight aircraft during take-off roll, take-off, final approach, landing roll and when taxiing onto a runway or taxiing out. An aircraft should be watched closely by the tower so that proper clearances may be issued if the aircraft might need assistance. See figure below.

Figure 18: Area view of General Hassan Usman Katsina international Airport (DNKA) Kaduna showing the location of the Kaduna Tower and the ARFFS watch room
