AIRCRAFT ACCIDENT REPORT

NPF/2022/26/01/F

Final Report on the Accident Involving a Bell 429 Helicopter operated by Nigeria Police Air Wing with Nationality and Registration marks 5N-MDA, which occurred at Sir Abubakar Tafawa Balewa Airport Bauchi, Nigeria on 26 January 2022

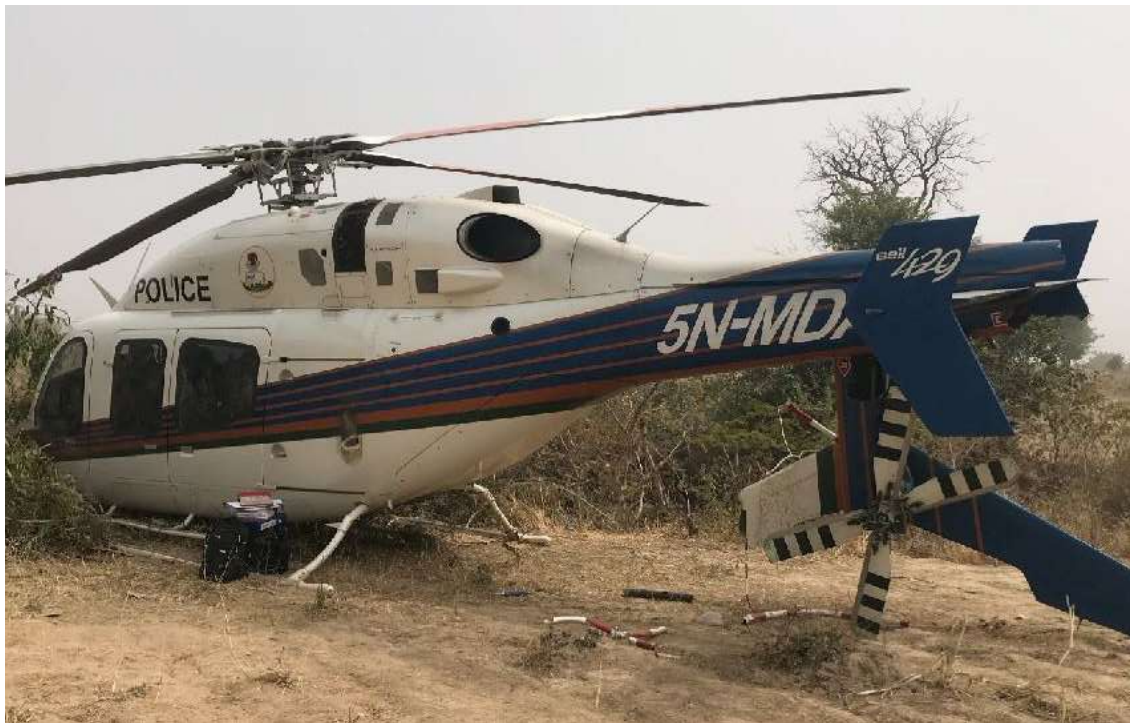
The helicopter was substantially damaged.

Figure 2: Left view of the helicopter post occurrence

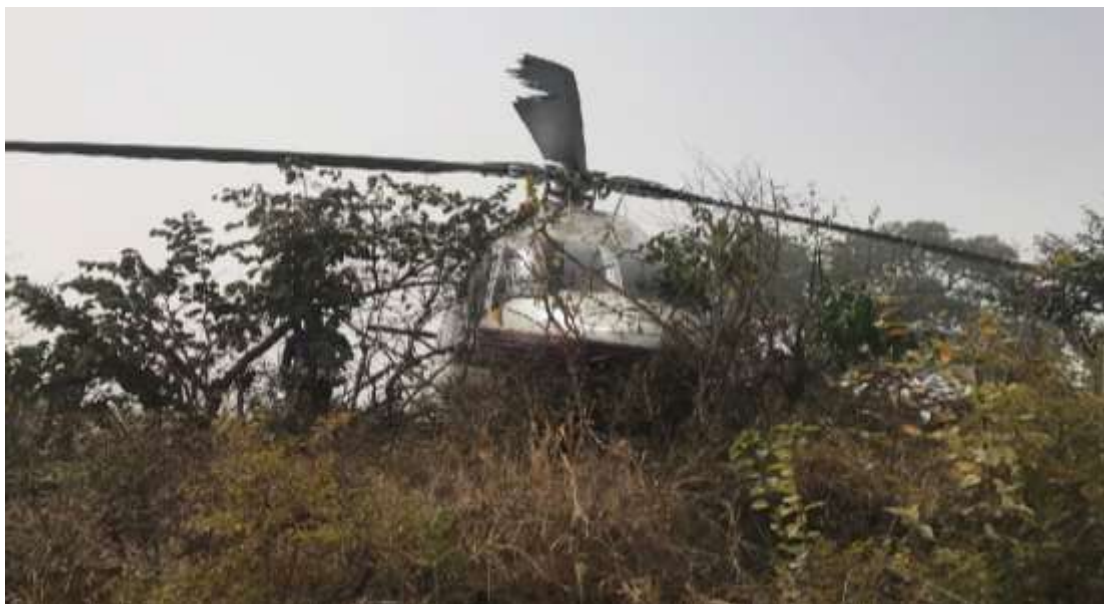
During the approach, the helicopter's Main Rotor blade hit the top branches of a 5 m high tree, while the Tail Rotor blades impacted and cut the tree trunk. The helicopter crash landed 20.60 m northeast of the tree on a magnetic heading of 359°. The crash site coordinate was 10° 28' 6" N, 9° 44' 14" E.

Figure 3: Damaged Main Rotor Blade

The helicopter impacted the tree while hovering to land, and the damage to the main rotor blade was consistent with impact at low speed. The accident was survivable; there was liveable volume in the cockpit. The seat and seat restraints were found intact and

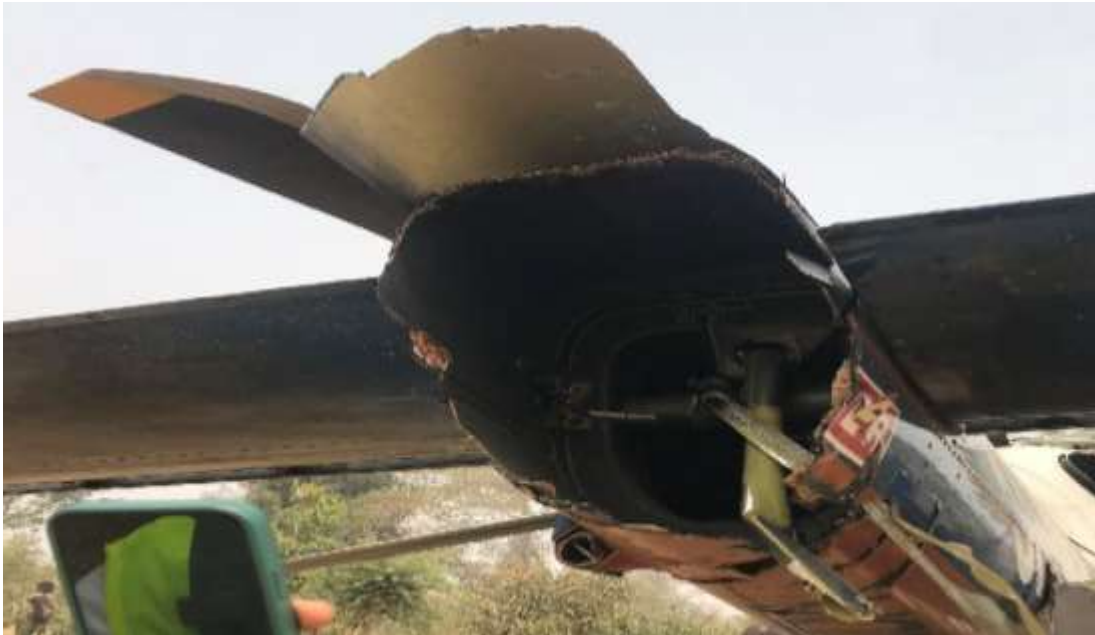
1. One Main Rotor Blade was damaged
2. The Tail Boom of the helicopter was sheared off
3. The Tail Rotor Shaft was broken
4. The Tail Rotor Blades had minor damage at their Leading Edges
5. The helicopter's left side skid collapsed
6. The right side aft passenger window was broken
7. The right side Vertical Stabilizer was broken

Figure 4: Broken Tail Boom

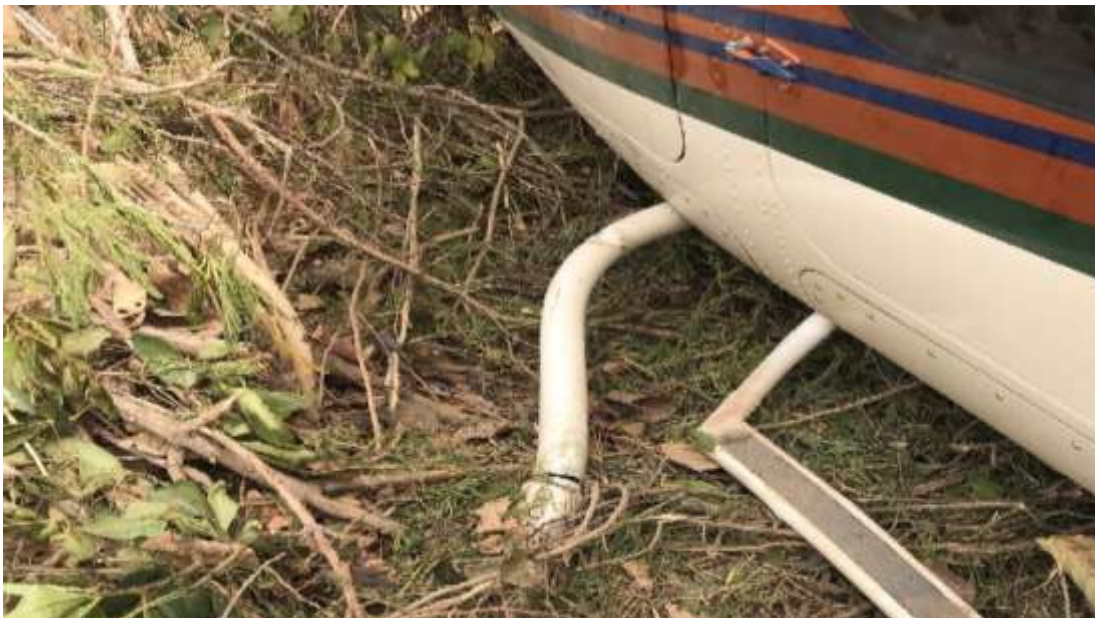
Figure 5: Collapsed left side Skid

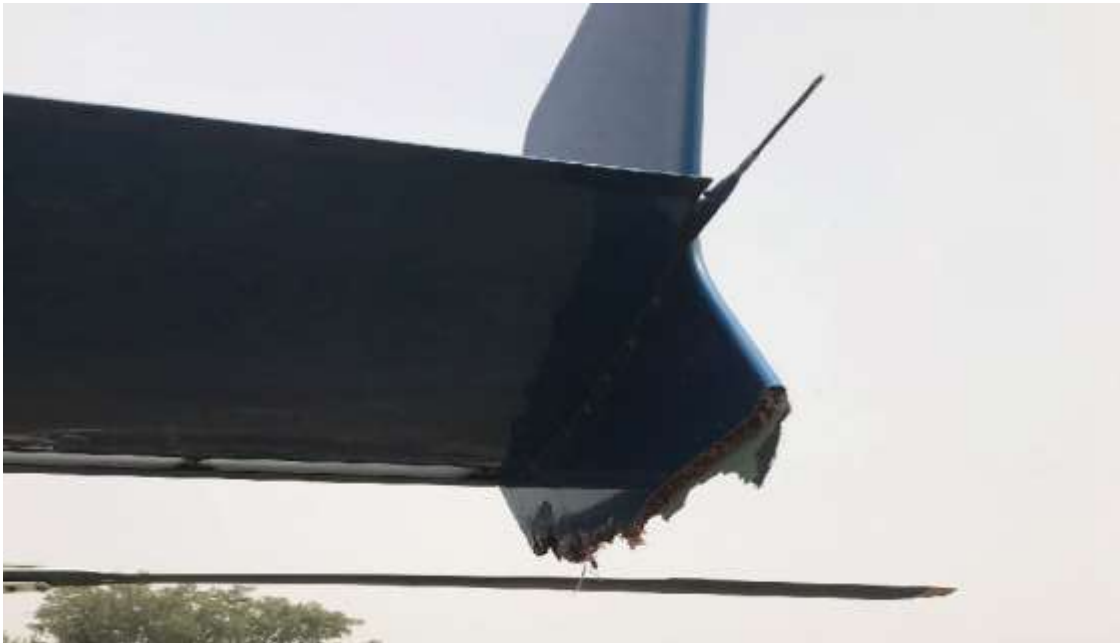
Figure 6: Damaged Vertical Stabiliser
