Preliminary Report on the Accident involving a Cessna 172E aircraft with nationality and registration marks 5N-ASR, operated by Skypower Express Airways Nigeria Limited, which occurred during approach to Runway 17 at Sam Mbakwe International Cargo Airport, Owerri (DNIM), on 16 December 2025

Operator:	Skypower Express Airways Nigeria Limited
Owner:	YOMED Nigeria Limited
Aircraft type and model:	Cessna 172E
Manufacturer:	REIMS Aviation S. A., Reims, France, under licence from Cessna Aircraft Company, USA
Year of manufacture:	1968
Nationality and registration marks:	5N-ASR
Serial number:	FR172-00366
Location:	About 270 m from the threshold on the Approach Path of RWY 17, DNIM, at coordinates 5°26' 28.8384" N, 7°12'9.8028" E.
Date and time:	16 December, 2025 at about 20:02 h
<i>All times in this report are local time equivalent to UTC+1 unless otherwise stated.</i>

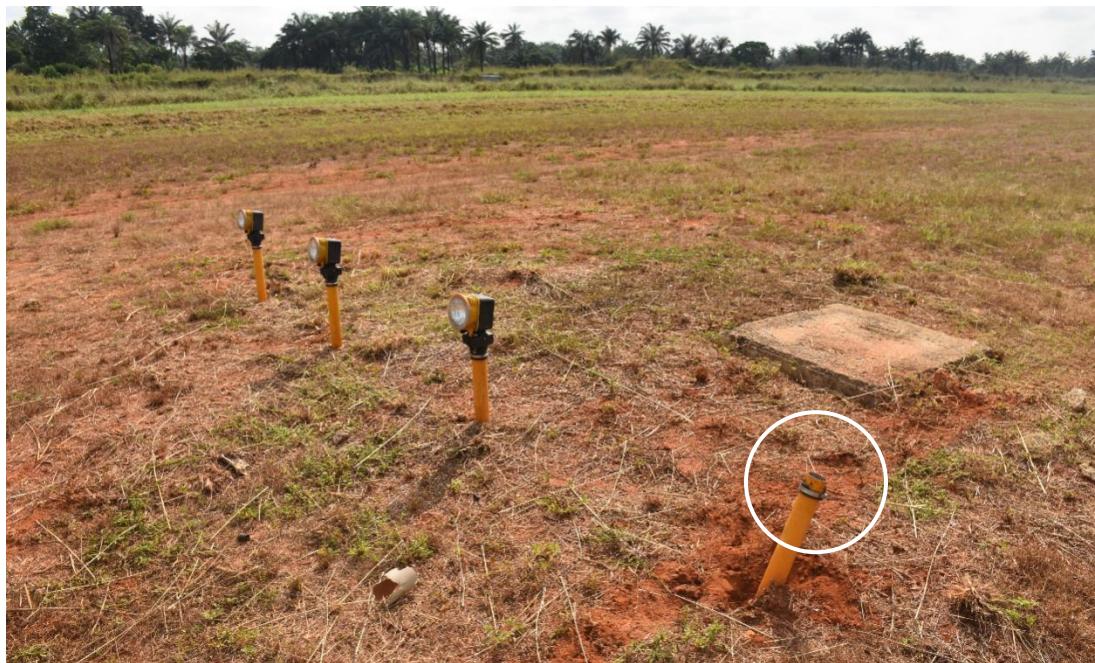
Nine approach lights on the Approach Path of Runway 17 were damaged.

Figure 1: A damaged approach light on Row 11

Impact marks show that the aircraft impacted the three rows of the approach Lights, damaging nine Approach Lights in all.

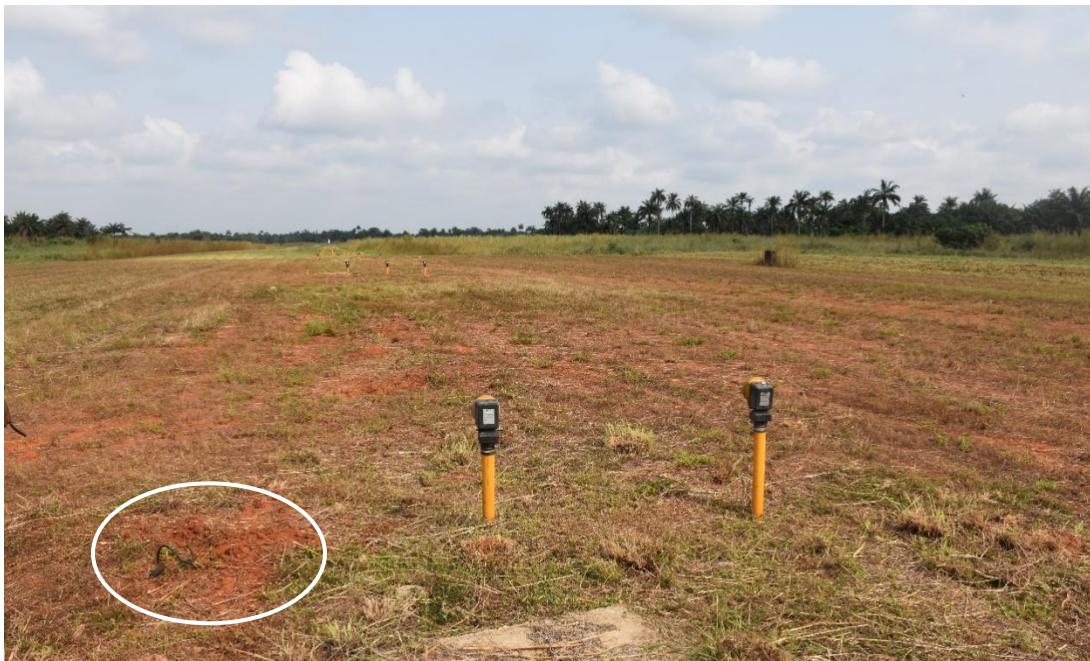
Figure 2: Another damaged approach light on Row 10

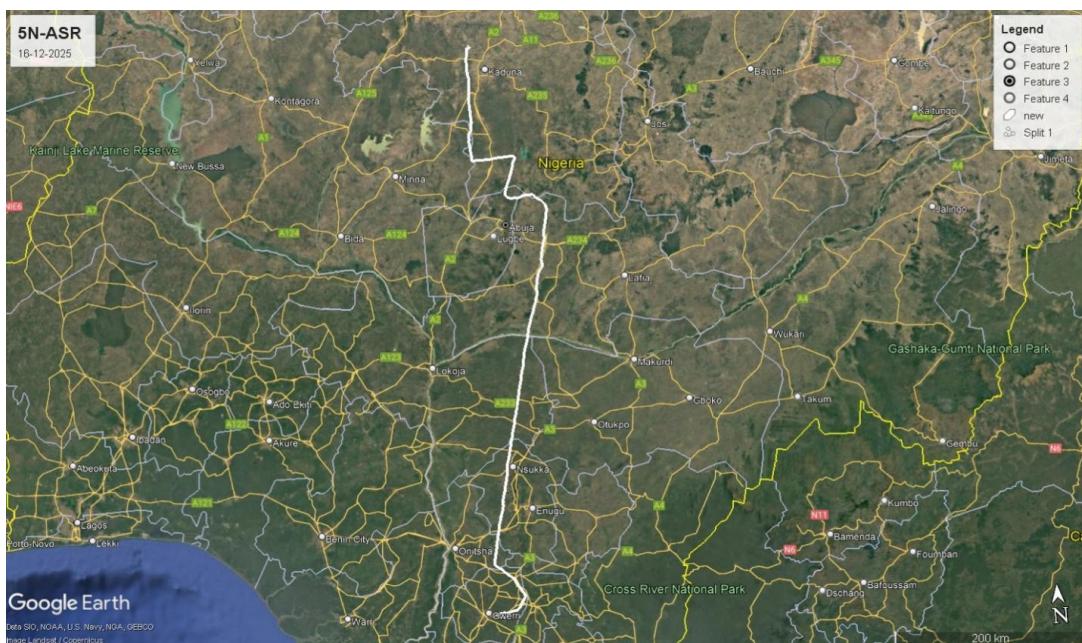
It shows that the aircraft departed Runway 05 at Hassan Usman Katsina International Airport (DNKA), Kaduna at 15:16:44 Z. The last recorded point was at coordinates latitude $5^{\circ}26' 28.8384''$, longitude $7^{\circ}12'9.8028''$ at 19:13:40 Z, 270 m short of Runway 17 on the extended centerline at Sam Mbakwe International Cargo Airport, Owerri.

Figure 3: GPS track from DNKA to crash point (DNIM)

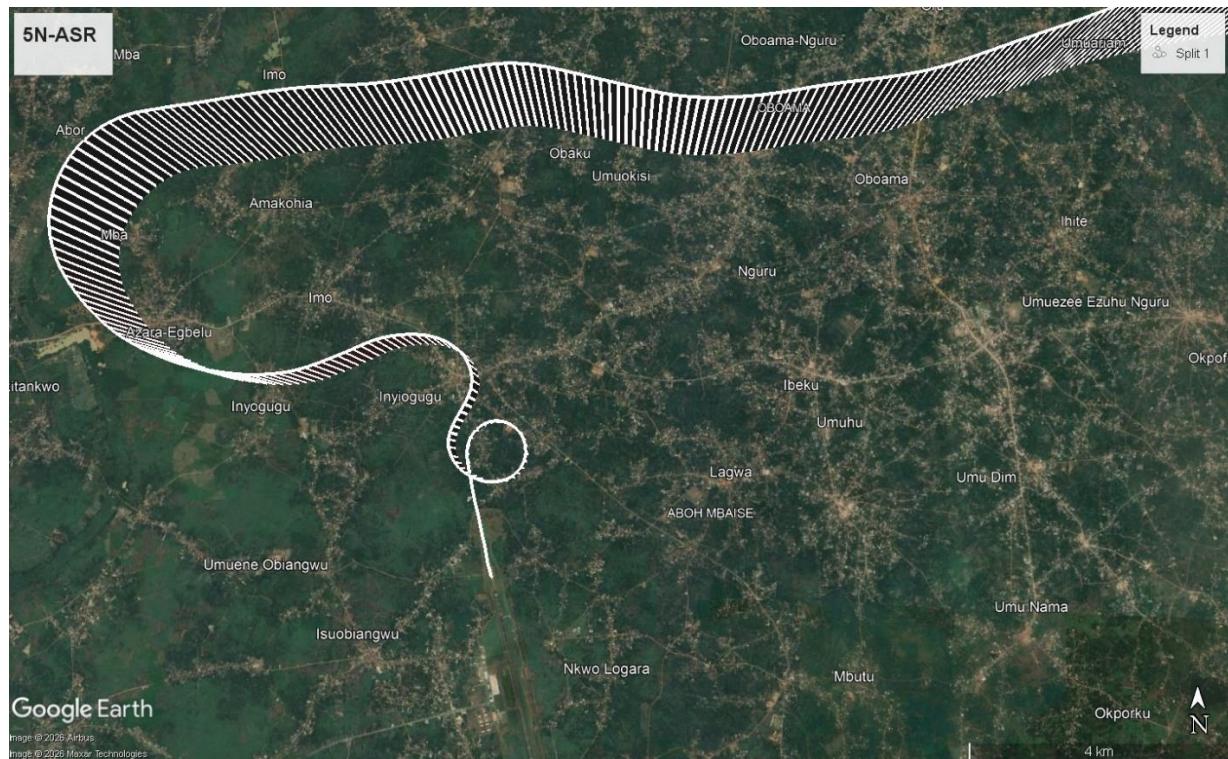
Figure 4: Final Portion of the flight

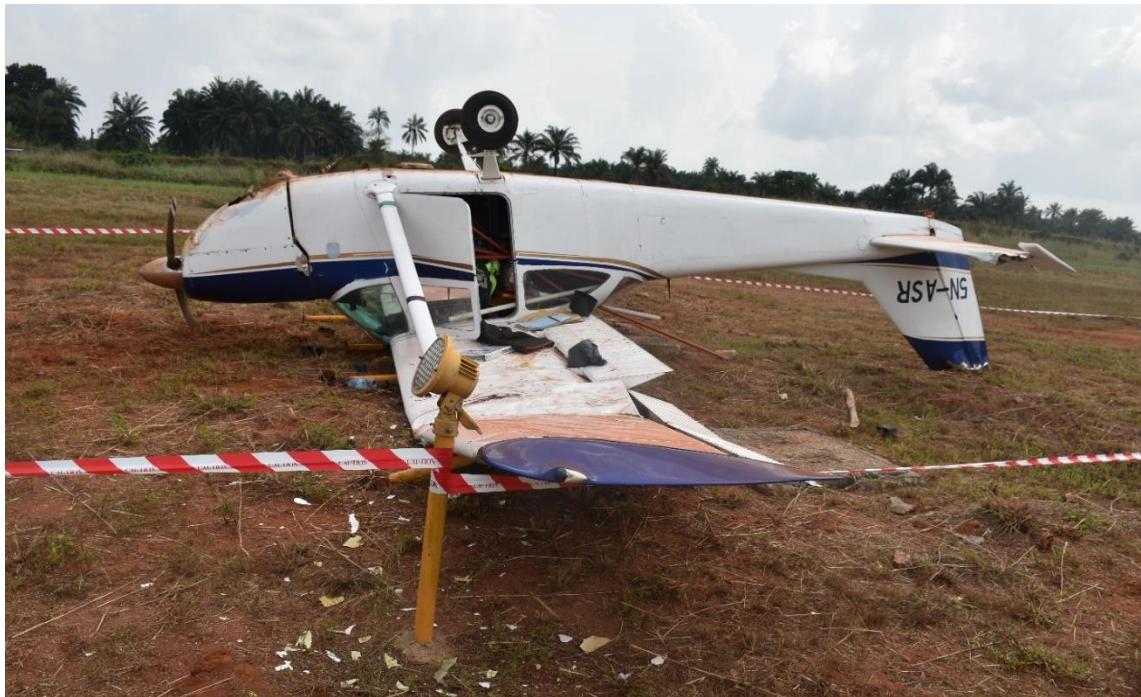
The aircraft was found relatively intact, overturned onto its wings and with its nose pointing away from Runway 17 and towards the Approach Path. Five approach lights were trapped underneath the wreckage.

The Right Wing was found bent downward at about a 30-degree angle, beginning about 2.3 m from the Wing Root. The left Wing was dented and twisted slightly downward at the Leading Edge Wingtip. Approach Light Poles had punctured both Wings tanks. There was no evidence of fluid spillage, such as aviation fuel, hydraulic fluid, or engine oil. The Flaps were in the Fully Extended Position; the Left Aileron was found in the UP position, while the right aileron was in the DOWN position.

Figure 5: Aircraft final position viewed from the right side

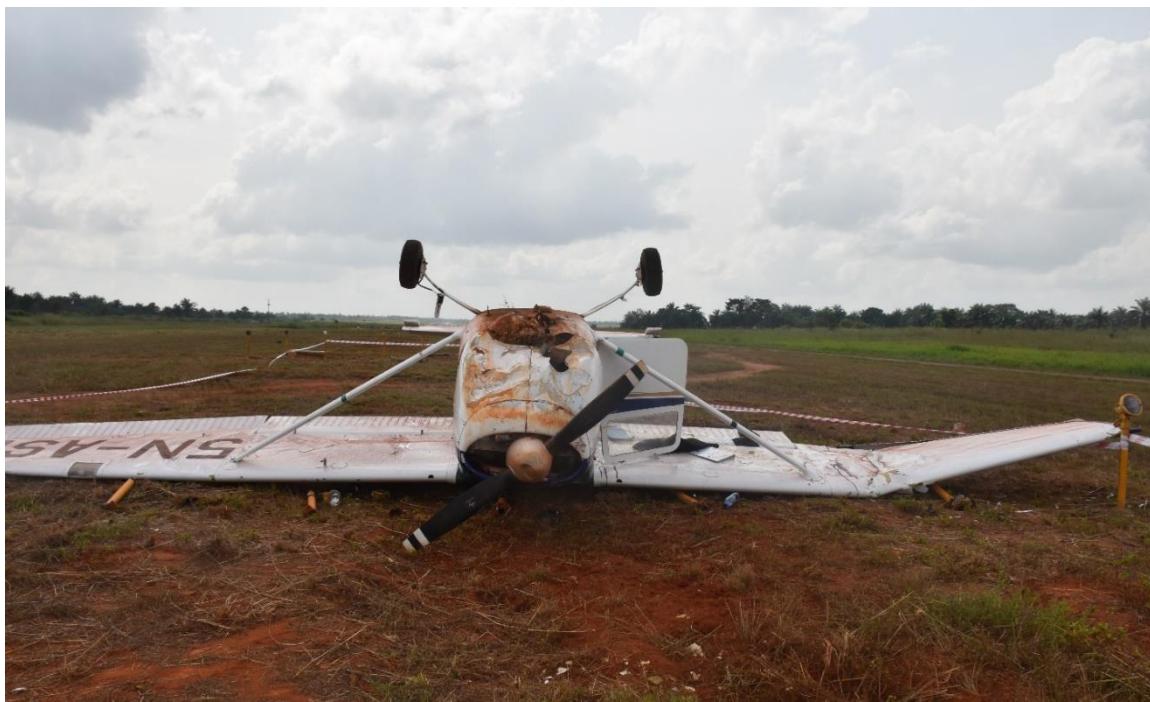
The aircraft wreckage was found about 270 m from the threshold of Runway 17, at the coordinates $5^{\circ}26' 28.8384^{\prime\prime}$ N, $7^{\circ}12'9.8028^{\prime\prime}$ E, about 24 m from the edge of the access road.

Figure 6: Aircraft at its final position

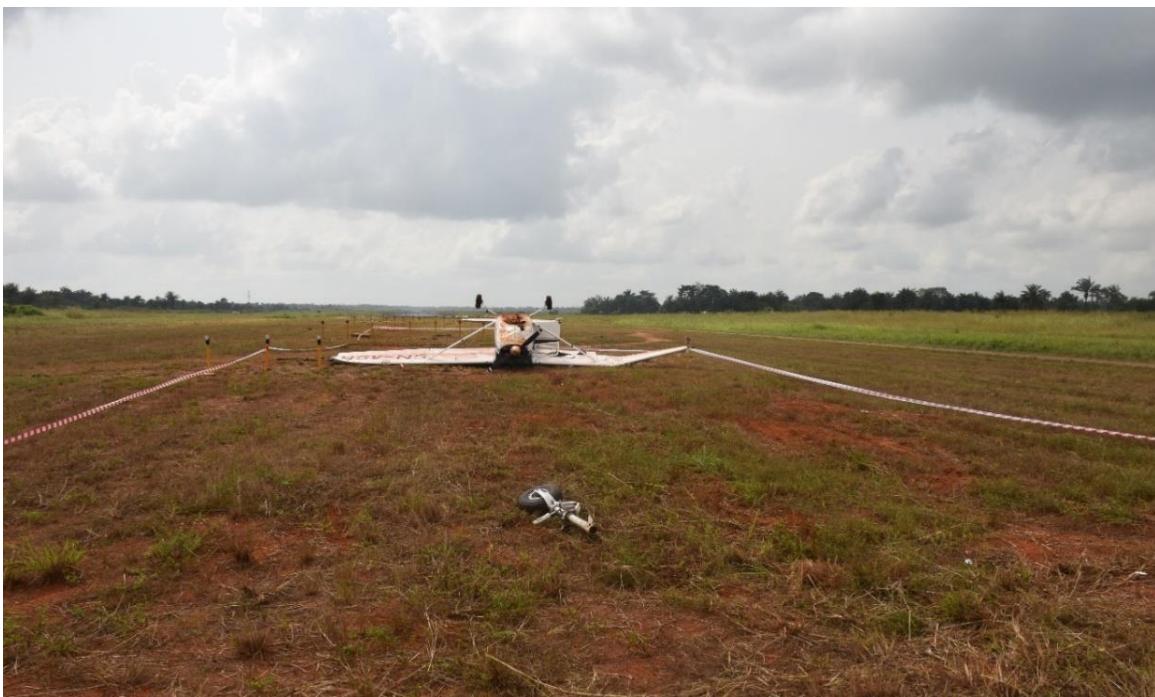
Figure 7: Some views of the aircraft at the occurrence site

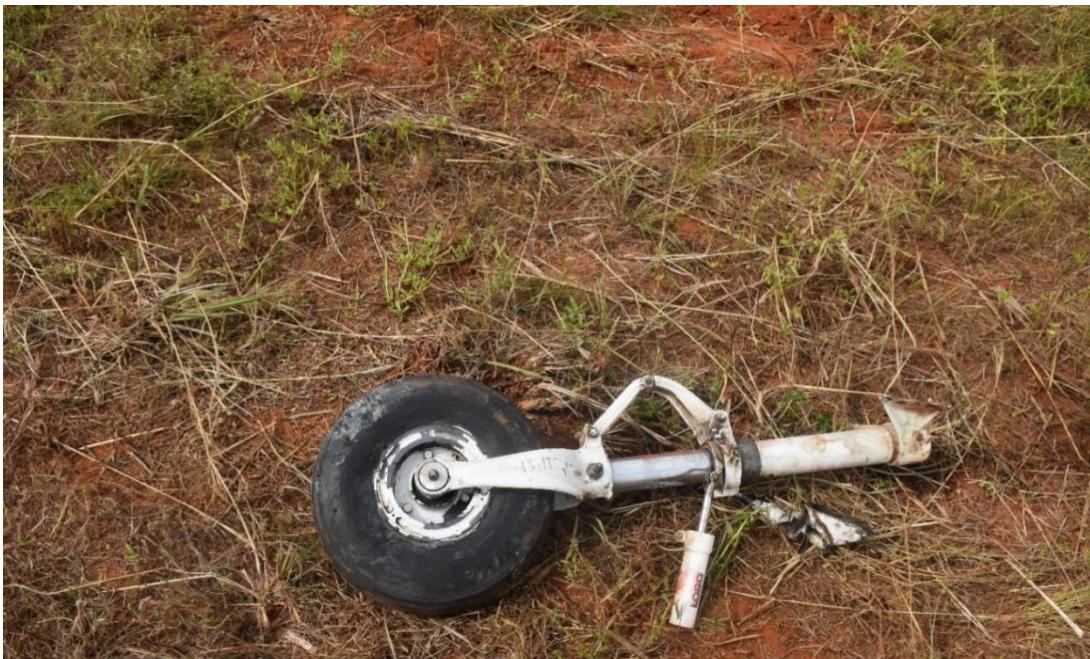
The Nose Landing Gear, detached from the Engine Firewall, and was found 17 m away from the main wreckage. The skin of the lower engine cowling at the point of detachment of the nose landing gear was torn and dented due to impact with terrain.

Dislodged earth and dried grass were found embedded in the torn skin. The Nose and Main Landing Gear Tyres remained inflated.

Figure 8: The detached nose landing gear

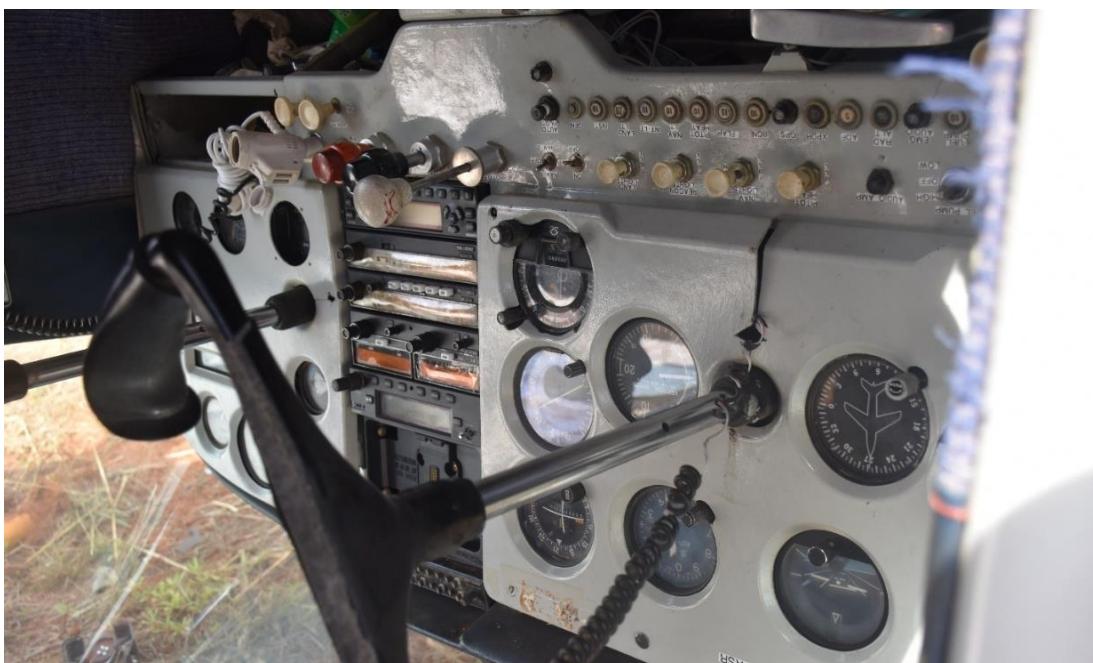
Figure 9: A view of the instrument panel in the overturned aircraft

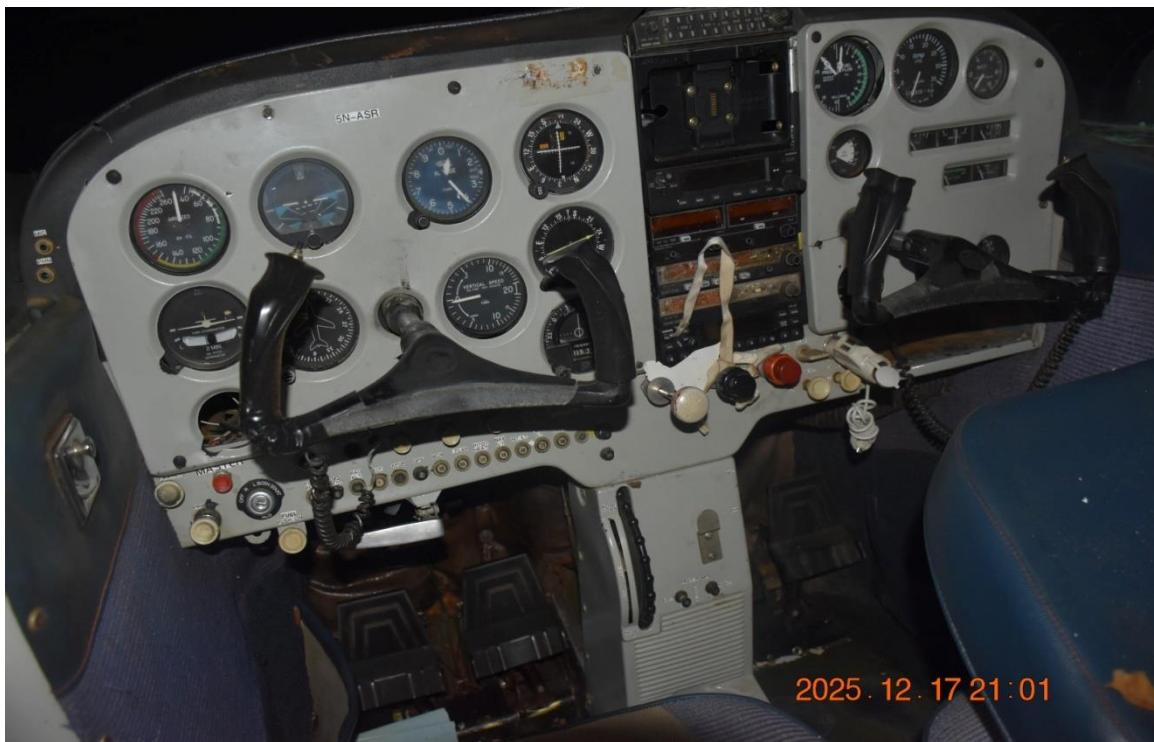
Figure 10: The aircraft cockpit area

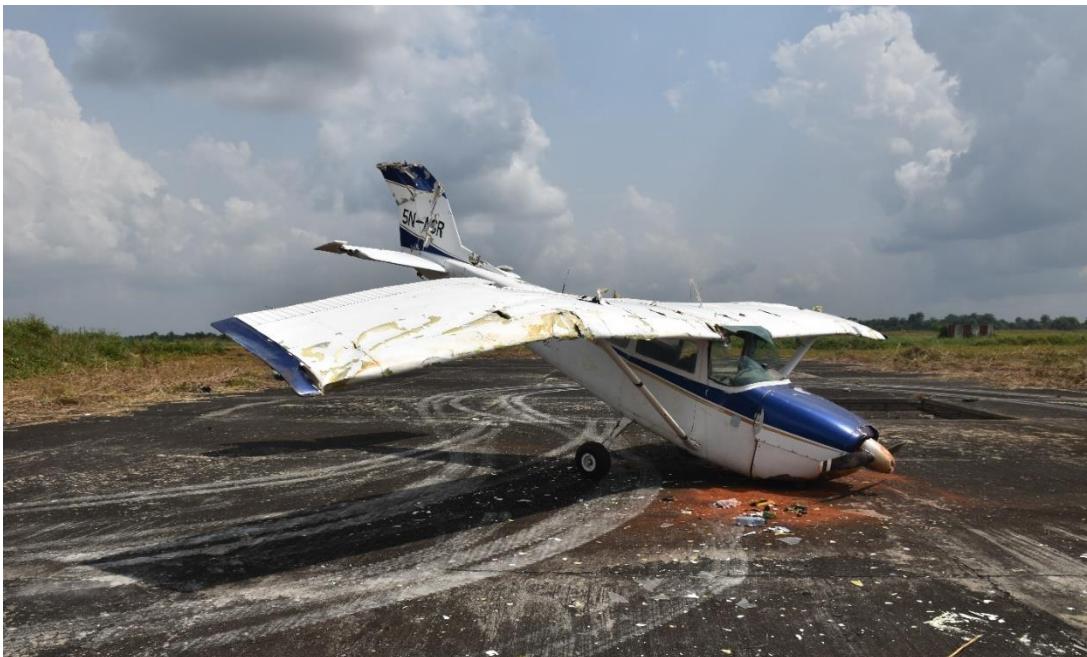
Figure 12: The aircraft after wreckage recovery
