**Preliminary Report on the Serious Incident involving a Boeing 737-700 aircraft with nationality and registration marks 5N-MJF operated by Arik Air Limited, which occurred during climb out of FL 260 for FL 290 en-route Obafemi Jeremiah Awolowo International Airport (DNPO), Port Harcourt on 11 February, 2026.**

<b>Operator:</b>	Arik Air Limited
<b>Type and model:</b>	Boeing 737-700
<b>Manufacturer:</b>	The Boeing Aircraft Company, USA
<b>Year of manufacture:</b>	2007
<b>Nationality and registration marks:</b>	5N-MJF
<b>Serial number:</b>	34762
<b>Location:</b>	En-route Port Harcourt
<b>Date and Time:</b>	11 February, 2026 at about 07:35 h

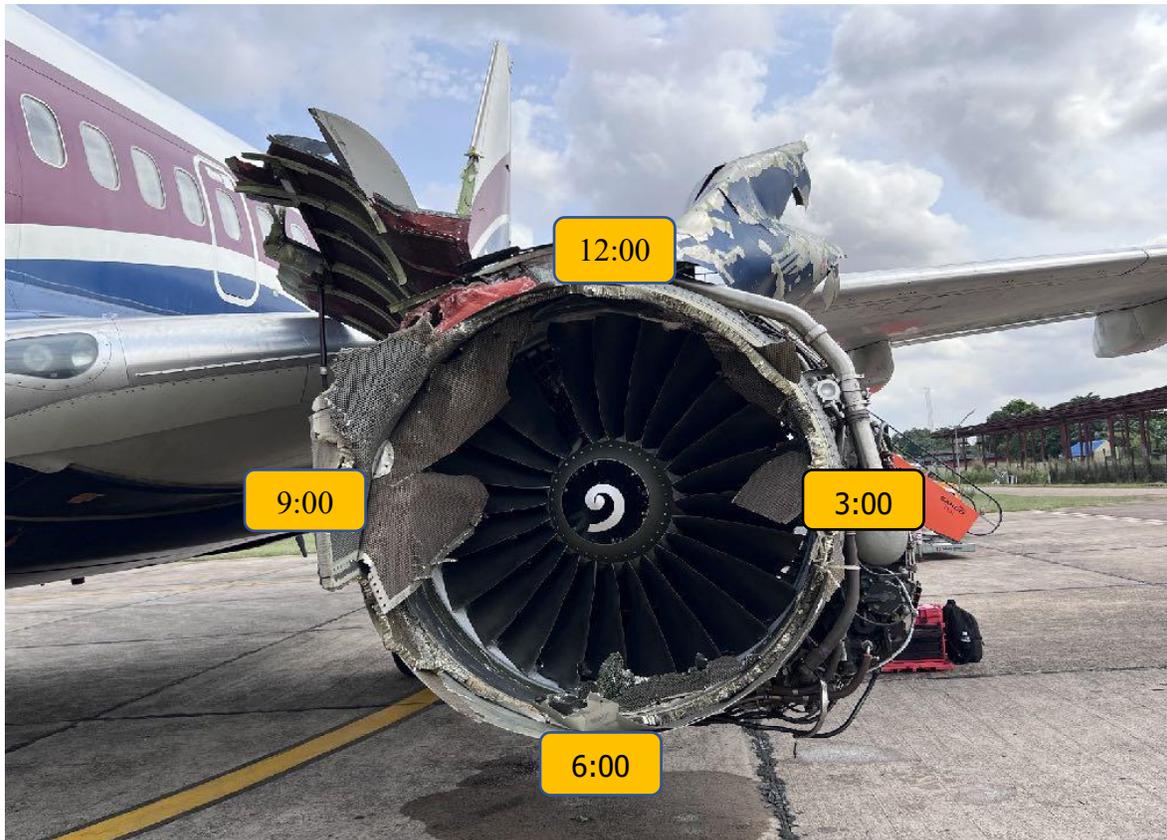
1. Engine inlet cowling missing.
2. Number 6 fan blade of engine was broken with the root left attached.
3. The remaining 23 fan blades were all chipped off and damaged.

**Figure 4:** The damaged number 1 engine

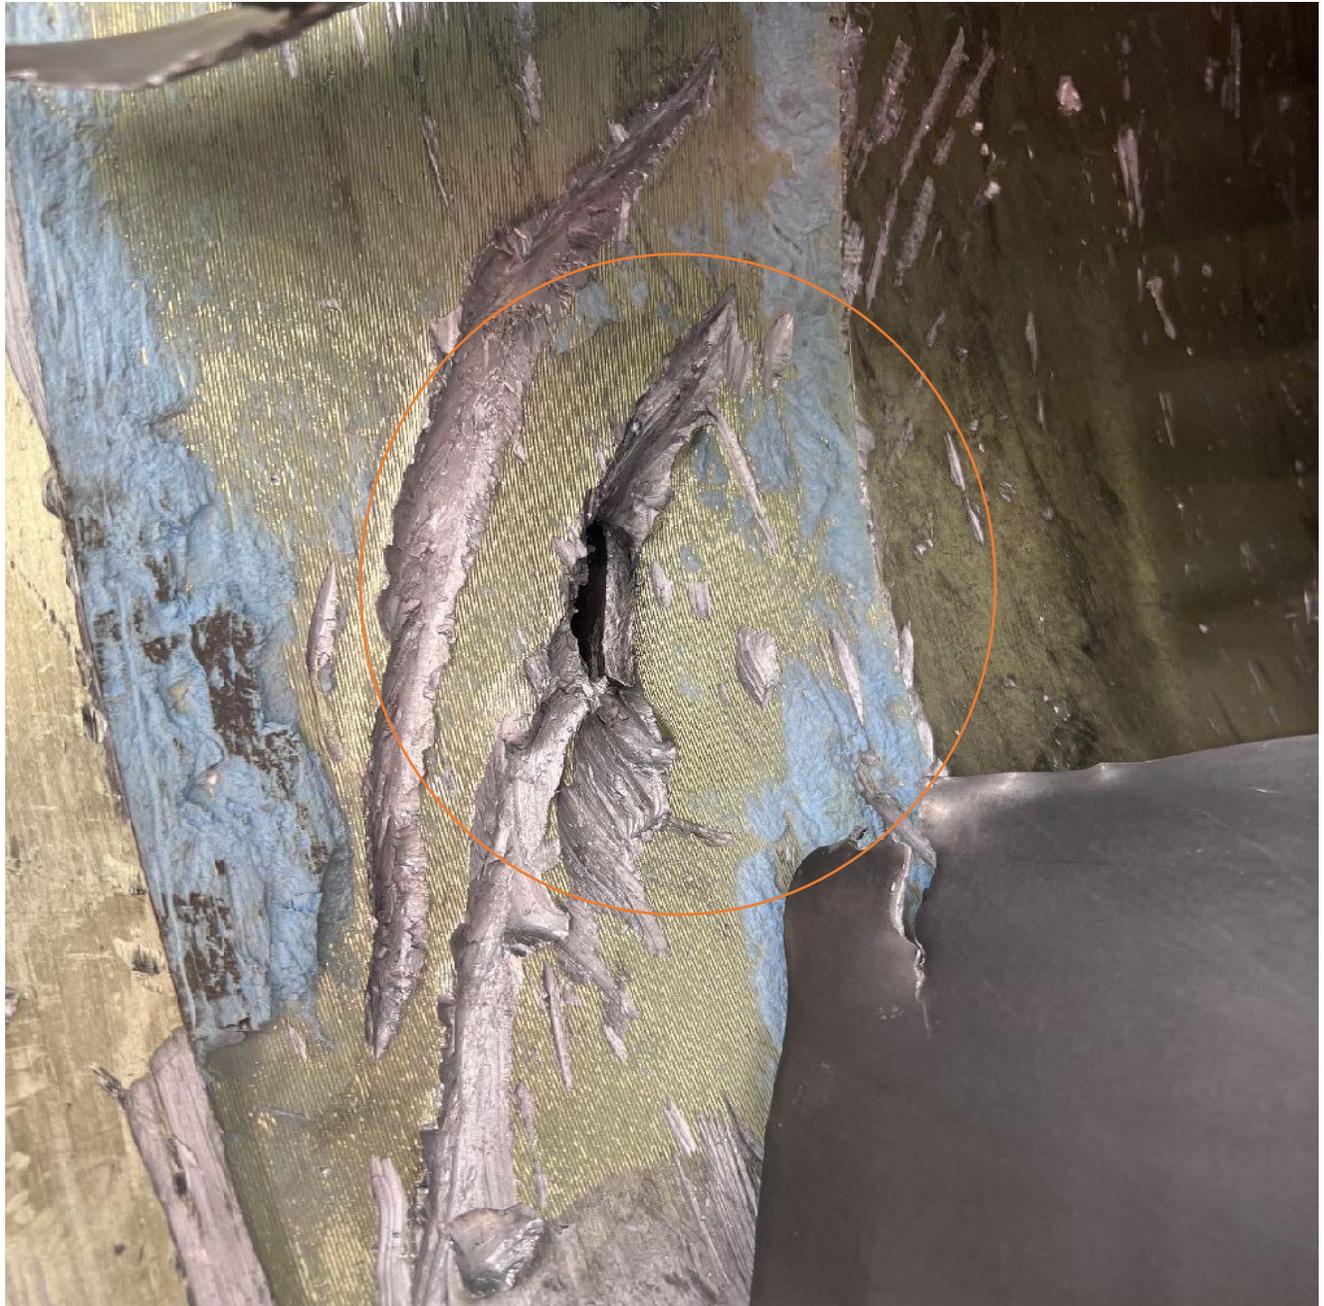
**Figure 5:** Broken fan blade fragment lodged in the engine case containment

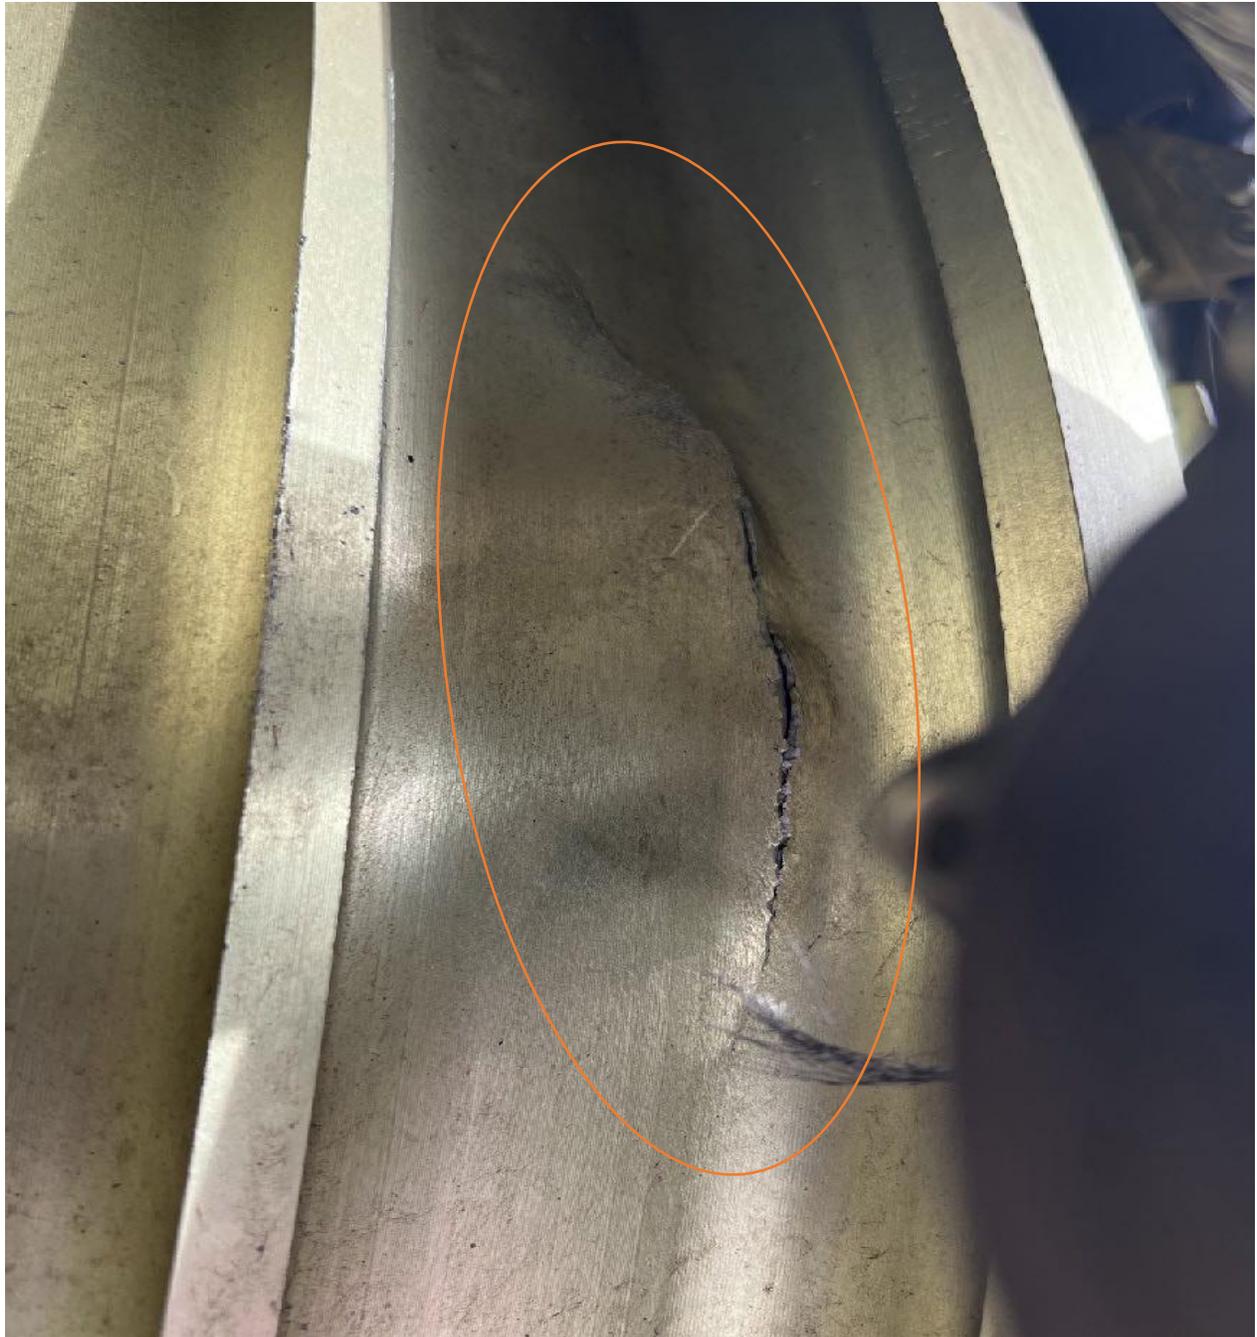
8. Cracks were observed on the exterior of the engine case containment.
9. The Outlet Guide Vanes (OGV) at 5, 6, and 7 o'clock positions were missing.
10. The engine-driven pump sustained damage.

**Figure 6:** Crack on the external part of the containment case

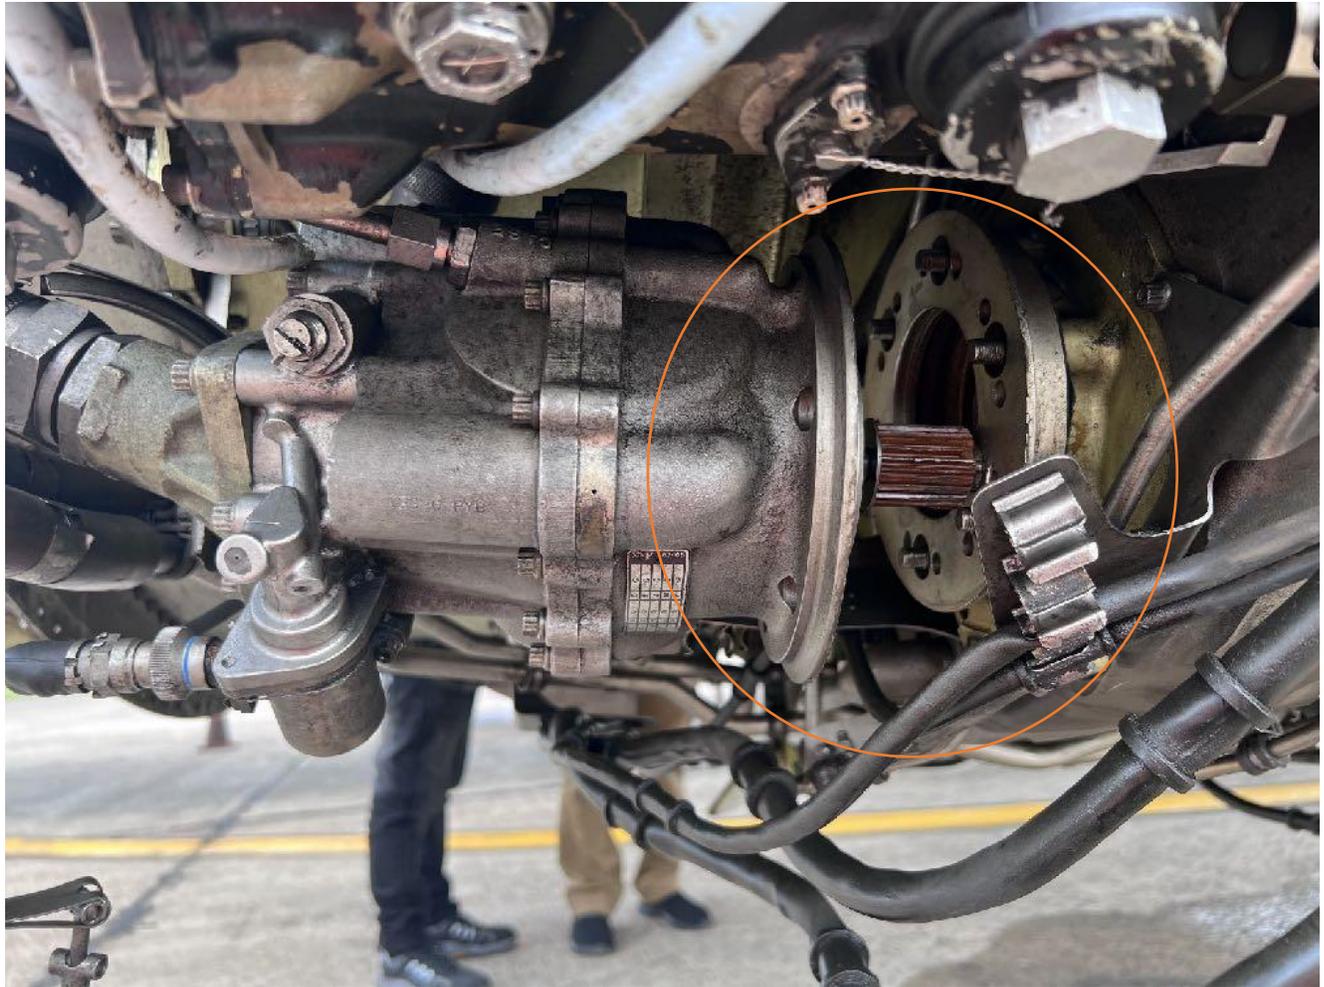
**Figure 7:** Decoupled Engine-driven pump (EDP)

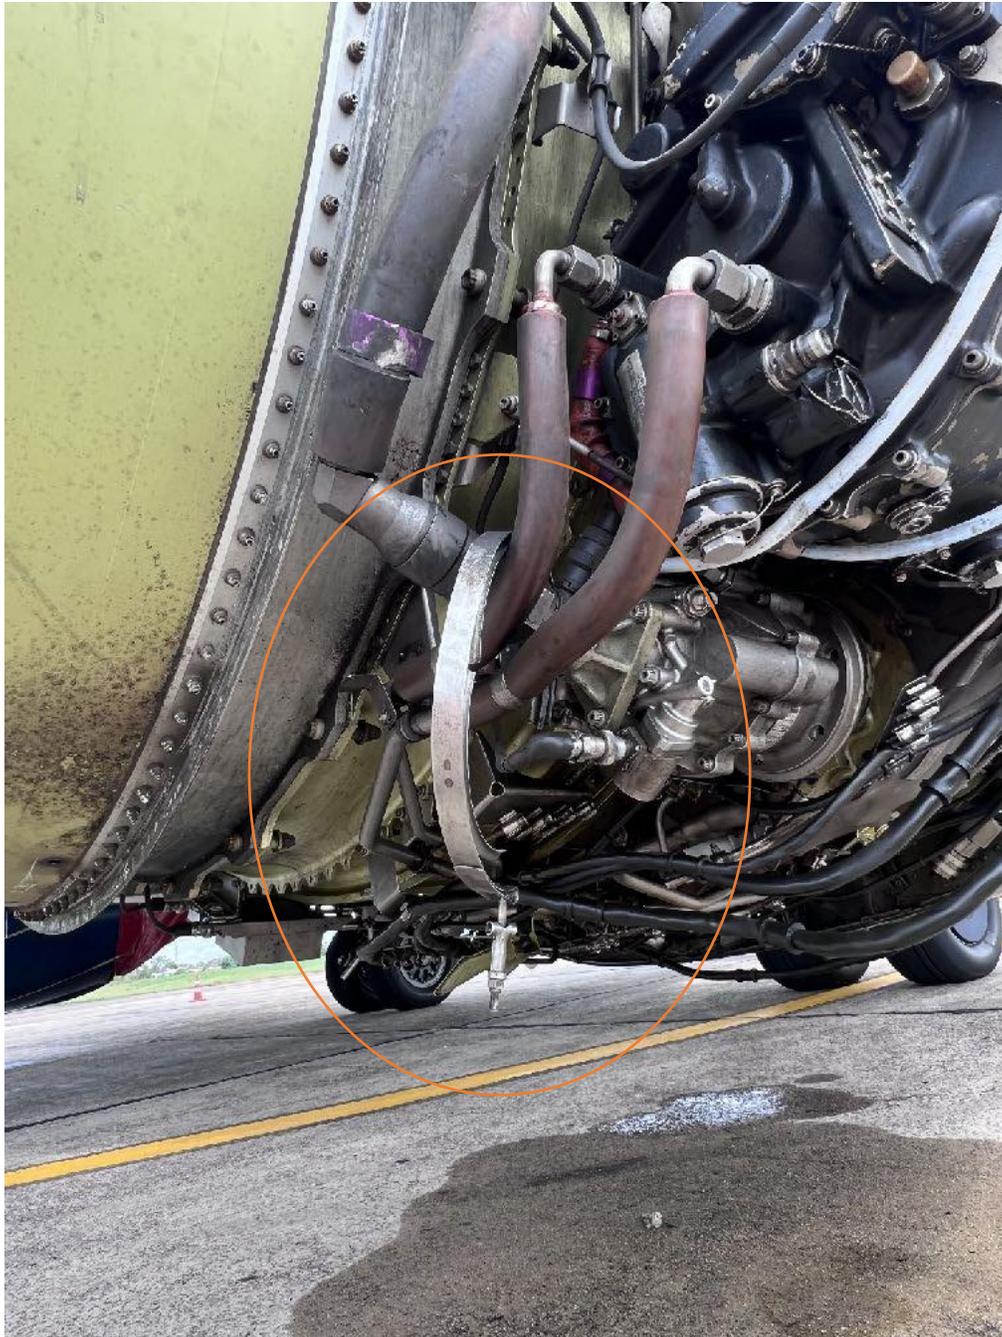
4. Inboard and outboard engine cowling covers were folded upward, exposing the engine accessories.
5. The engine-driven pump (EDP) clamp was found loose.

**Figure 8:** Loosed engine-driven pump (EDP) Clamp

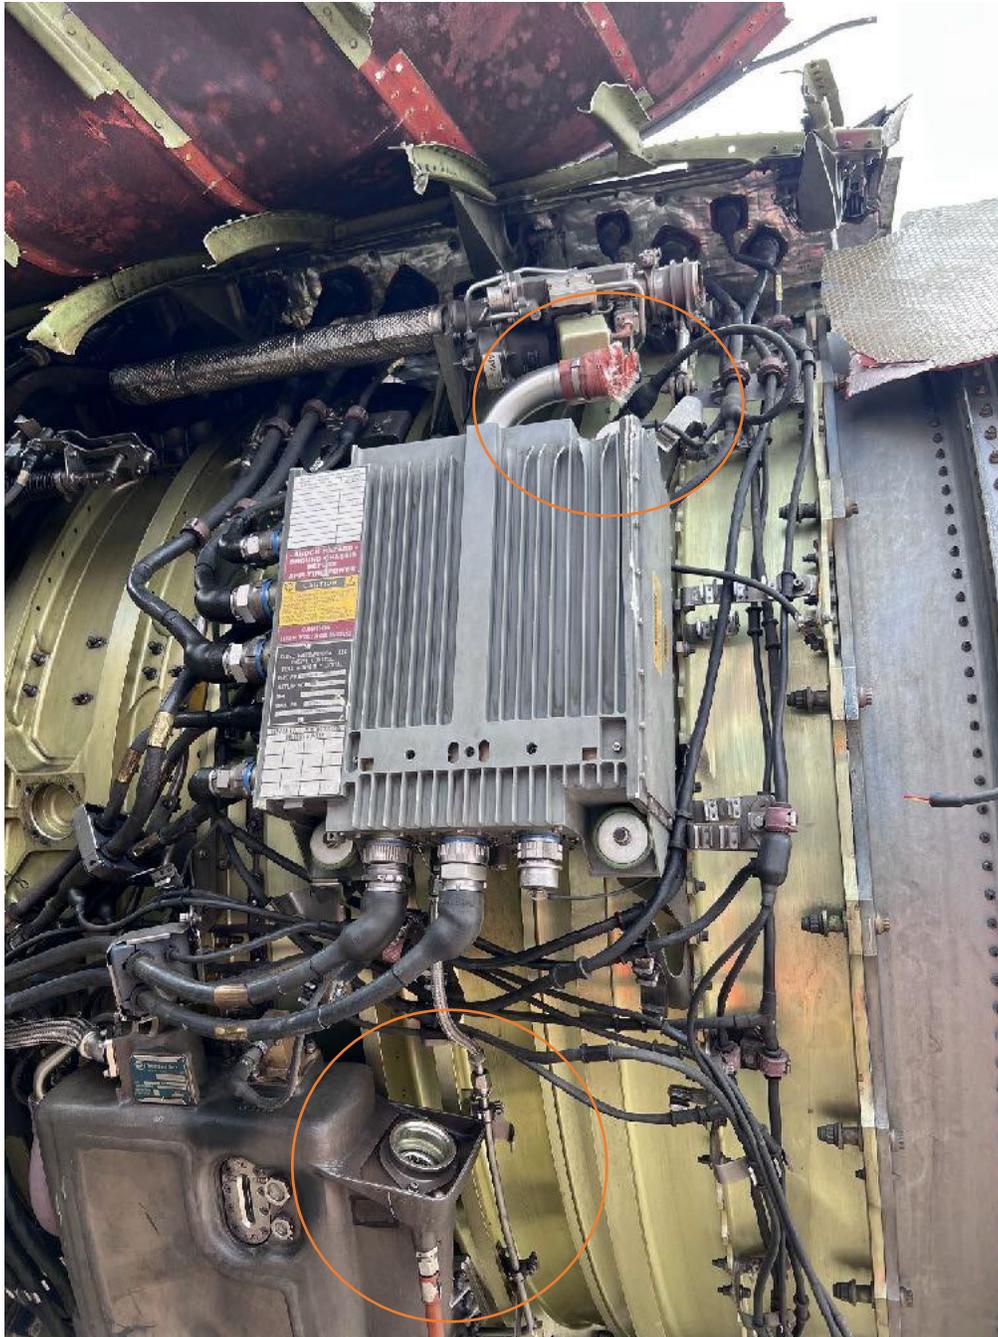
11. There was visible damage on the exhaust assembly.
12. The engine oil tank filler cap was missing.
13. The anti-ice duct was broken, and part of it was missing.

**Figure 9:** Broken Anti-ice duct and missing Engine oil tank filler cap

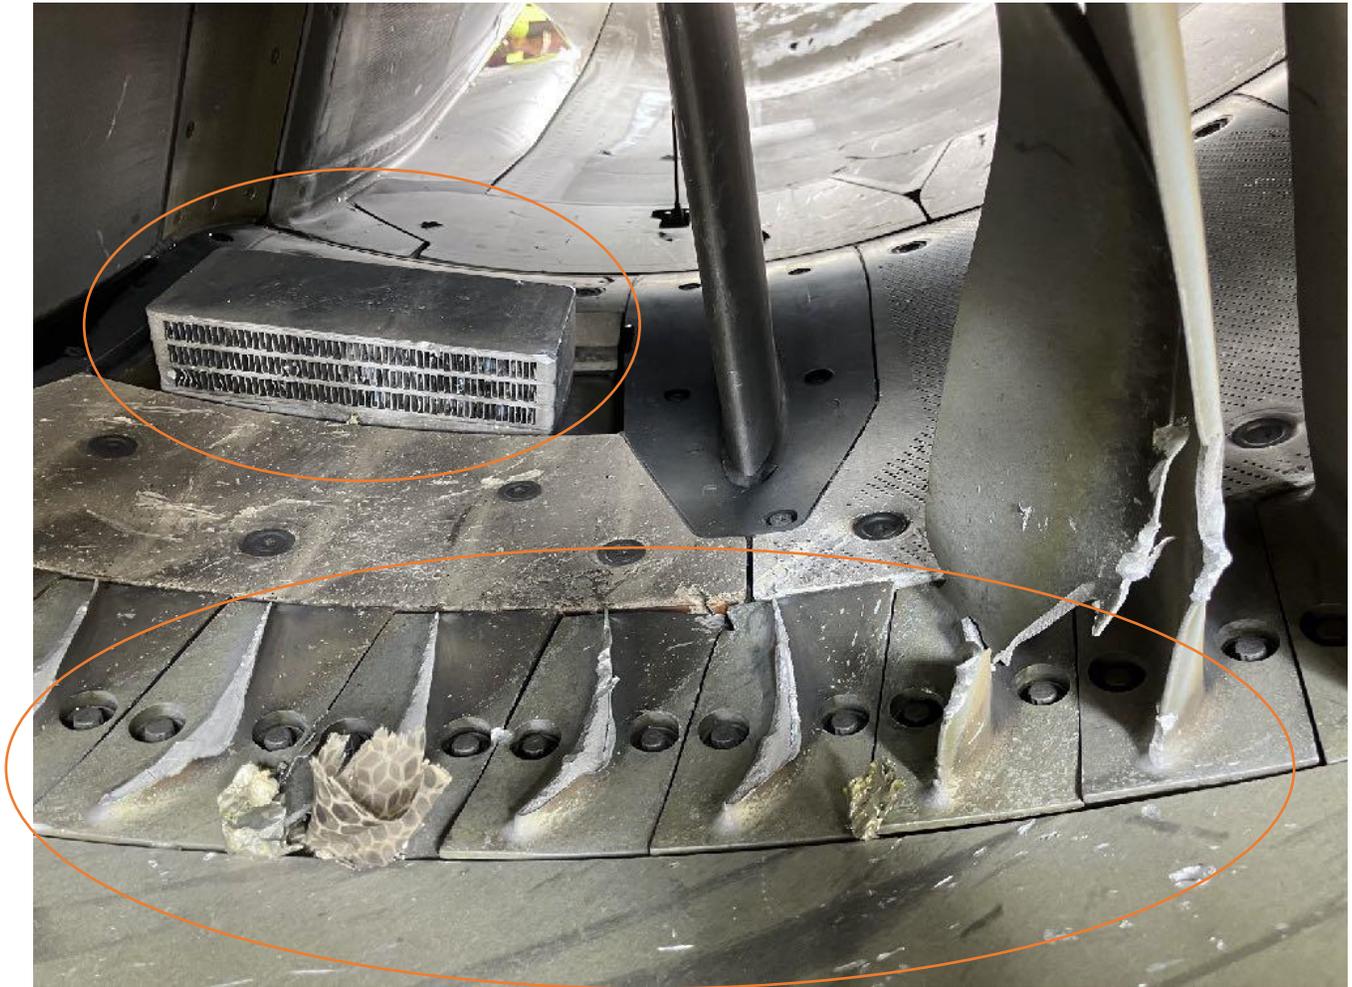
14. The left-hand vortex generator was damaged.
15. The Integrated Drive Generator (IDG) oil cooler was damaged.
16. There were dents and punctures at various locations on the airframe.

**Figure 10:** Damaged Integrated Drive Generator (IDG) oil cooler and Outlet guide vanes (OGV) at 5, 6, and 7 o'clock position.

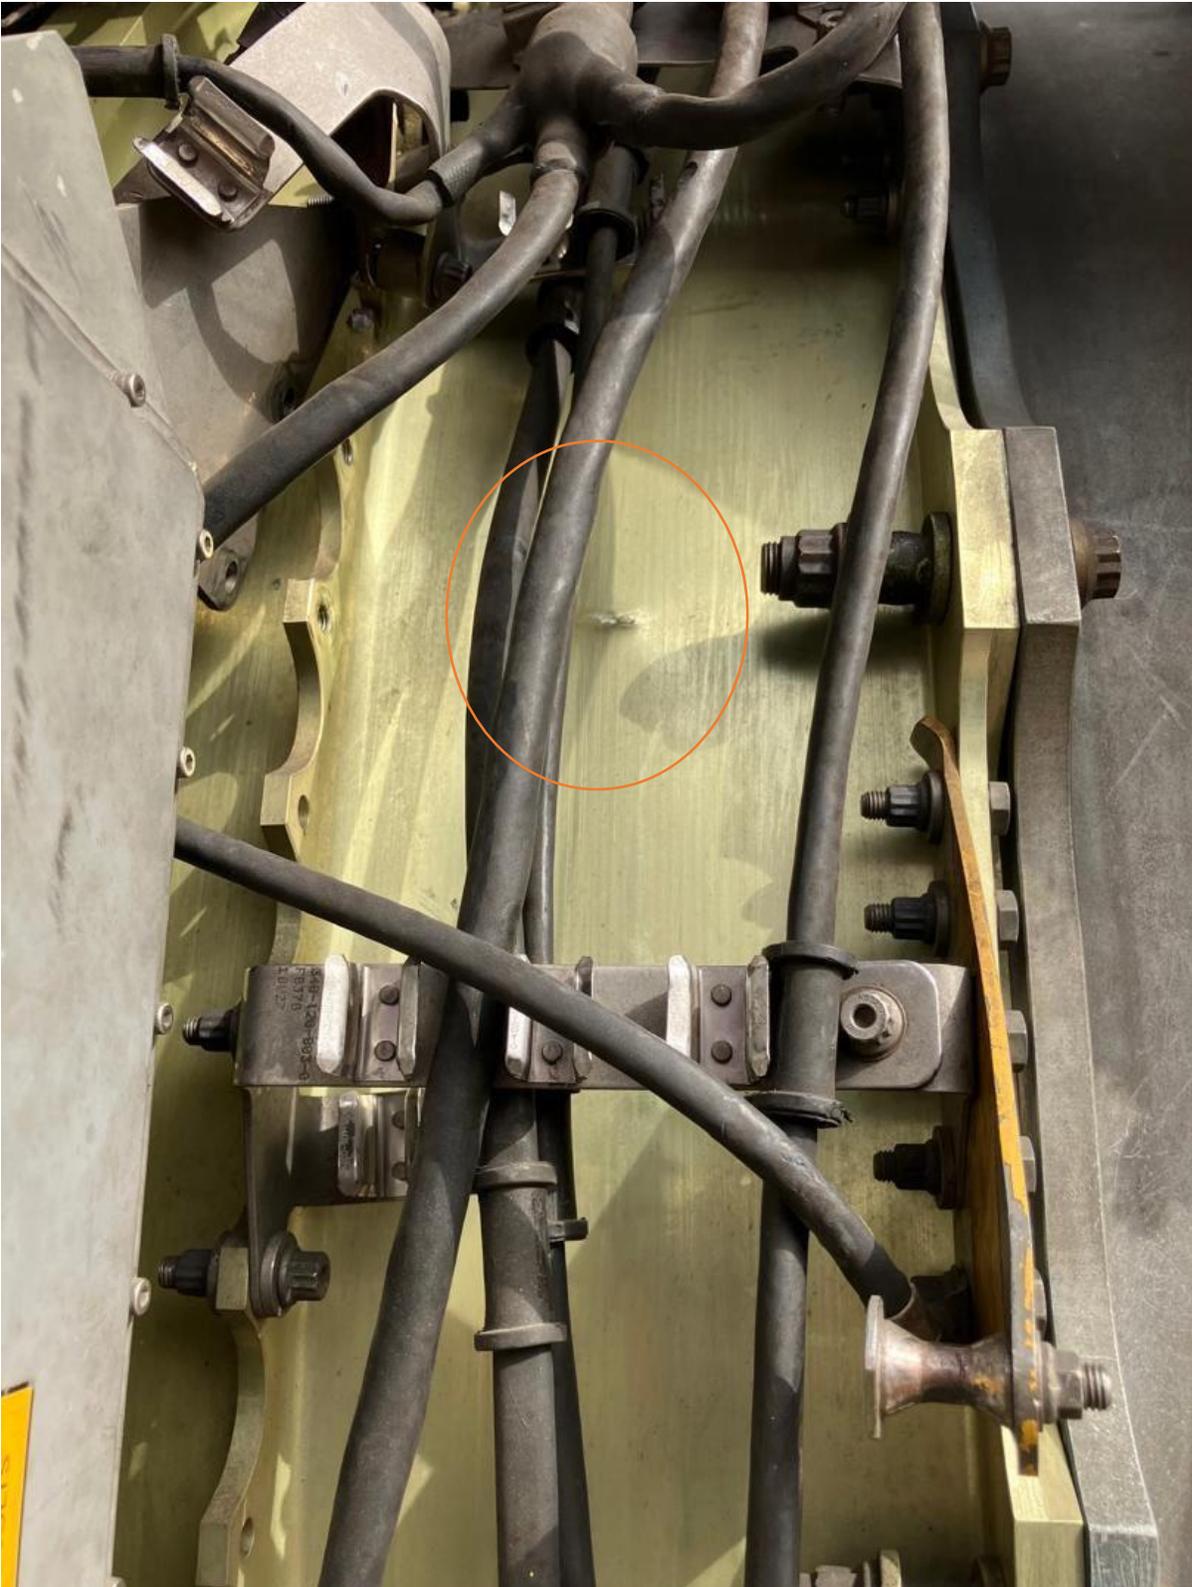
6. A deep cut about 0.6 inches long on the containment case was observed at the 2 o'clock position.
7. A long, deep cut about 7.2 inches on the containment case was observed at the 1 o'clock position.

**Figure 11:** Crack on the external part of the containment case

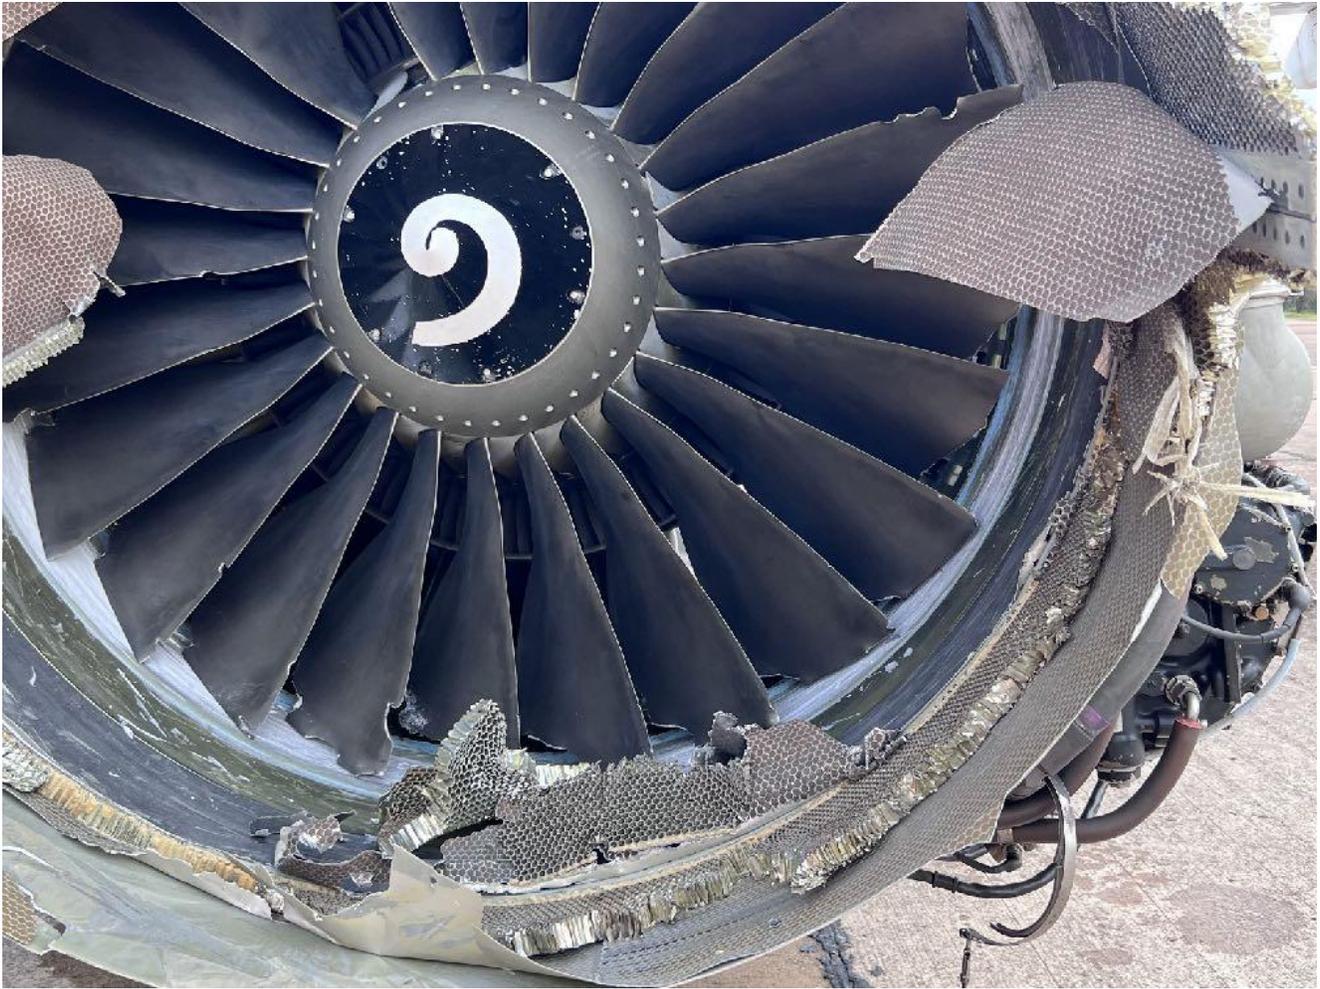
**Figure 12:** Chipped fan blades

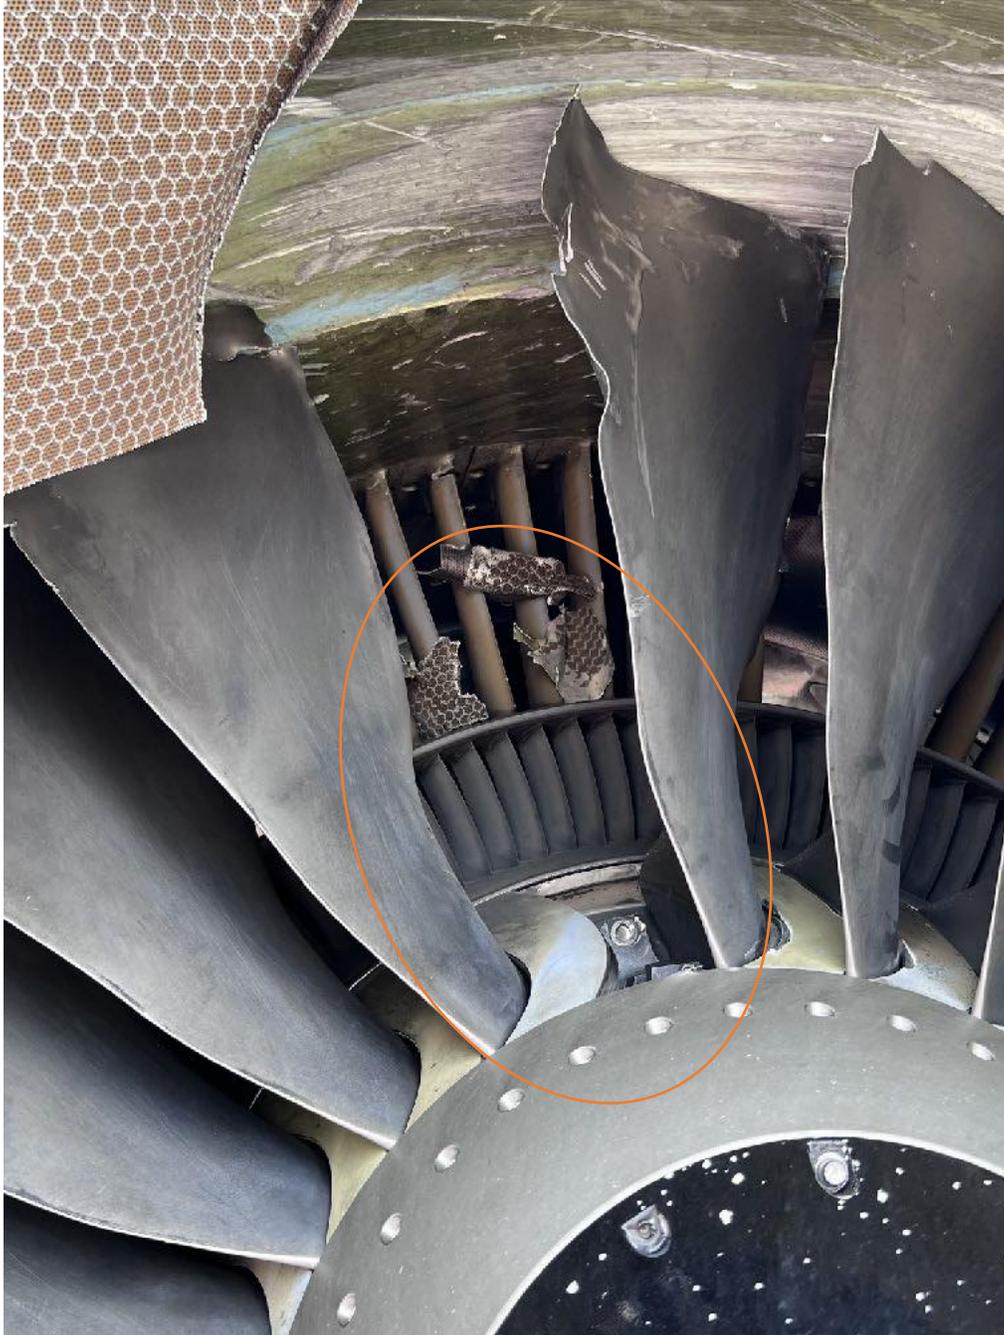
**Figure 13:** Missing Number 6 fan blade

6. The No. 6 fan blade of number 1 engine was missing upon landing at Benin.
7. As of 24 December, 2019, the incident engine ESN 805612 was installed on number 2 position on an aircraft with Romanian registration, YR-BMD, operated by Blue Air Aviation S.A. – CAMO.

1. Metallurgical examination of the missing number 6 engine fan blade root.
2. Metallurgical examination of the remaining 23 engine fan blades
3. Teardown/stripping of the number 1 engine

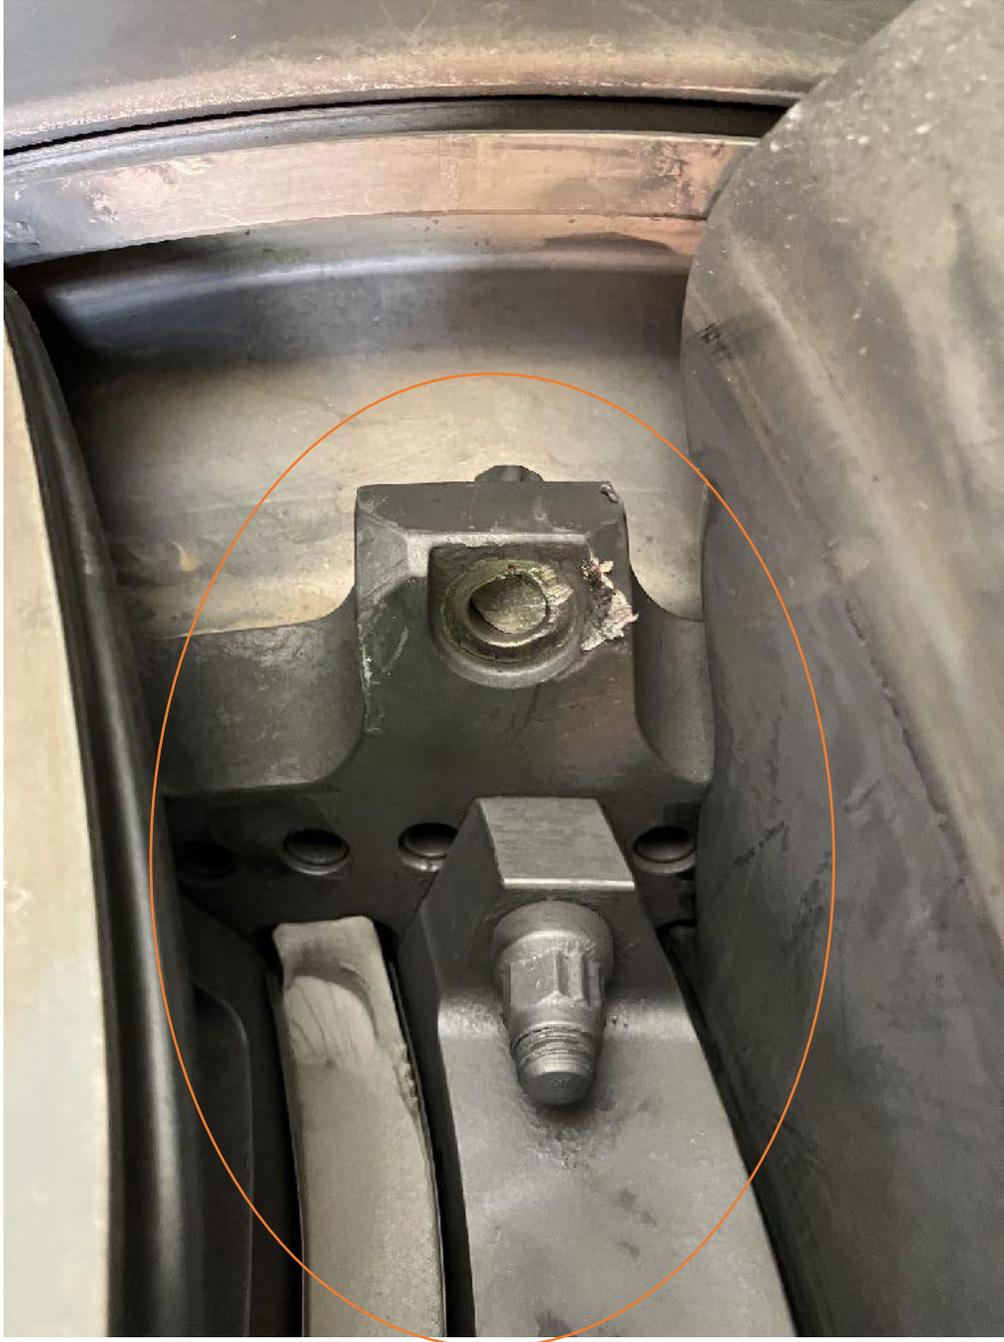
**Figure 14:** Root of the fractured fan blade

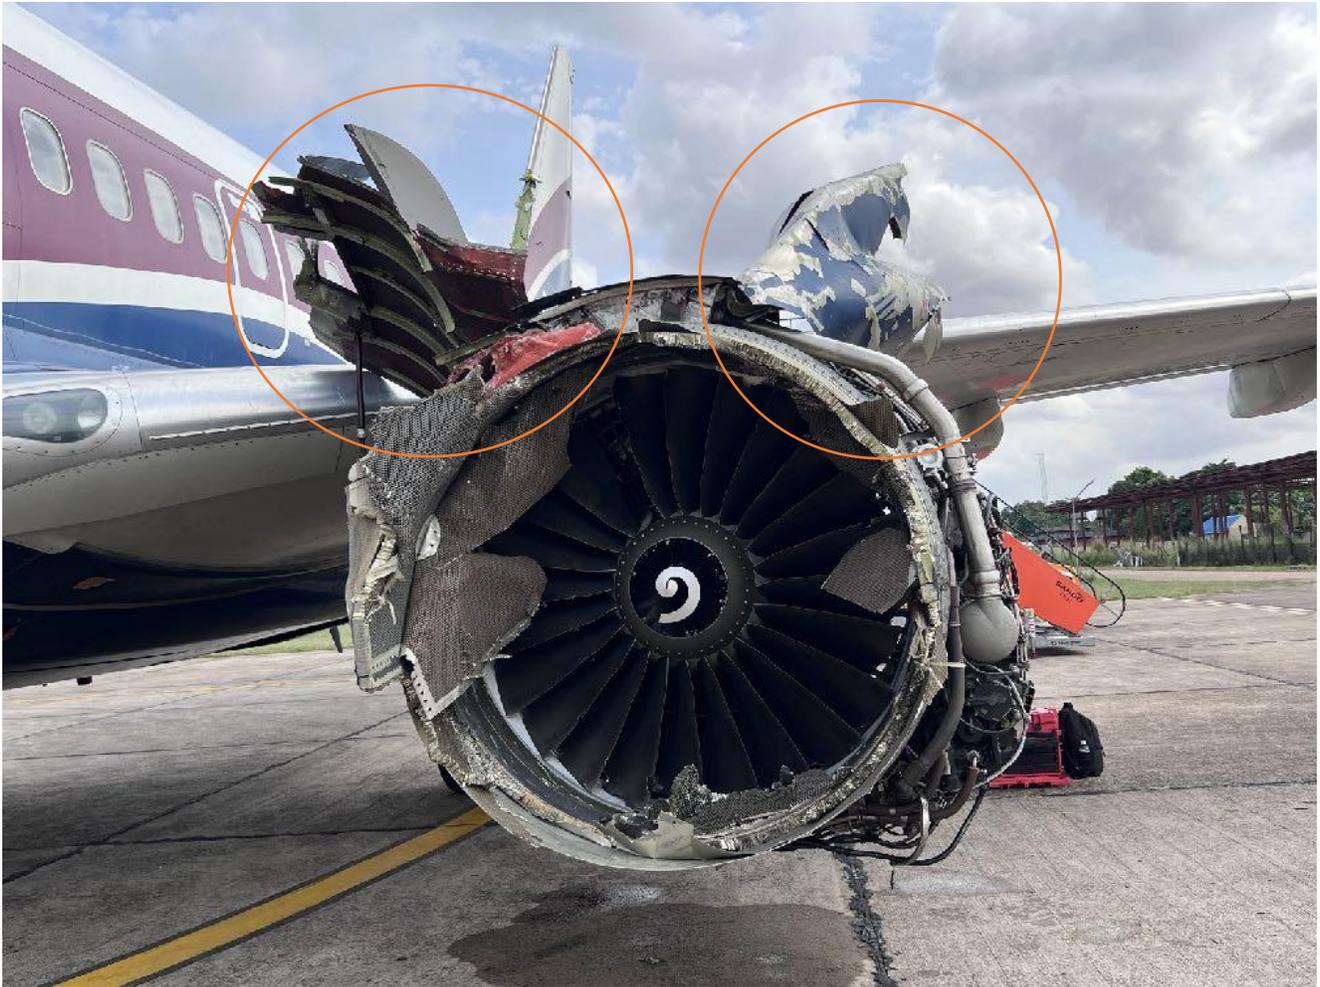
**Figure 15:** Folded inboard and outboard engine cowlings

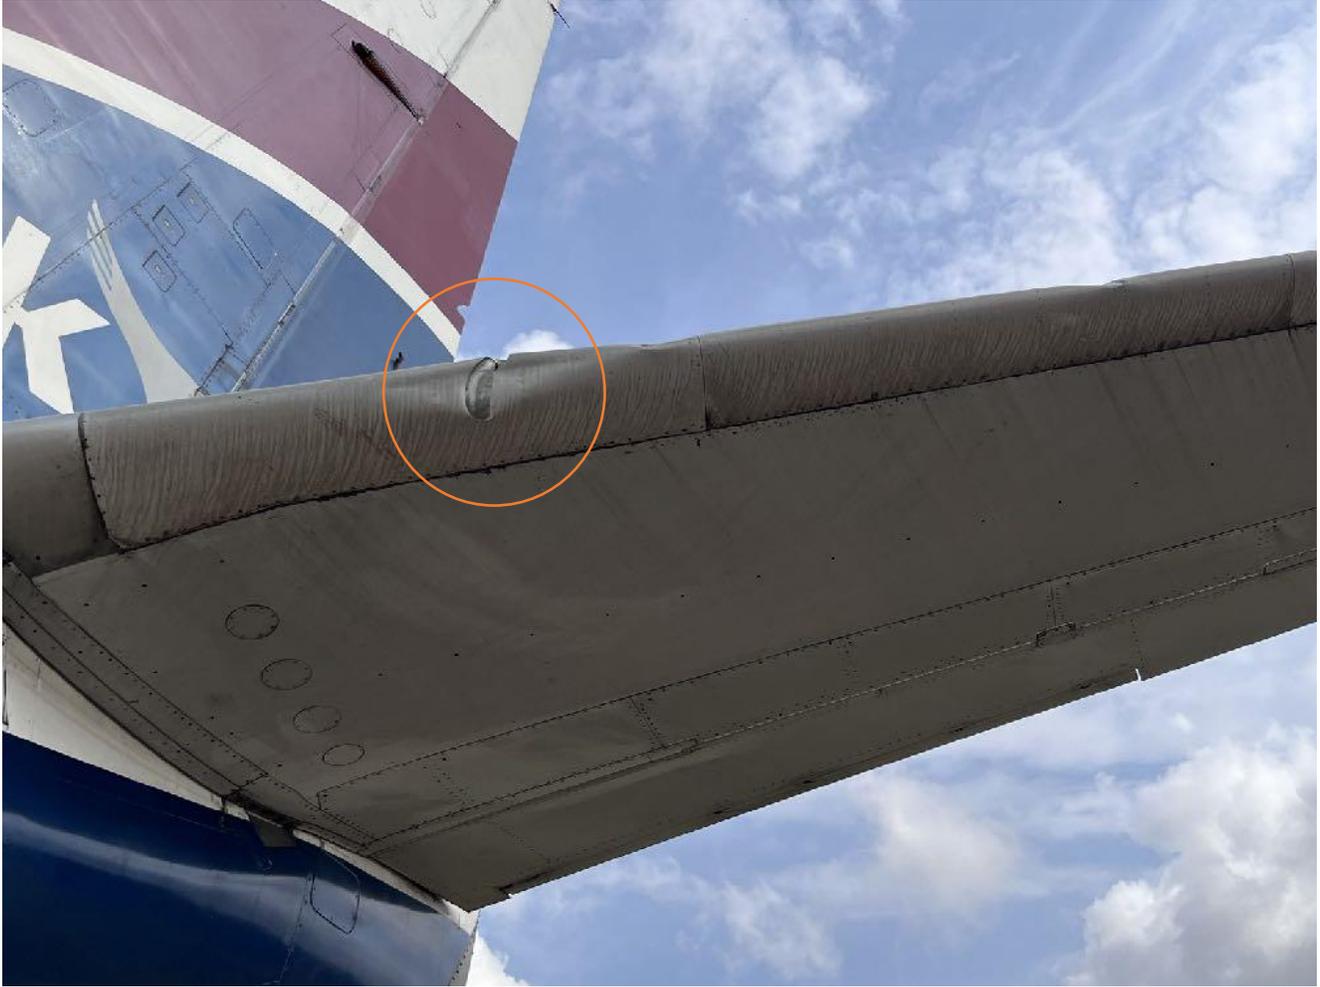
20. The left horizontal stabilizer leading edge was damaged.

**Figure 16:** Deep cut on the left horizontal stabilizer leading edge

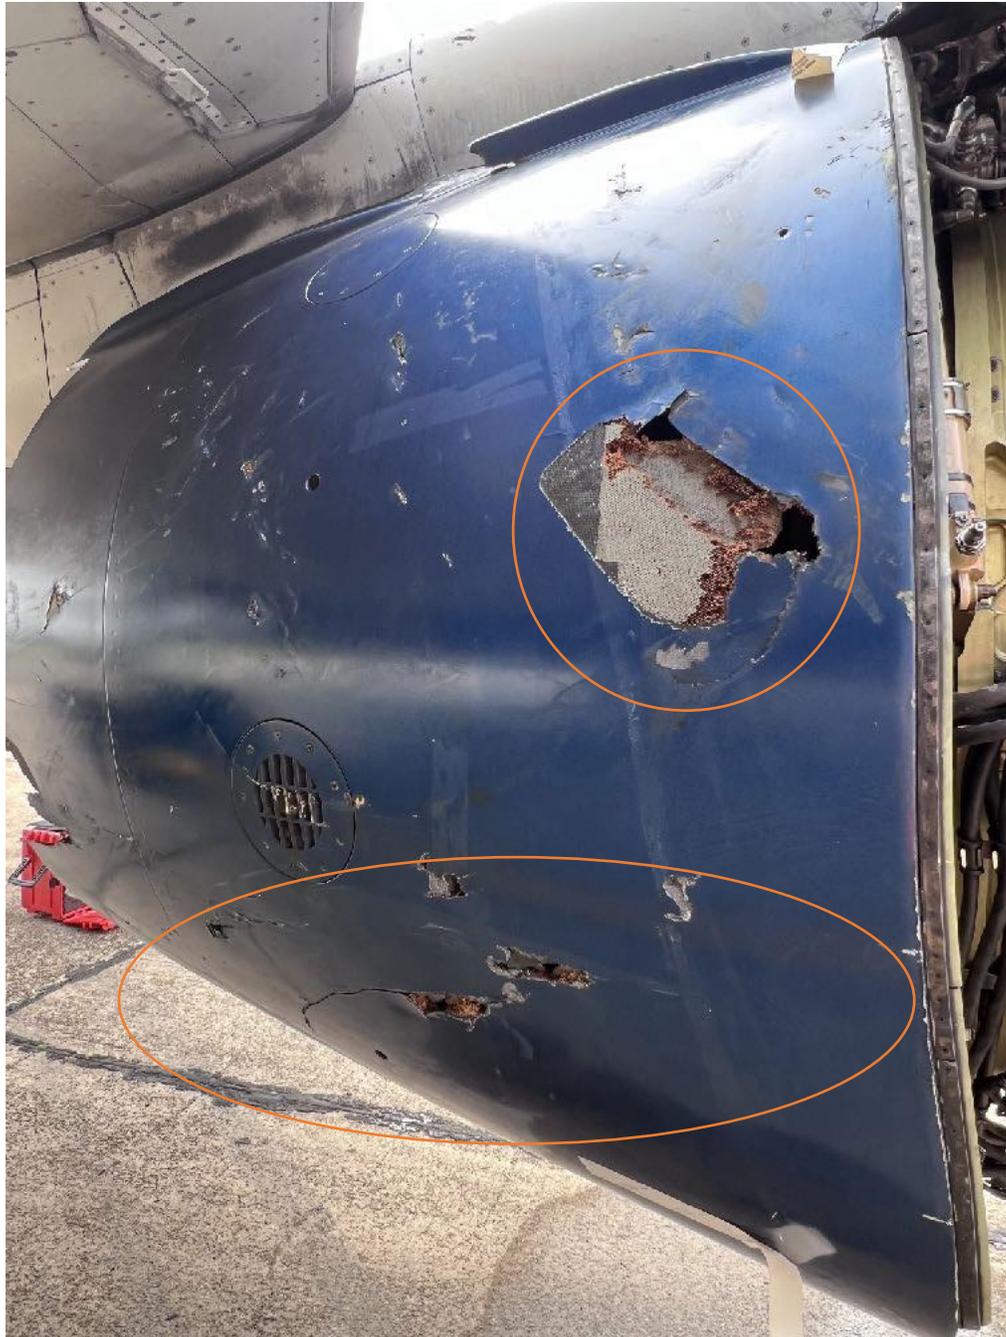
**Figure 17:** Damage to the inboard engine core cowling

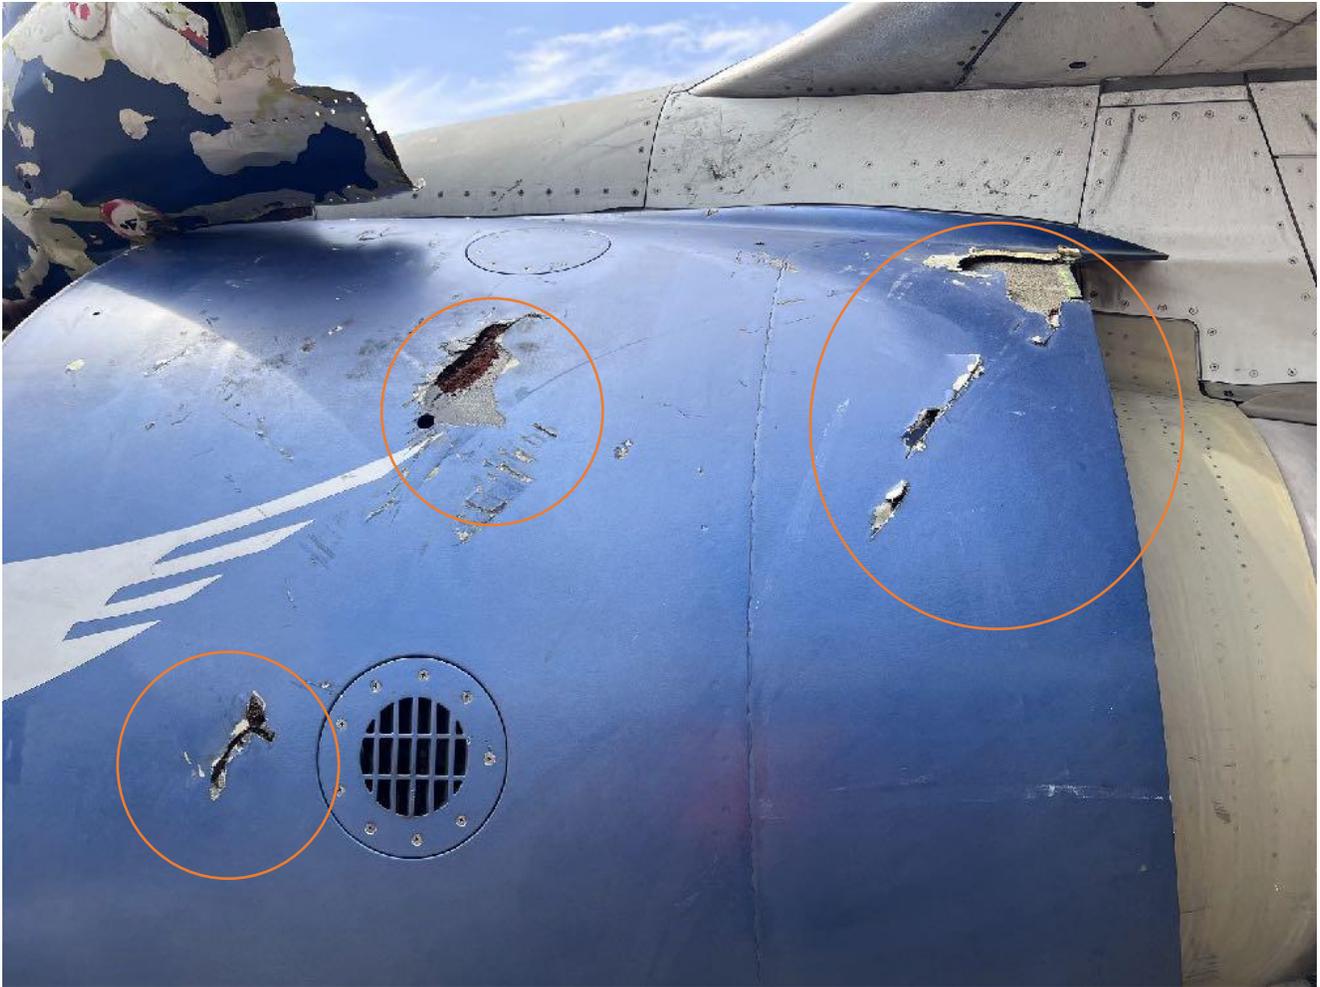
**Figure 18:** Damage to the outboard engine cowling

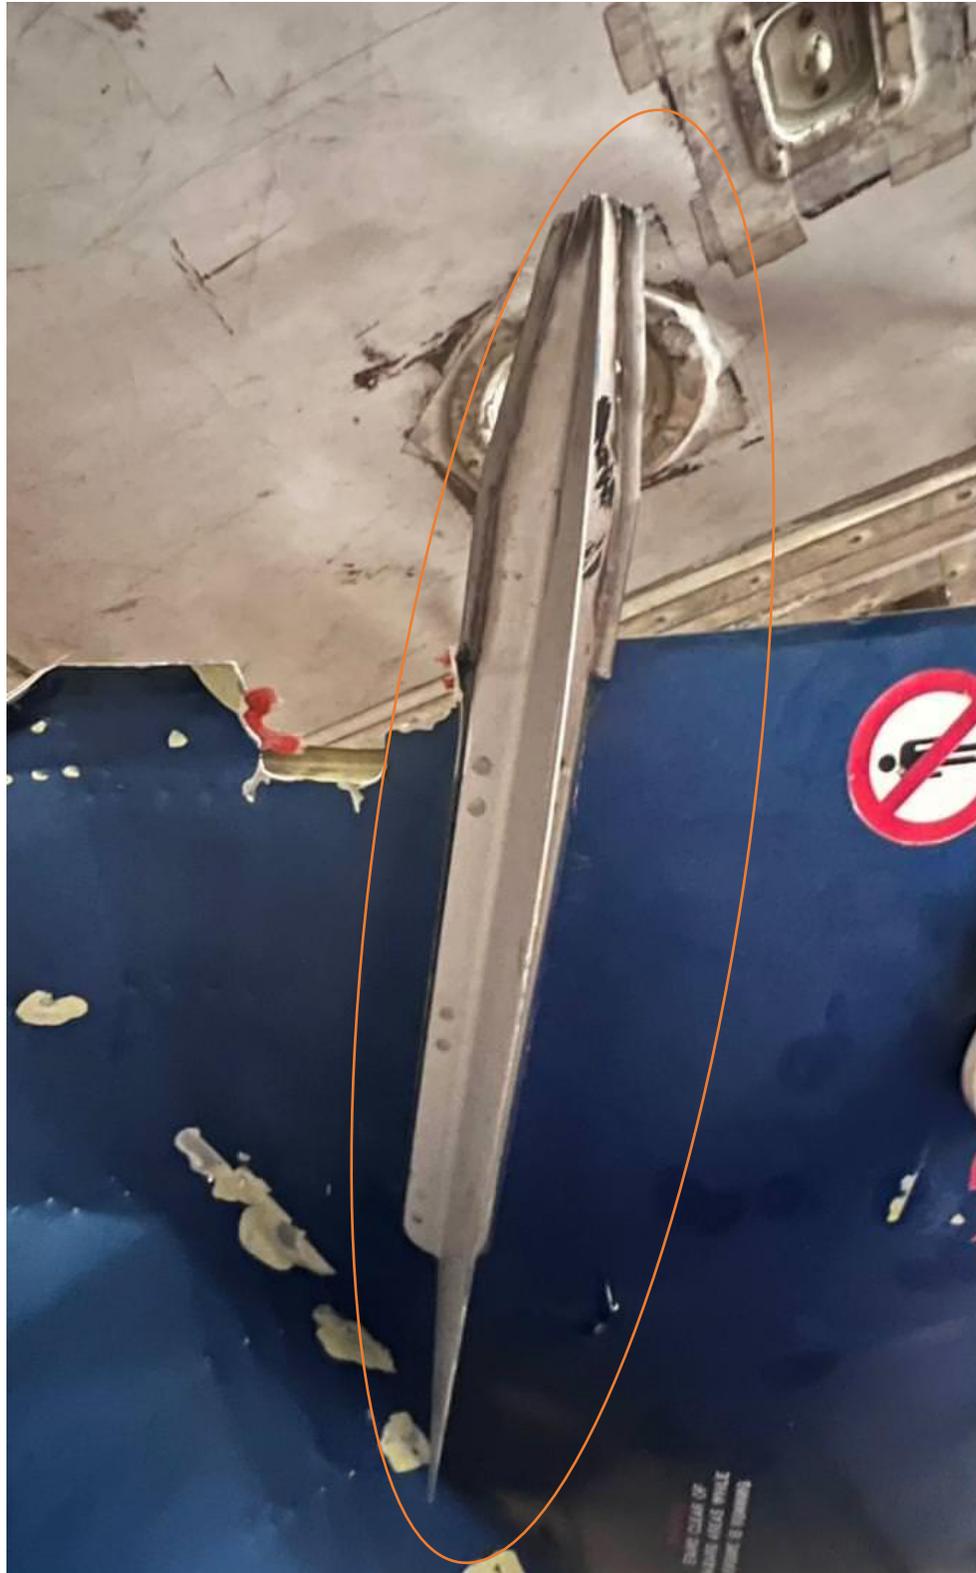
**Figure 19:** Damaged left hand vortex generator
