**Preliminary Report on the Serious Incident involving a Boeing 737-700 aircraft with nationality and registration marks 5N-MJF operated by Arik Air Limited, which occurred during climb out of FL 260 for FL 290 en-route Obafemi Jeremiah Awolowo International Airport (DNPO), Port Harcourt on 11 February, 2026.**

<b>Operator:</b>	Arik Air Limited
<b>Type and model:</b>	Boeing 737-700
<b>Manufacturer:</b>	The Boeing Aircraft Company, USA
<b>Year of manufacture:</b>	2007
<b>Nationality and registration marks:</b>	5N-MJF
<b>Serial number:</b>	34762
<b>Location:</b>	En-route Port Harcourt
<b>Date and Time:</b>	11 February, 2026 at about 07:35 h

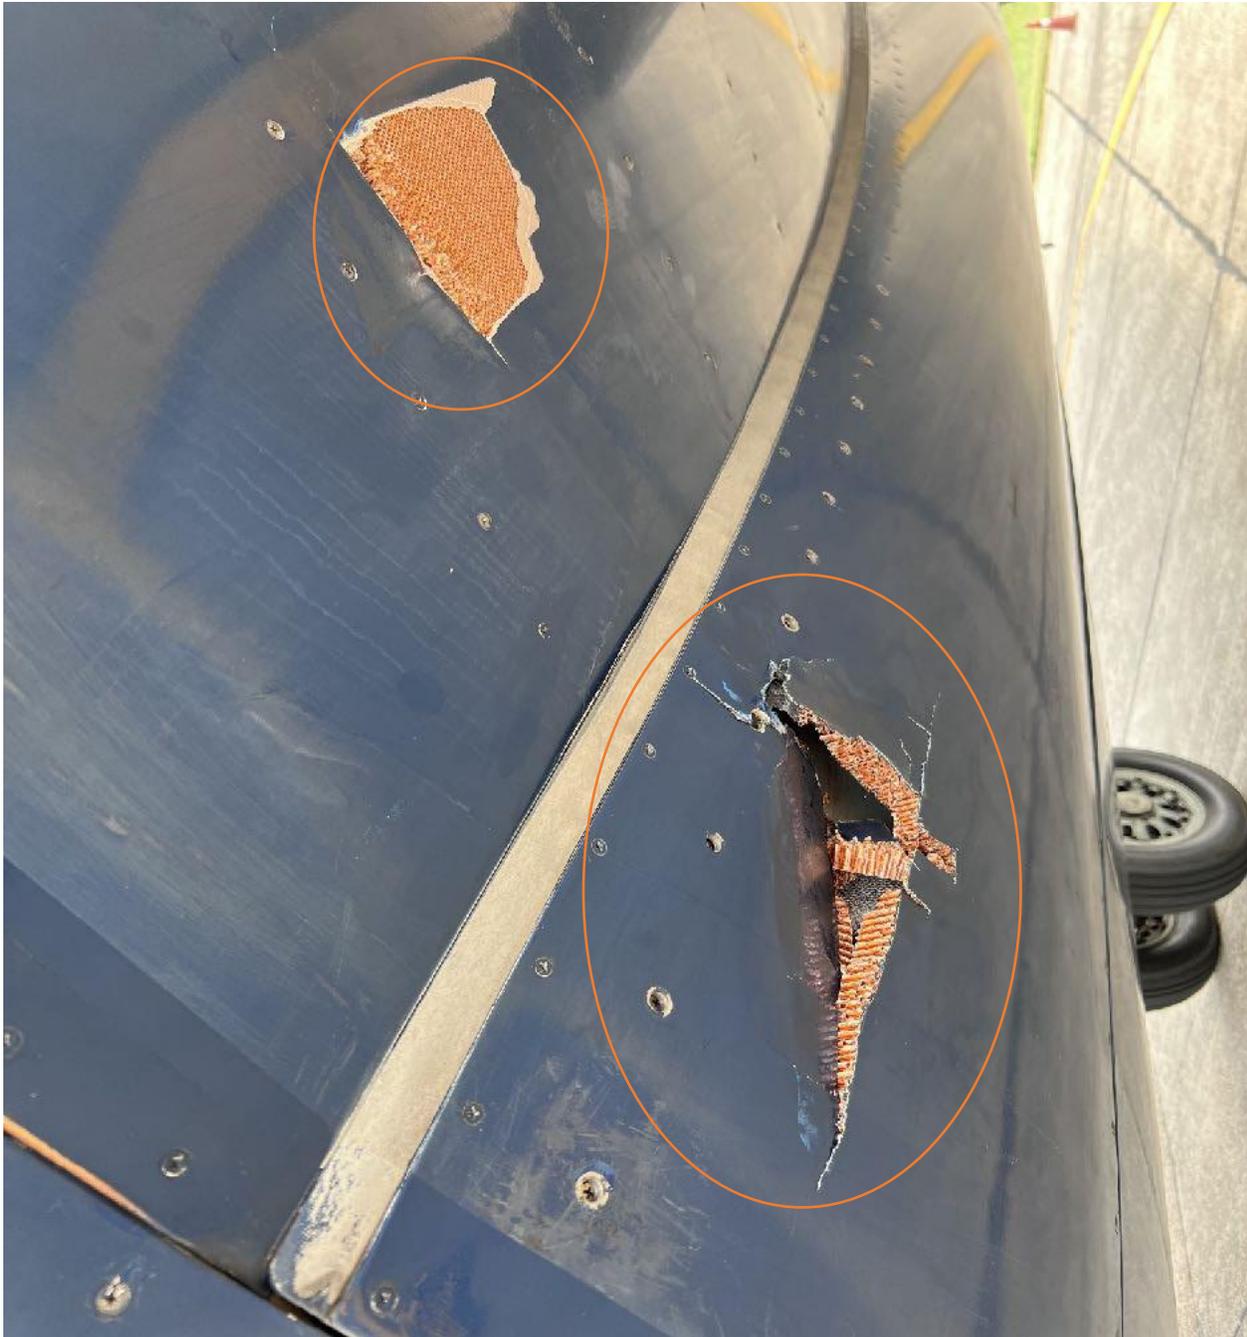
14. The left-hand vortex generator was damaged.
15. The Integrated Drive Generator (IDG) oil cooler was damaged.
16. There were dents and punctures at various locations on the airframe.

**Figure 20:** Tear on the lower section of the fuselage

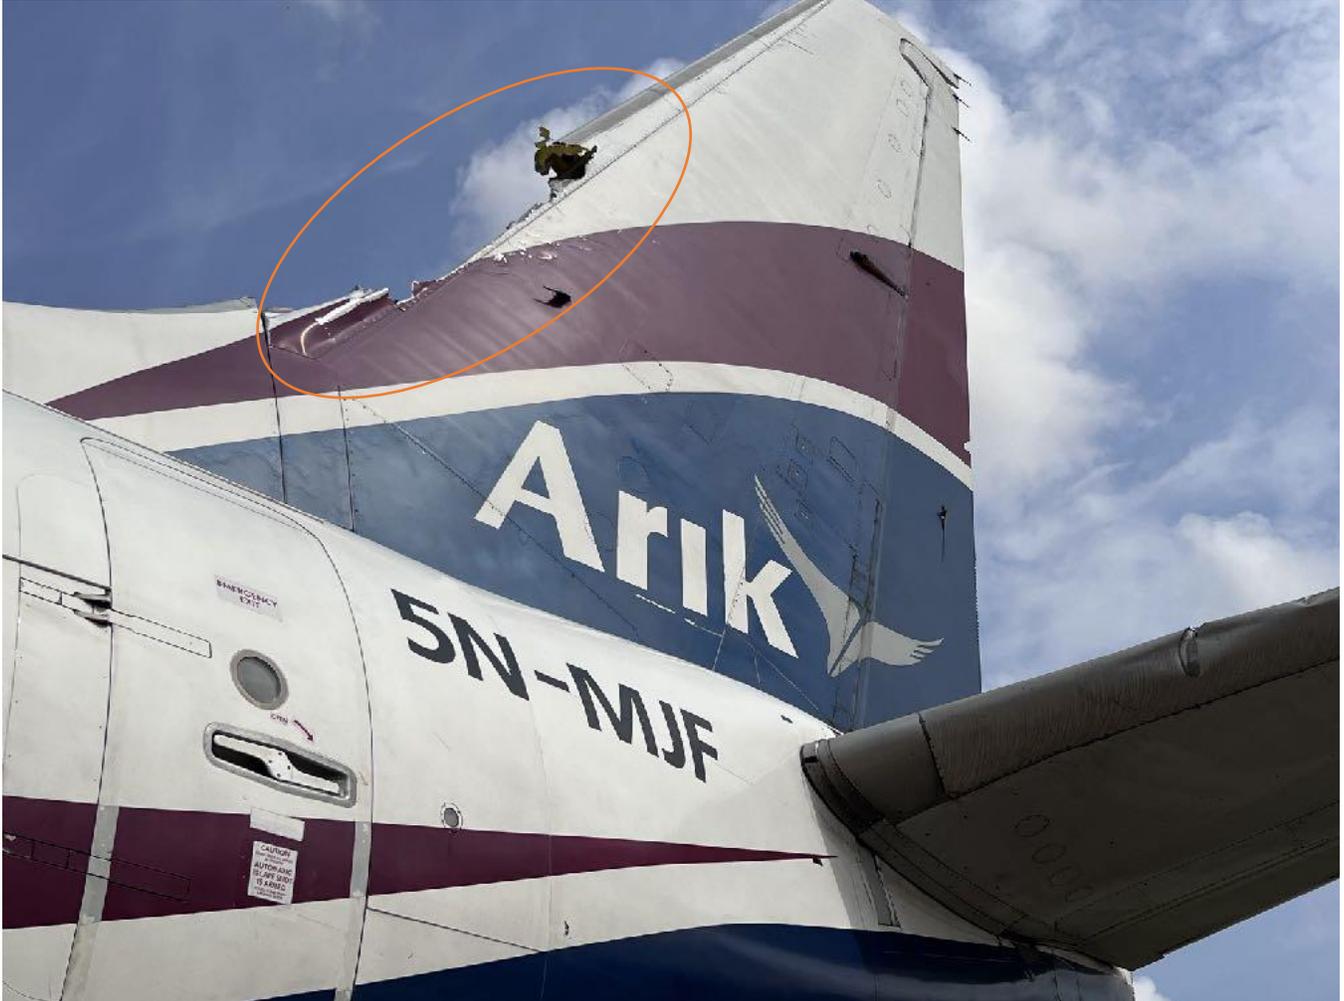
21. The upper surface of the horizontal stabilizer was damaged, with large cuts.
22. The vertical stabilizer leading edge was damaged.
23. There was visible damage on the rudder surface

**Figure 21:** Damaged vertical stabilizer leading edge

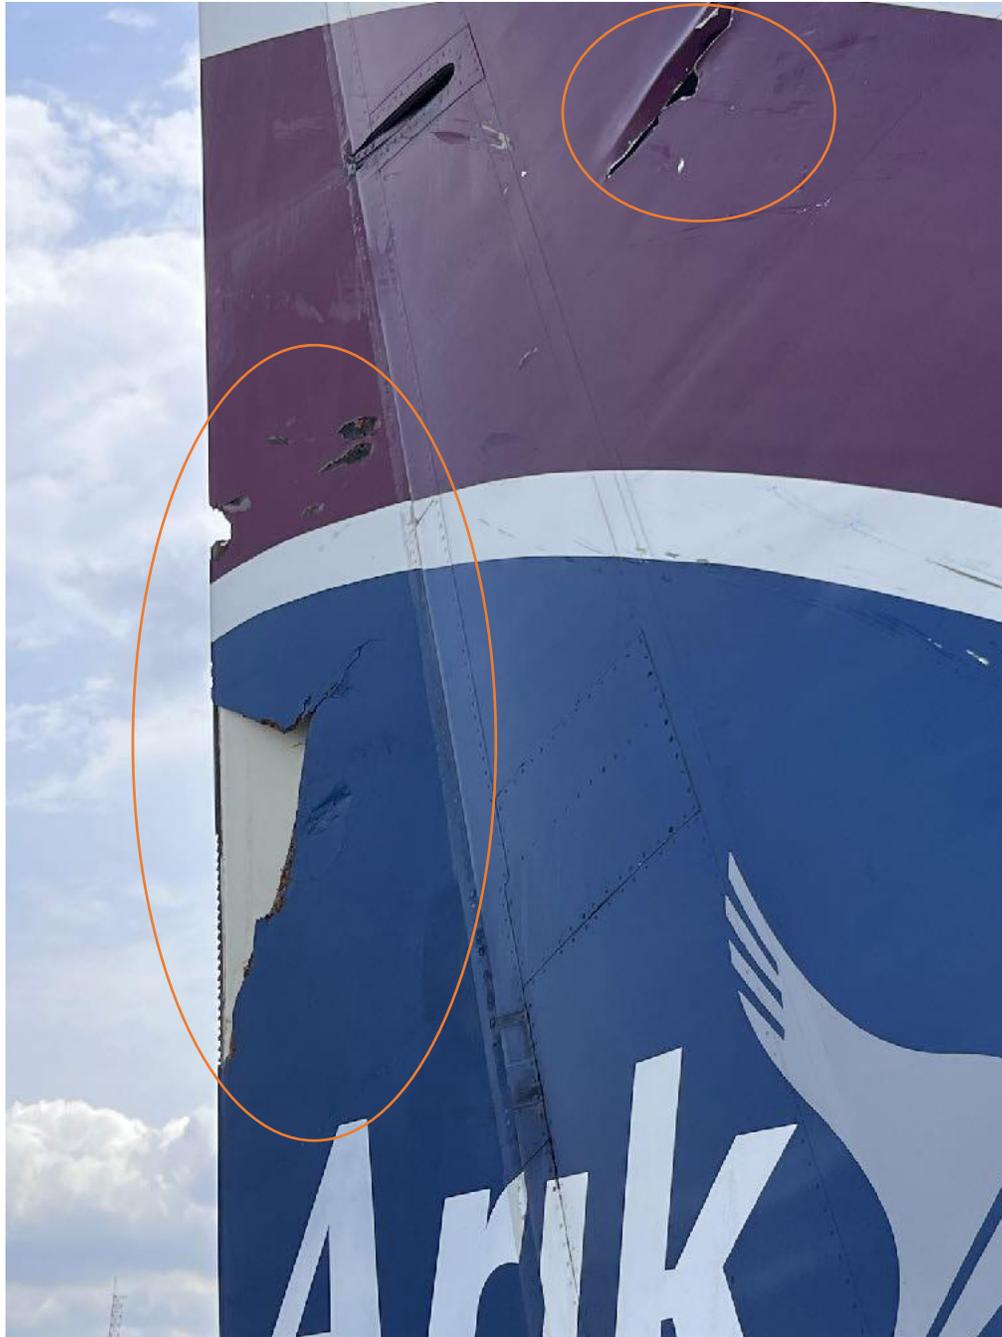
**Figure 22:** Damage to the rudder surface
