PRELIMINARY REPORT ON SERIOUS INCIDENT INVOLVING AN MD-82 AIRCRAFT OPERATED BY DANA AIRLINES LIMITED WITH NATIONALITY AND REGISTRATION MARKS 5N-BKI, WHICH OCCURRED ON RUNWAY 18L MURTALA MUHAMMED INTERNATIONAL AIRPORT, LAGOS ON 23 APRIL 2024

Registered operator:	Dana Airlines Limited
Aircraft type and model:	McDonnell Douglas MD-82
Manufacturer:	Boeing McDonnell Douglas
Year of manufacture:	1996
Nationality and registration marks:	5N-BKI
Serial number:	53542
Location:	Runway 18L, Murtala Muhammed International Airport, Lagos 6°34'32"N, 3°19'46"E
Date and time:	23 April 2024 at about 09:37:43 h. <i>(All times in this report are local time (UTC+1) unless otherwise stated)</i>

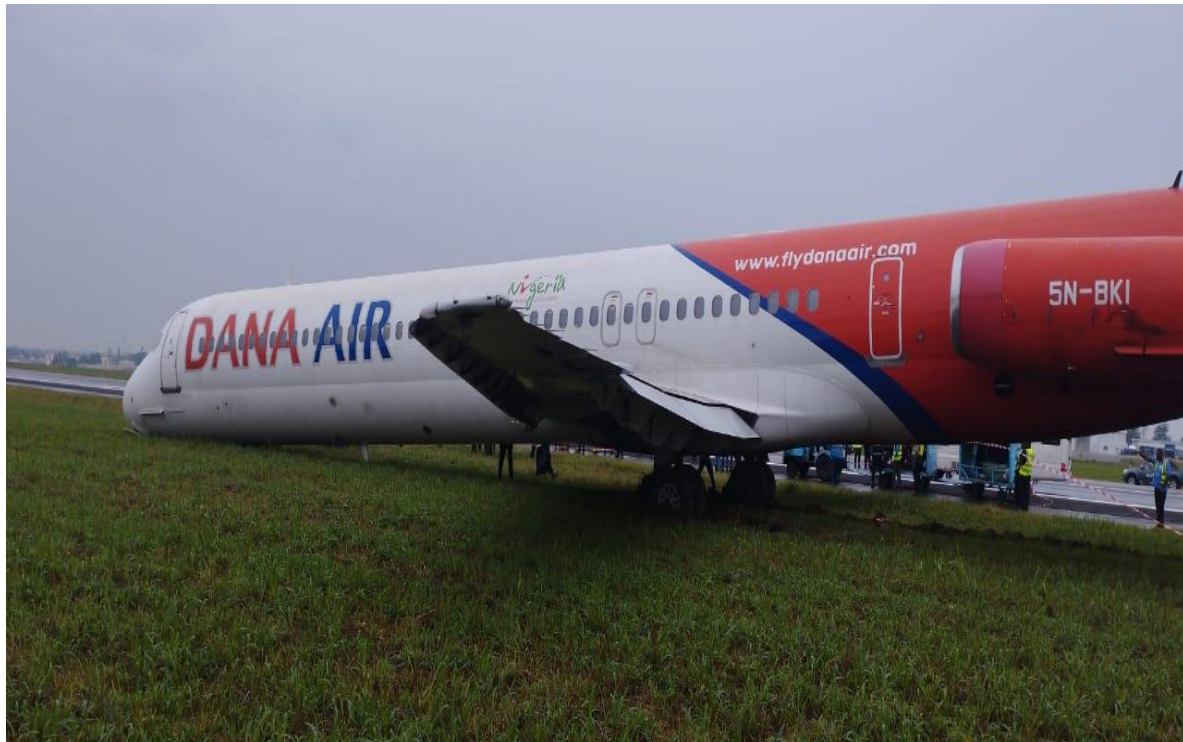
Figure 1: DAN0352 at its Final Stop Position

The crew stated that on reaching 80 knots during the Landing Roll, the Nose Landing Gear (NLG) collapsed, the aircraft lost directional control, veered off to the left of the runway centreline, and exited the runway at about 2,094 m from the threshold. It continued in the grass verge, crossed the paved Link 6, and came to a stop at about 2,343 m from the threshold of runway 18L, 36 m from the runway centreline.

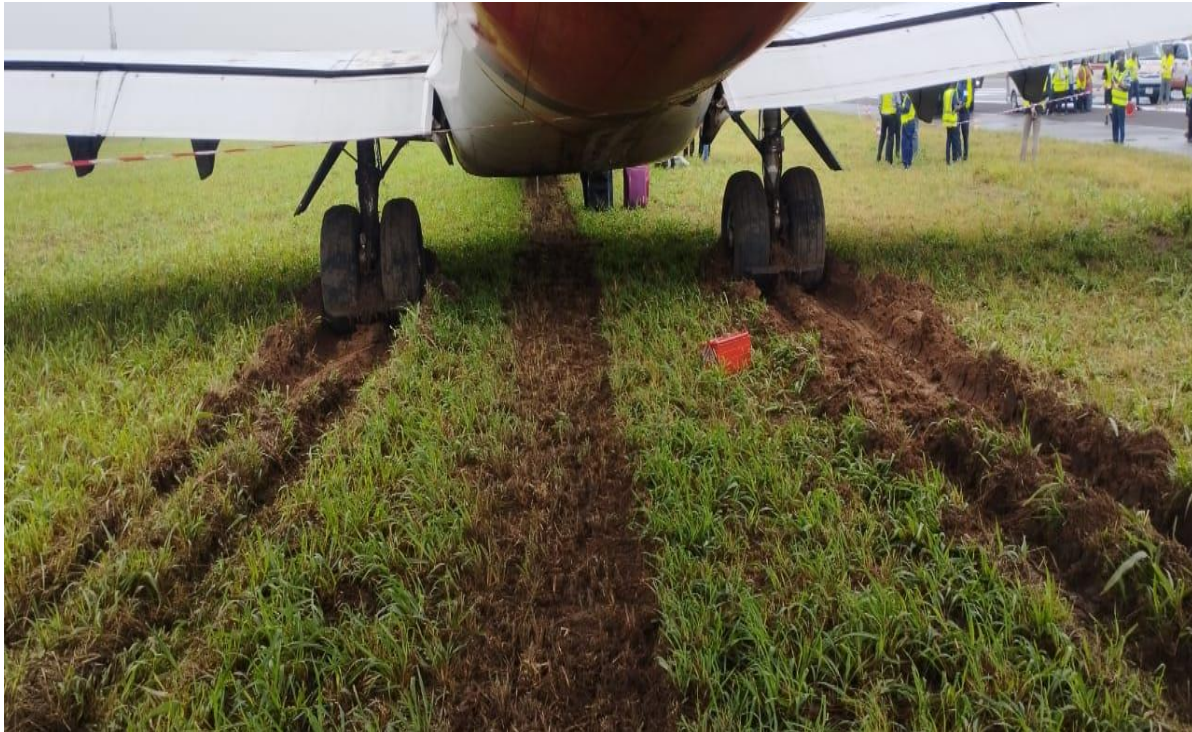
Figure 2: Track of Wheels on Grass Verge

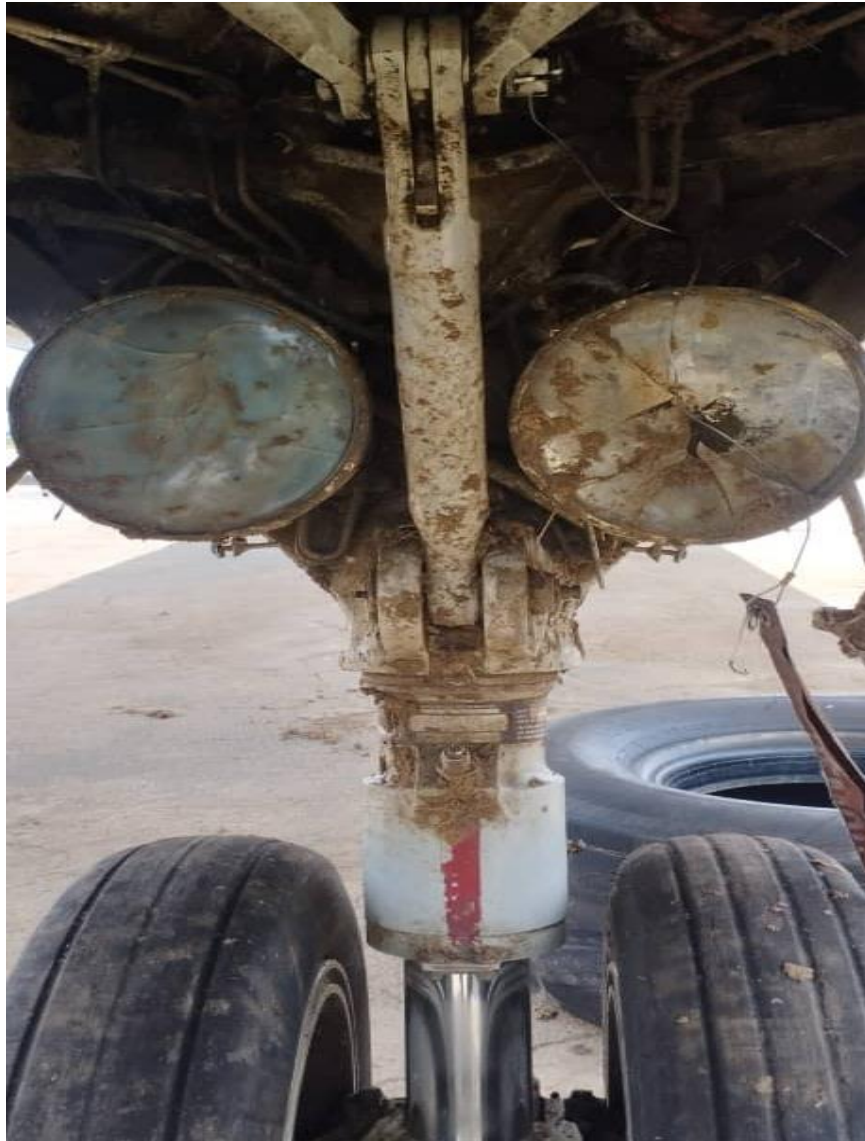
1. Distress to lower forward skin
2. The NLG lights were broken.
3. The Galley Drain was deformed.
4. An Antenna was broken.
5. The NLG Wheel Well Aft Door was damaged.

Figure 4: Damaged nose landing gear light
