Preliminary Report on an Accident involving A Sikorsky S76c+ Helicopter with nationality and registration marks 5N-BQG operated by East Wind Aviation Logistics Services Limited, which Occurred in the Atlantic Ocean Southeast of Eket, Bight of Bonny, Nigeria on 24 October 2024

Operator:	Eastwind Aviation Logistics Services Limited
Aircraft type and model:	Sikorsky S76C+
Manufacturer:	Sikorsky Aircraft Corporation
Year of manufacture:	1998
Nationality and registration marks:	5N-BQG
Serial number:	760486
Location:	Southeast of Eket, Bight of Bonny (04°13'37"N, 008°19'22"E)
Date and Time:	24 October 2024 at about 11:25 h

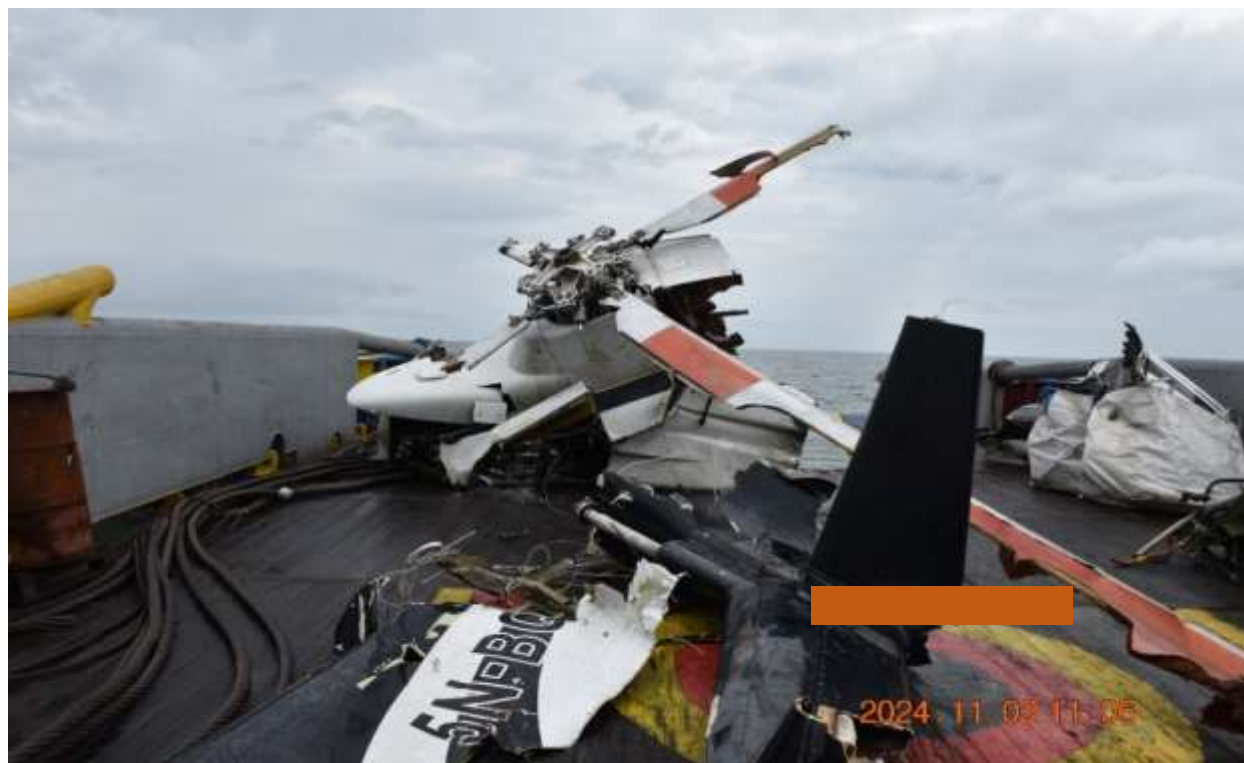
The helicopter was destroyed.

Figure 1: Helicopter wreckage after recovery from the ocean

The aircraft crashed into the Atlantic Ocean and disintegrated. The main wreckage was found at Coordinates 04°13'37" N 008°19'22" E at a depth of 42 m.

The occurrence was not survivable as the helicopter disintegrated upon impact with the water surface and its various parts scattered. The crash occurred in the ocean about 1.4 km from NNPC FPSO (Nuim Antan) at the Bight of Bonny Finima. Some life vests and three bodies were recovered from the crash area. Some of the bodies recovered had inflated life vests on them. Further perimeter search was carried out, and no additional
