Preliminary Report on an Accident involving A Sikorsky S76c+ Helicopter with nationality and registration marks 5N-BQG operated by East Wind Aviation Logistics Services Limited, which Occurred in the Atlantic Ocean Southeast of Eket, Bight of Bonny, Nigeria on 24 October 2024

Operator:	Eastwind Aviation Logistics Services Limited
Aircraft type and model:	Sikorsky S76C+
Manufacturer:	Sikorsky Aircraft Corporation
Year of manufacture:	1998
Nationality and registration marks:	5N-BQG
Serial number:	760486
Location:	Southeast of Eket, Bight of Bonny (04°13'37"N, 008°19'22"E)
Date and Time:	24 October 2024 at about 11:25 h <i>All times in this report are local time (UTC +1) unless otherwise stated</i>

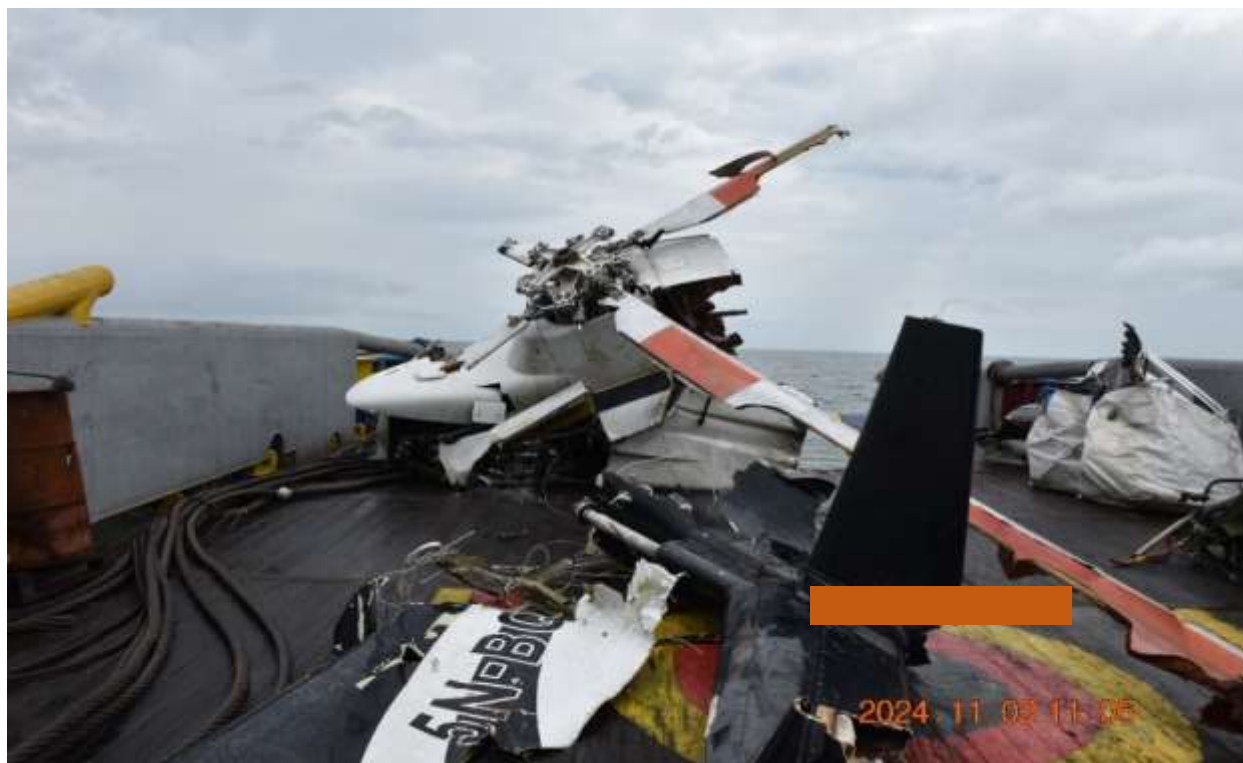
The helicopter was destroyed.

Figure 1: Helicopter wreckage after recovery from the ocean

The aircraft crashed into the Atlantic Ocean and disintegrated. The main wreckage was found at Coordinates 04°13'37" N 008°19'22" E at a depth of 42 m.

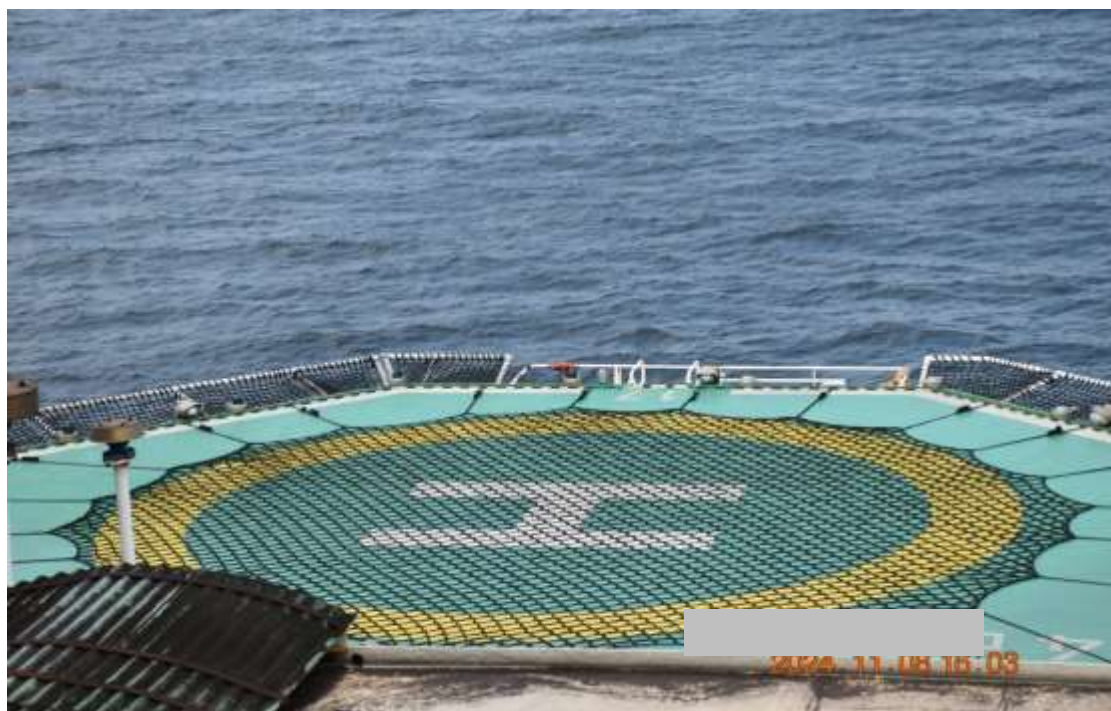
At 11:20:07 h, the PF and the PM briefly discussed whose landing it was going to be. The PM suggested that the PF land the aircraft due to the current wind direction of 045°/10kts, as the orientation of the helideck bearing is 220°.

Figure 2: FPSO NUIM ANTAN Helideck
