Preliminary Report on the Incident involving Hawker 900XP aircraft with nationality and registration marks 5N-KAL operated by Flybird Aircraft Management Services Limited, which occurred during climb out from Nnamdi Azikiwe International Airport (DNAA), Abuja, Nigeria to Kotoka International Airport (DGAA), Accra; Ghana on 6 December 2024

Operator:	Flybird Aircraft Management Services Limited
Aircraft type and model:	Hawker 900XP
Manufacturer:	Textron Aviation, USA
Year of manufacture:	2010
Nationality and registration marks:	5N-KAL
Serial number:	HA-158
Location:	FL 260 during climb out of Nnamdi Azikiwe International Airport (DNAA)
Date and time:	6 December 2024 at about 17:51 h (All times in this report are local time, equivalent to UTC+1 unless otherwise stated)

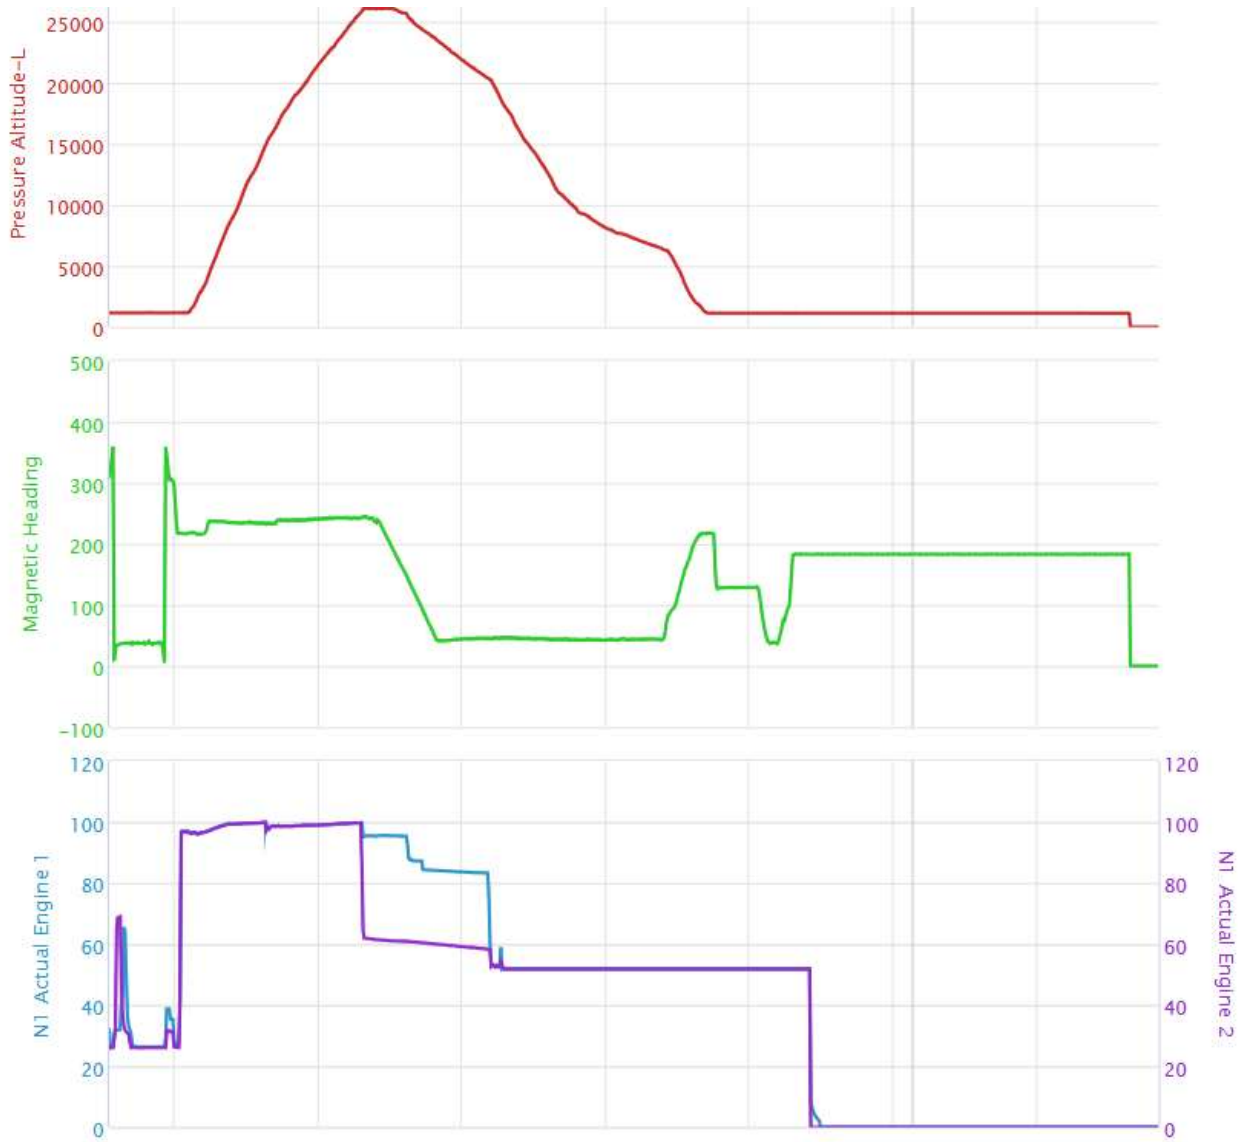
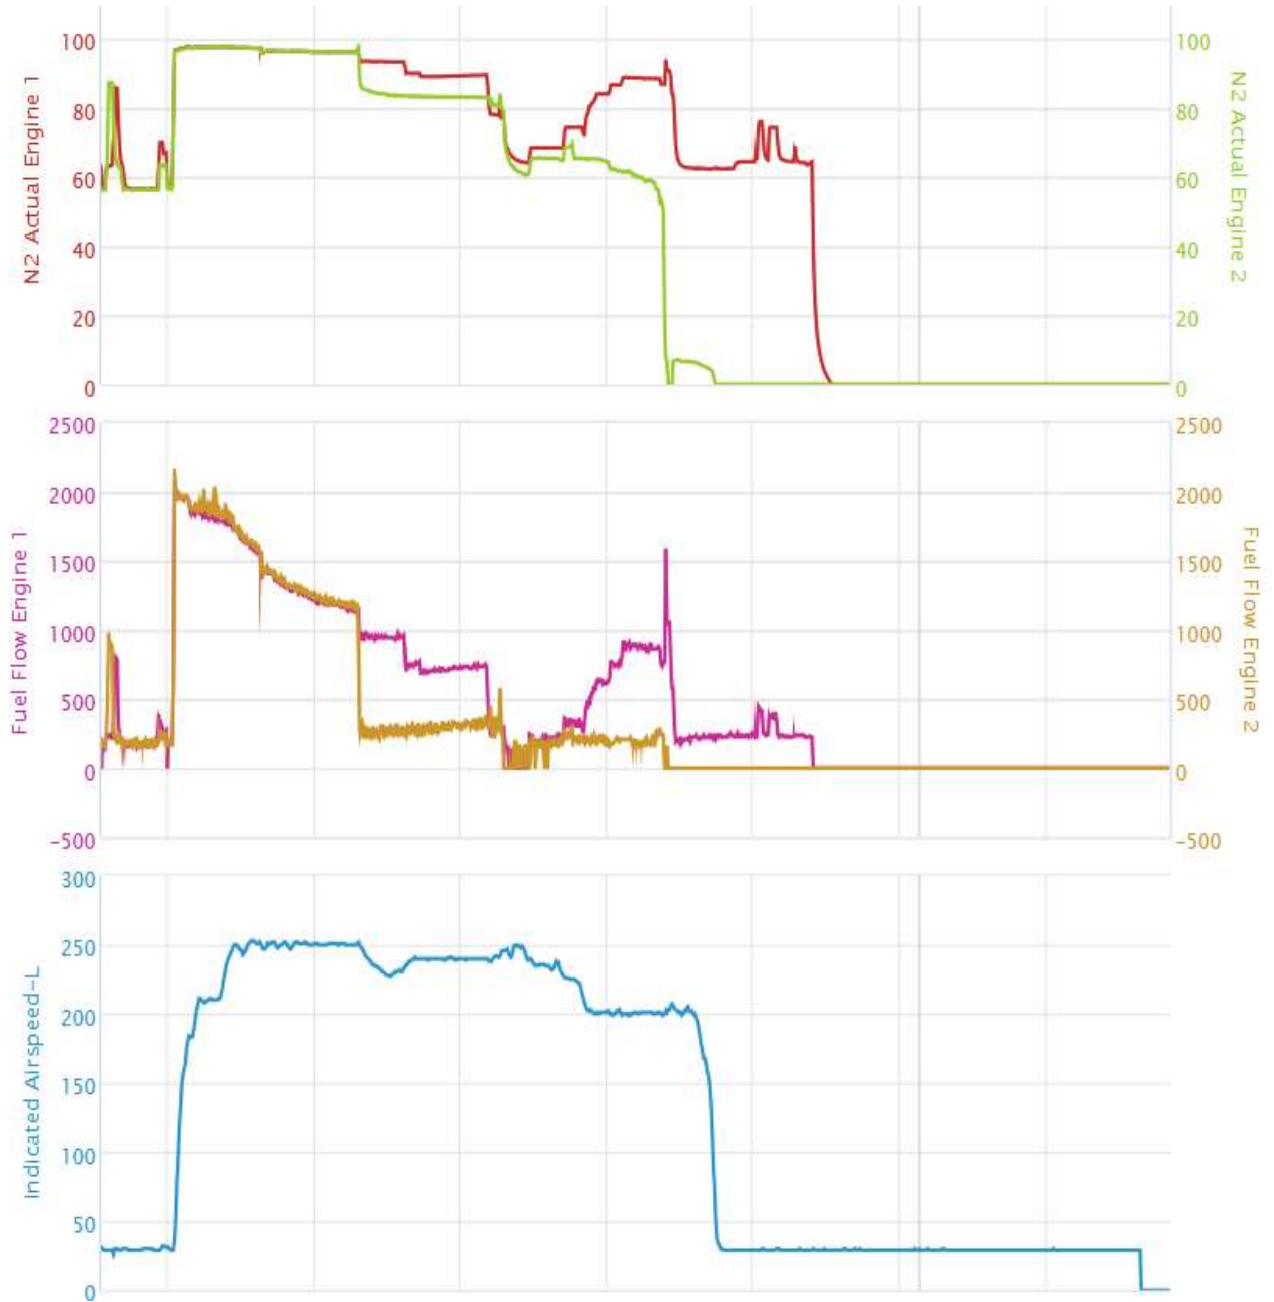
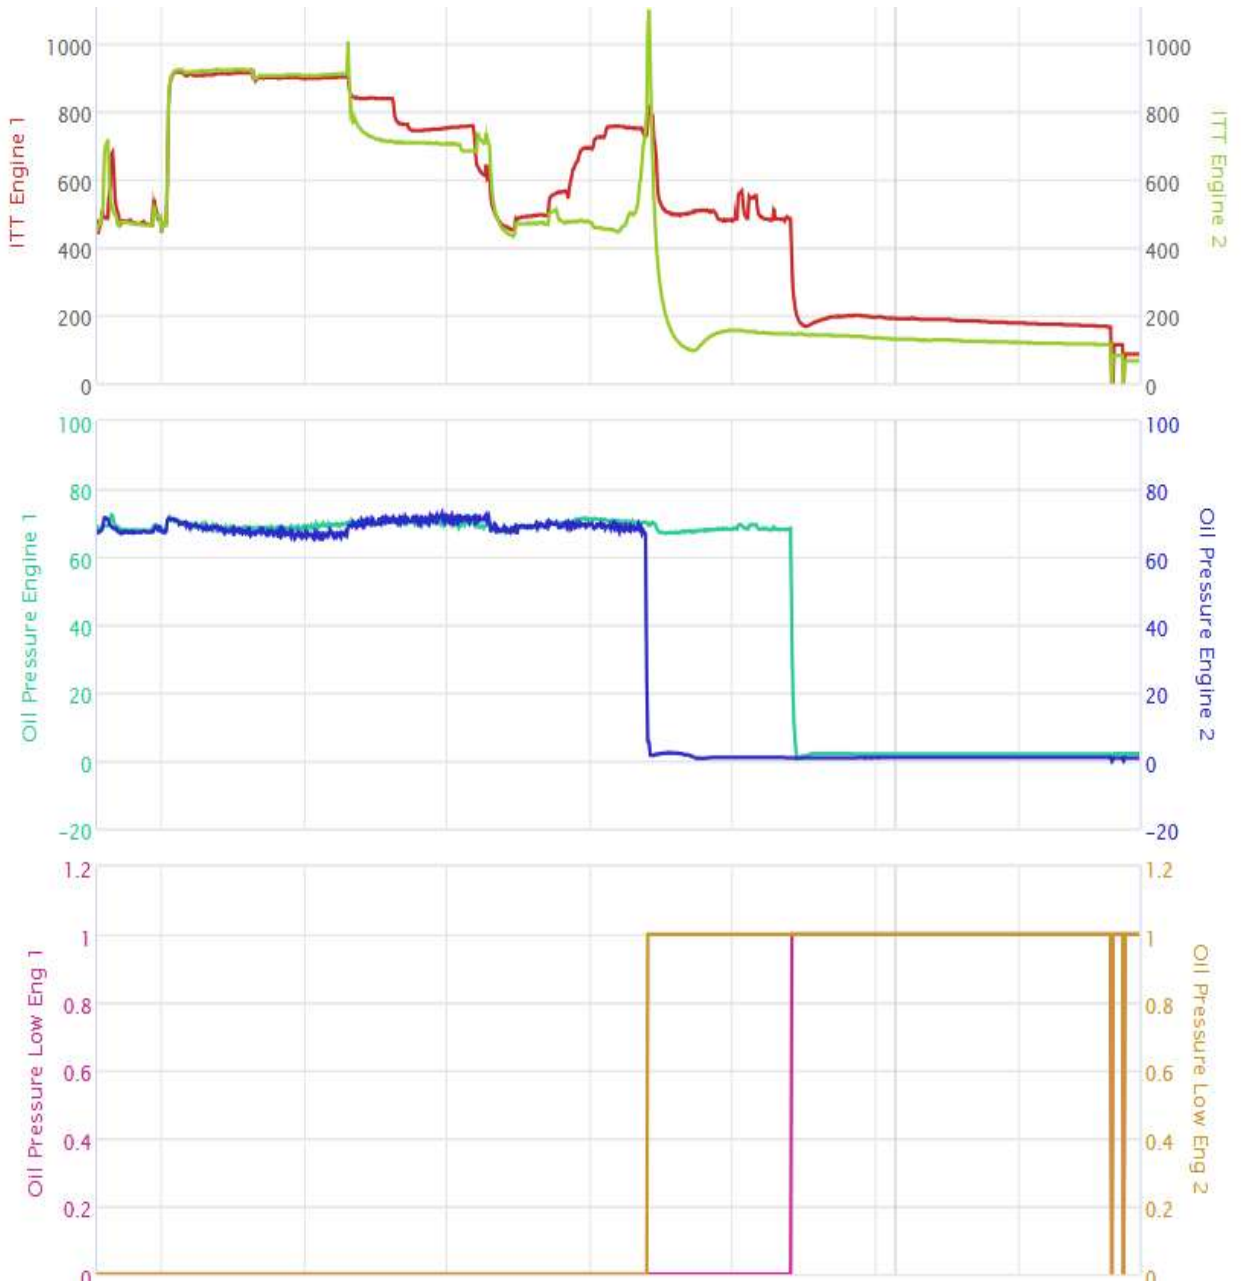
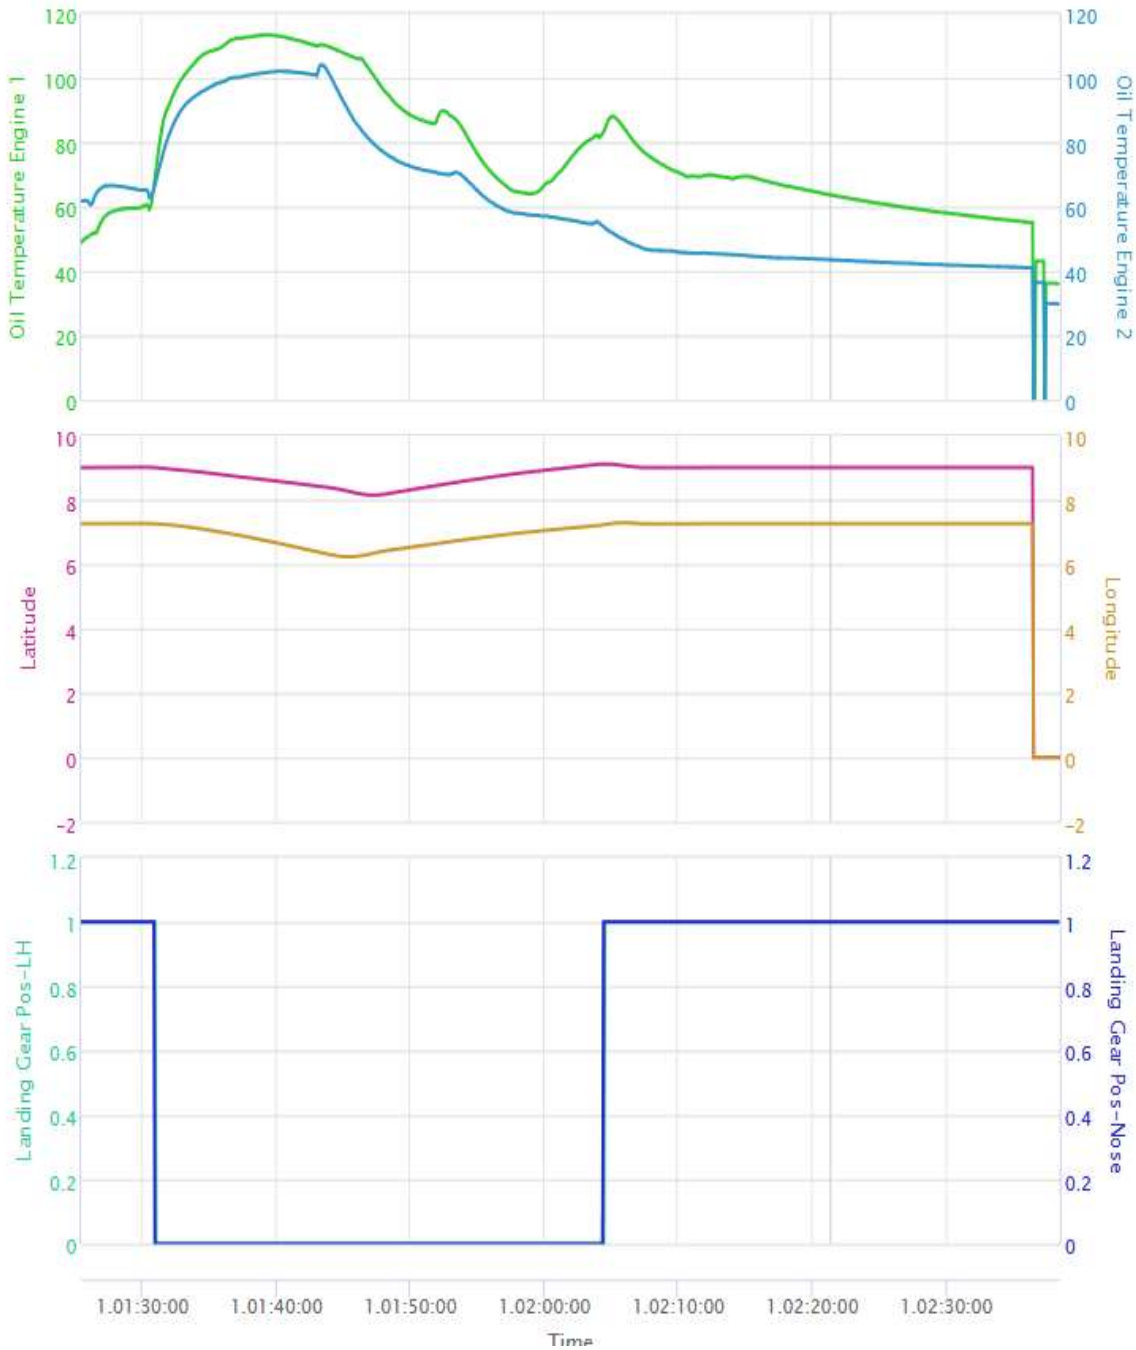
Figure 3: Flight and Engine parameters for the flight

From the parameters above, a spike in the Inter-Turbine Temperature (ITT) for Engine Number 2 could be observed around FL 260; ITT Engine 1 was 906°C, and ITT Engine 2 was 1014 °C.

A reduction in Engine Number 2 parameters N1 and Fuel Flow, from 99.68% and 1200 lb/h to 61.56% and 224 lb/h, respectively, immediately after the first ITT spike indicates a possible reduction in the TLA for the associated engine, as the associated parameters for Engine Number 1 remained at 95.43% and 944 lb/h even after the first spike for Engine Number 2.

Also, the ITT for Engine Number 2 spiked to 1098 °C from 910°C during descent to FL 065.

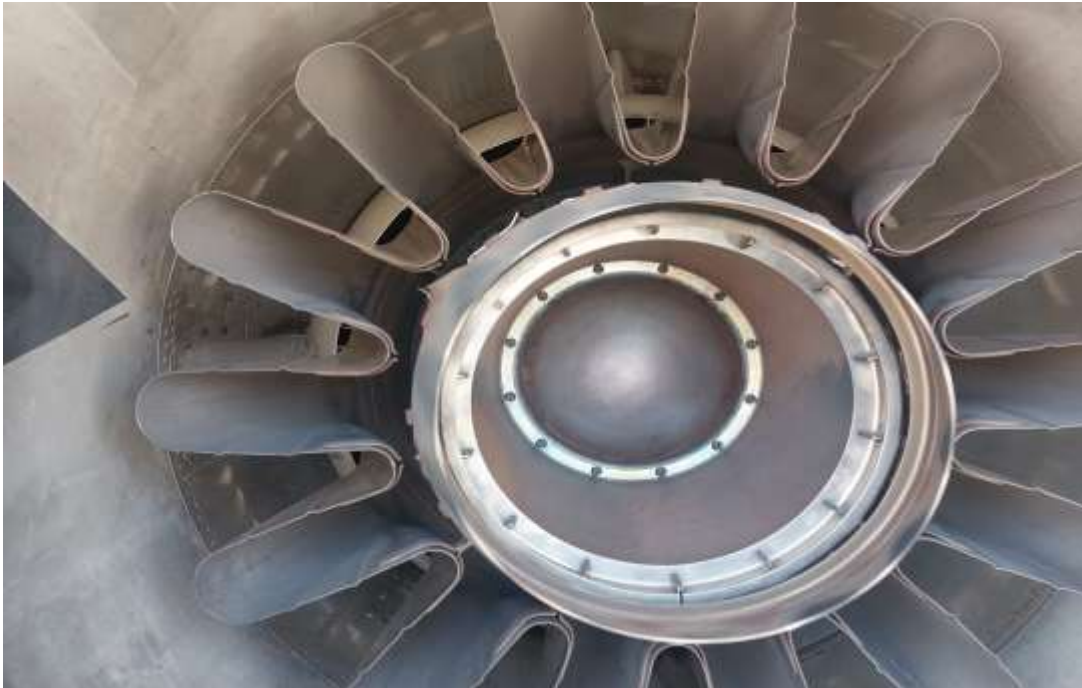
Figure 7: Exhaust section of Engine Number 2

Visual examination of Engine Number 2 revealed some damage around the exhaust, the extent of which is being determined by the investigation.

1. Conduct of detailed inspection of both engines to identify the fault(s) and the associated root causes of the failure and thrust anomaly.
2. Review the maintenance records of the engines.
