Preliminary report on an Accident involving a Boeing 737-400 Aircraft with nationality and registration marks 5N-MBD operated by Max Air Limited which occurred at Mallam Aminu Kano International Airport, Kano Nigeria on 28 January 2025

Registered owner:	Max Air Limited
Operator:	Max Air Limited
Aircraft type and model:	Boeing 737-400
Manufacturer:	The Boeing Company, USA
Year of manufacture:	1997
Nationality and registration marks:	5N-MBD
Serial number:	28704
Location:	Mallam Aminu Kano International Airport (DNKN), Kano runway 06.
Date and Time:	28 January, 2025 at about 22:49 h <i>(All times in this report are local time, equivalent to UTC+1 unless otherwise stated)</i>

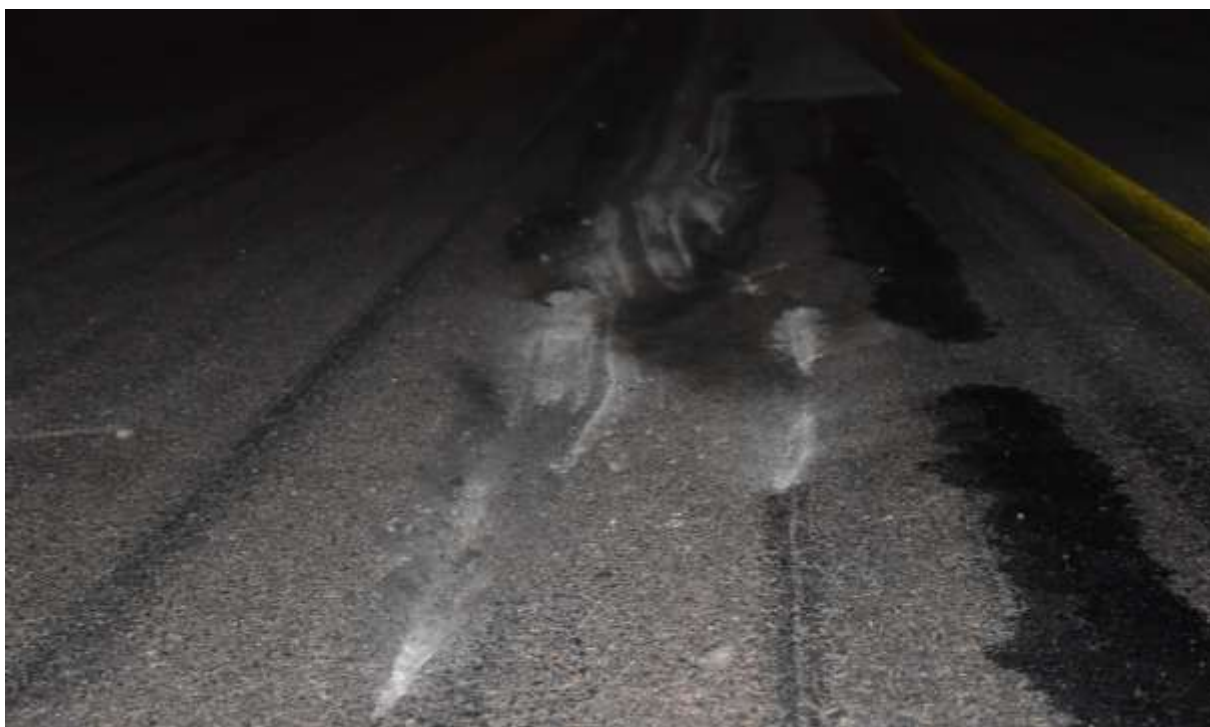
Figure 2: Scratch marks on the runway surface

10. Impact marks were observed on the runway at the point at which the nose landing gear collapsed.
11. The aircraft came to a stop at a distance of 2703 m from runway 06 threshold.

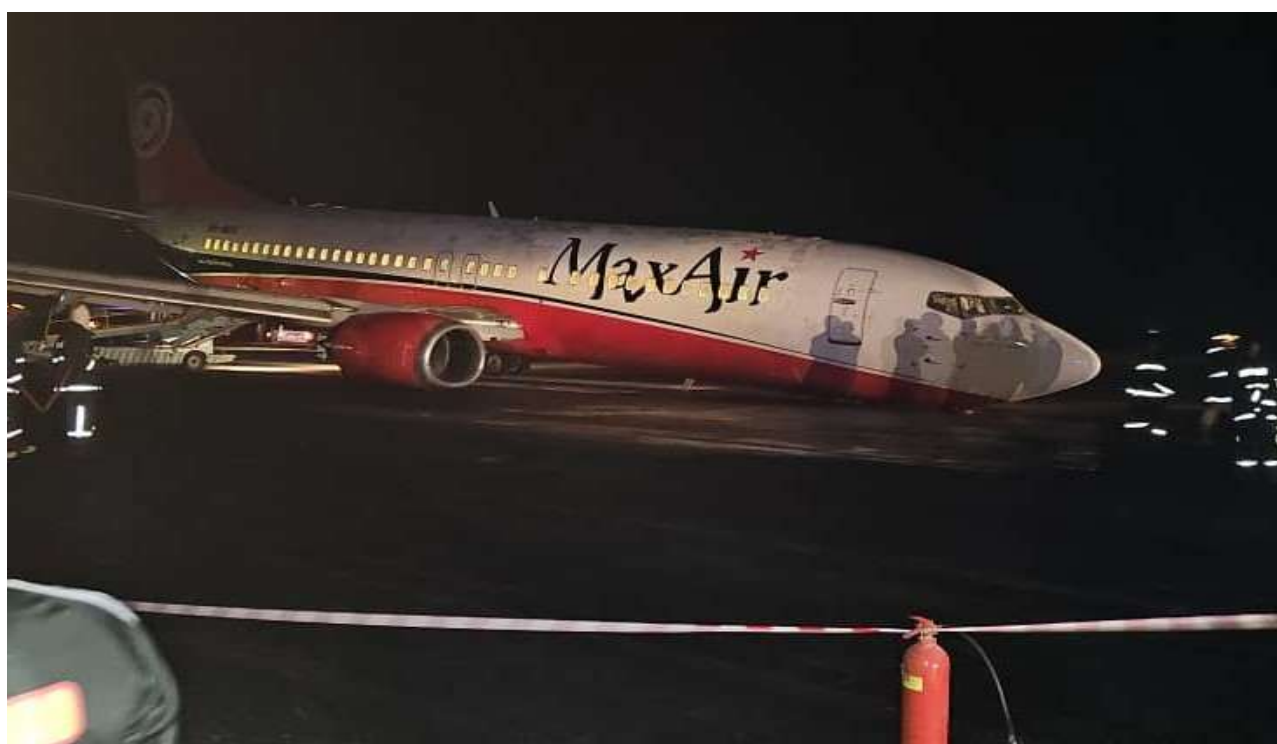
Figure 3: 5N-MBD post-occurrence on the runway.

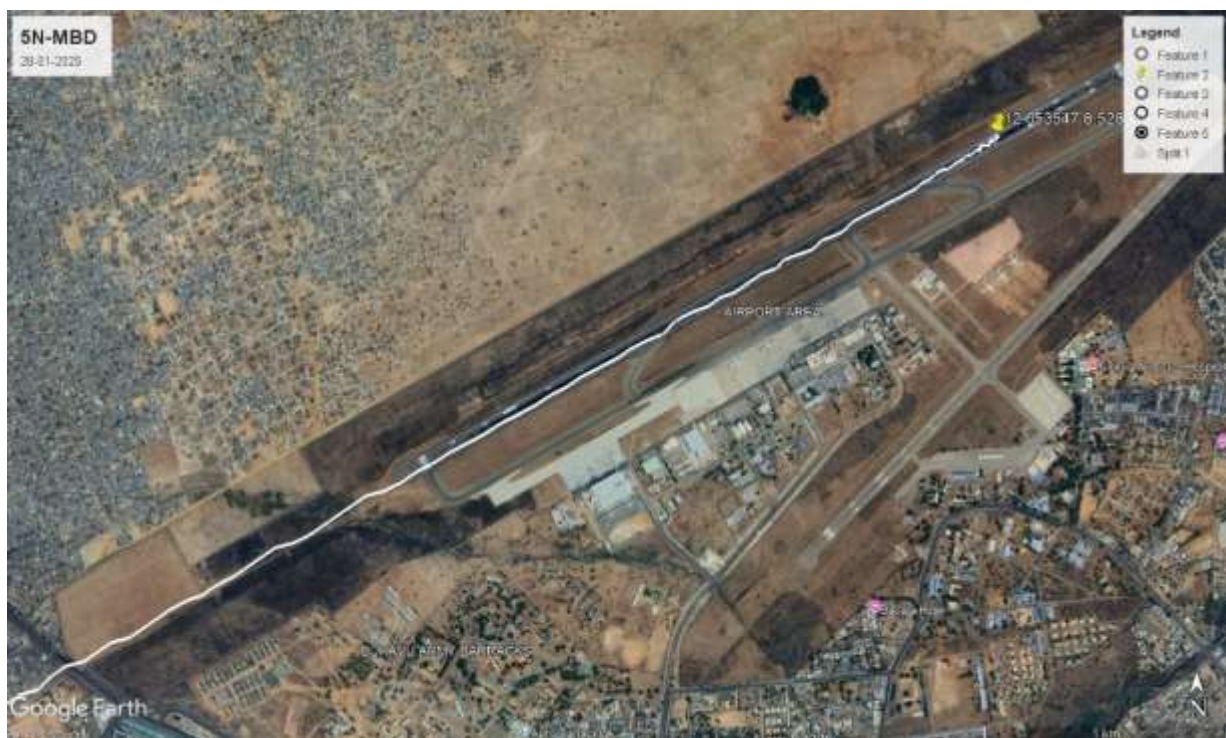
The aircraft landed right of runway 06 centerline, while on landing roll at a distance of about 2180 m from the runway threshold, the nose wheel gear collapsed. The aircraft continued for about 523 m in contact with the runway surface and came to a stop at about 2703 m from the runway threshold.

Figure 5: Aerial view showing distance travelled by the aircraft on the runway

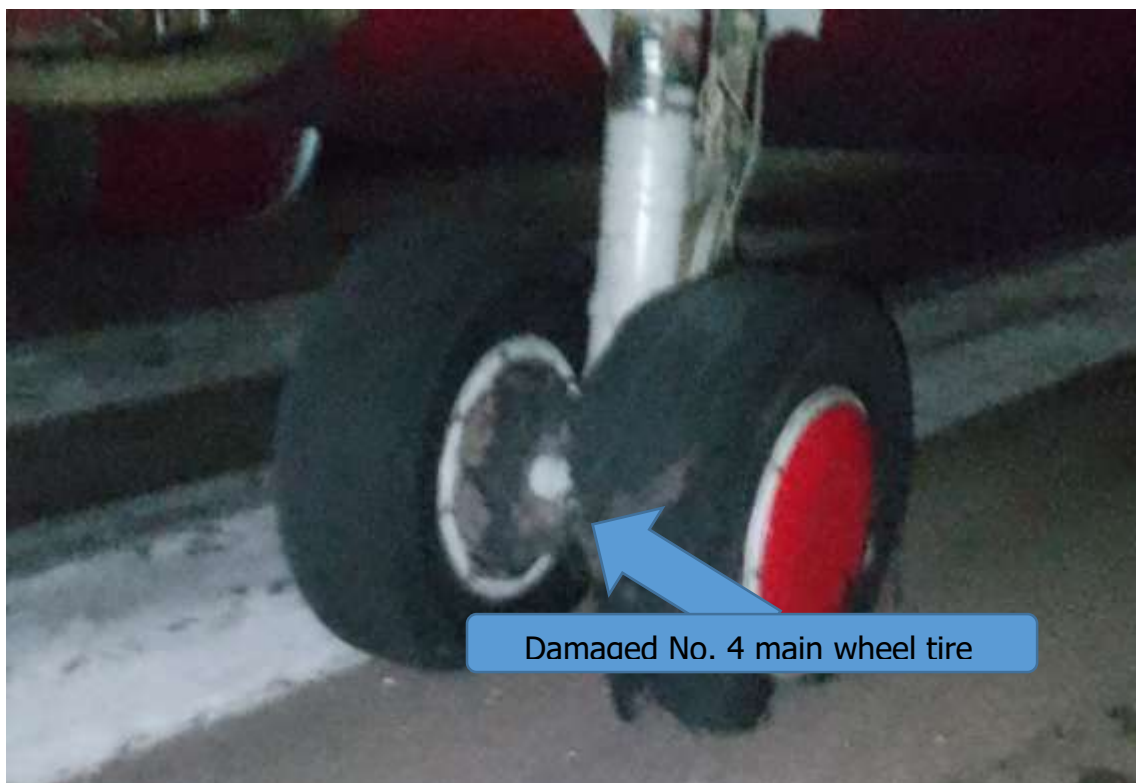
Figure 6: Damaged No. 4 main wheel tire

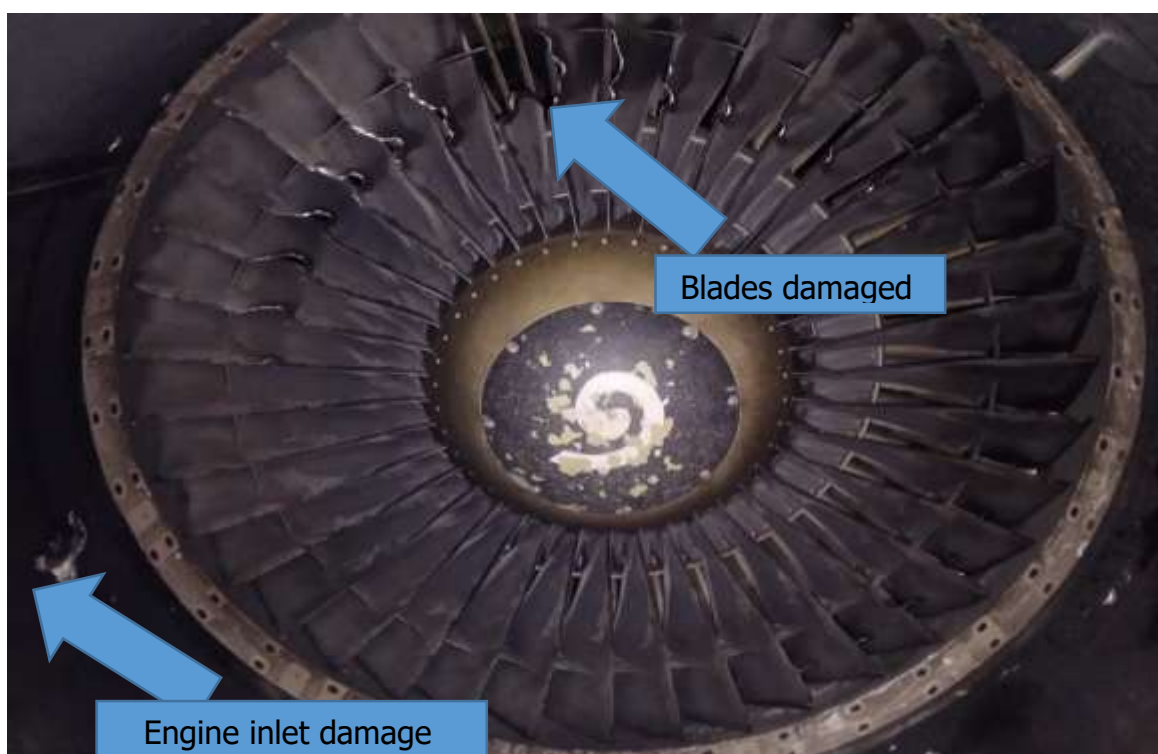
Figure 7: Engine No. 2 inlet and fan blades damage

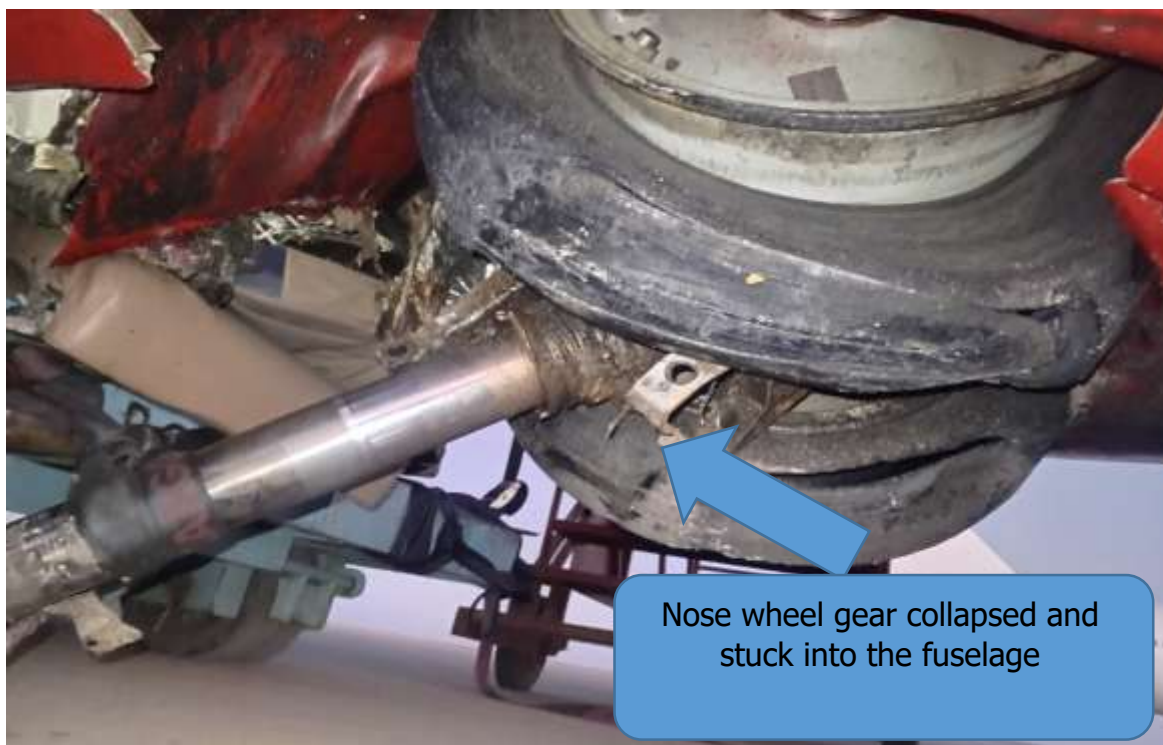
Figure 8: Nose wheel gear collapsed and stuck into the fuselage belly.

9. During the landing roll, the nose landing gear (NLG) collapsed rearward and became stuck under the belly of the fuselage, approximately 2180 m from the runway threshold.

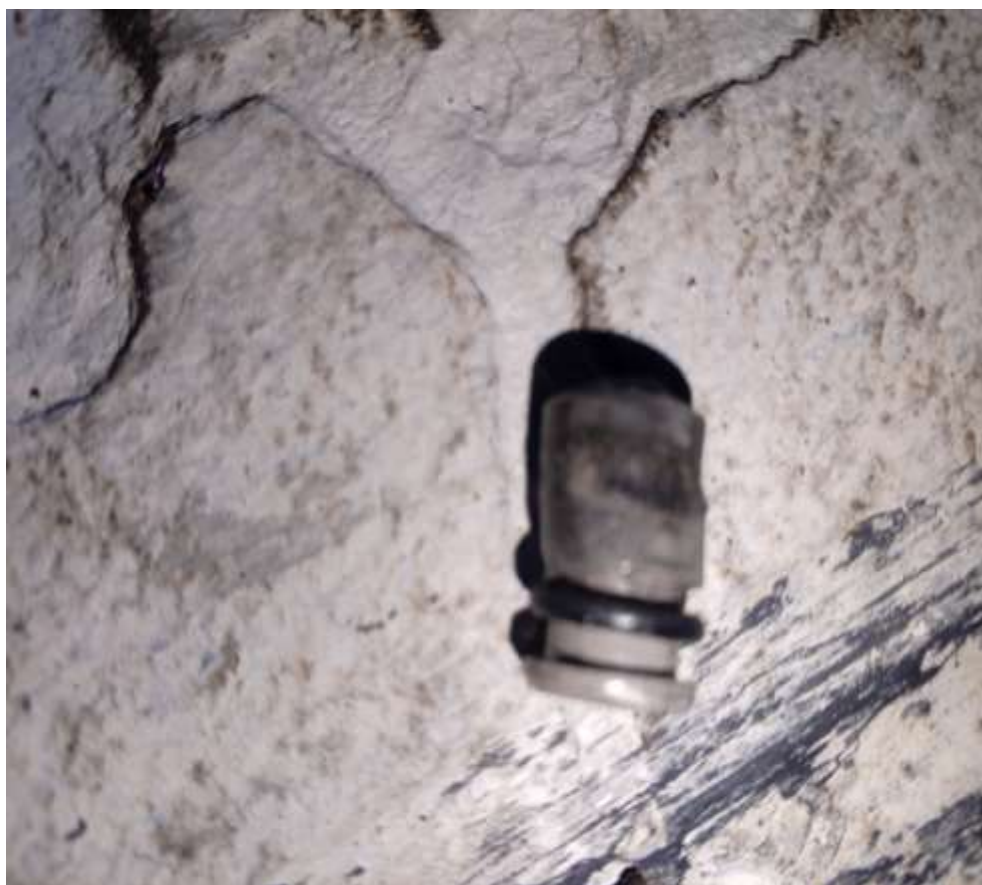
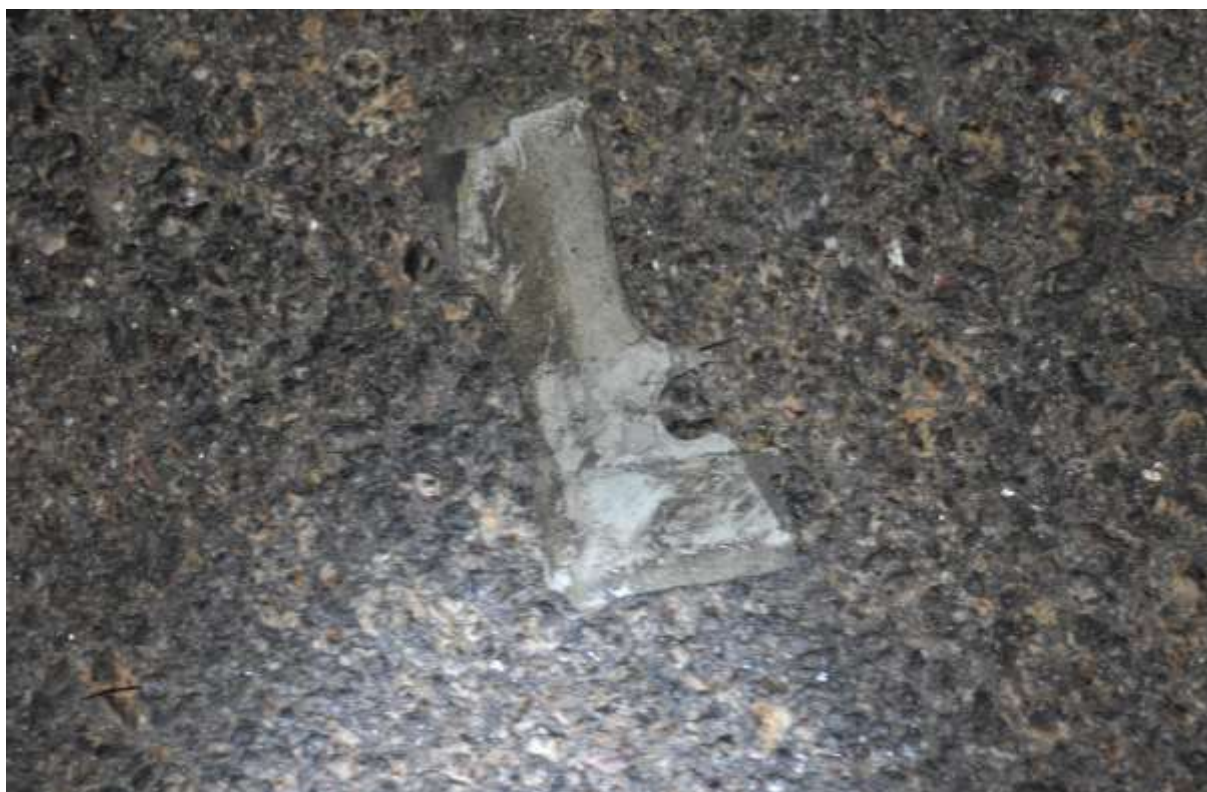
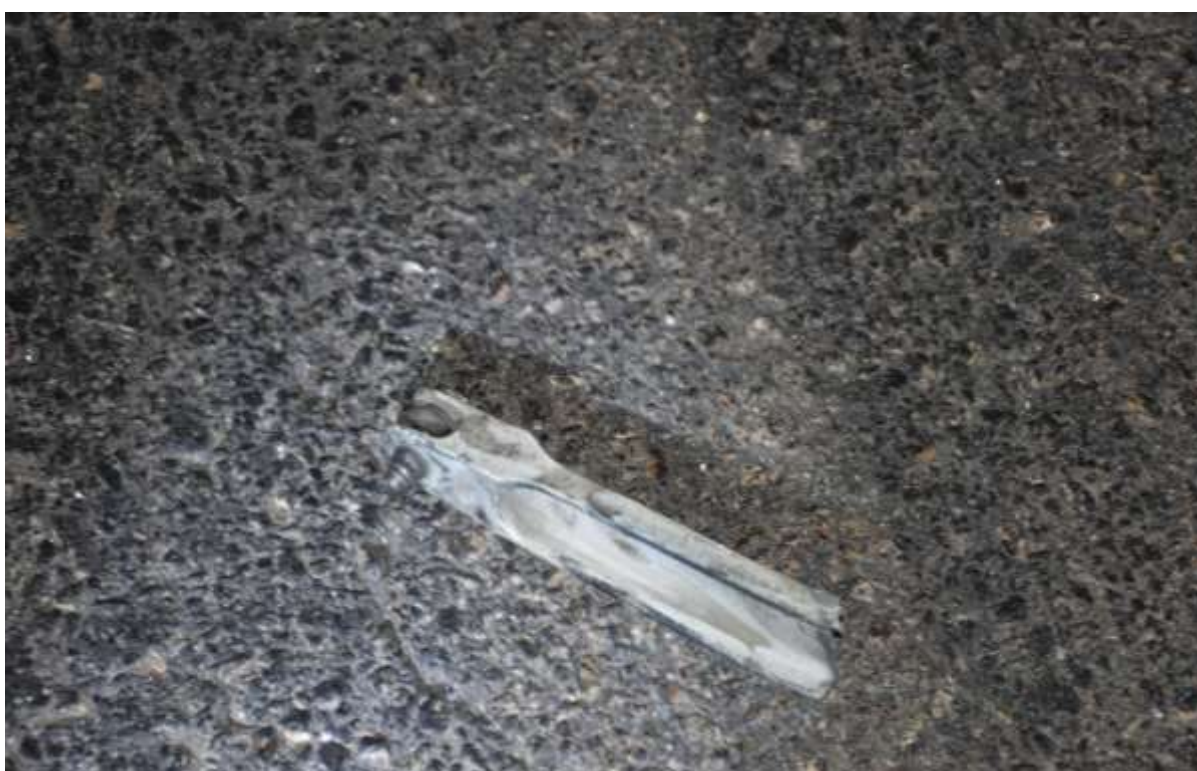
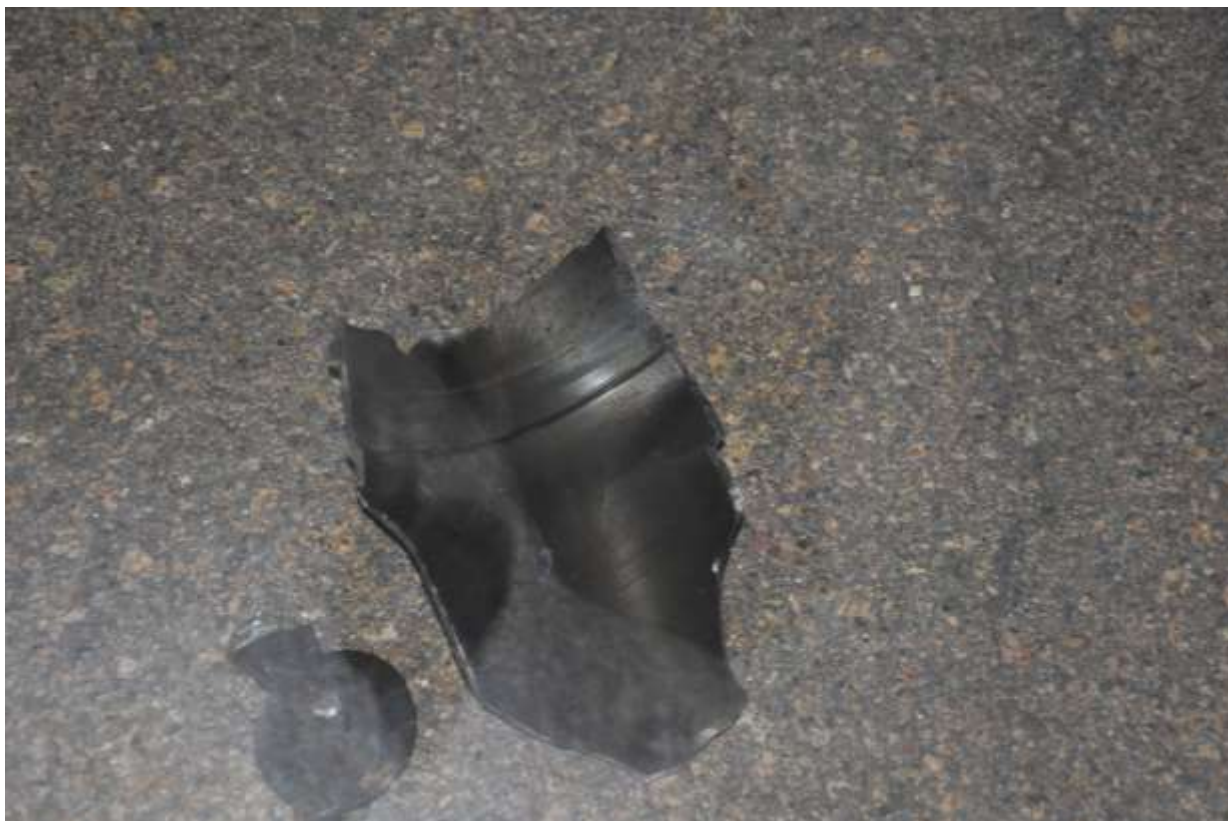
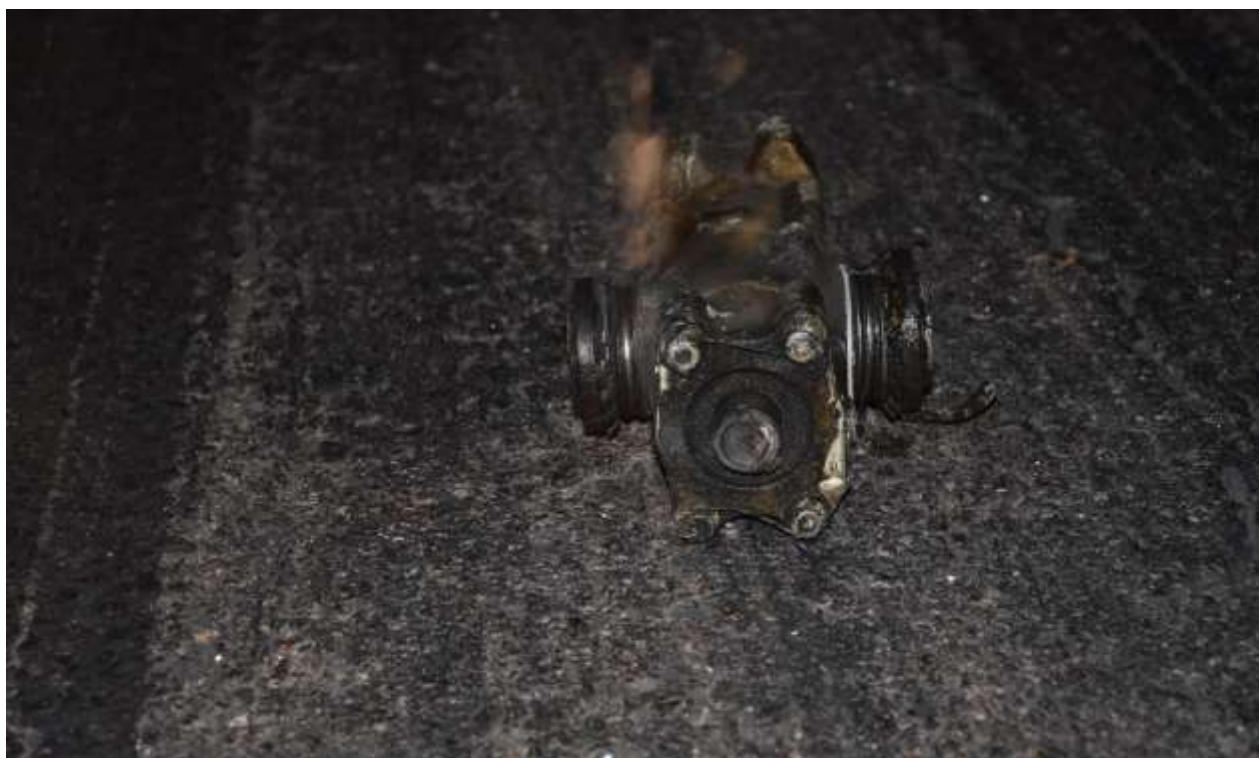
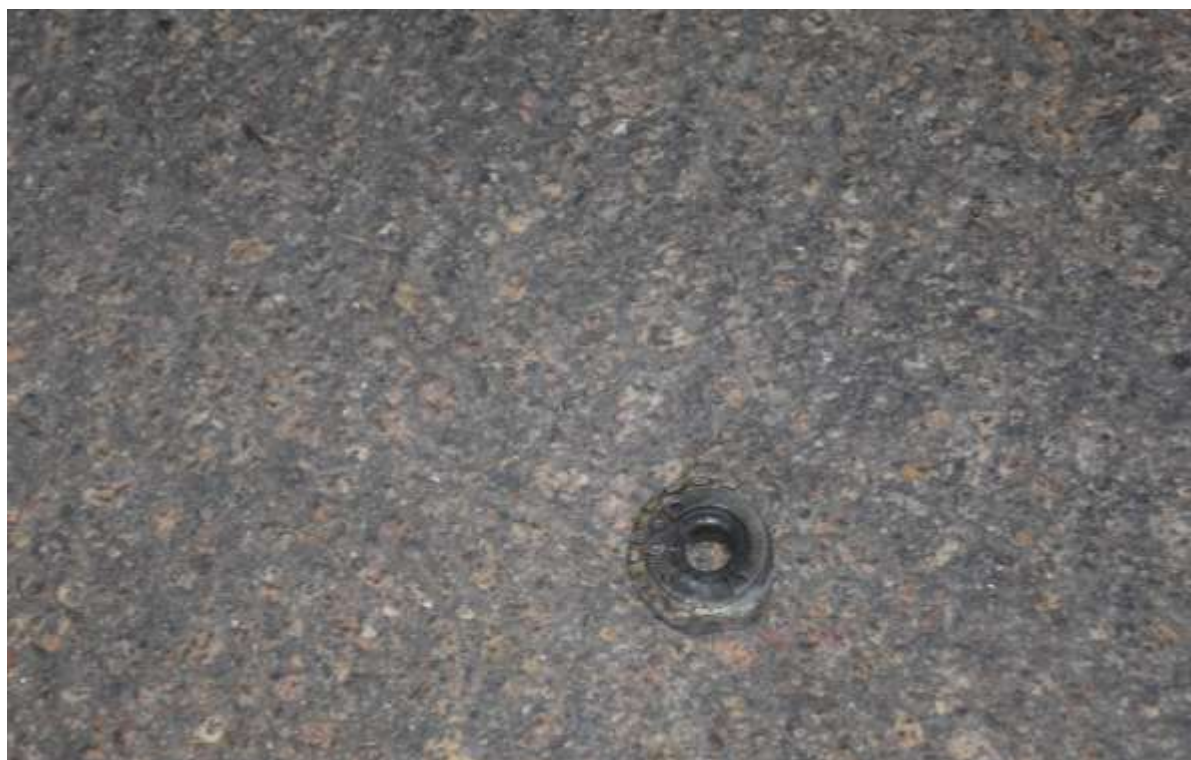
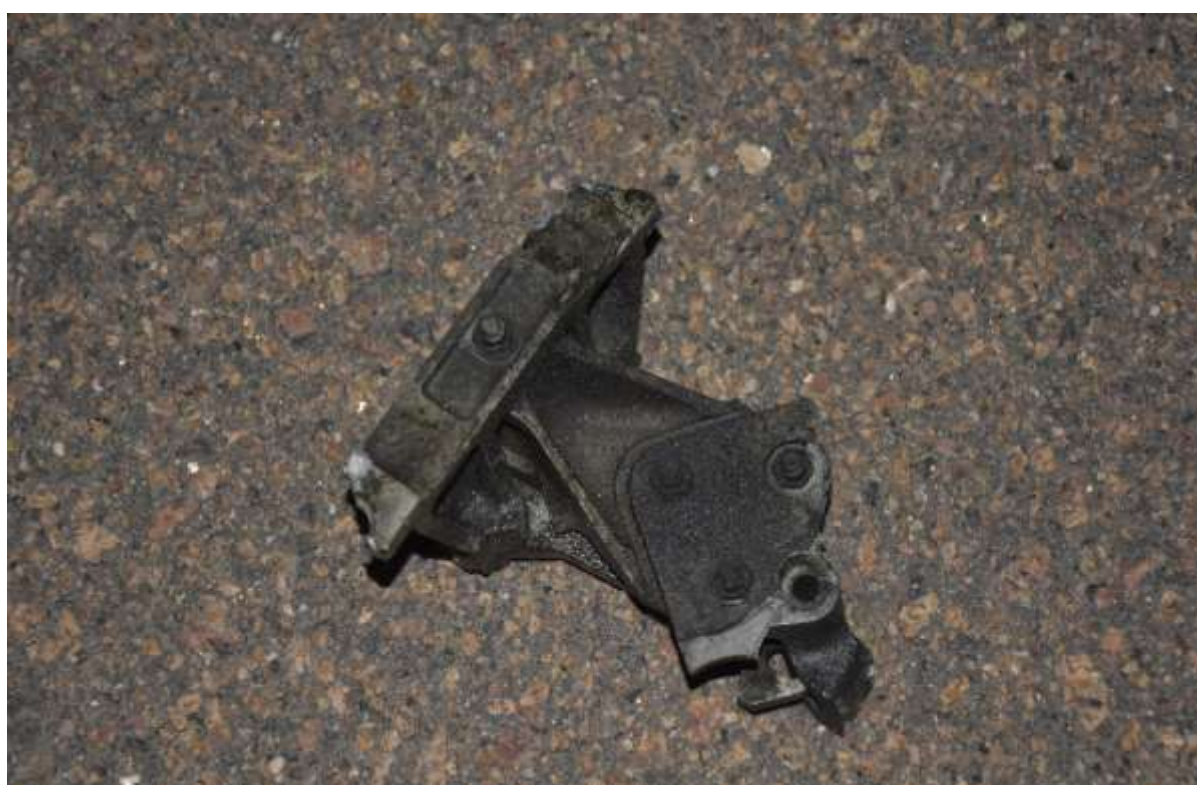
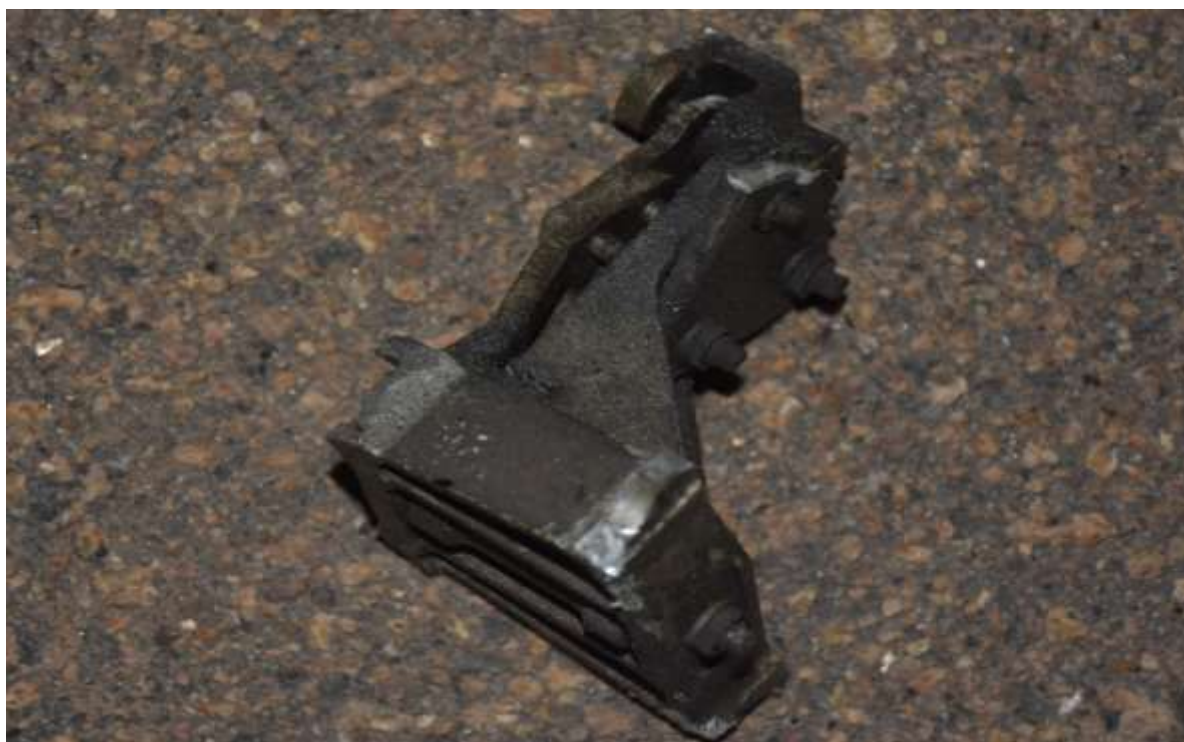
Figure 9: Debris of the damaged nose landing gear

15. The rear left service door was used for the disembarkation
16. All aircraft occupants disembarked unhurt.
17. The accident occurred at night.
18. Debris from the nose landing gear and tyres was observed along the wreckage trail.

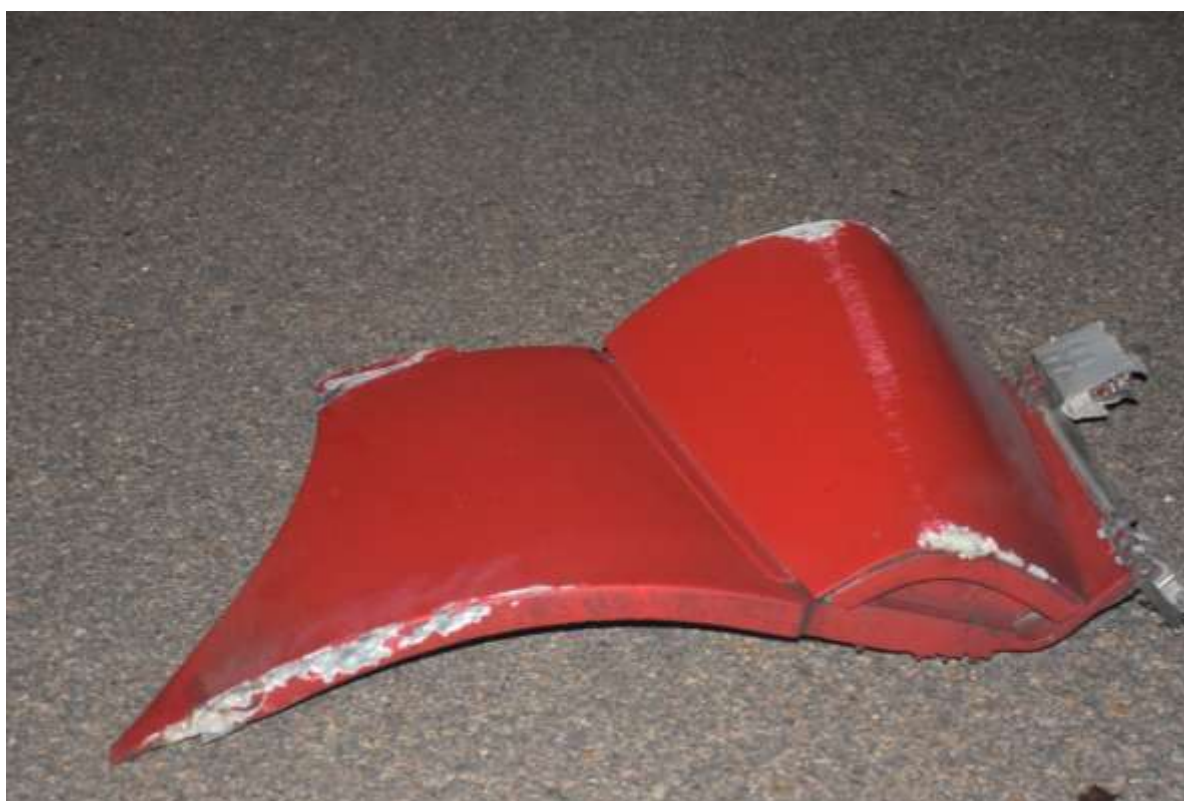
Figure 17: No.2 Main wheel well door

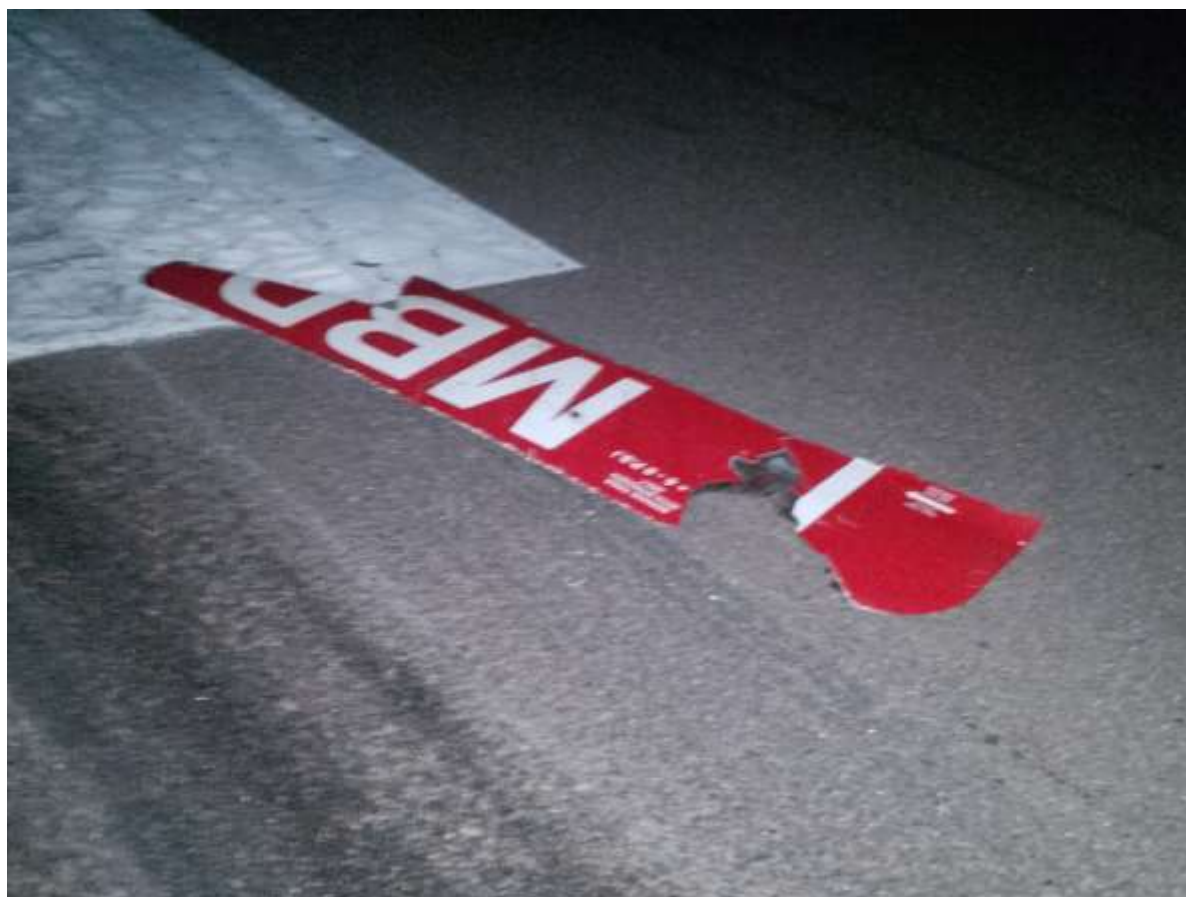
Figure 18: Nose wheel well door.
