Preliminary Report on accident involving a Boeing 737-400 aircraft with nationality and registration marks 5N-MBD operated by Max Air Limited, which occurred at Mallam Aminu Kano International Airport (DNKN), Kano Nigeria on 28 January 2025.

Operator:	Max Air Limited
Aircraft type and model:	Boeing 737-400
Manufacturer:	The Boeing Company, USA
Year of manufacture:	1997
Nationality and registration marks:	5N-MBD
Serial number:	28704
Location:	Runway 06, Mallam Aminu Kano International Airport (DNKN), Kano
Date and Time:	28 January 2025 at 22:49 h <i>(All times in this report are local time, equivalent to UTC+1 unless otherwise stated)</i>

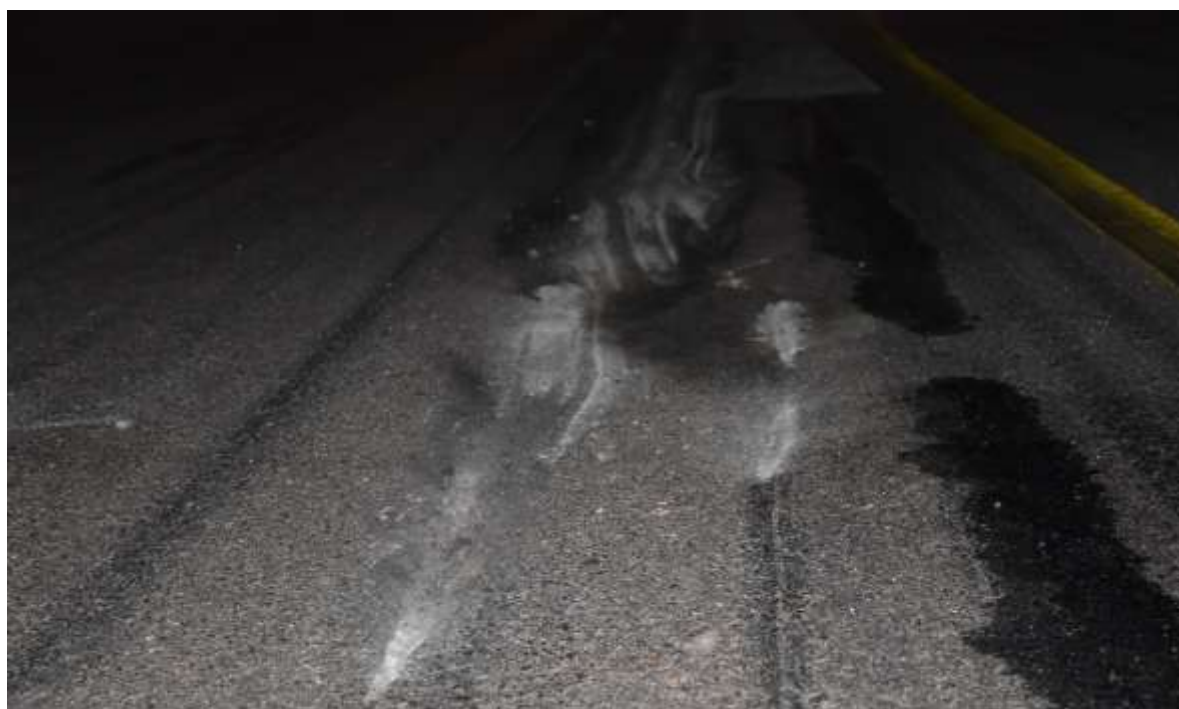
The scratch mark on the runway was 1.28 m wide and 2.04 m long.

Figure 2: Scratch marks on the runway surface

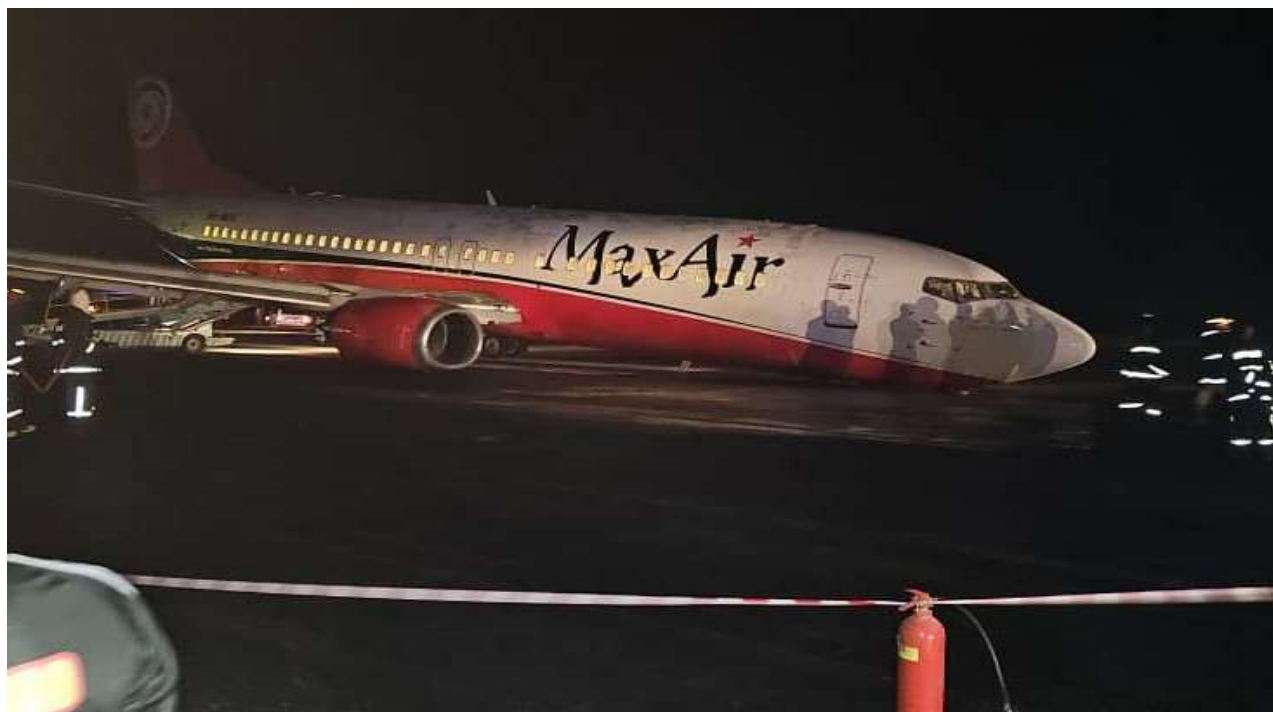
Figure 3: 5N-MBD post-occurrence on the runway at DNKN.

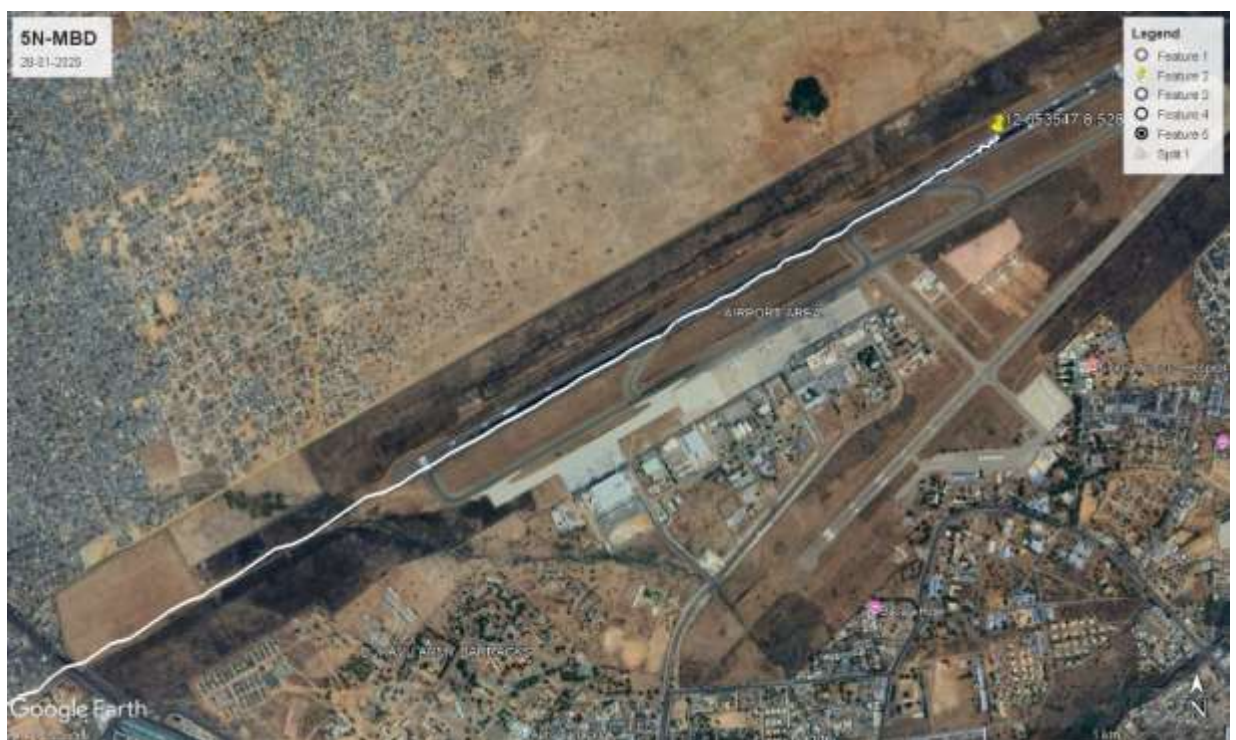
The aircraft landed right of runway 06 centerline, while on landing roll at a distance of about 2180 m from the runway threshold, the nose wheel gear collapsed. The aircraft continued for about 523 m in contact with the runway surface and came to a stop at about 2703 m from the runway threshold.

Figure 5: Aerial view showing distance travelled by the aircraft on the runway

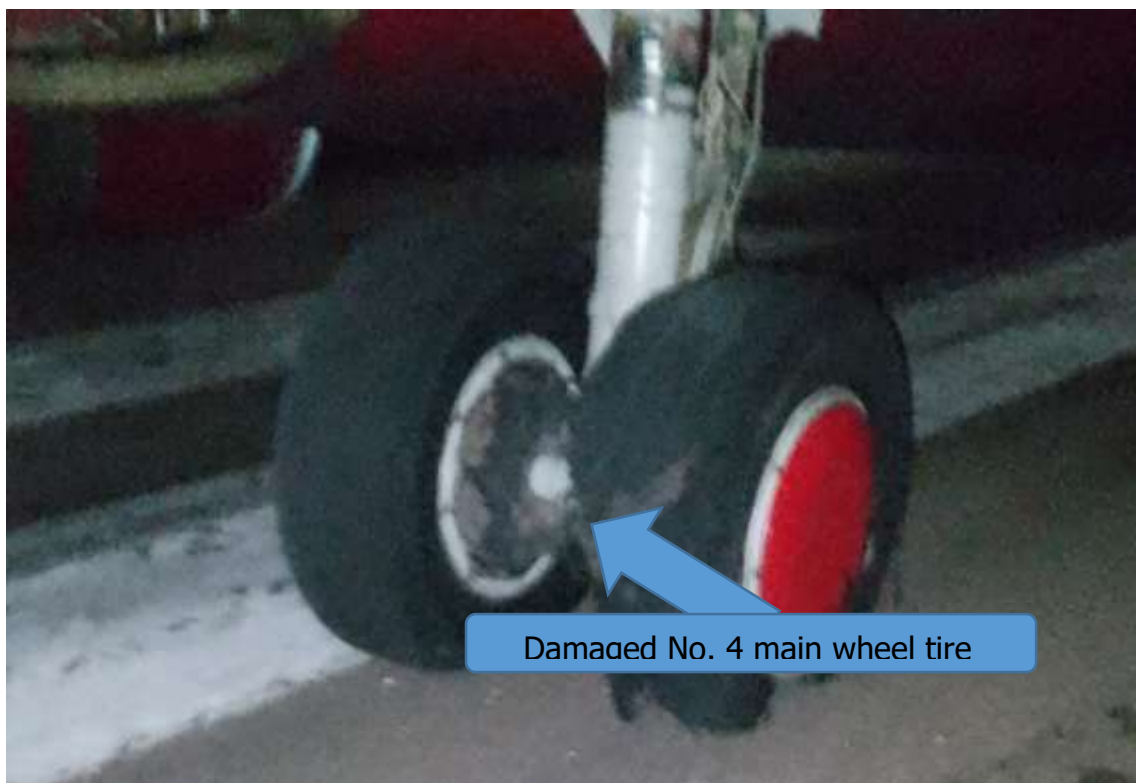
Figure 6: Damaged No. 4 main wheel tire

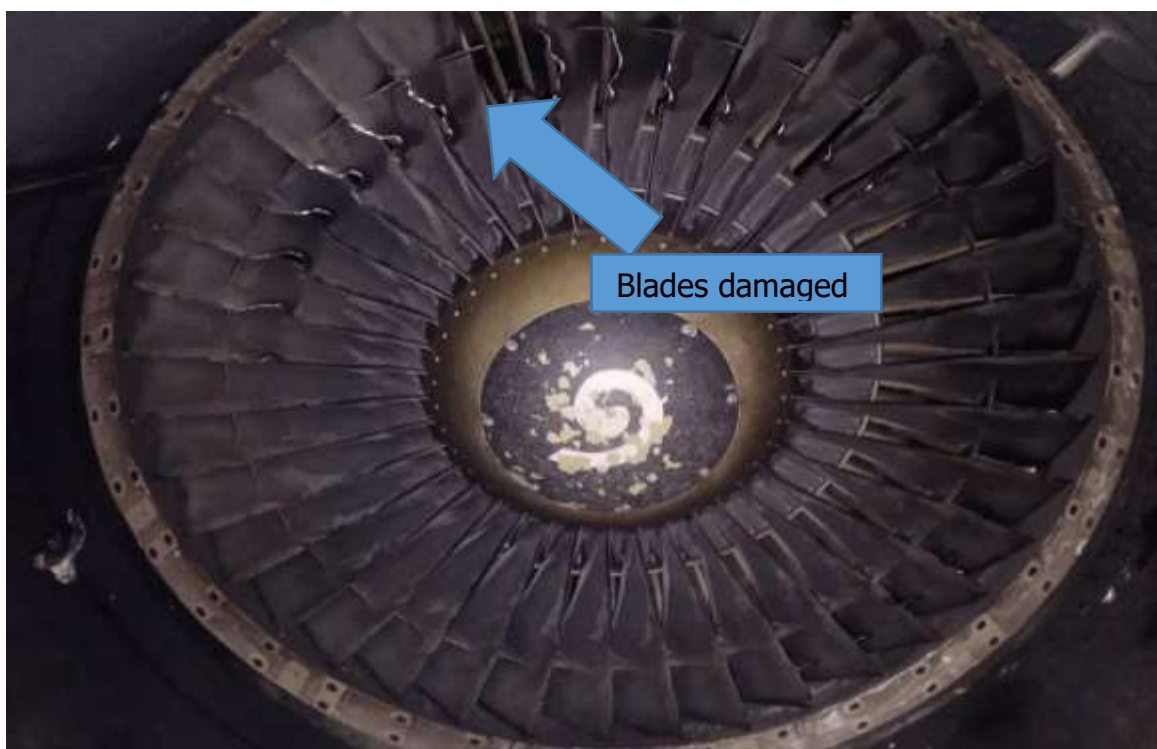
Figure 7: Engine No. 2 inlet and fan blades damage

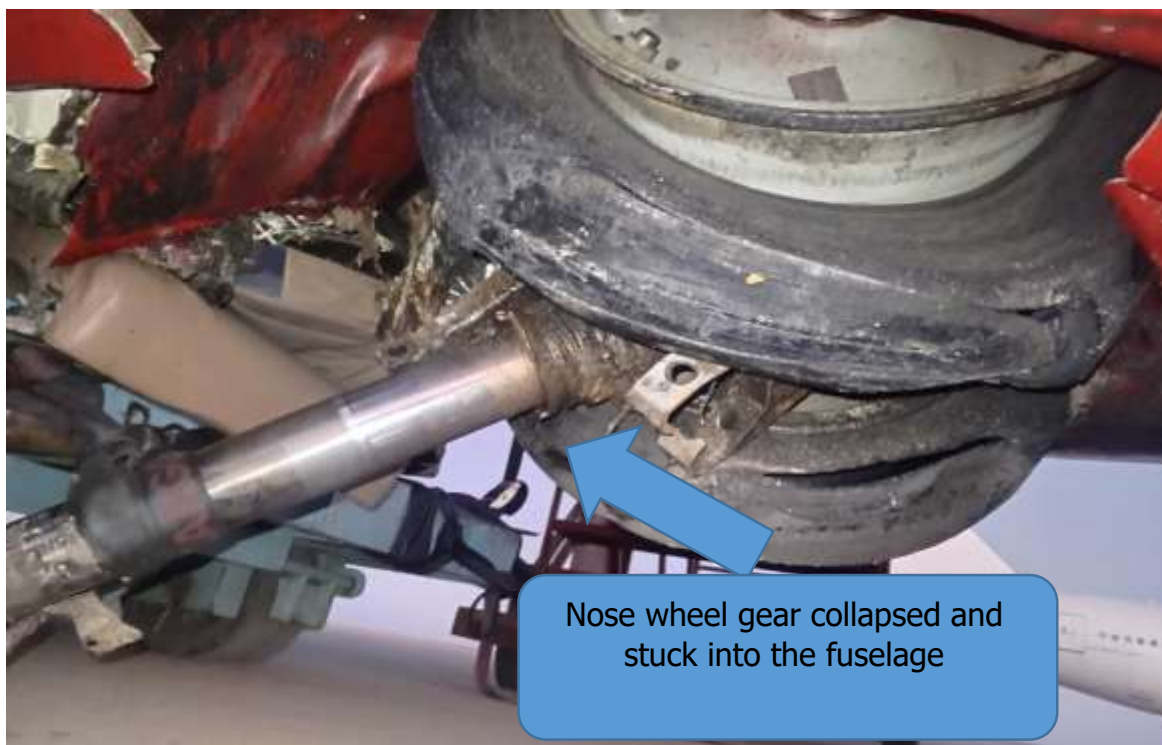
1. Nose wheel gear collapsed rearward and stuck under the belly of the fuselage.
2. Number 2 engine inlet punctured and dents on 16 fan blades
3. Number 4 main wheel tyre burst
4. Nose wheel tyres.
5. Right main landing gear wheel well door sheared off
6. Nose wheel landing gear right door sheared off

Figure 8: Nose wheel gear collapsed and stuck into the fuselage belly.

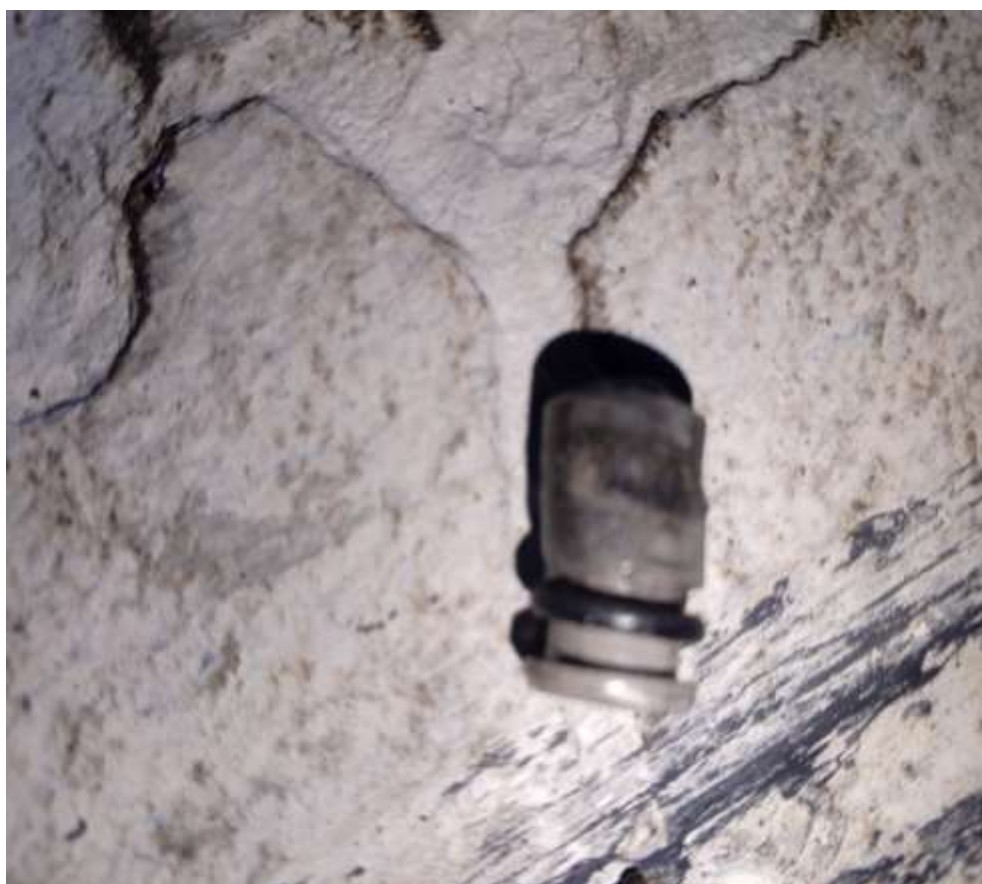
Figure 9: Debris of the damaged nose landing gear

1. Detailed inspection and testing of the collapsed Nose Landing Gear.

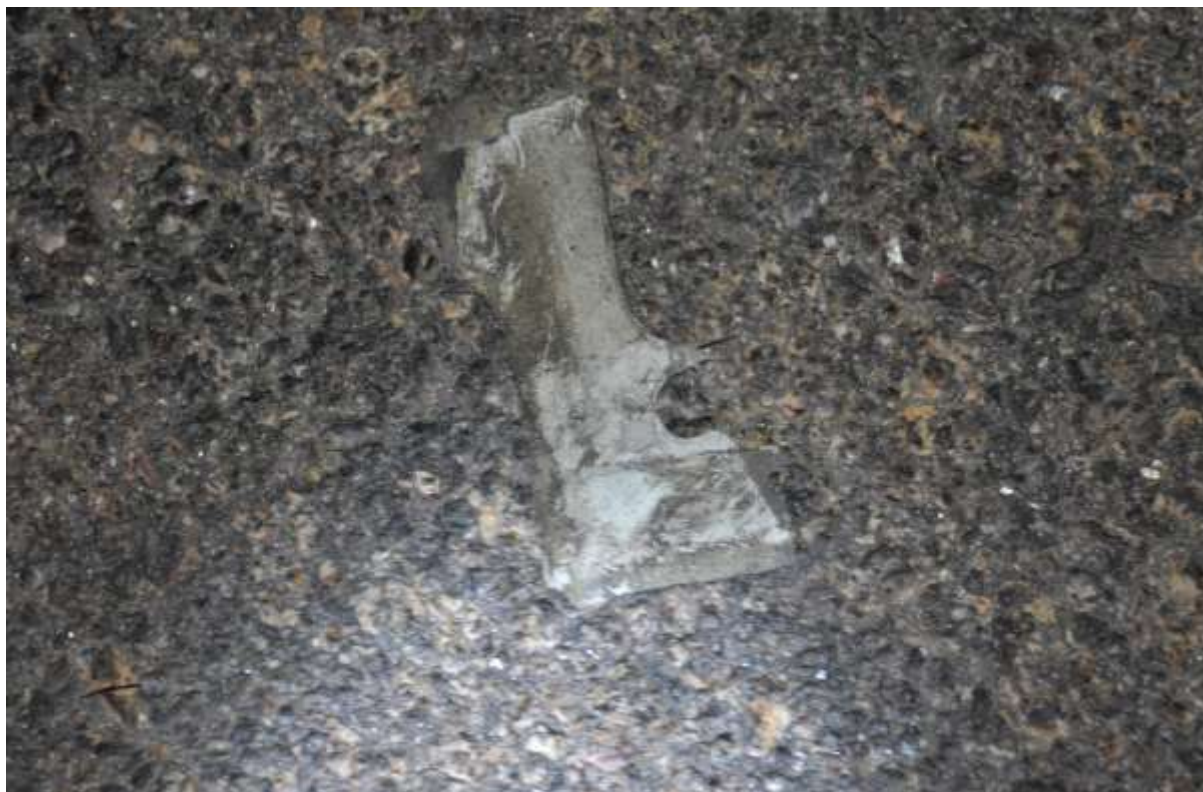
Figure 10: Debris of the damaged nose landing gear

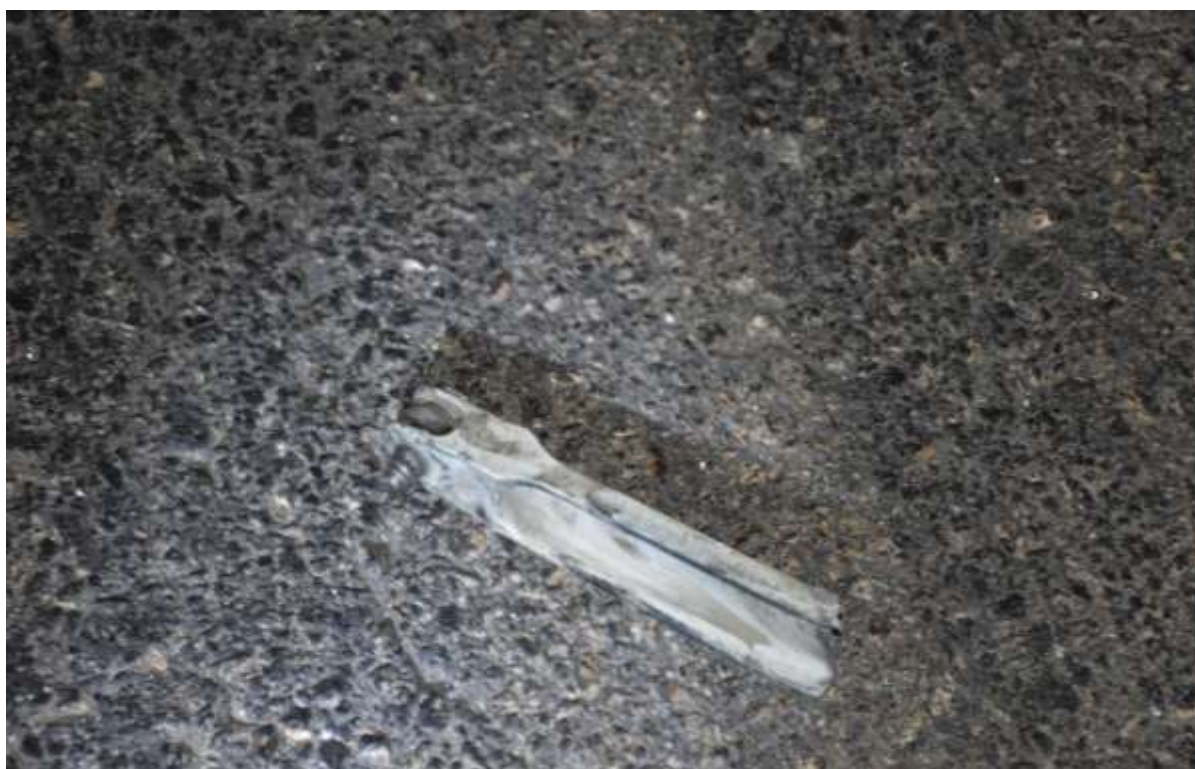
Figure 11: Debris of the damaged nose landing gear

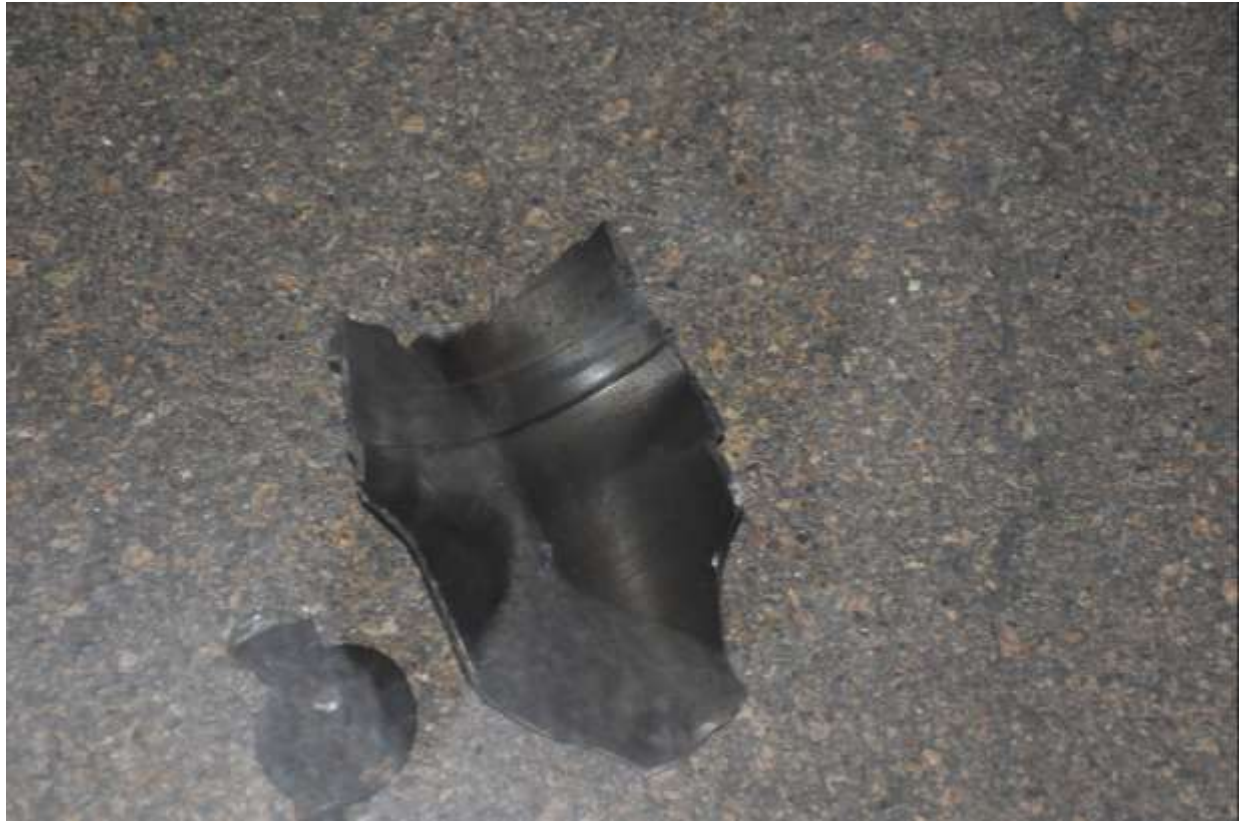
Figure 12: Debris of the damaged nose landing gear

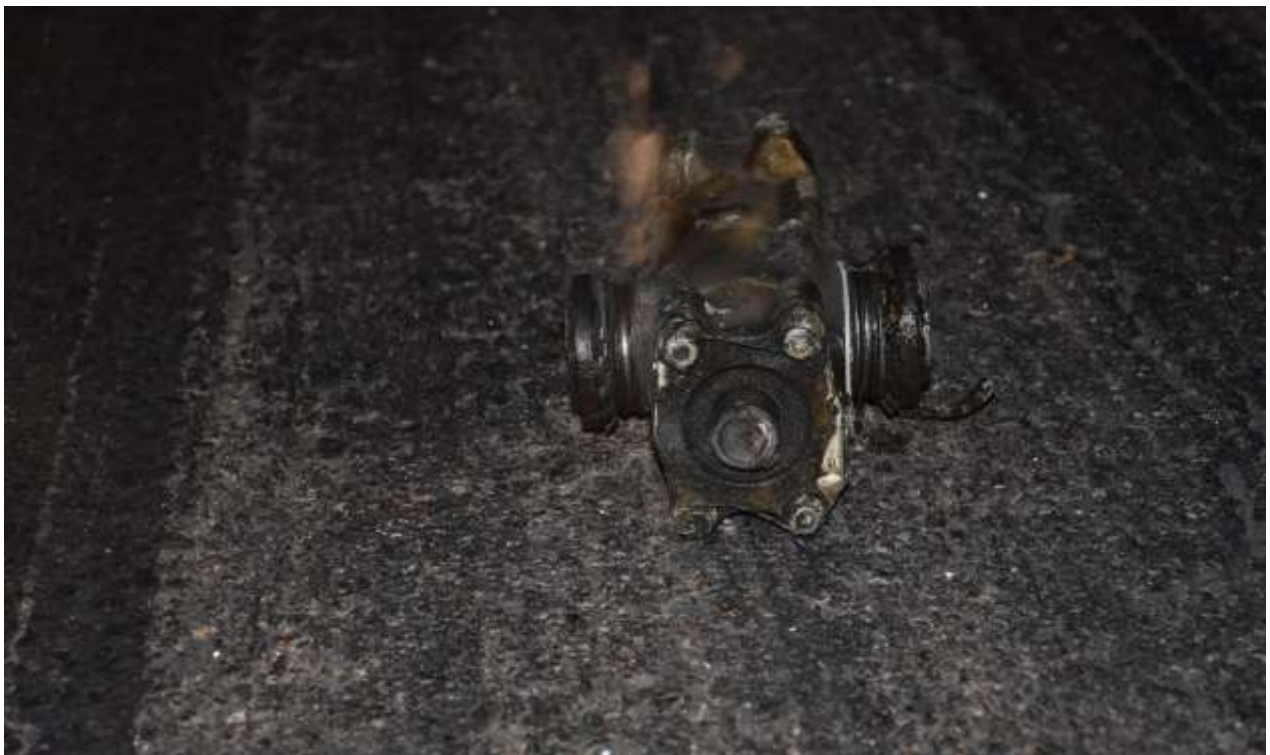
Figure 13: Debris of the damaged nose landing gear

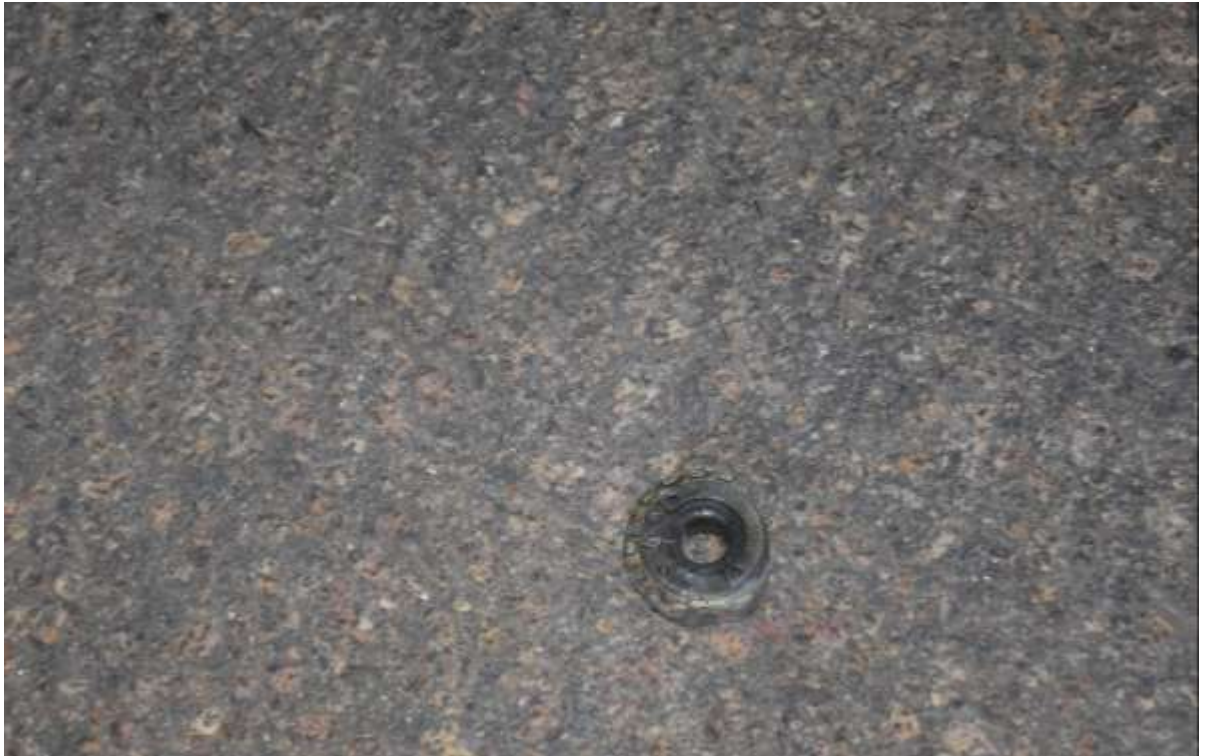
Figure 14: Debris of the damaged nose landing gear

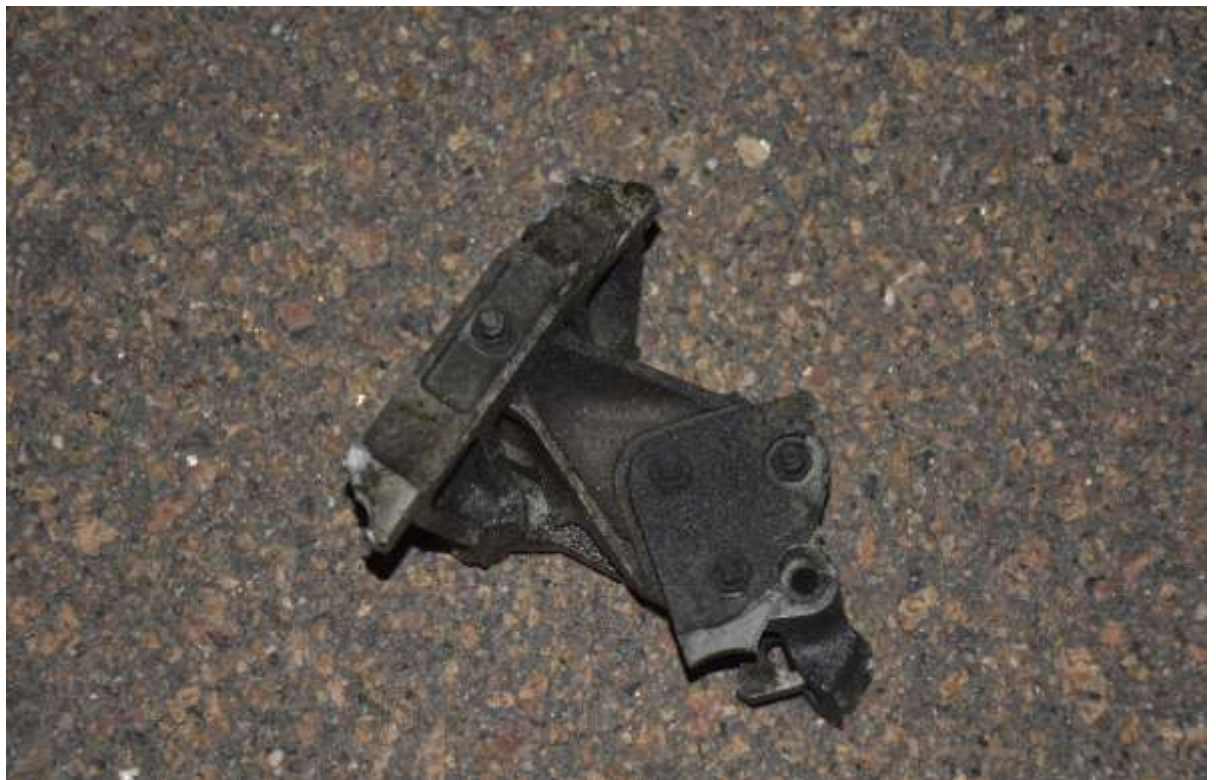
Figure 15: Debris of the damaged nose landing gear

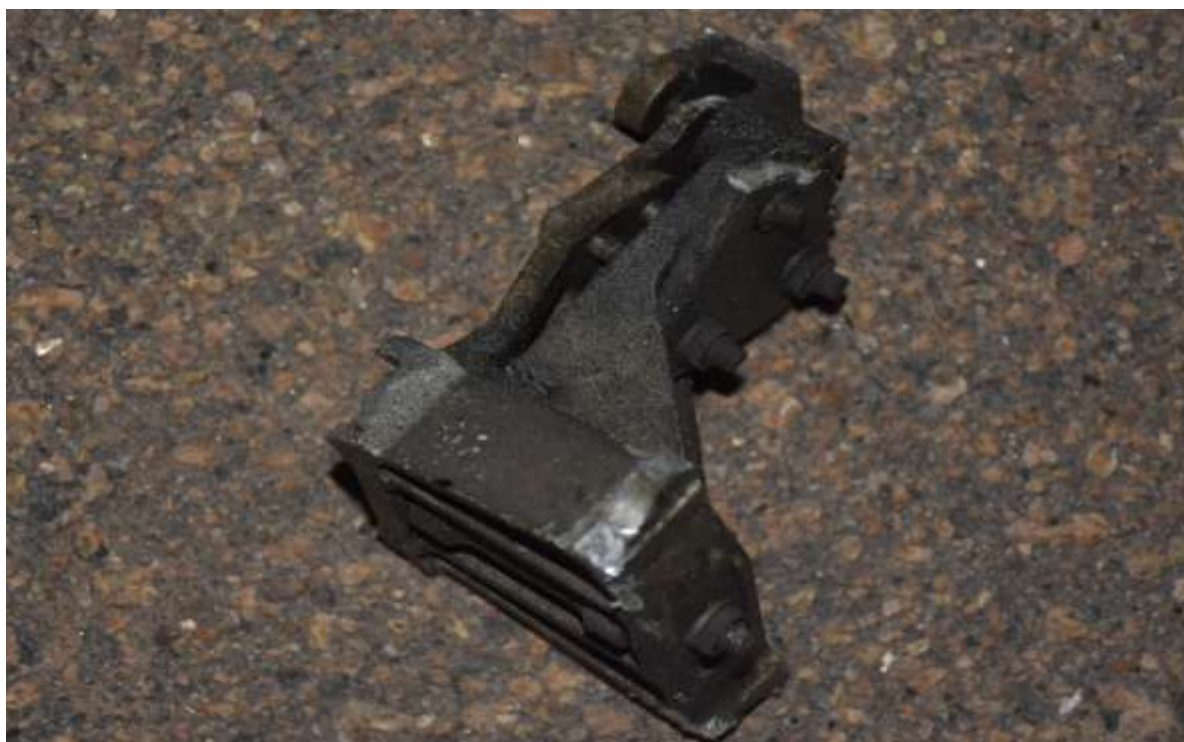
Figure 16: Debris of the damaged nose landing gear
