Preliminary Report on the Serious Incident involving a Boeing 737-524 aircraft with nationality and registration marks 5N-BQQ operated by Air Peace Limited, which occurred at Jeremiah Obafemi Awolowo International Airport, (DNPO) Omagwa, Port-Harcourt, Rivers State, Nigeria on 13 July, 2025

5N-BQQ

Operator: Air Peace Limited

Aircraft type and model: Boeing 737-524

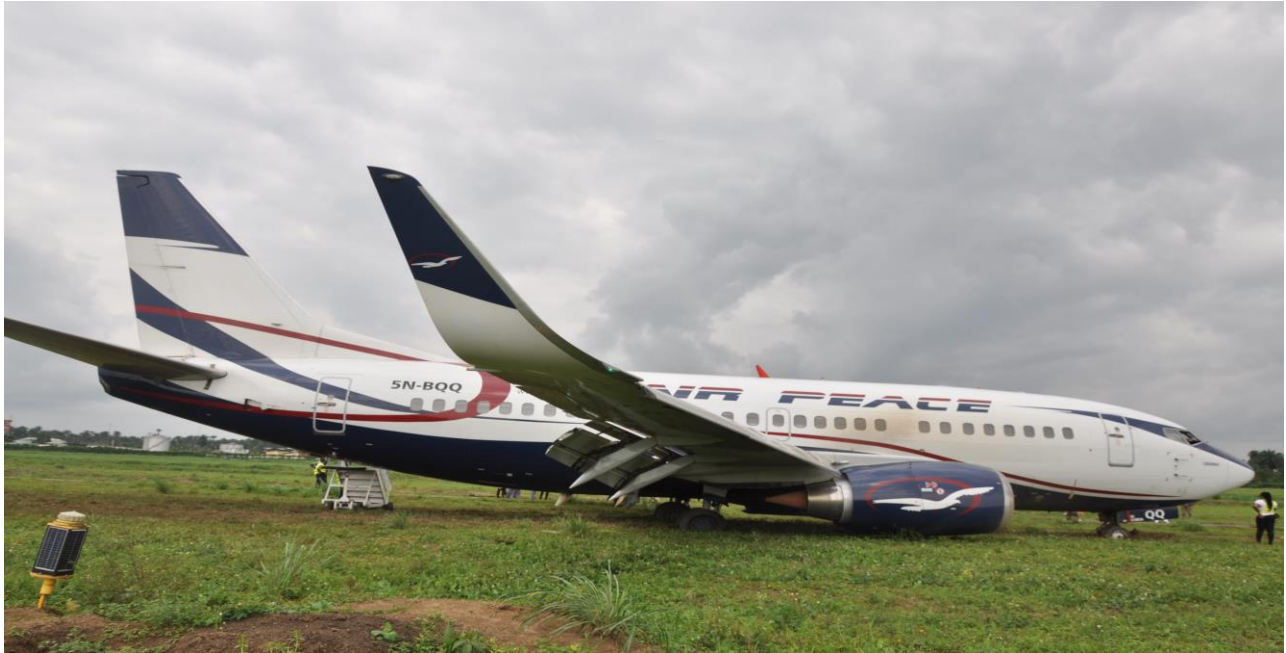
The aircraft touched down at a distance of about 2,264 m from the threshold of Runway 21. It then travelled a distance of 209 m into the clearway before coming to a final stop.

Figure 1: The Aircraft after the occurrence

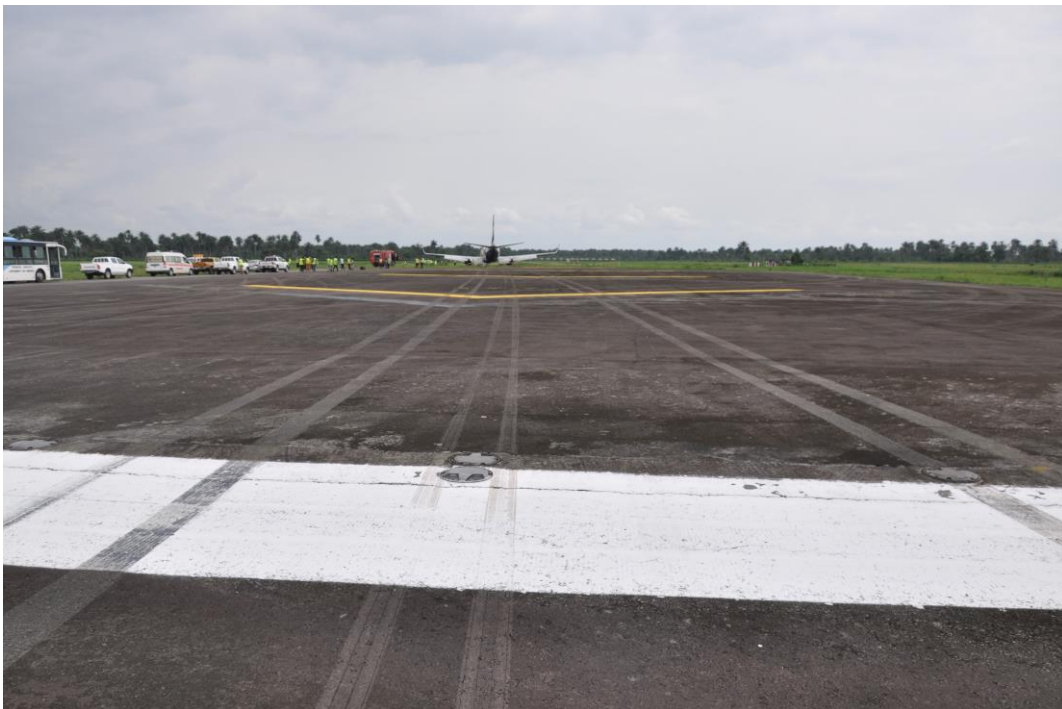
Figure 2: Tyre marks on the runway

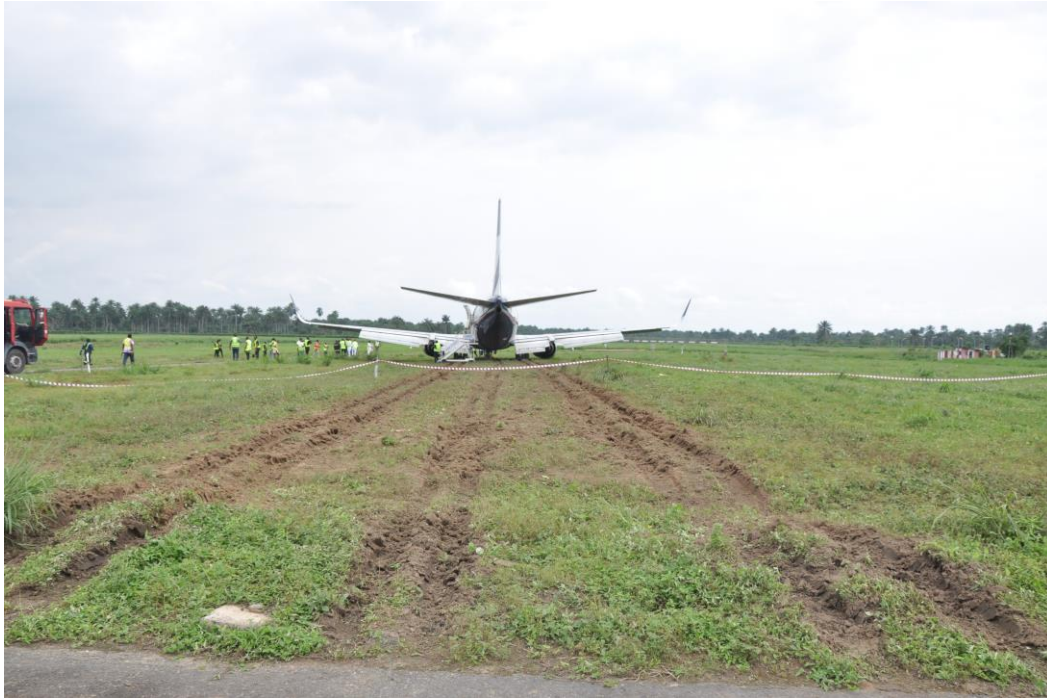
The aircraft landed at a distance of 2,264 m from the threshold of Runway 21, and travelled a total distance of 945 m before coming to a final stop 209 m from the end of the runway.

Figure 3: Path aircraft passed before stopping
