Preliminary Report on the Serious Incident involving an Embraer 145LR aircraft operated by Rano Air Limited with nationality and registration marks 5N-BZY, which occurred en route to Saddiq Abubakar III International Airport (DNSO), Sokoto State, on 29 June 2025

| Aircraft type and model: | Embraer 145LR |
| Nationality and registration marks: | 5N-BZY |

This Preliminary Report outlines the initial facts, discussions, and findings related to the incident. It includes information gathered from witness statements, the ATC transcript, and a preliminary inspection of the aircraft.

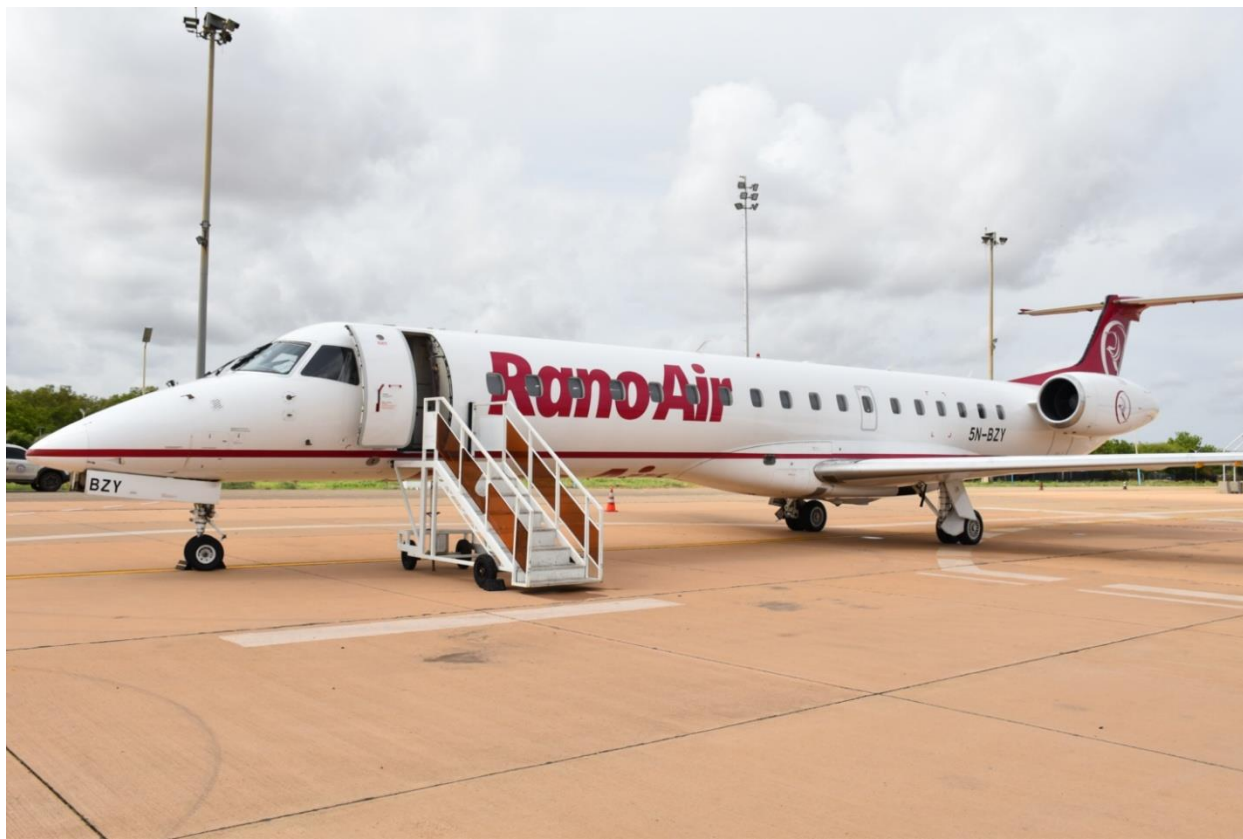
Figure 1: 5N-BZY after the occurrence.
