**Preliminary Report on the Serious Incident involving a Boeing 737-524 aircraft with nationality and registration marks 5N-BQQ operated by Air Peace Limited, which occurred at Jeremiah Obafemi Awolowo International Airport, (DNPO) Omagwa, Port-Harcourt, Rivers State, Nigeria on 13 July, 2025.**

| <b>Type and model:</b> | Boeing 737-524 |
| <b>Nationality and registration marks:</b> | 5N-BQQ |
| <b>Date and Time:</b> | 13 July 2025 at about 07:46 h<br><br>(All times in this report are local time,<br>equivalent to (UTC+1) unless otherwise<br>stated) |

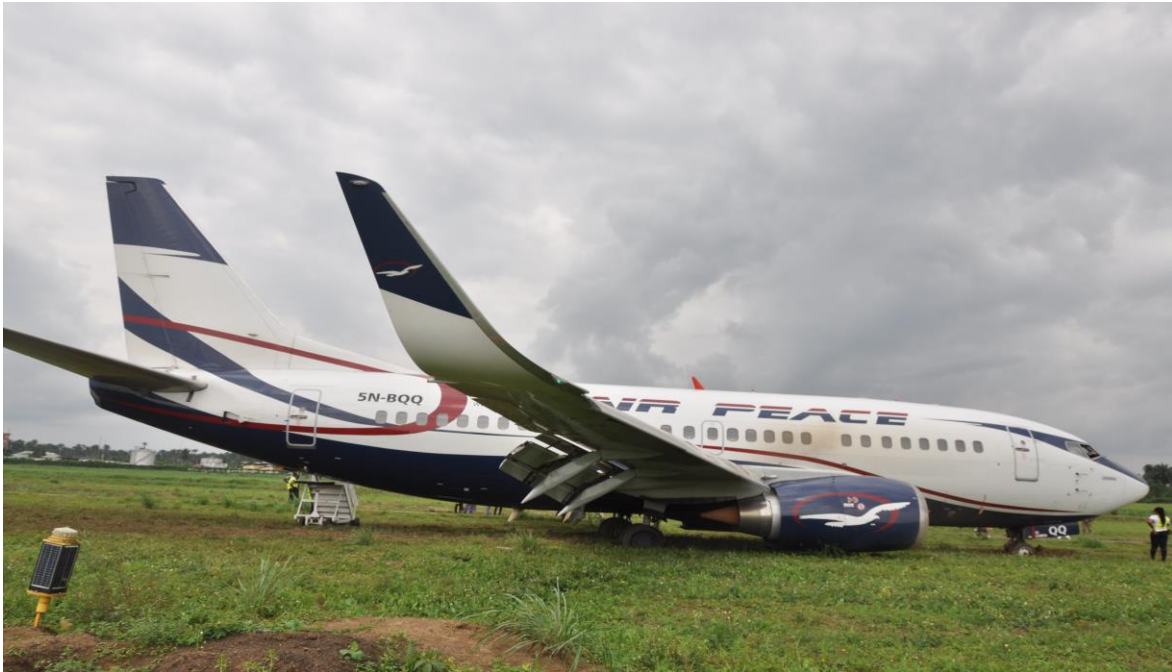
The aircraft touched down at a distance of about 2,264 m from the threshold of Runway 21. It then travelled a distance of 209 m into the clearway before coming to a final stop.

**Figure 1:** The Aircraft after the occurrence

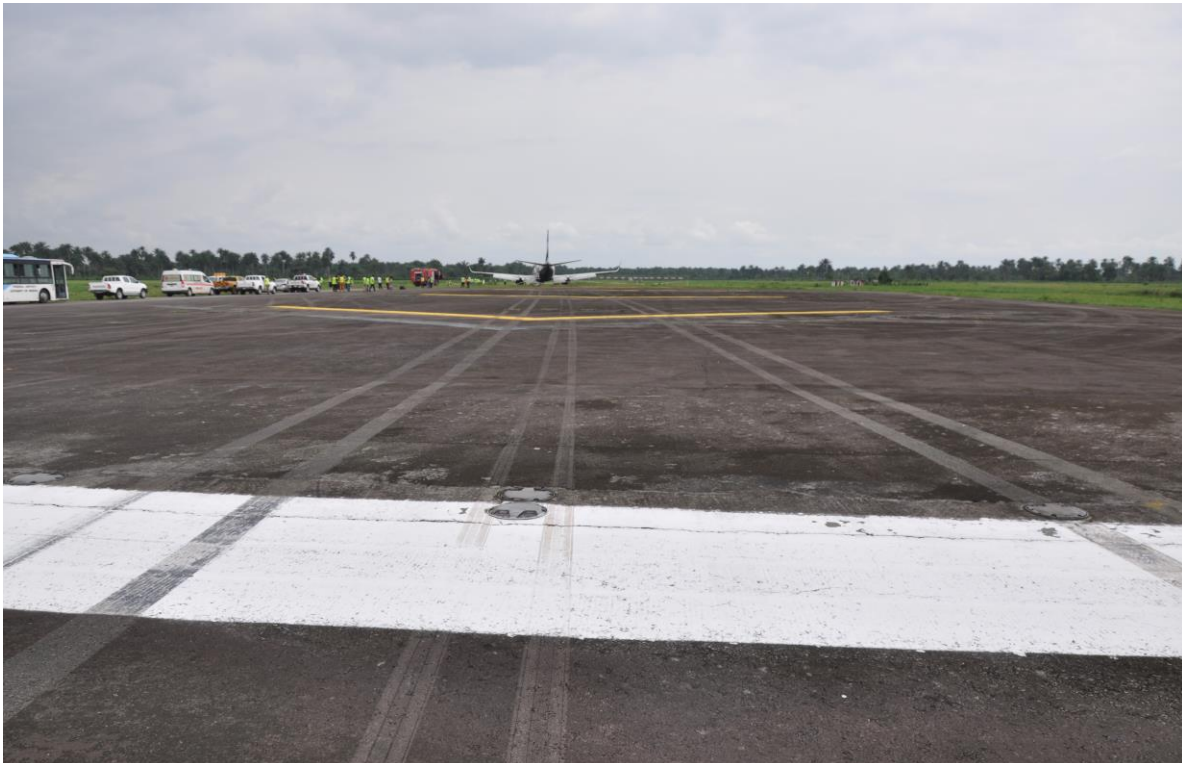
**Figure 2:** Tyre marks on the runway

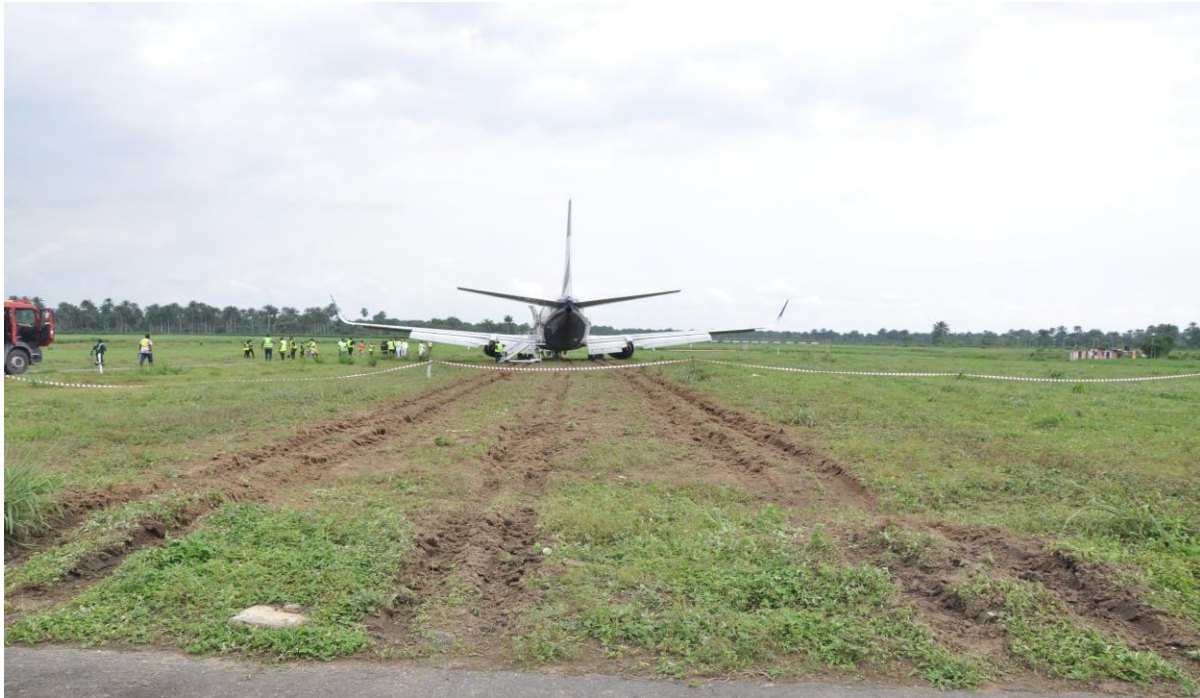
**Figure 3:** Path aircraft passed before stopping
