PRELIMINARY REPORT ON A SERIOUS INCIDENT INVOLVING A LEONARDO S.p.A AW139 AIRCRAFT WITH NATIONALITY AND REGISTRATION MARKS 5N-BSG OPERATED BY CAVERTON HELICOPTERS LIMITED, ENROUTE BONGA FPSO ON 20TH JANUARY 2024

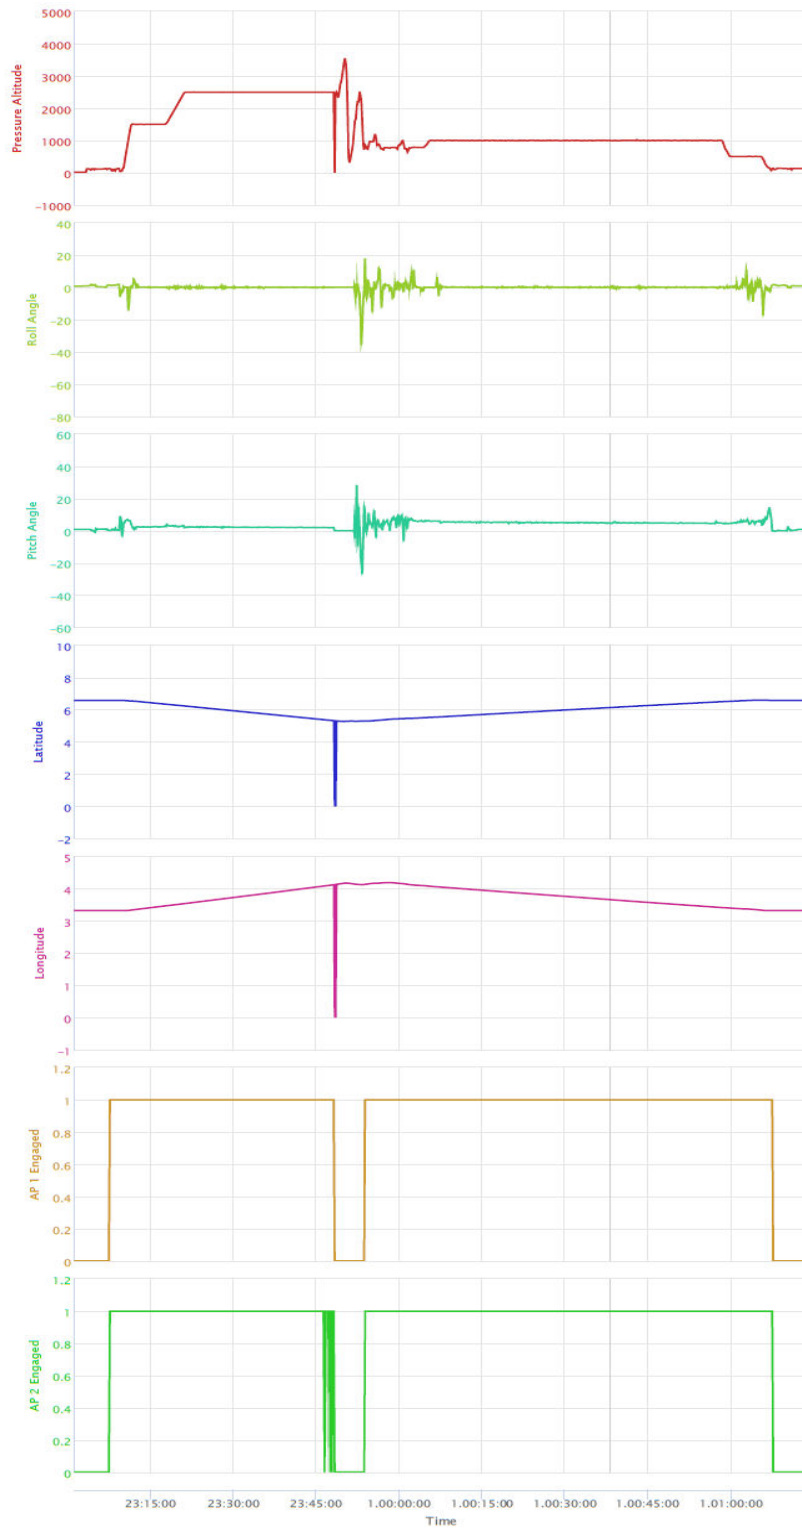
According to FDR data, simultaneous with the attempts to re-engage the AFCS, the aircraft climbed to about 3,500 ft within a period of 1 min and 40 s, followed by a rapid descent to 330 ft in 45 s. FDR shows that the aircraft commenced another climb to 2,500 ft in the next 2 mins within which period, several pitch and roll control inputs were recorded; pitch angle varied between 28° pitch up and 12° pitch down before a maximum

25° pitch down motion was recorded, simultaneous with the maximum recorded roll angle of 37° to the right.

Some flight data recorder parameters were analysed as contained in the plots below.

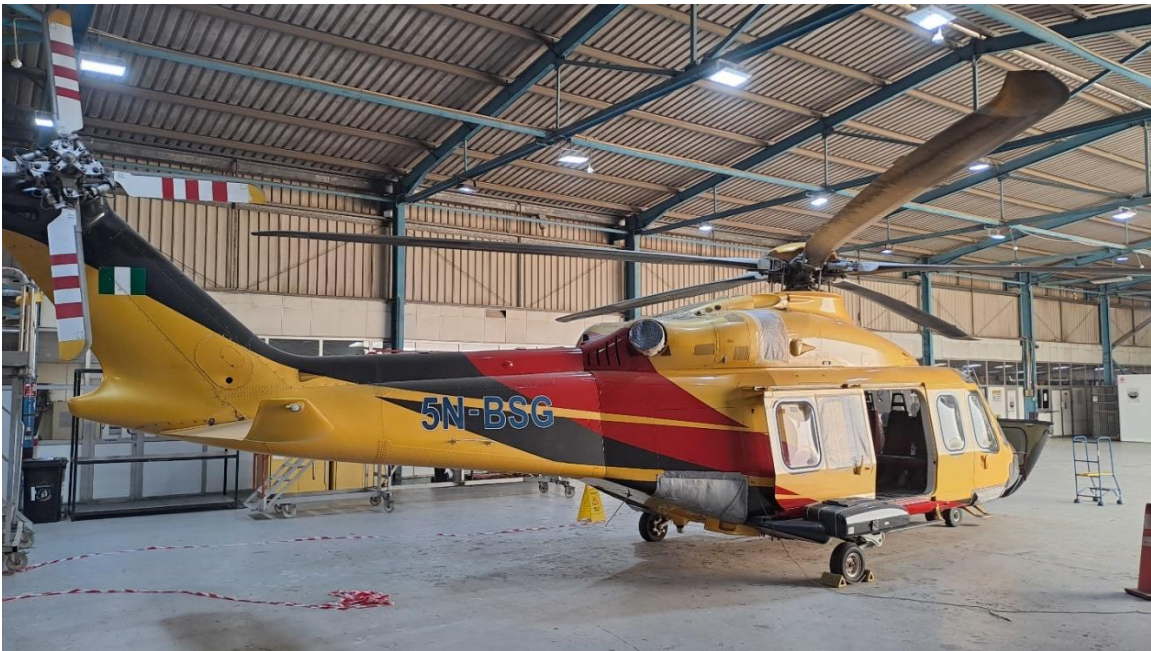
Figure 1: The aircraft parked in the hangar after the occurrence

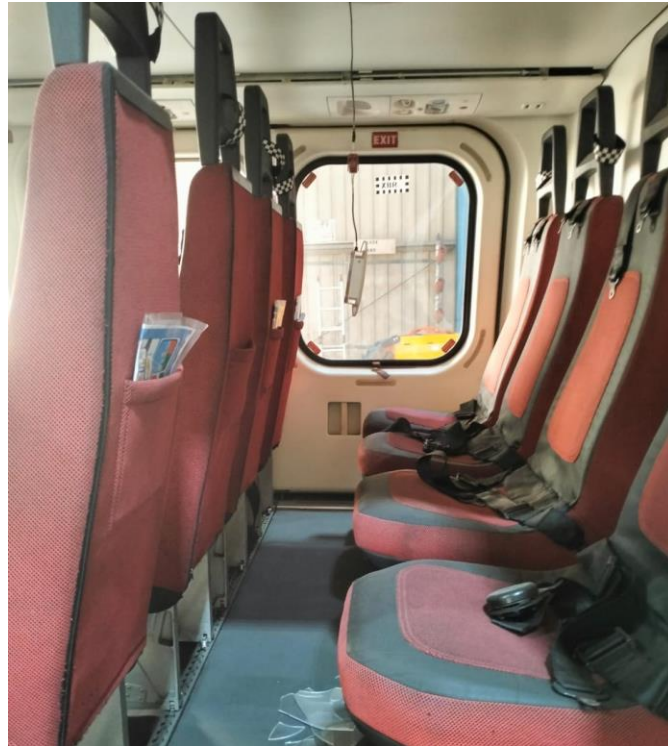
1. Two cabin windows were blown out in flight, and missing on ground.
2. Debris from a broken third window was found in the cabin.
3. A main rotor blade had a broken glass shrapnel stuck to the blade root.
4. The main rotor lightning conductor was broken.
5. A cabin light lens and transparent light cover were broken.

Figure 2: Views of the cabin post occurrence showing some damage
