Preliminary Report on serious incident involving a Hawker 800XP aircraft with nationality and registration marks 5N-ISB operated by Flybird Aircraft Management Services Limited, which occurred at Mallam Aminu Kano International Airport (DNKN), Kano, Kano State, on 14 December 2025.

Aircraft type and model: Hawker 800XP

Nationality and registration marks: 5N-ISB

Location: Runway 06, Mallam Aminu Kano International Airport, (DNKN), Kano.

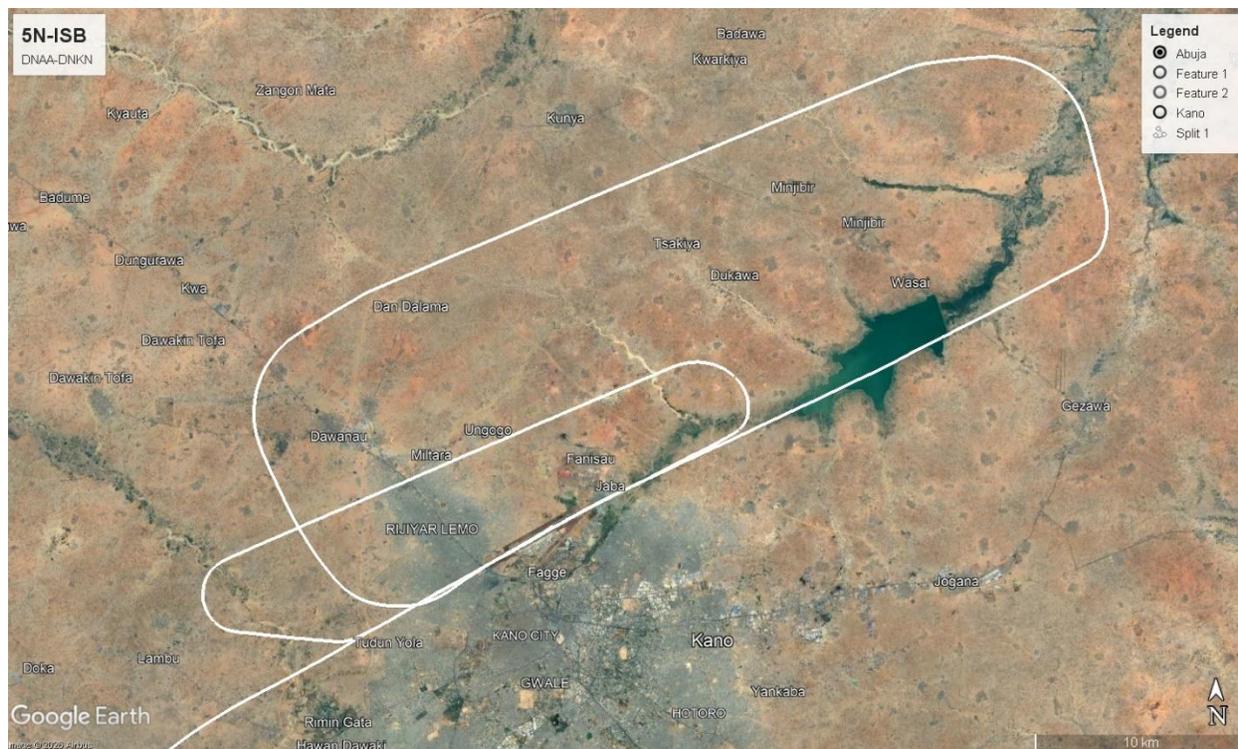
Figure 1: Flight track of 5N-ISB at DNKN

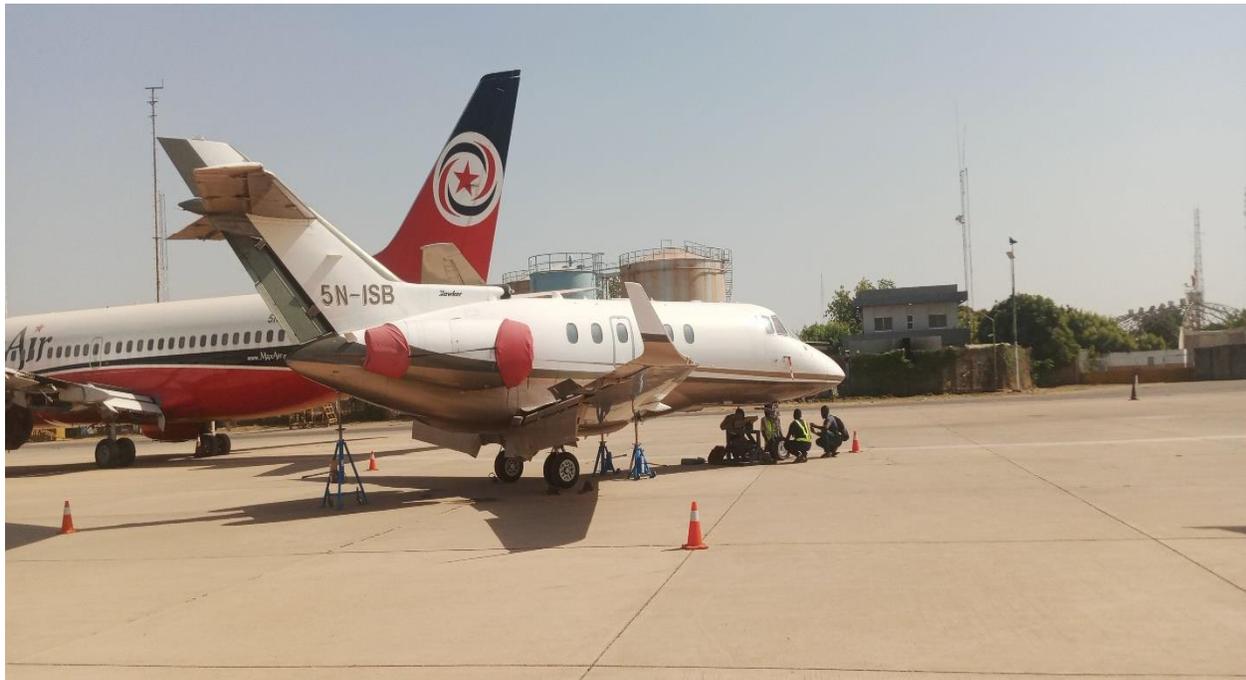
Figure 2: Recovered 5N-ISB parked at bay 5 left of Apron A

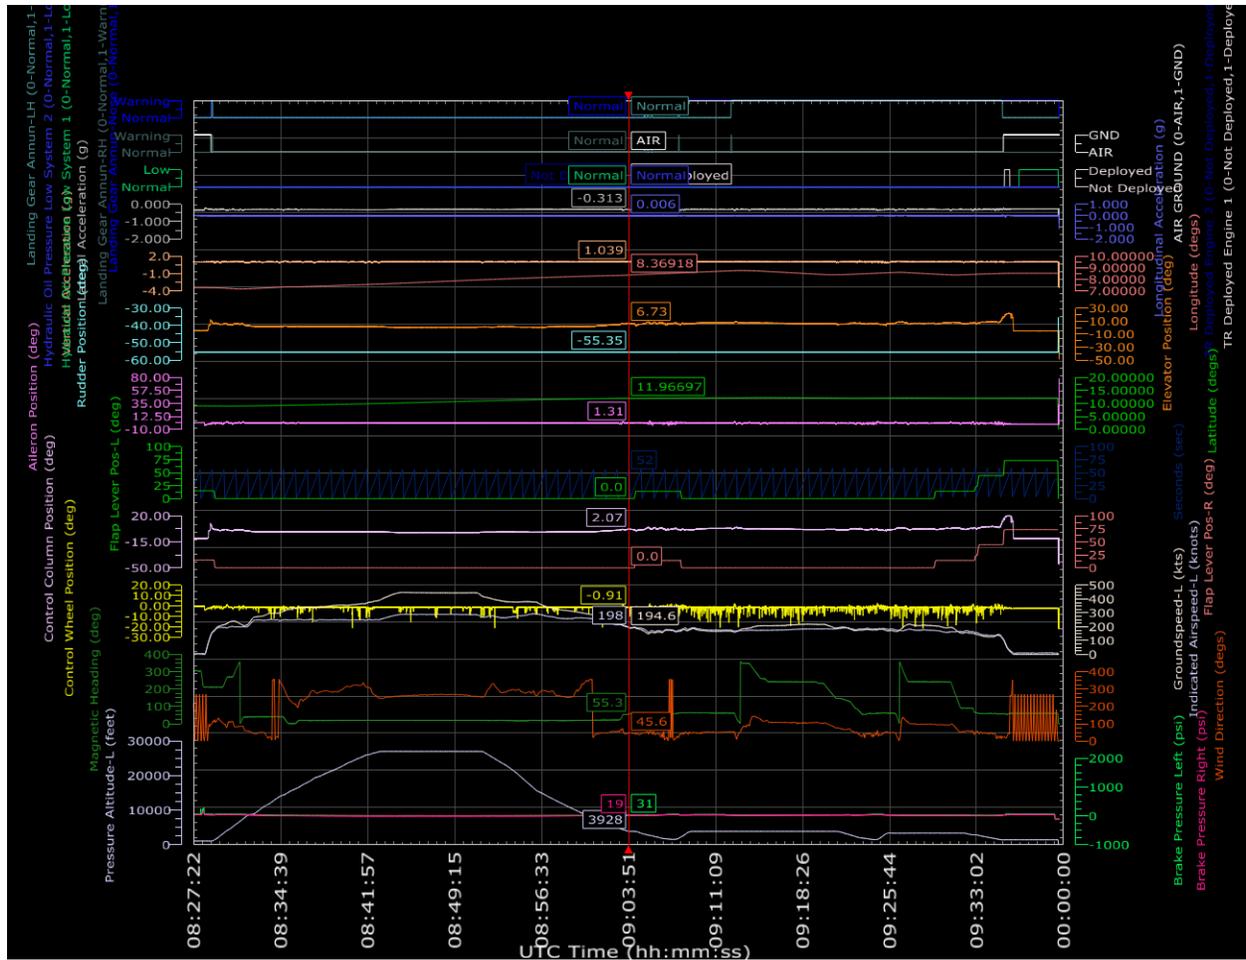
Figure 3: 5N-ISB FDR plot

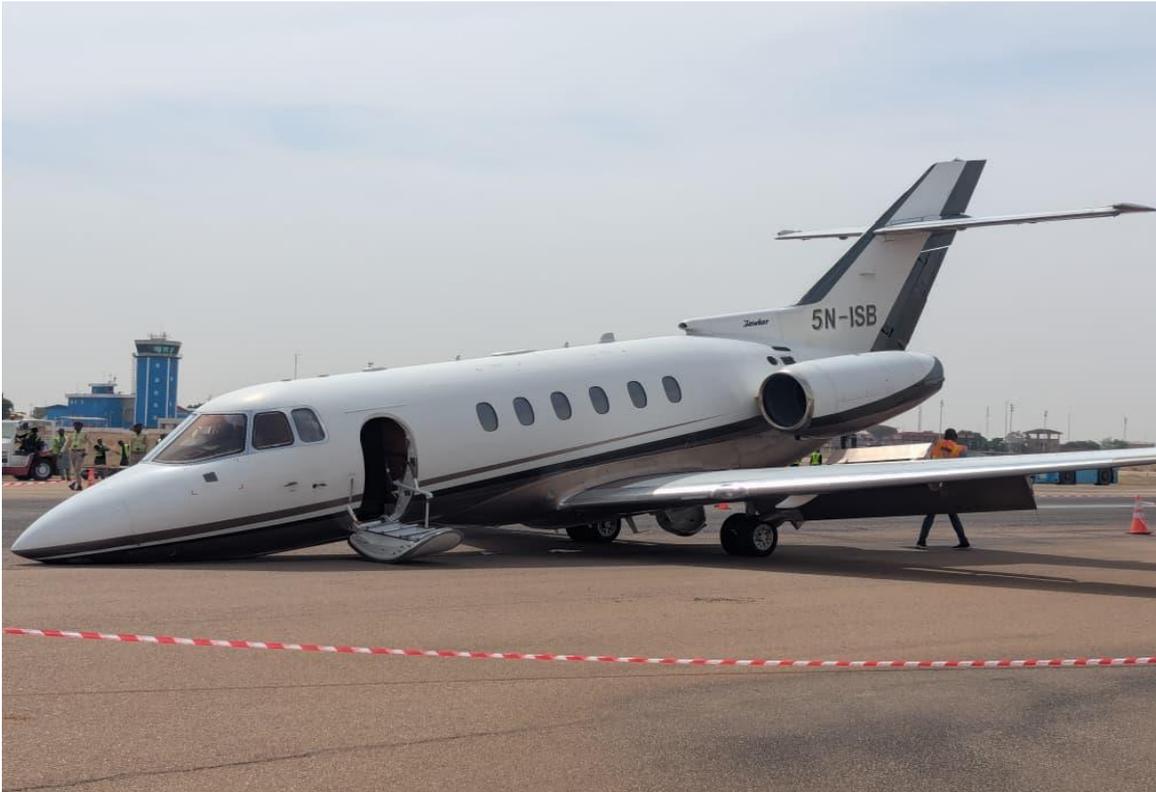
1. The aircraft veered 9.2 m left of runway 06 centreline. 5N-ISB dragged with the nose on the runway further for 514 m before coming to a final stop.
2. The nose landing gear wheel well doors detached, and the hinges were bent at the attachment points on the aircraft.

Figure 4: 5N-ISB Final resting position on Runway 06 after the occurrence

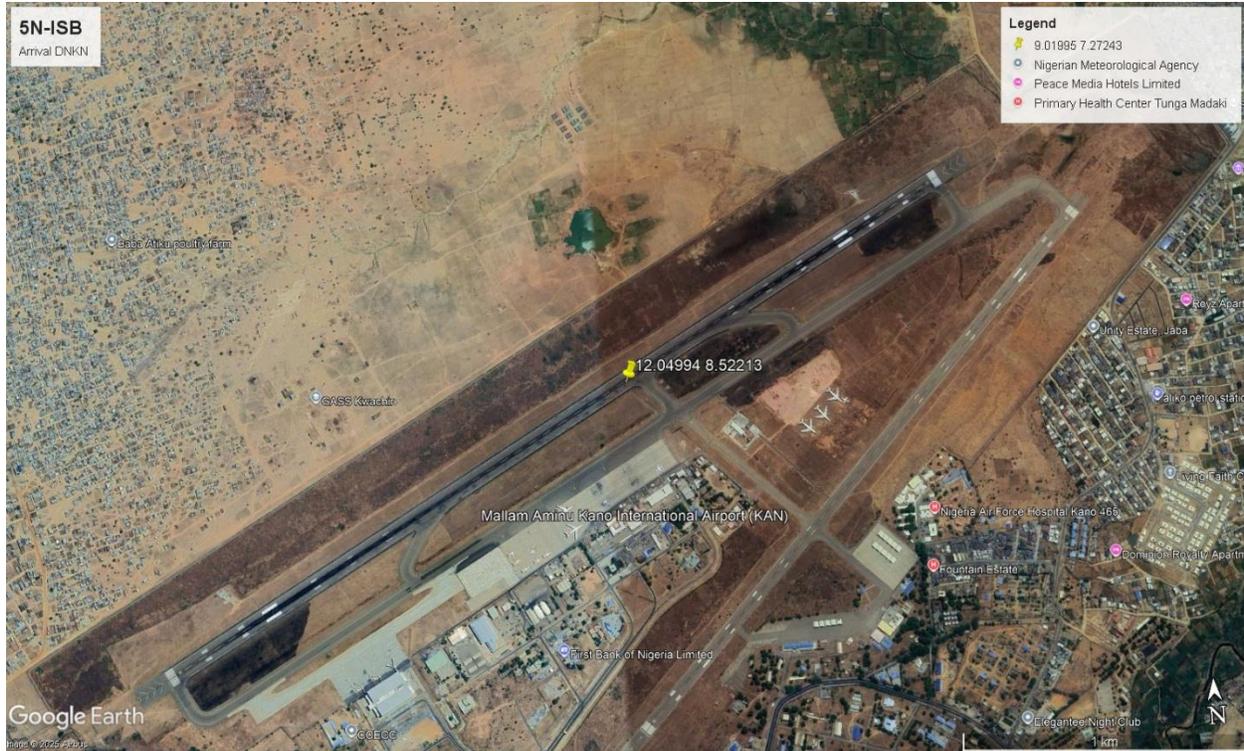
Figure 5: 5N-ISB Final resting position on Runway 06

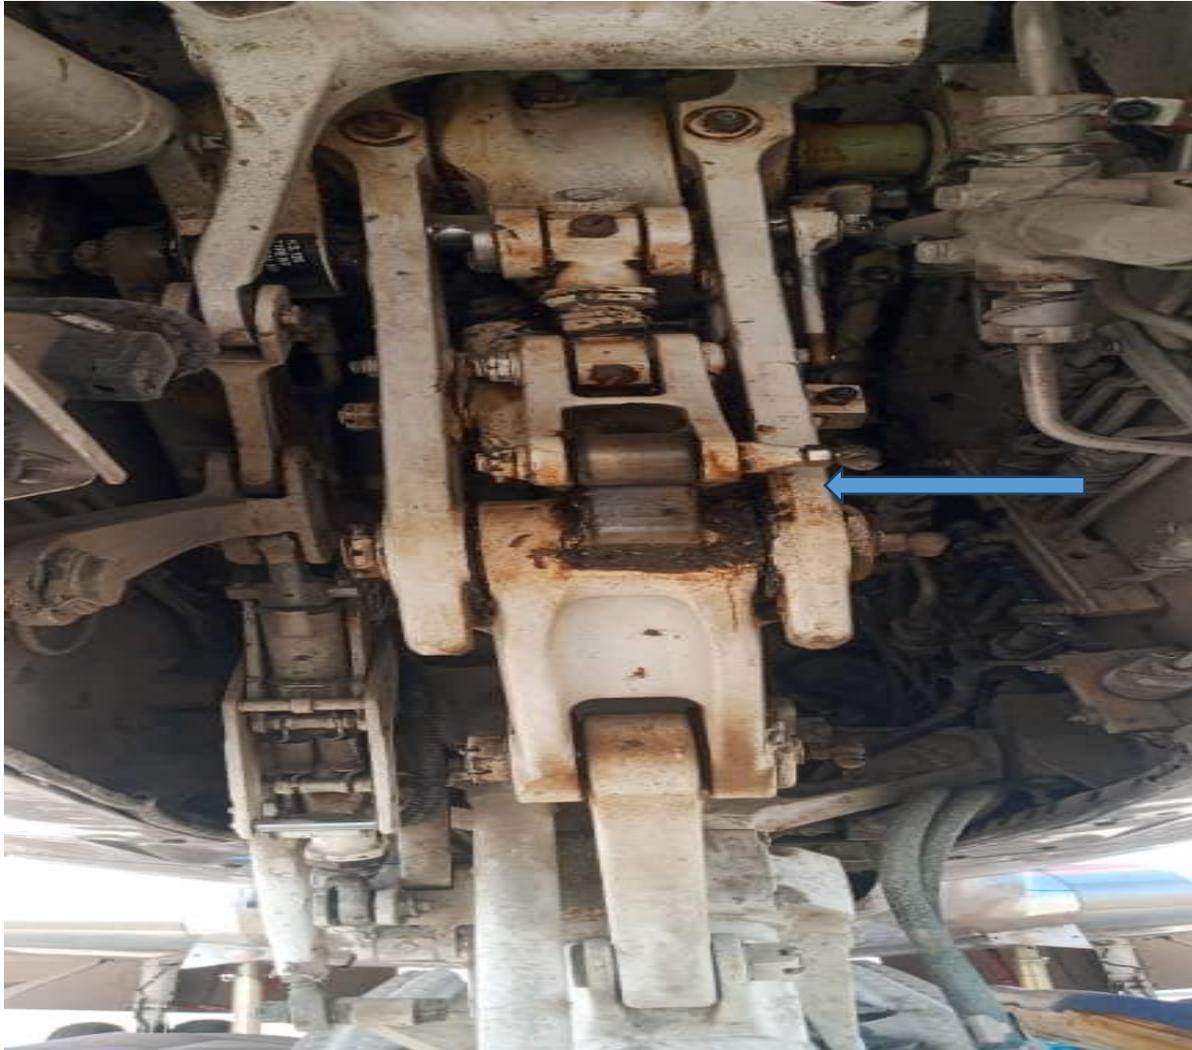
Figure 6: Nose landing gear down lock mechanism

9. The nose wheel touched down at a distance of 2,201 m from the runway 06 threshold and collapsed shortly afterwards.
10. The nose landing gear wheel well doors detached, and the hinges were bent at the attachment points on the aircraft.

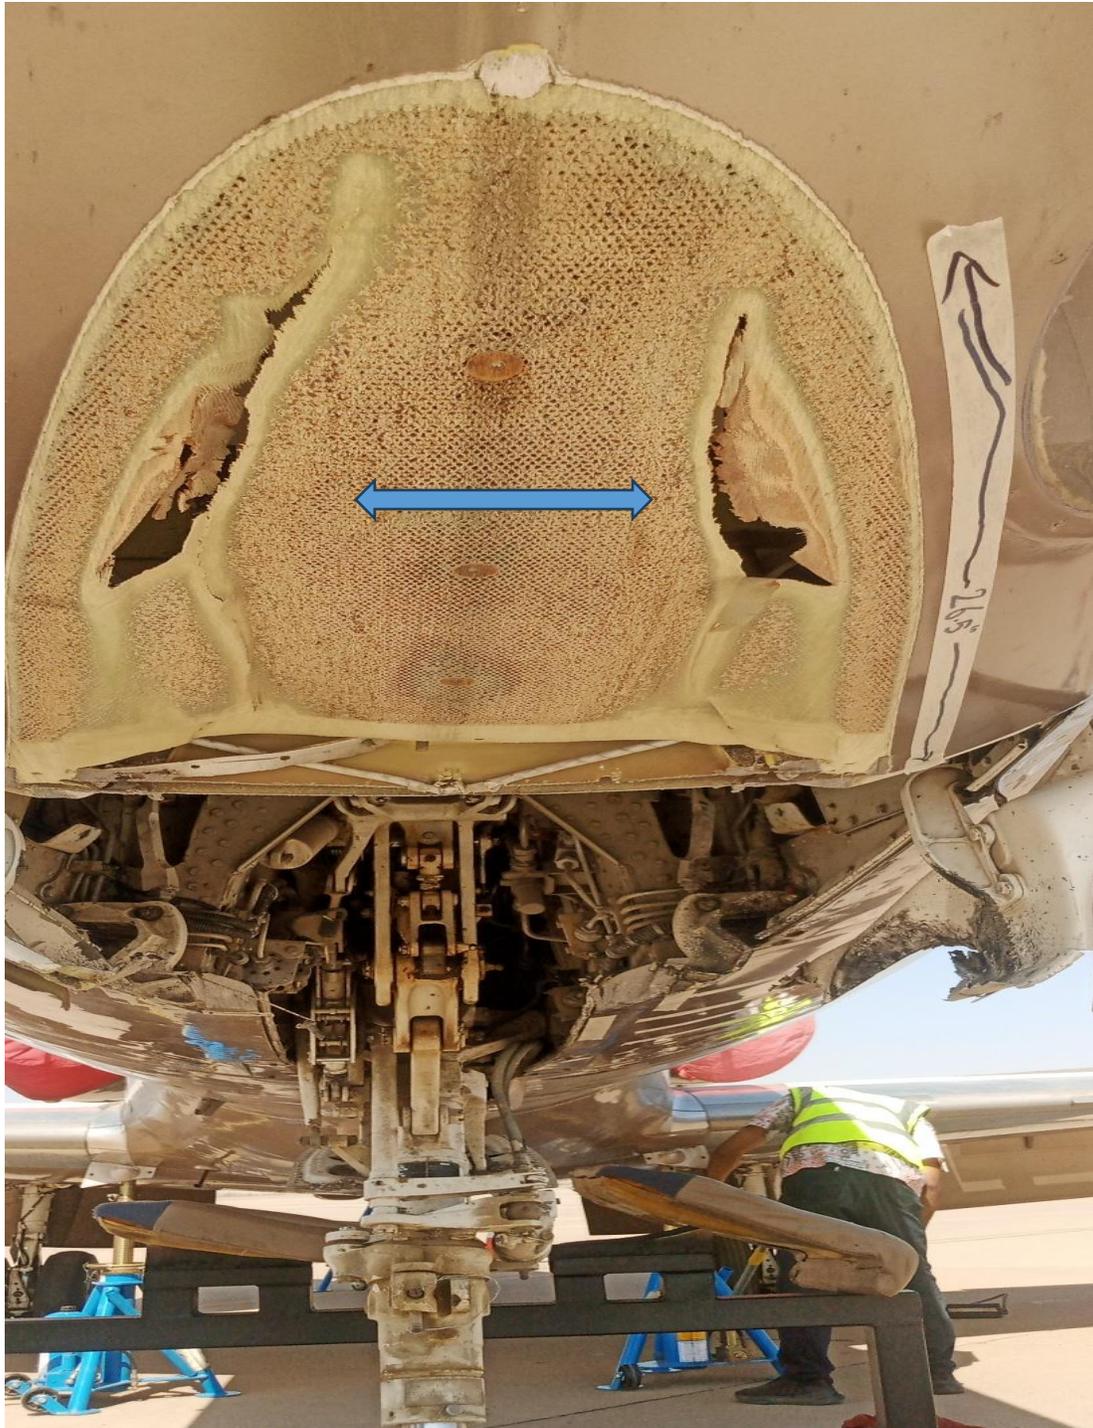
Figure 7: Bottom Section of the nose

11. The lower section of the nose suffered abrasion.

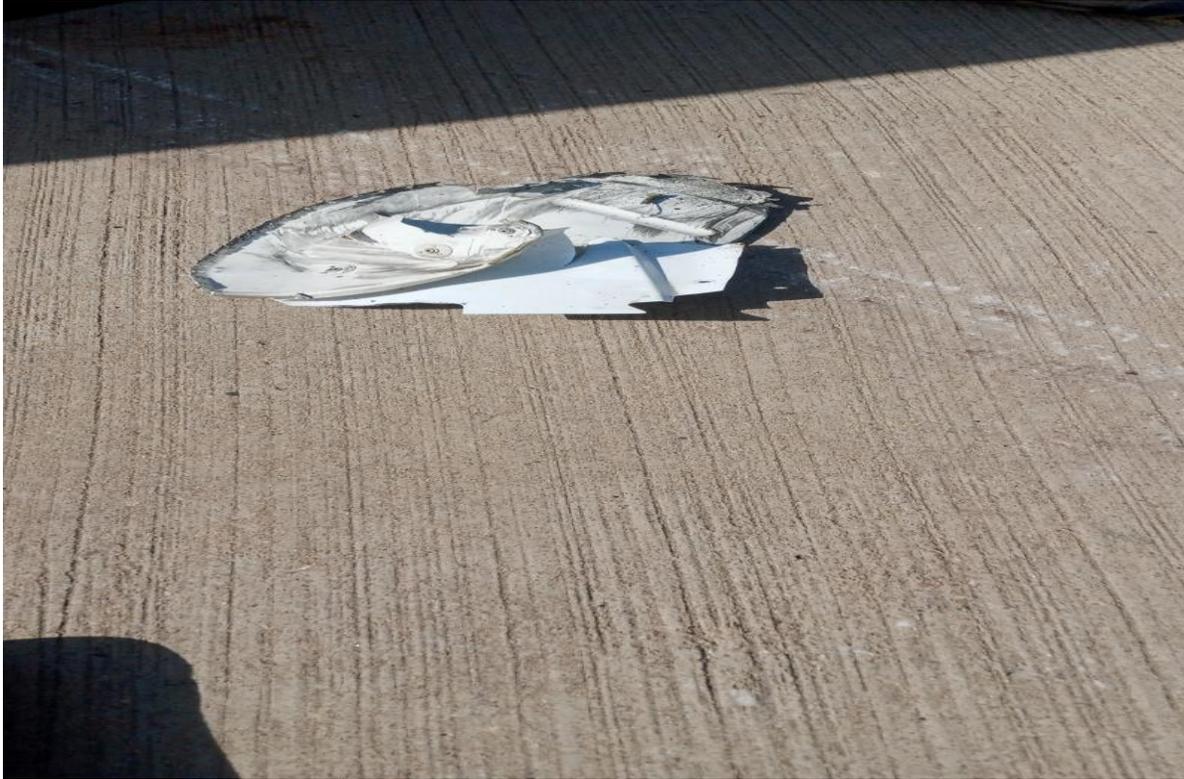
3. The nose wheel well door debris was found at a distance of 190.3 m from where the nose landing gear collapsed.
4. The lower section of the nose suffered abrasion.

Figure 8: Nose landing gear wheel well door debris
