**PRELIMINARY REPORT ON SERIOUS INCIDENT INVOLVING CHALLENGER 601-3R AIRCRAFT OWNED AND OPERATED BY MATTINI AIRLINE SERVICES LTD. WITH NATIONALITY AND REGISTRATION MARKS N580KR WHICH OCCURRED AT IBADAN AIRPORT, OYO STATE ON 26TH JANUARY, 2024**

<b>Registered owner and operator:</b>	Mattini Airline Services Ltd.
<b>Aircraft type and model:</b>	Challenger 601 – 3R
<b>Manufacturer:</b>	Bombardier Inc.
<b>Date of manufacture:</b>	1994
<b>Nationality and registration marks:</b>	N580KR
<b>Serial number:</b>	5148
<b>Location:</b>	Clearway, N07 <sup>0</sup> 21' 00", E003 <sup>0</sup> 58' 12" about 236 m from the end of Runway 22, Ibadan Airport, Oyo state
<b>Date and time:</b>	26th January 2024 at about 11:55 h

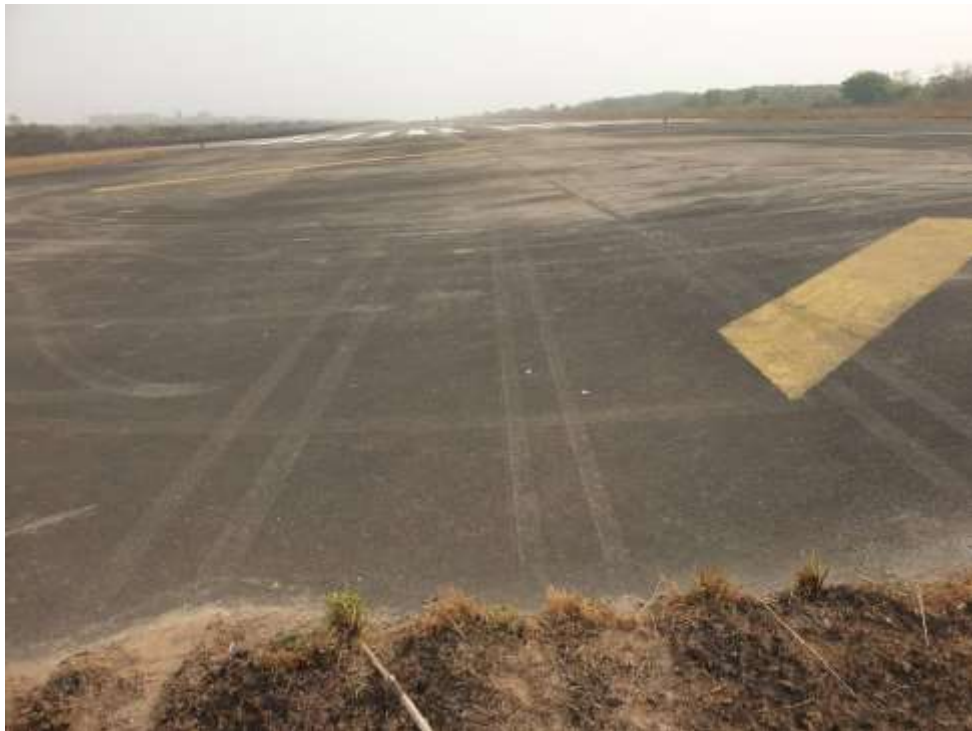
The NSIB investigation team observed conspicuous tyre marks at a distance of about 214 m to the end of runway 22.

Conspicuous tyre marks were observed at a distance of about 214 metres to the end of runway 22. Shortly after, the aircraft started veering to the right in order to avoid a direct collision with the approach lights on runway 04.

**Figure 1: A view of the Runway 22 End Safety Area showing the aircraft tracks**

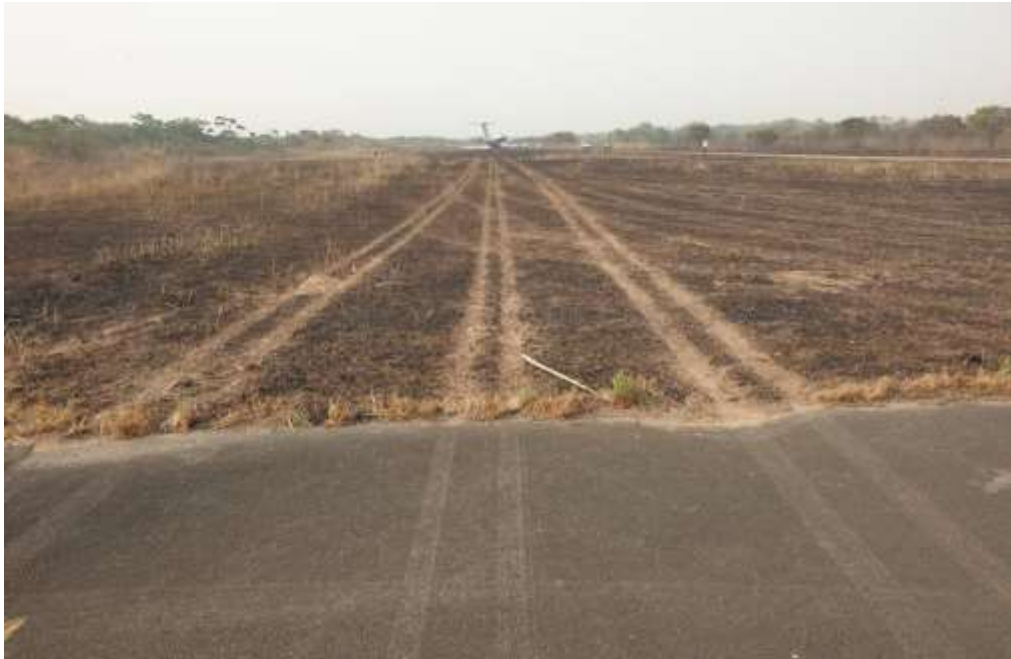
Thereafter, the aircraft entered the clearway and travelled a distance of 163 m.

The total distance travelled by the aircraft from the end of runway 22 into the clearway before coming to a stop was 236 m.

**Figure 2: A view of the Runway 22 clearway showing the aircraft tracks**

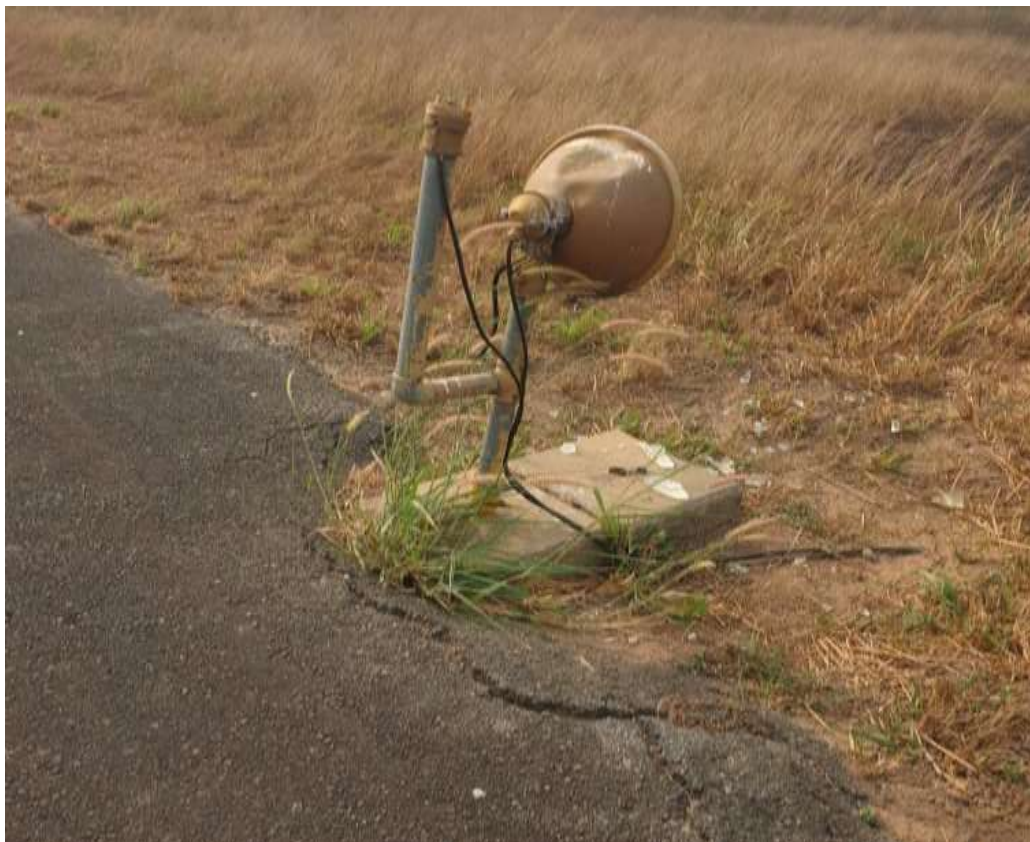
One of the approach lights on runway 04<sup>1</sup> was broken

**Figure 3: Back view of the broken approach light on runway 22 end**

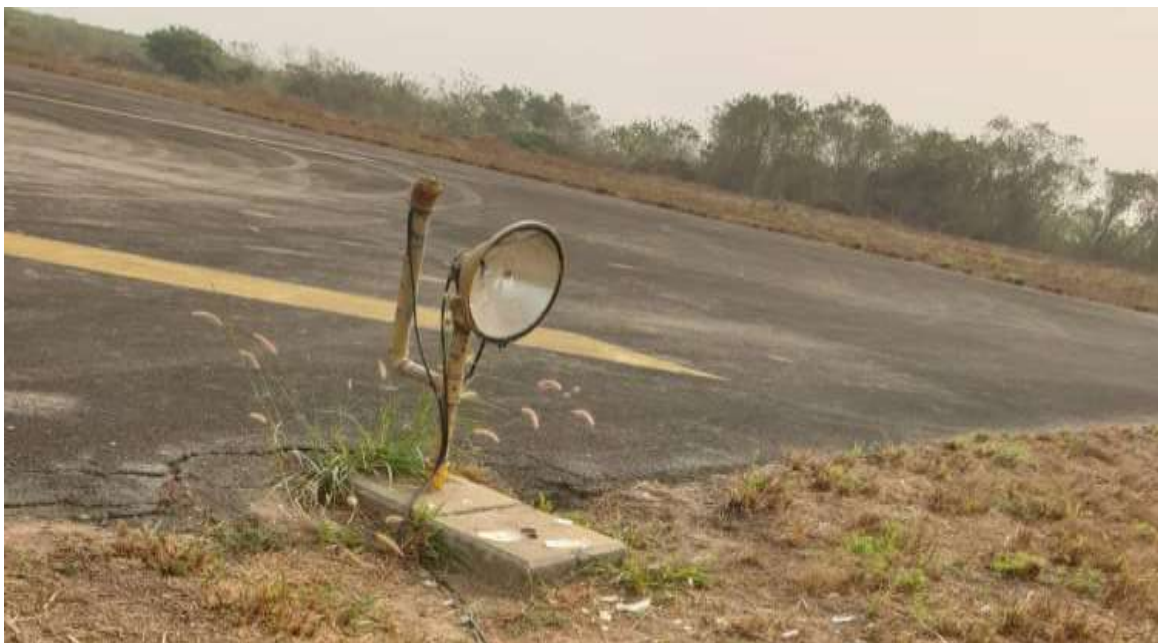
**Figure 4: Front view of the broken approach light on runway 22 end**

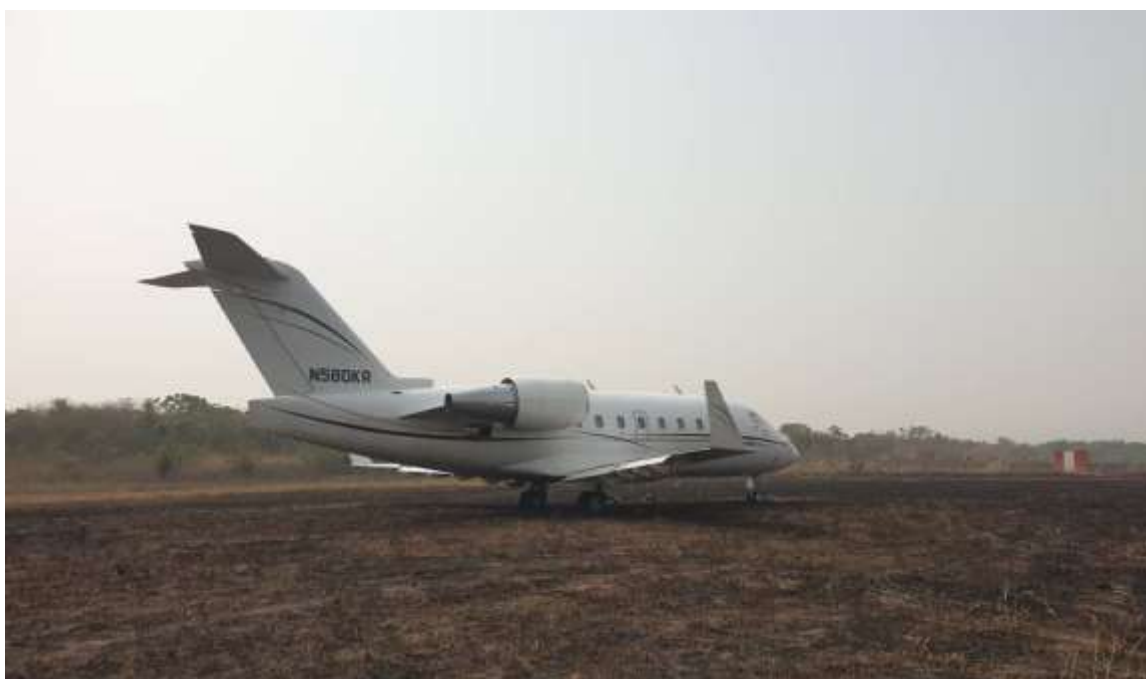
The aircraft was intact with no visible damage, except the dent on the leading edge of the left-wing.

**Figure 5: The aircraft where it stopped**

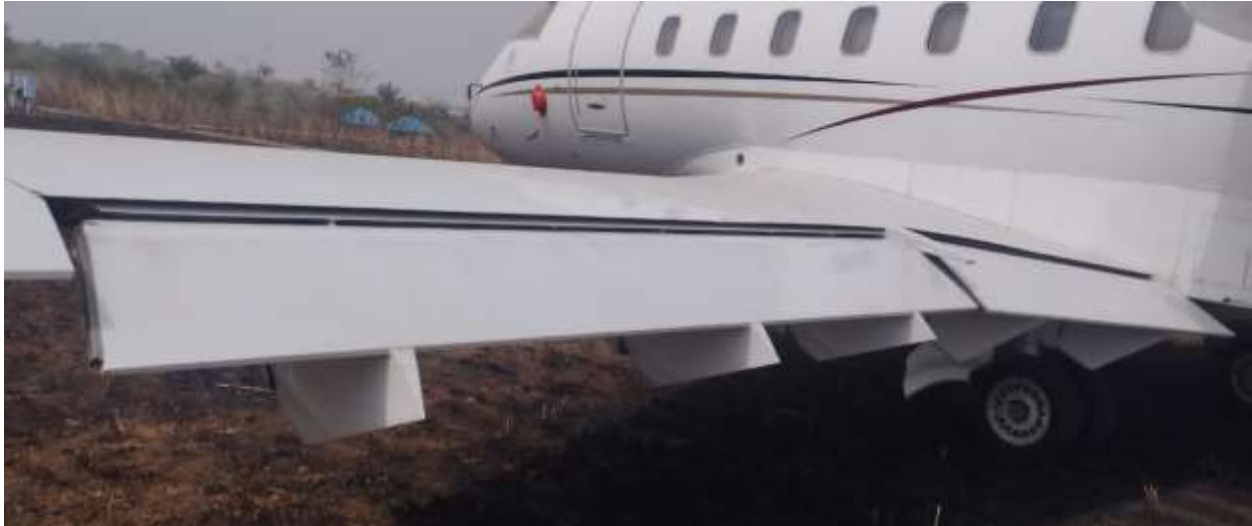
7. Post Occurrence inspection revealed that flap surface position was in agreement with the flap selector.
8. The aircraft had a valid Certificate of Airworthiness.

**Figure 6: The left-wing Flap surface position on landing**

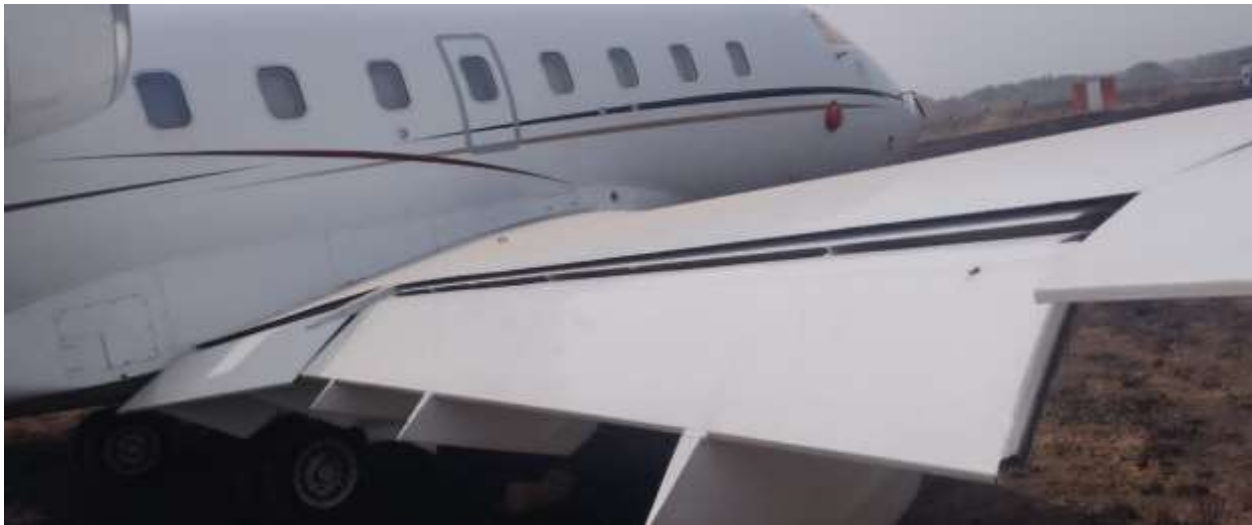
**Figure 7: The right-wing flap surface position on landing**

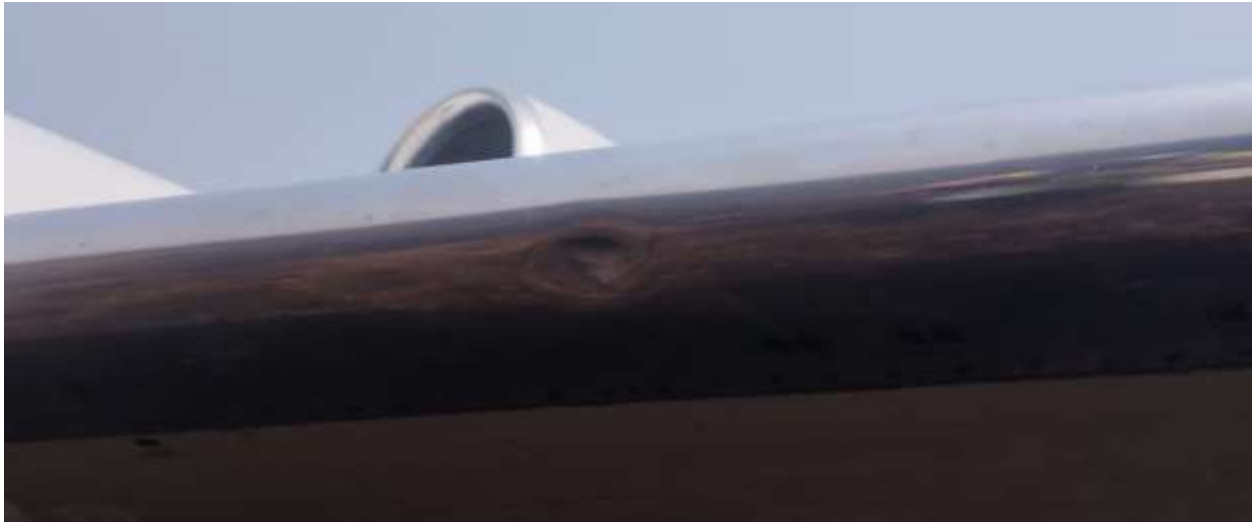
However, the mid-section of the left-wing leading edge impacted one approach light. The approach light was broken and a dent with dimension (2x1.5x.25 inches) was produced on the leading edge surface.

**Figure 8: Dent created about the mid-section of left wing leading edge surface**

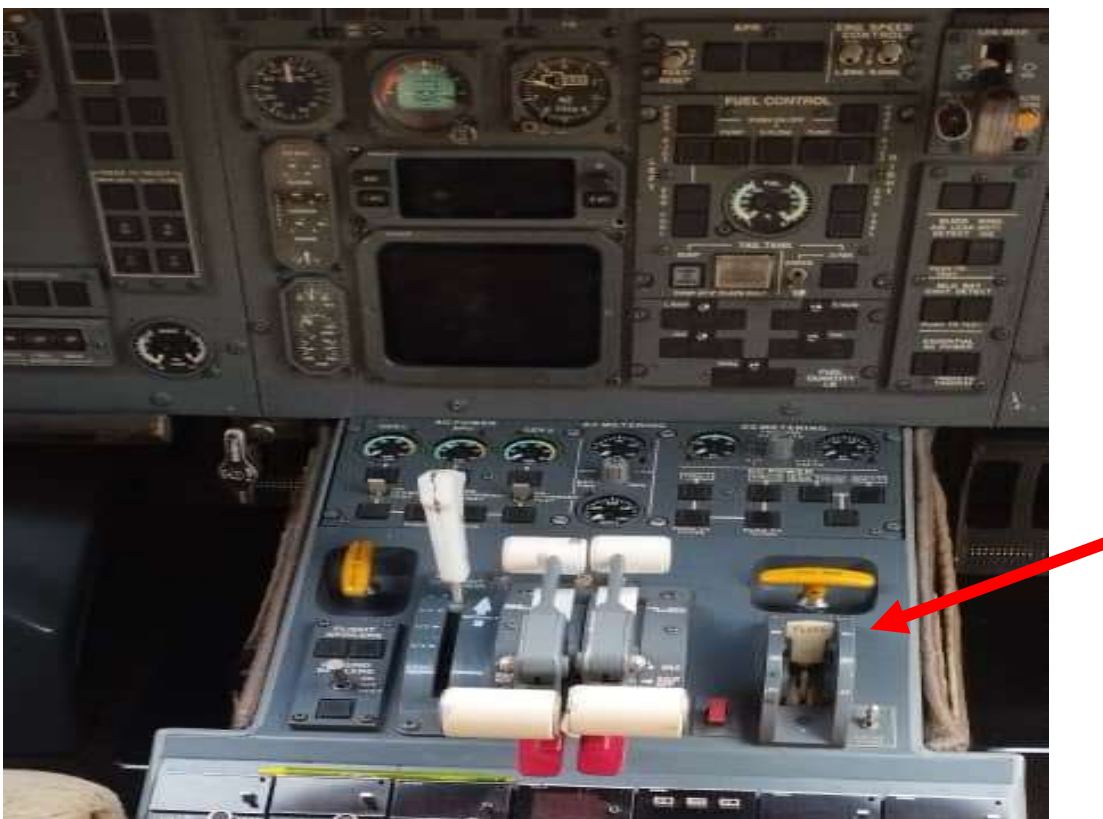
5. The crew stated that the flap selector was stuck at 20<sup>0</sup> detent after the aircraft has been configured for landing during the approach.
6. The crew did not report the flaps failure to the ATC.

**Figure 9: Flap handle Selector position on the flight pedestal**
