# **PRELIMINARY REPORT ON THE SERIOUS INCIDENT INVOLVING AN EMBRAER ERJ 145 AIRCRAFT OPERATED BY UNITED NIGERIA AIRLINES WITH NATIONALITY AND REGISTRATION MARKS 5N-BWW WHICH OCCURRED ON RUNWAY 18L MURTALA MUHAMMED INTERNATIONAL AIRPORT, LAGOS ON 31ST MAY, 2023**

<b>Registered operator:</b>	United Nigeria Airlines Limited
<b>Aircraft type and model:</b>	Embraer ERJ 145LR
<b>Manufacturer:</b>	Yabora Industria Aeronautica, S.A.
<b>Date of manufacture:</b>	January, 2002
<b>Nationality and registration marks:</b>	5N-BWW
<b>Serial number:</b>	145553
<b>Location:</b>	Runway 18L, Murtala Muhammed International Airport, Lagos
<b>Date and time:</b>	31st May 2023 at about 16:04:41 h

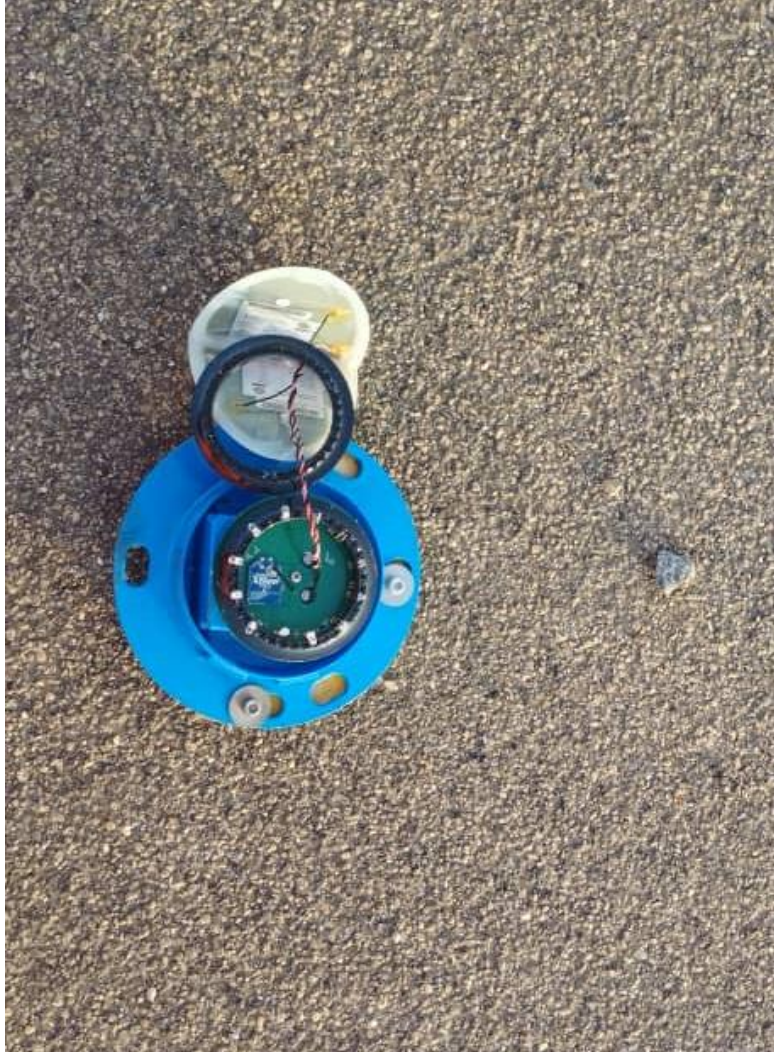
Two taxi-way edge lights were broken.

**Figure 1: Picture of broken taxiway edge light**

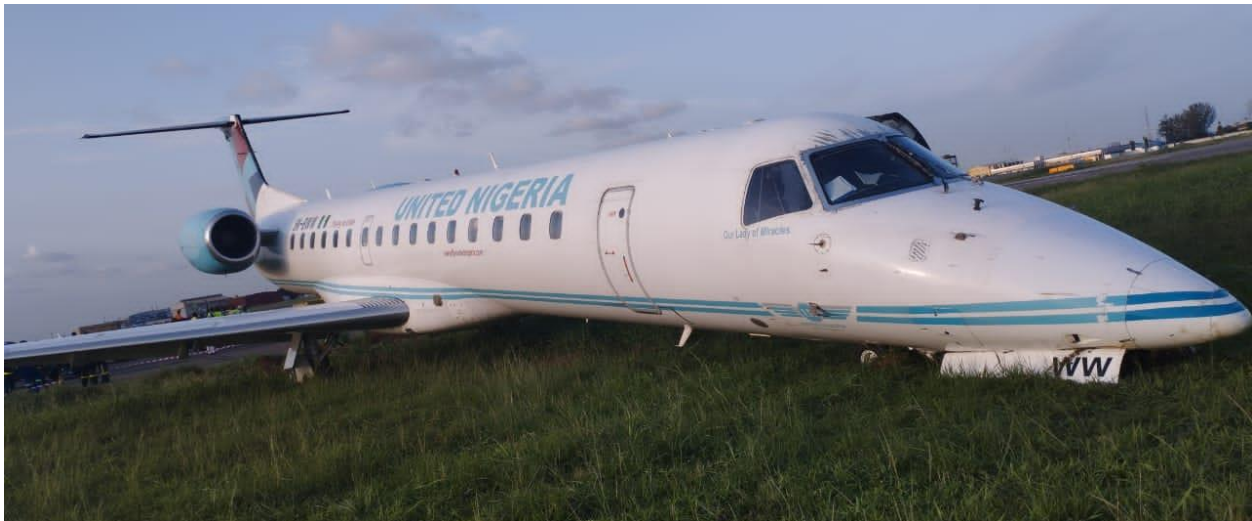
During landing roll, the aircraft veered to the right of runway 18L centreline for a distance of about 936 m from the runway threshold to the runway shoulder and continued onto

the grass verge. It further moved on the grass verge, crossed a drainage channel onto the paved way at Link B3, a distance of about 1,760 m and continued onto the grass verge on the other side of the link. The aircraft then crossed another drainage channel and having travelled a total distance of about 1,860 m from the runway threshold, came to a stop. In the process, the aircraft nose landing gear assembly collapsed.

**Figure 2: The aircraft where it stopped on the grass verge**

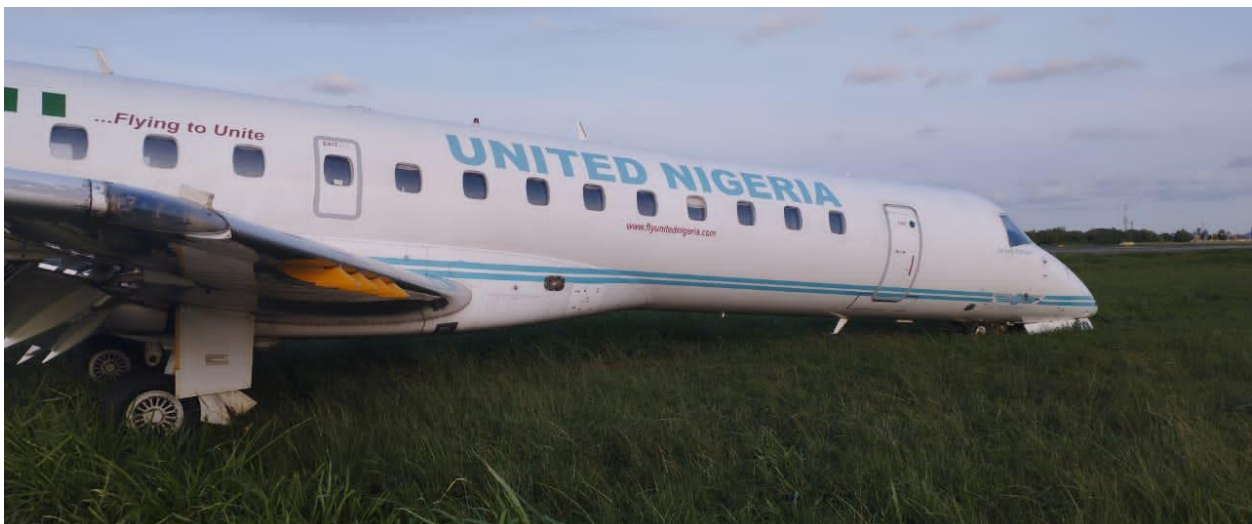
**Figure 3: Picture of the final position of 5N BWW after the occurrence.**

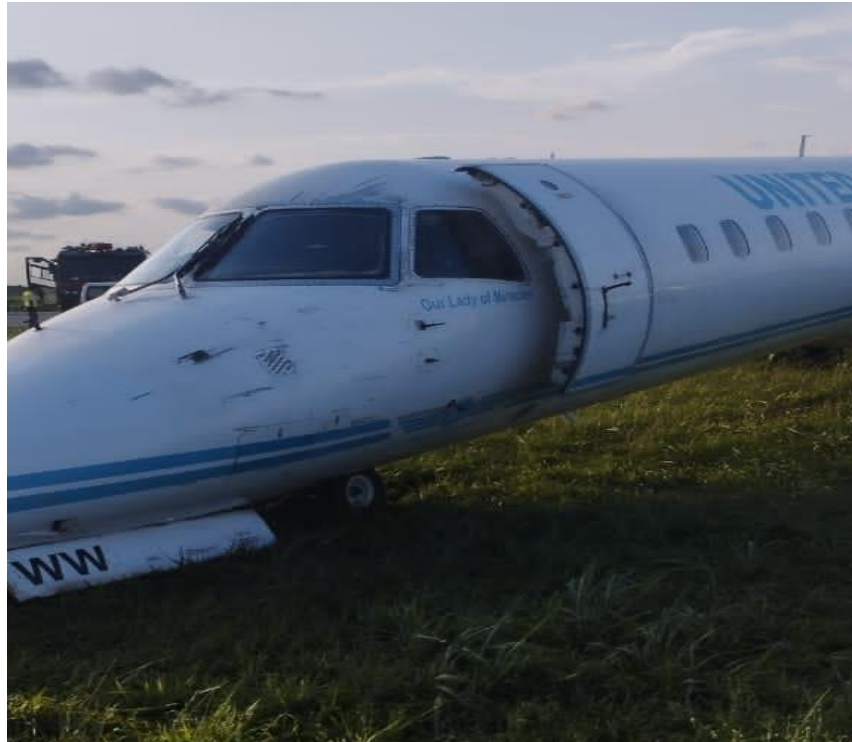
**Figure 4: The collapsed nose wheel landing gear**

United Nigeria Airlines should ensure compliance with Embraer Service Bulletin (SB) 145-32-0099 (current revision 03, dated April 8, 2005). The SB recommended upgrading the nosewheel steering hydraulic manifold, which required inspecting specific dimensions that were considered critical for the proper operation of the O-ring seals within the EHSV to ensure that they were within tolerance limits.
