**PRELIMINARY REPORT ON SERIOUS INCIDENT INVOLVING A BOMBARDIER CRJ900 AIRCRAFT WITH NATIONALITY AND REGISTRATION MARKS 5N-BXR OWNED AND OPERATED BY FLYFORVALUE AVIATION LIMITED AT PORT HARCOURT INTL. AIRPORT, RIVERS STATE ON 14TH NOVEMBER 2023**

<b>Registered owner and operator:</b>	Flyforvalue Aviation Limited (Value Jet)
<b>Aircraft type and model:</b>	Bombardier CRJ900
<b>Manufacturer:</b>	Mitsubishi Heavy Industries Ltd.
<b>Date of manufacture:</b>	2006
<b>Nationality and registration marks:</b>	5N-BXR
<b>Serial number:</b>	15065
<b>Location:</b>	Grass verge adjacent Link A5, Runway 21, Port Harcourt Airport, Rivers state
<b>Date and time:</b>	14th November 2023 at about 15:18 h

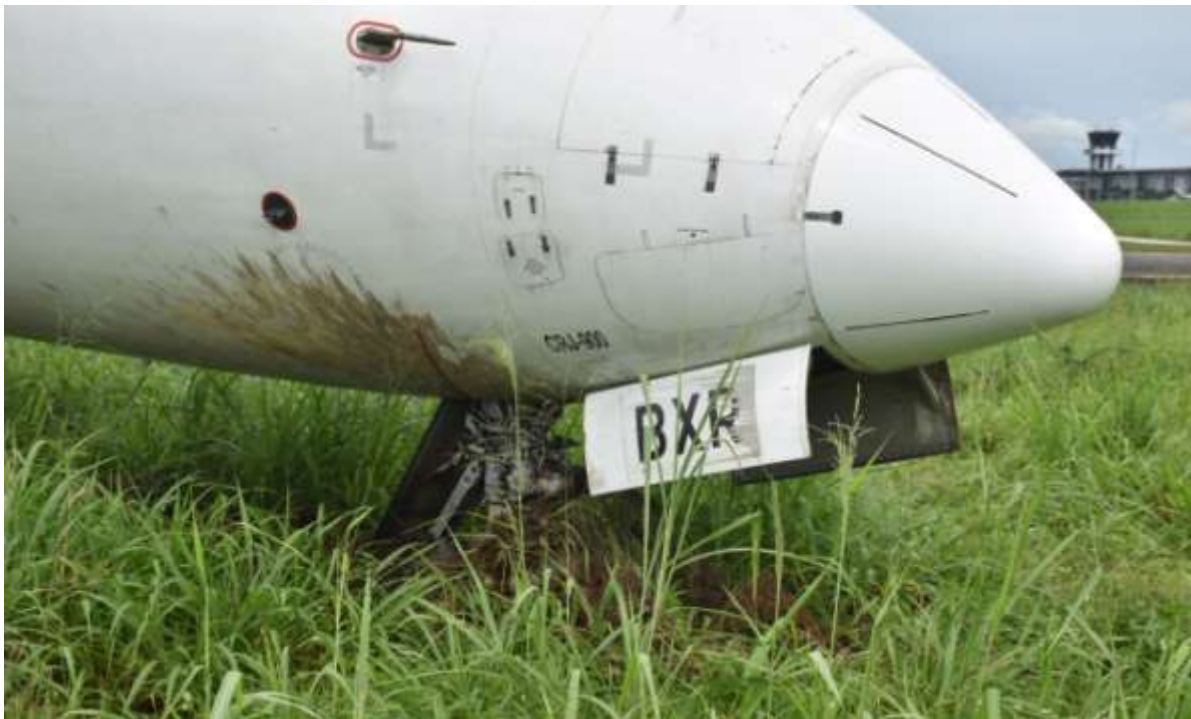
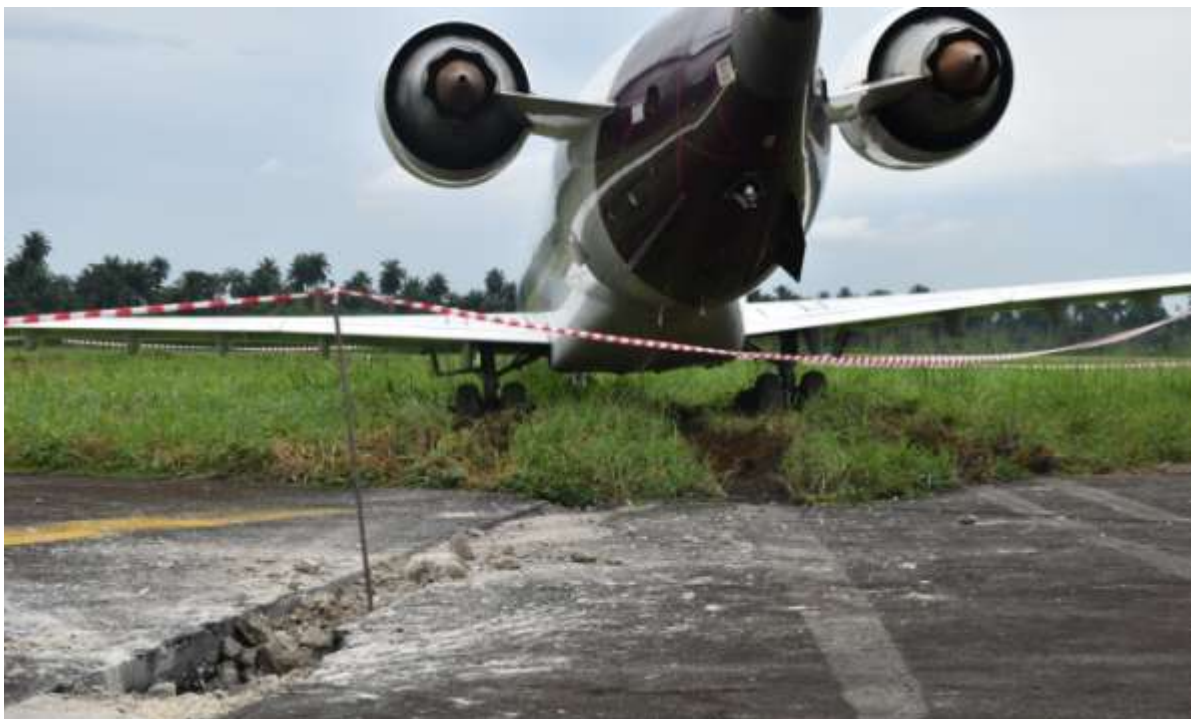
A drainage channel at the end of runway 21 was damaged where the aircraft crossed it en route the grass verge adjacent Link A5.

Tyre marks on the runway leading to the final position of the aircraft showed that the aircraft impacted and damaged a drainage duct and uprooted some embedded power cables.

**Figure 2: The damaged drainage duct (In the foreground)**
