**PRELIMINARY REPORT ON ACCIDENT INVOLVING HAWKER 800XP  
AIRCRAFT OPERATED BY FLINTS AERO SERVICES LTD. WITH NATIONALITY  
AND REGISTRATION MARKS 5N-AMM WHICH OCCURRED AT IBADAN  
AIRPORT, OYO STATE ON 3RD NOVEMBER, 2023**

<b>Registered owner and operator:</b>	Flints Aero Services Ltd
<b>Aircraft type and model:</b>	Hawker 800XP
<b>Manufacturer:</b>	Raytheon Aircraft Company, USA
<b>Date of manufacture:</b>	1999
<b>Nationality and registration marks:</b>	5N-AMM
<b>Serial number:</b>	258286
<b>Location:</b>	220 m short of the threshold, Runway 22, Ibadan Airport, Oyo state
<b>Date and time:</b>	3rd November 2023 at about 20:18 h

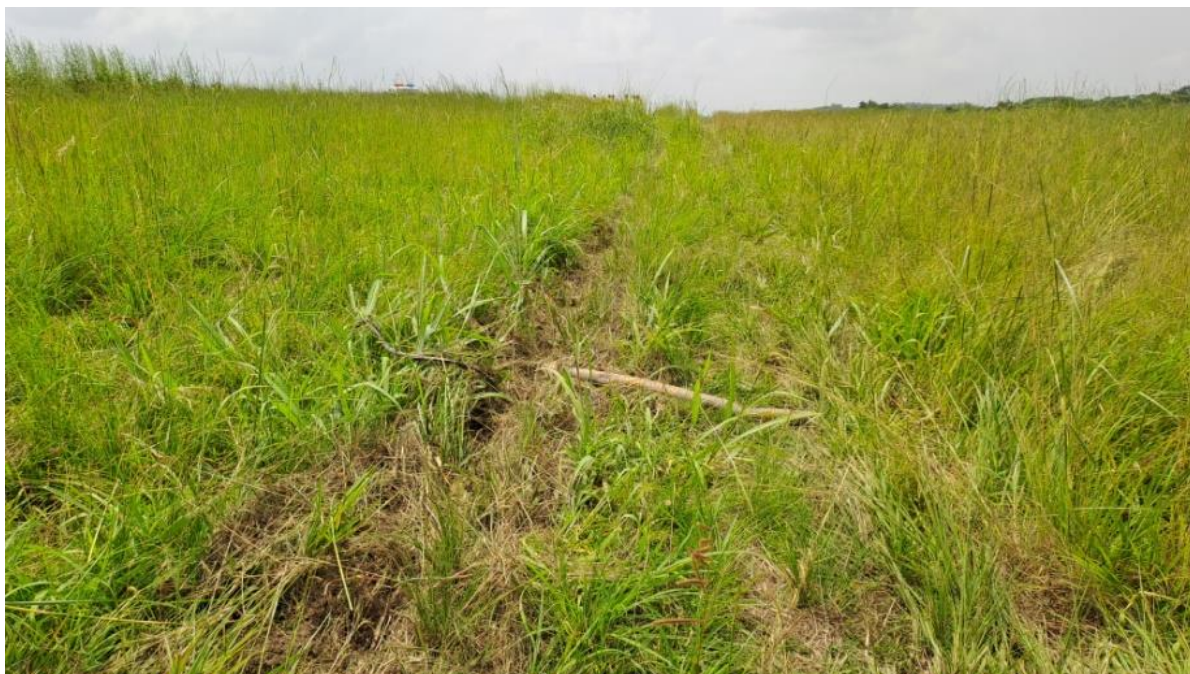
The aircraft touched down in the grass verge on the extended centreline of runway 22, about 220 m from the threshold. It travelled in a relatively straight direction through the grass verge impacting several rows of approach lights until it emerged unto the

**Figure 2: A view of the aircraft tracks from the grass verge. Runway 22 is just beyond the horizon**

1. The Nigerian Airspace Management Agency (NAMA) should ensure that it strictly observes the airport operational hours as published in the relevant Aeronautical Information Publication (AIP) and not permit extensions beyond the airport limitations.
2. The Nigerian Civil Aviation Authority (NCAA) should ensure that Flints Aero Services Limited operates within the limits of the approval given to it, in accordance with Section 18.2.4.3 of the Nigerian Civil Aviation Regulations 2015.
3. Flints Aero Services Limited should ensure that its flight crew have sufficient experience in night-time flight operations.
4. Federal Airports Authority of Nigeria (FAAN) should ensure that the overgrown grass verge on either side of runway 04/22 is immediately cleared.

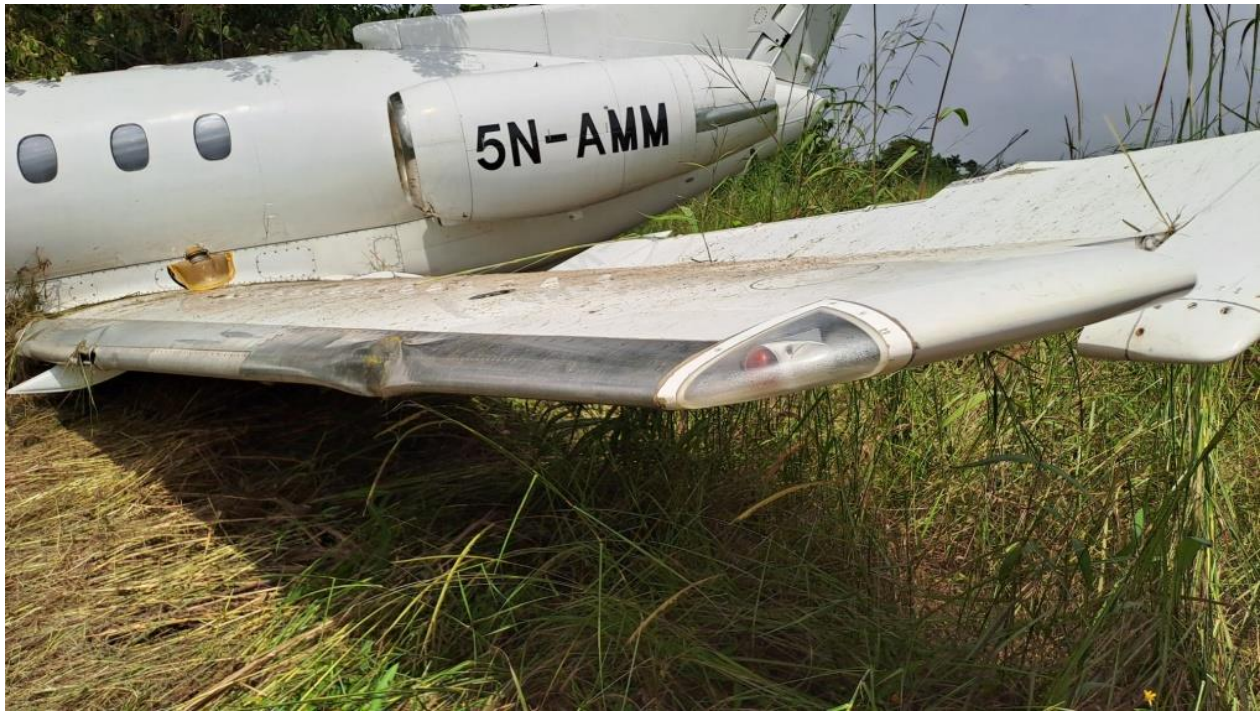
**Figure 6: Damage to the left wing leading edge and a fragment of the approach lighting fixture**

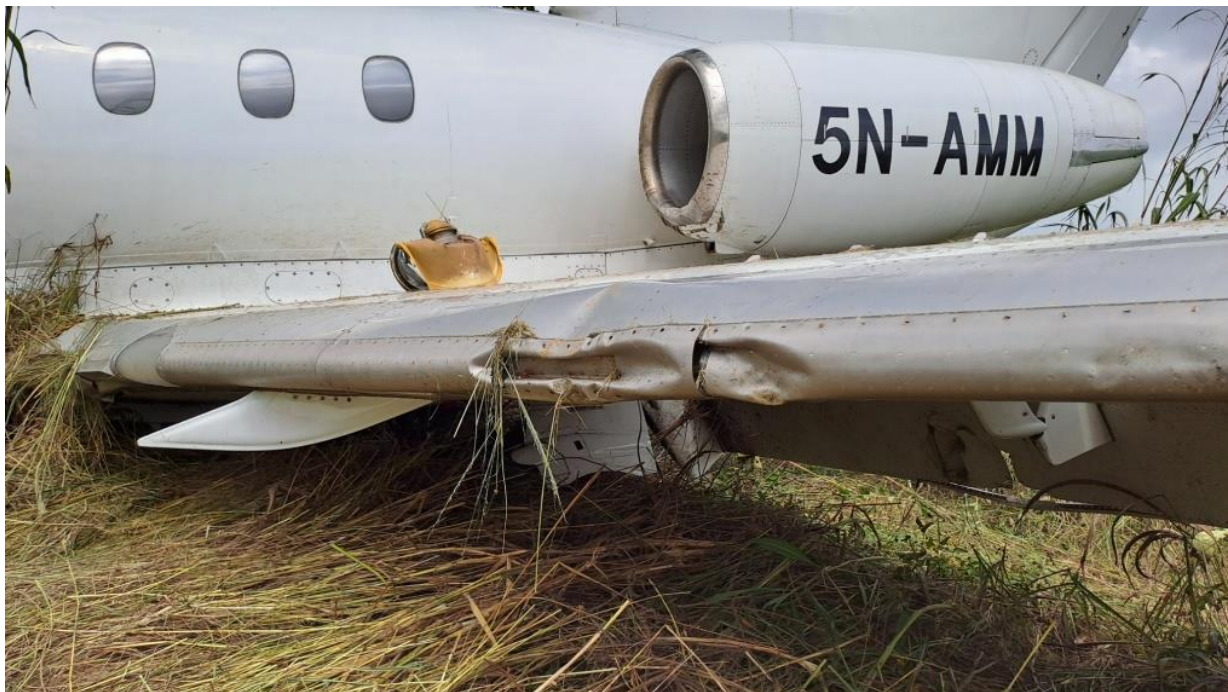
**Figure 7: Close-up of damage to the left wing leading edge**
