PRELIMINARY REPORT ON SERIOUS INCIDENT INVOLVING AN MD-82 AIRCRAFT OPERATED BY DANA AIRLINES LIMITED WITH NATIONALITY AND REGISTRATION MARKS 5N-BKI, WHICH OCCURRED ON RUNWAY 18L MURTALA MUHAMMED INTERNATIONAL AIRPORT, LAGOS ON 23 APRIL 2024

Registered operator:	Dana Airlines Limited
Aircraft type and model:	McDonnell Douglas MD-82
Manufacturer:	Boeing McDonnell Douglas
Year of manufacture:	1996
Nationality and registration marks:	5N-BKI
Serial number:	53542
Location:	Runway 18L, Murtala Muhammed International Airport, Lagos 6°34'32"N, 3°19'46"E
Date and time:	23 April 2024 at about 09:37:43 h. <i>(All times in this report are local time (UTC+1) unless otherwise stated)</i>

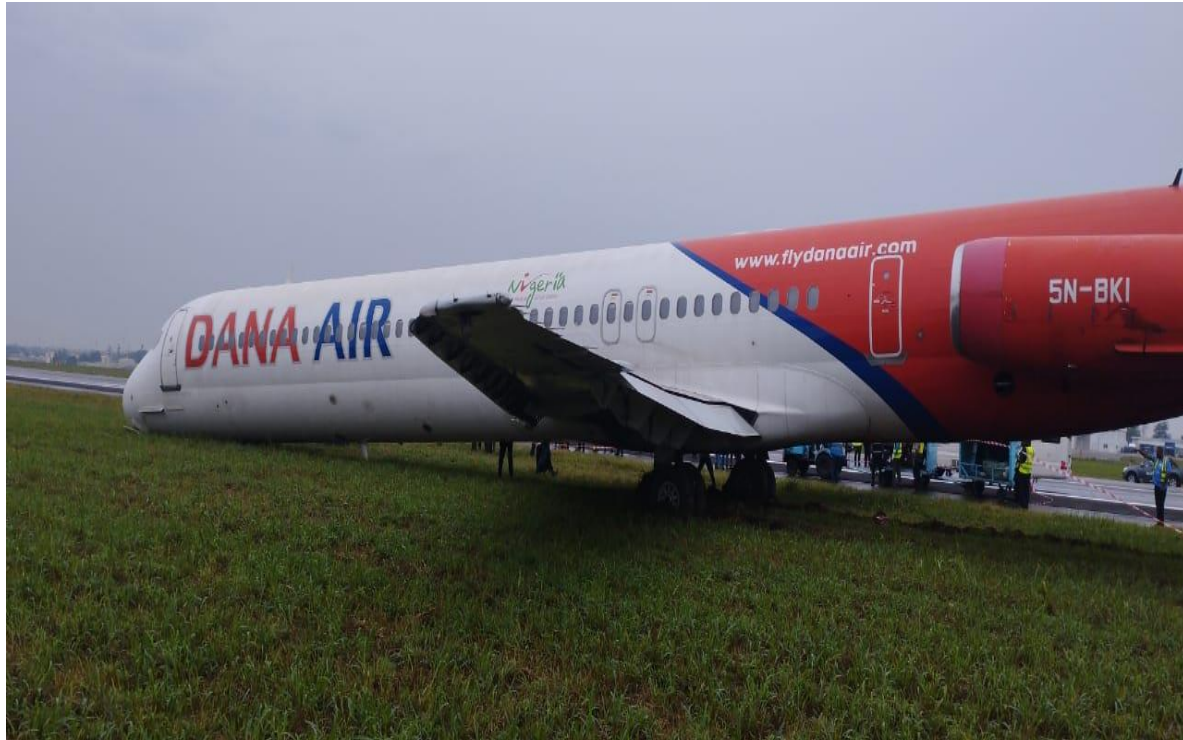
Figure 1: DAN0352 at its Final Stop Position

The crew stated that on reaching 80 knots during the Landing Roll, the Nose Landing Gear (NLG) collapsed, the aircraft lost directional control, veered off to the left of the runway centreline, and exited the runway at about 2,094 m from the threshold. It continued in the grass verge, crossed the paved Link 6, and came to a stop at about 2,343 m from the threshold of runway 18L, 36 m from the runway centreline.

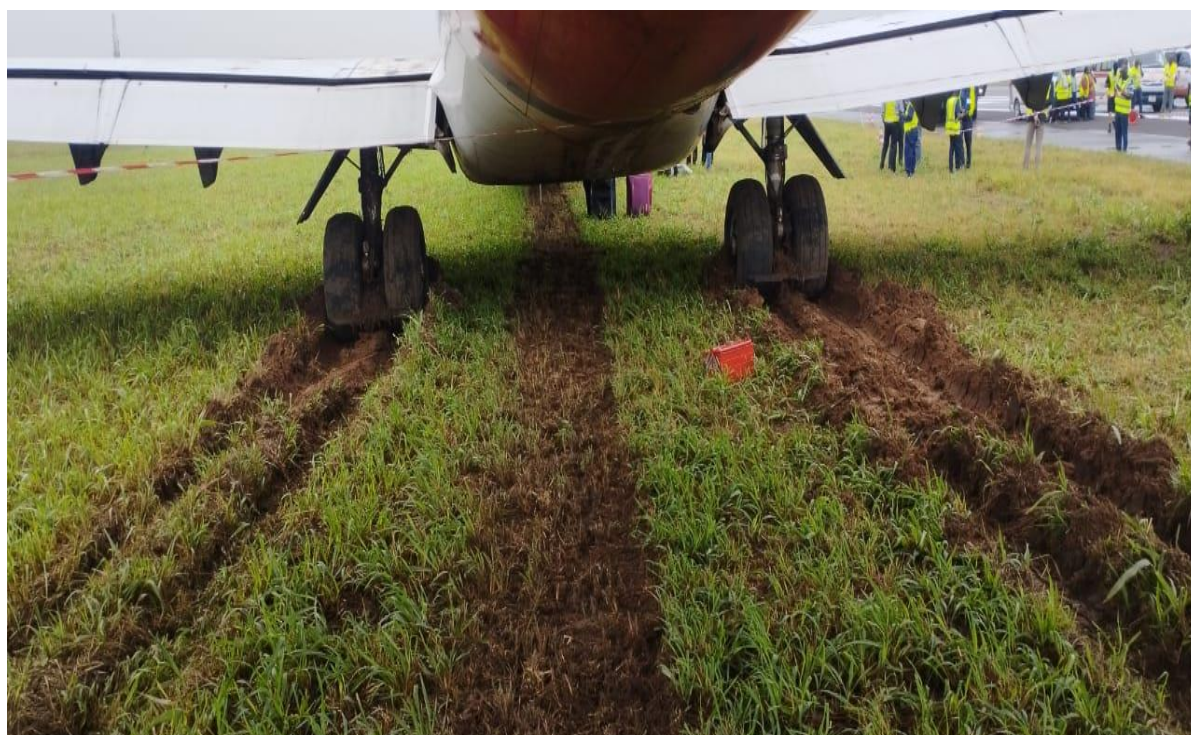
Figure 2: Track of Wheels on Grass Verge

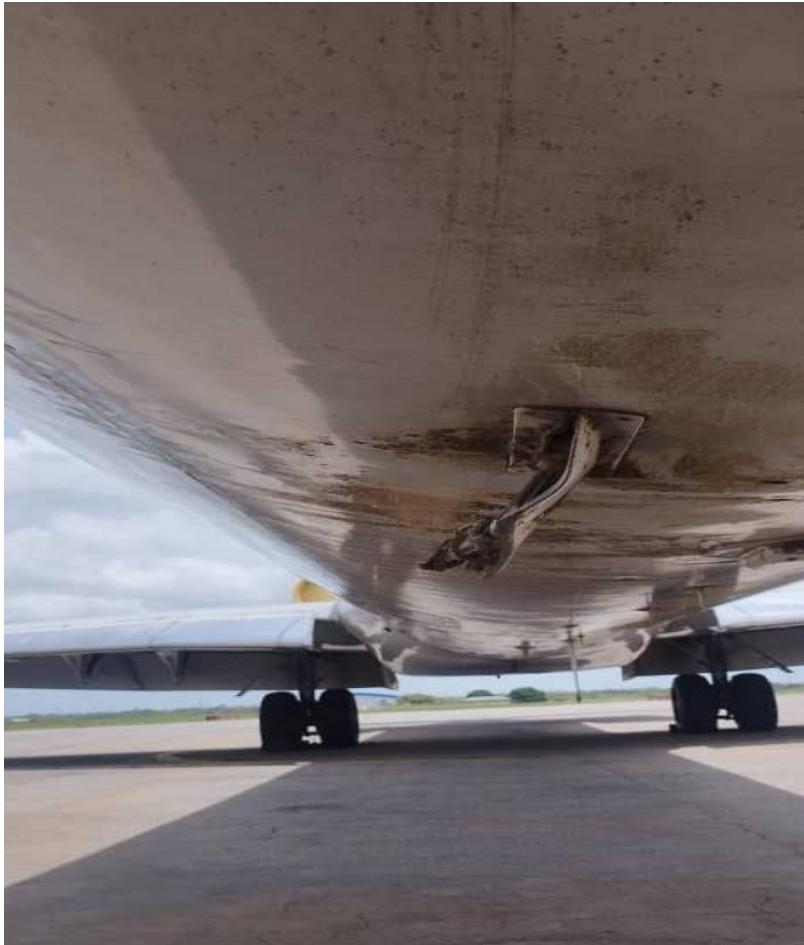
1. Distress to lower forward skin
2. The NLG lights were broken.
3. The Galley Drain was deformed.
4. An Antenna was broken.
5. The NLG Wheel Well Aft Door was damaged.

Figure 3: Damaged Galley Drain & Antenna
