**Preliminary Report on the Accident involving a Boeing 737-400 Freighter aircraft with nationality and registration marks 5N-JRT operated by Allied Air Limited, which occurred at Nnamdi Azikiwe International Airport (DNAA) Abuja, Nigeria on 11 December 2024.**

<b>Operator:</b>	Allied Air Limited
<b>Aircraft type and model:</b>	Boeing 737-400F
<b>Manufacturer:</b>	The Boeing Company, USA
<b>Year of manufacture:</b>	1993
<b>Nationality and registration marks:</b>	5N-JRT
<b>Serial number:</b>	26081
<b>Location:</b>	Runway 22 Nnamdi Azikiwe International Airport (DNAA) Abuja
<b>Date and Time:</b>	11 December 2024 at 10:04 h (All times in this report are local time, equivalent to (UTC+1) unless otherwise stated)

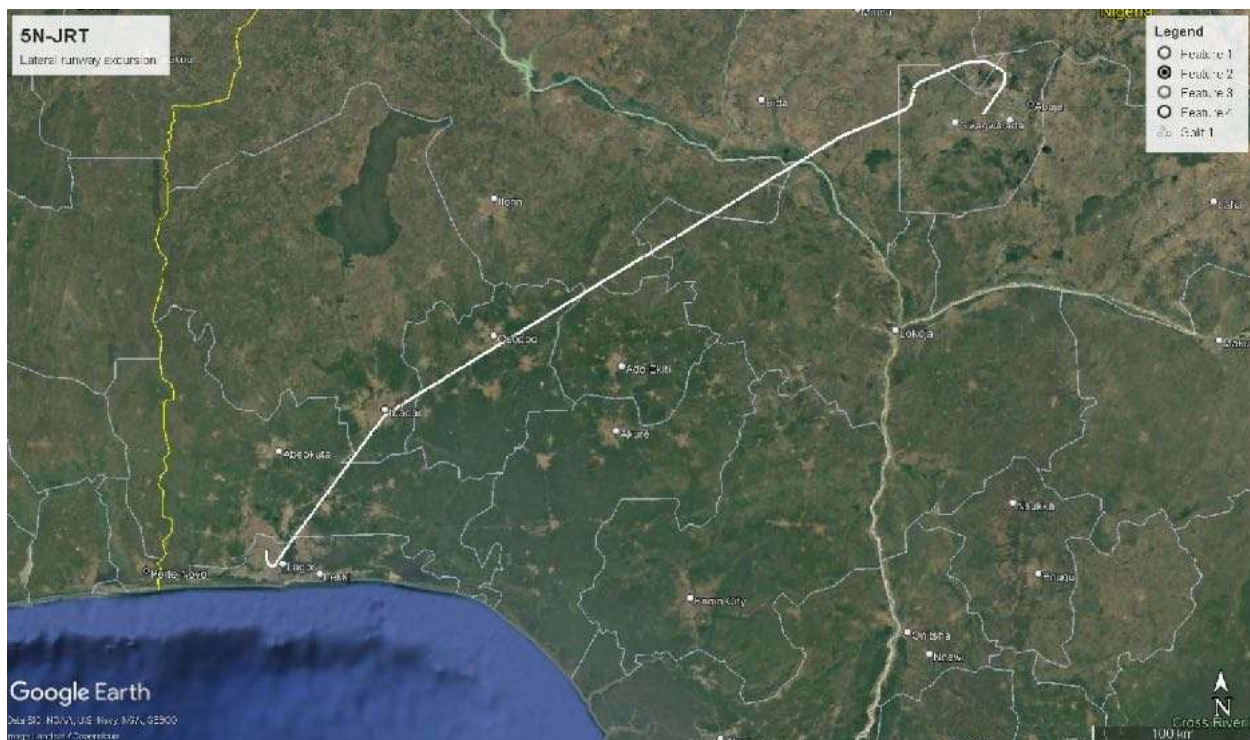
**Figure 1:** Flight track for AJK 206

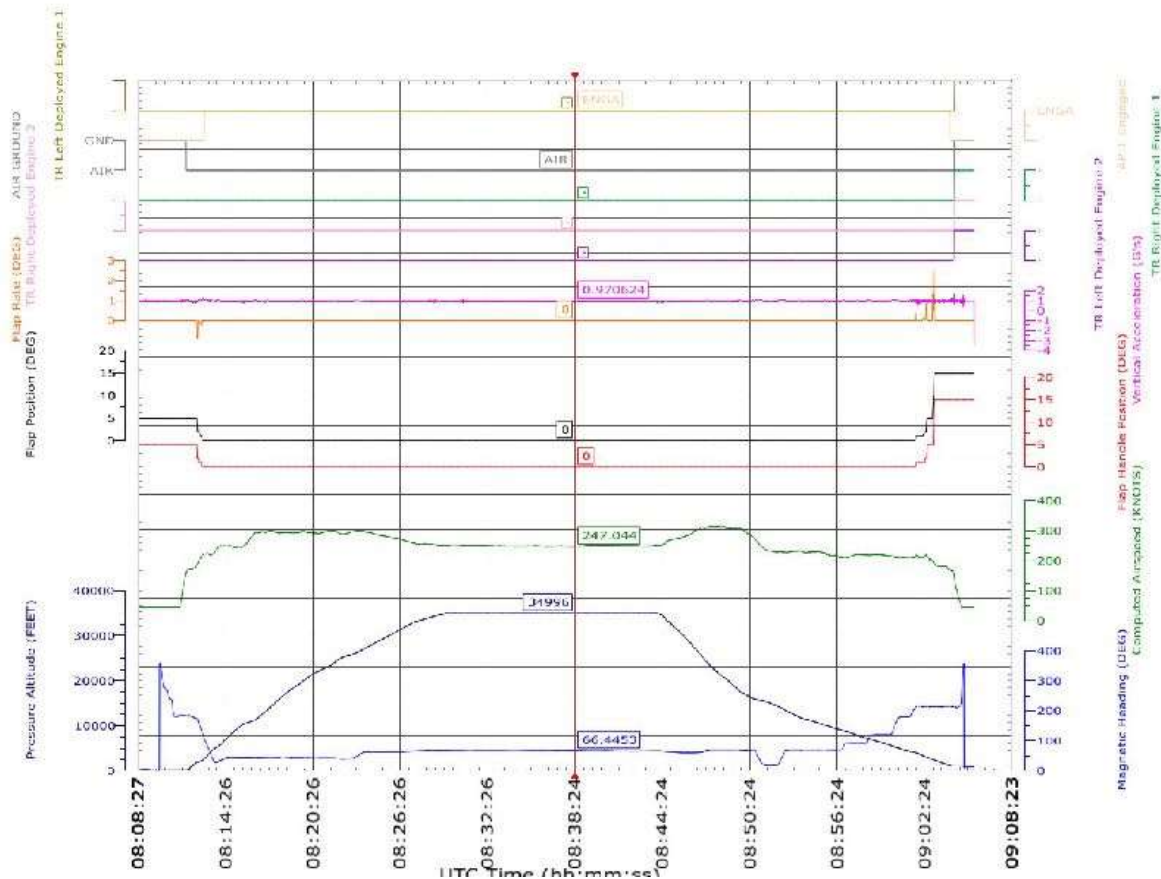
**Figure 2:** Relevant flight parameters for AJK 206

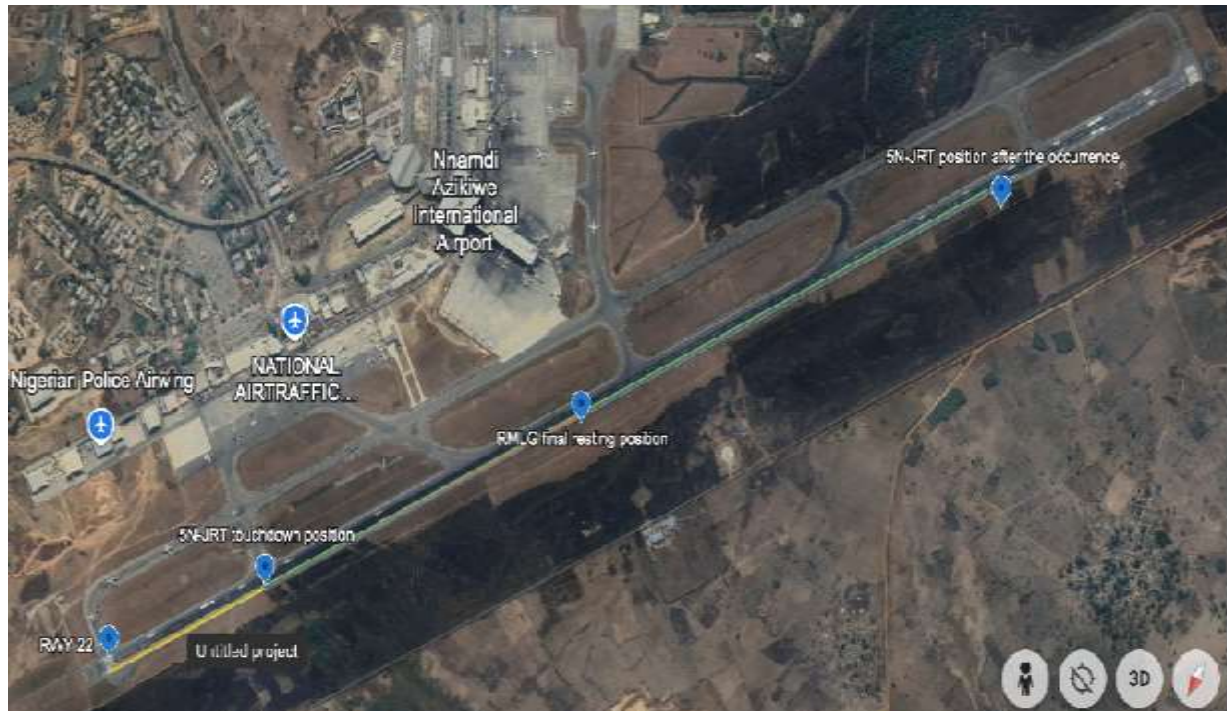
The aircraft continued the Landing Roll for 917 m from the Threshold of Runway 22, where the Right Main Landing Gear Assembly detached from its attachment points. The detached landing gear assembly was found on the grass verge right of Runway 22 at about 38 m from the runway centreline.

The aircraft continued its Landing Roll, with the underside of Engine number 2 Nacelle dragging on the runway for 1172 m before it veered off to the right of the runway, traversed the grass verge, and came to a stop about 54 m from the Runway Edge and 74 m from the Runway Centerline at a Heading of 170°.

**Figure 3:** Area view of DNAA showing the distance the aircraft moved.

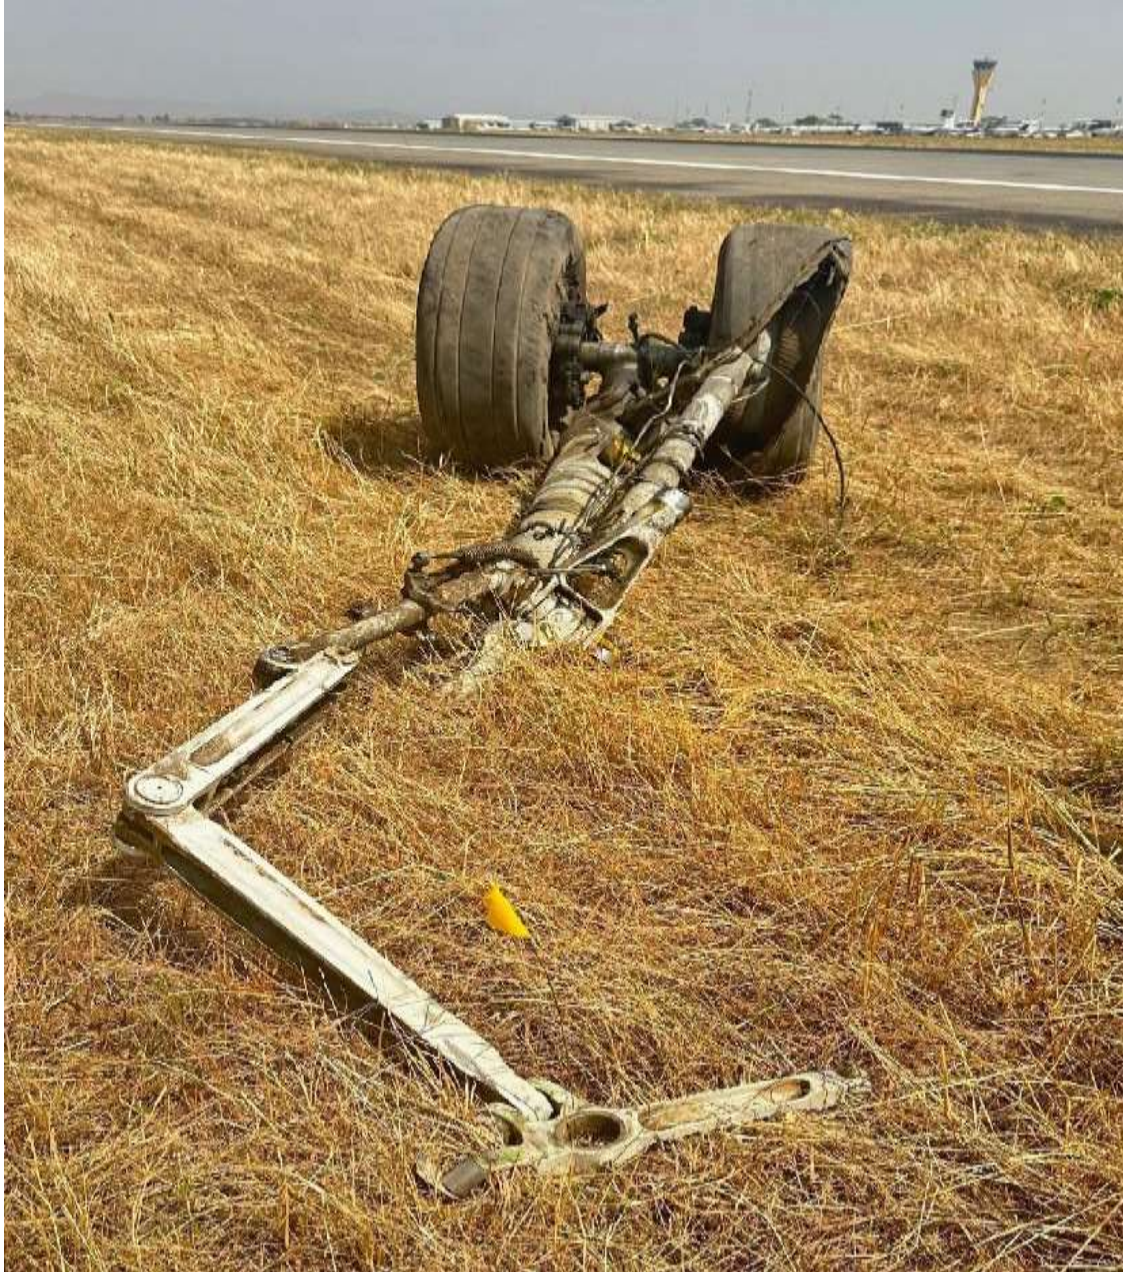
**Figure 4:** Detached Right Main Landing Gear found on the grass verge to the right of Runway 22

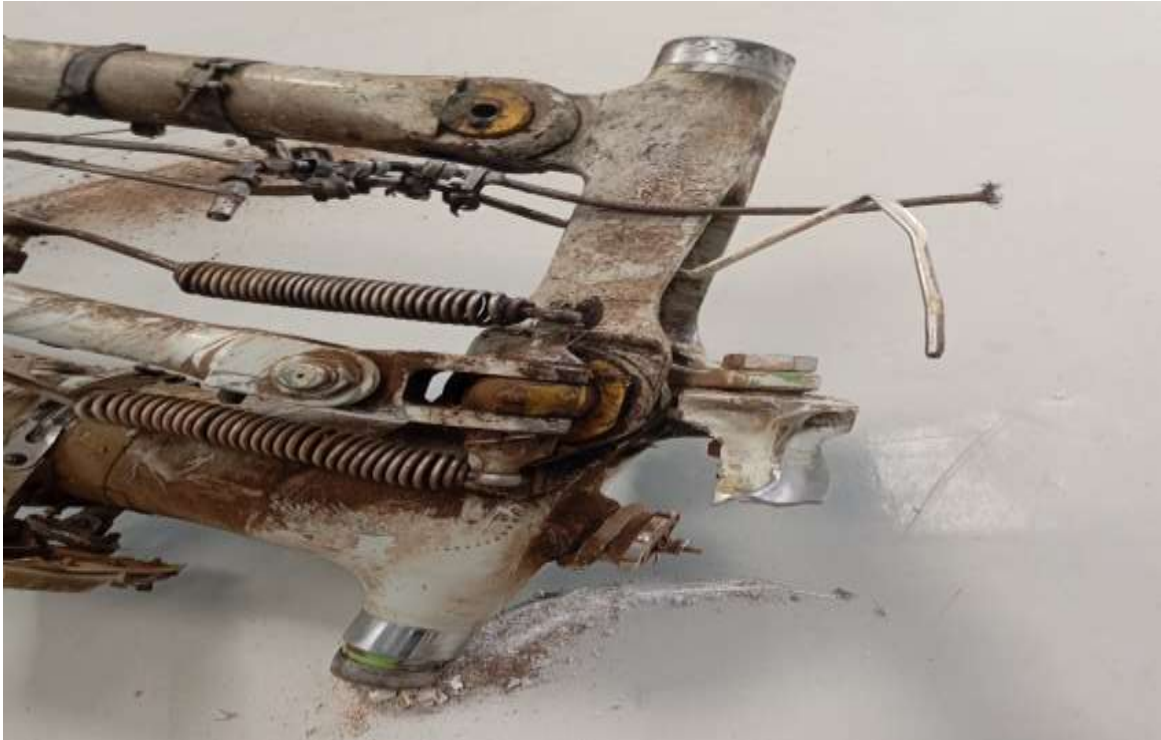
**Figure 5:** Point of attachment of the Right Main Landing Gear

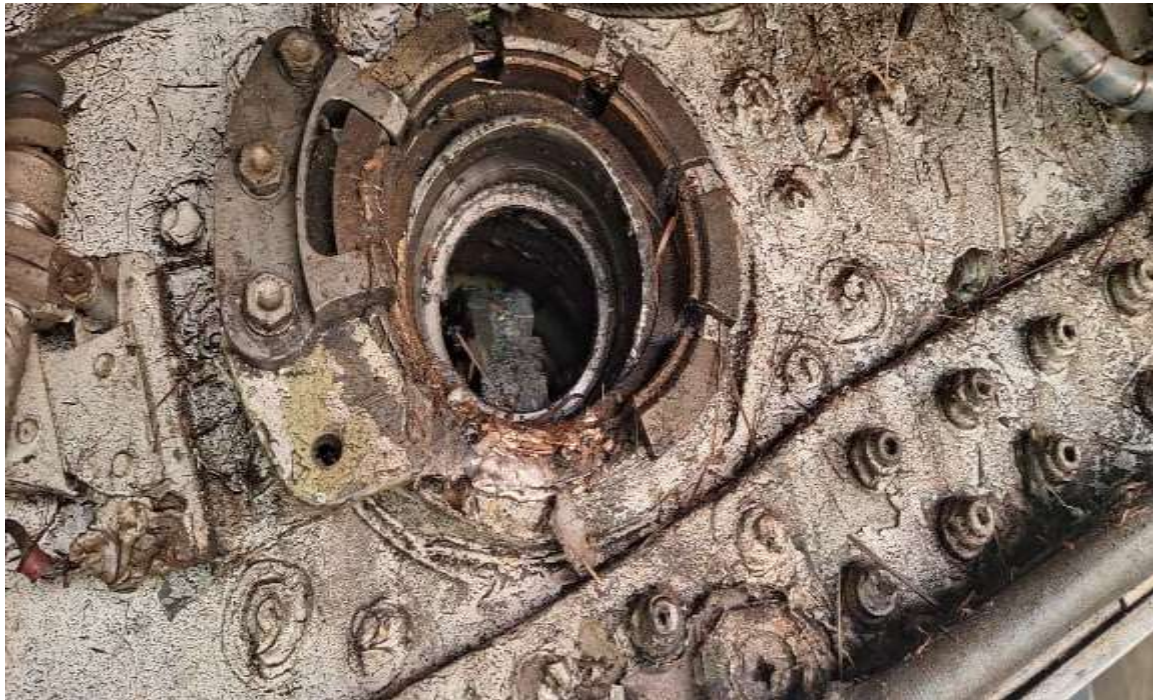
**Figure 6:** The Joint on the aircraft where the Right Main Landing Gear sheared off

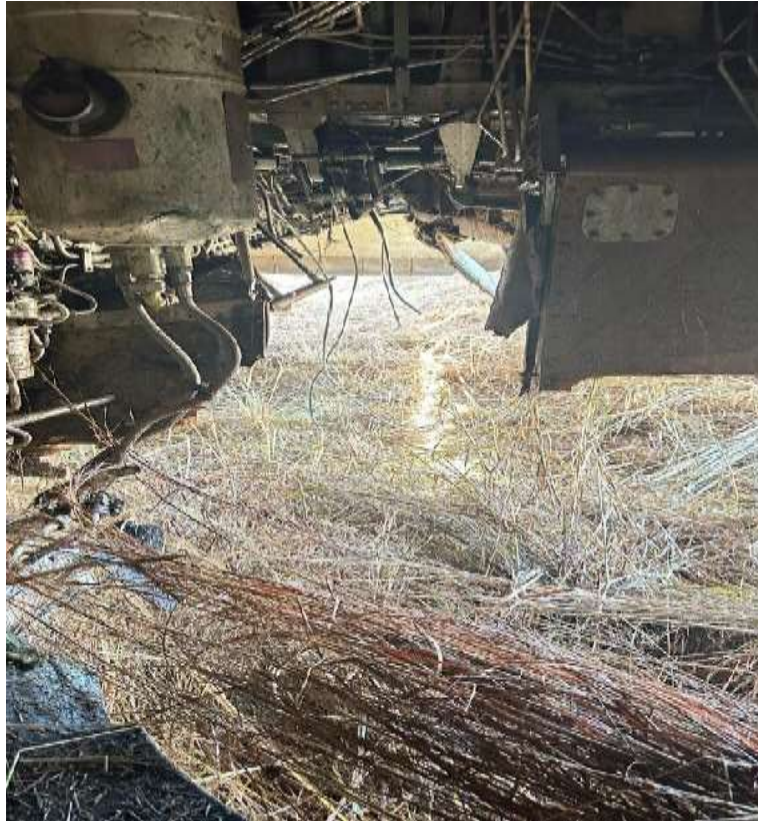
**Figure 7:** Landing Gear Wheel Well showing the position of the sheared-off Main Landing Gear

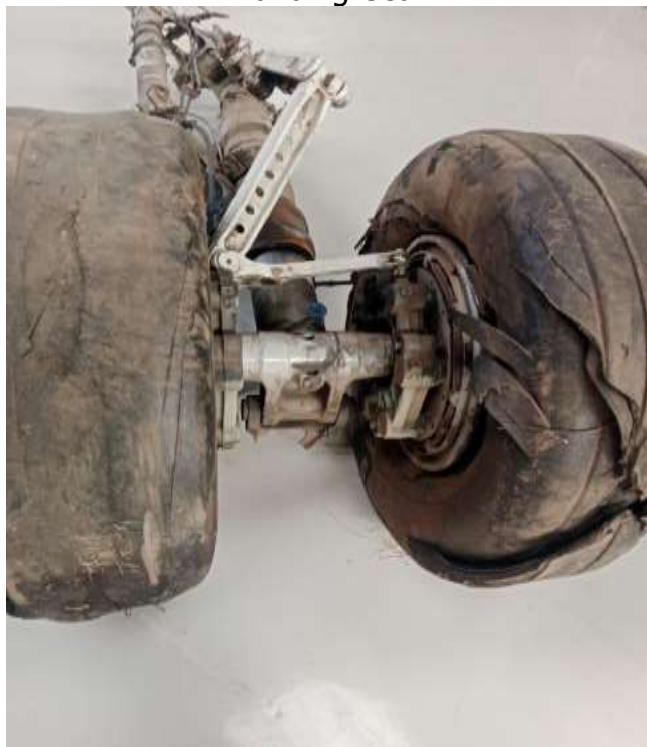
**Figure 8:** Damaged Right Main Wheel Tyres

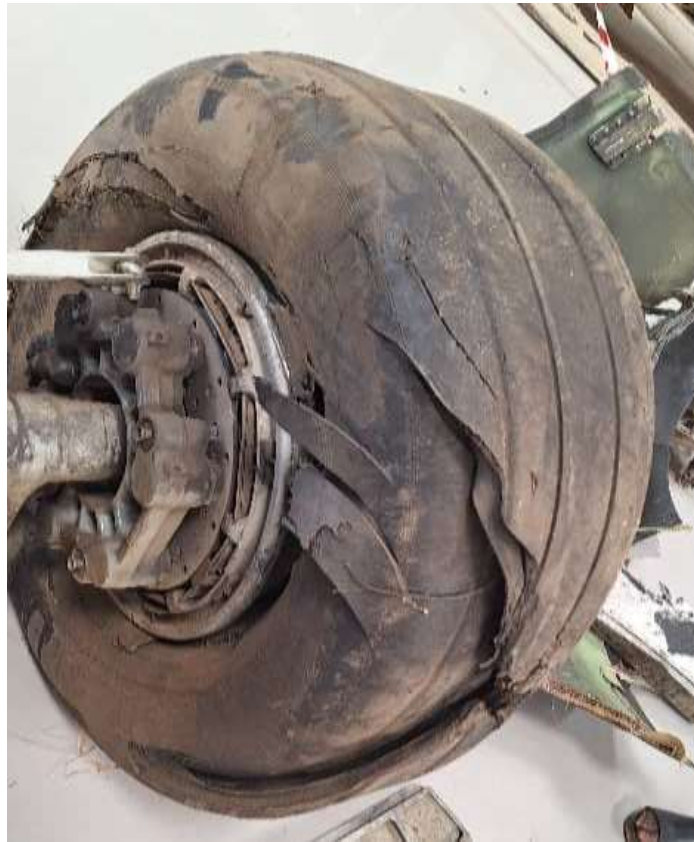
**Figure 9:** Damaged No.4 Main Wheel Assembly

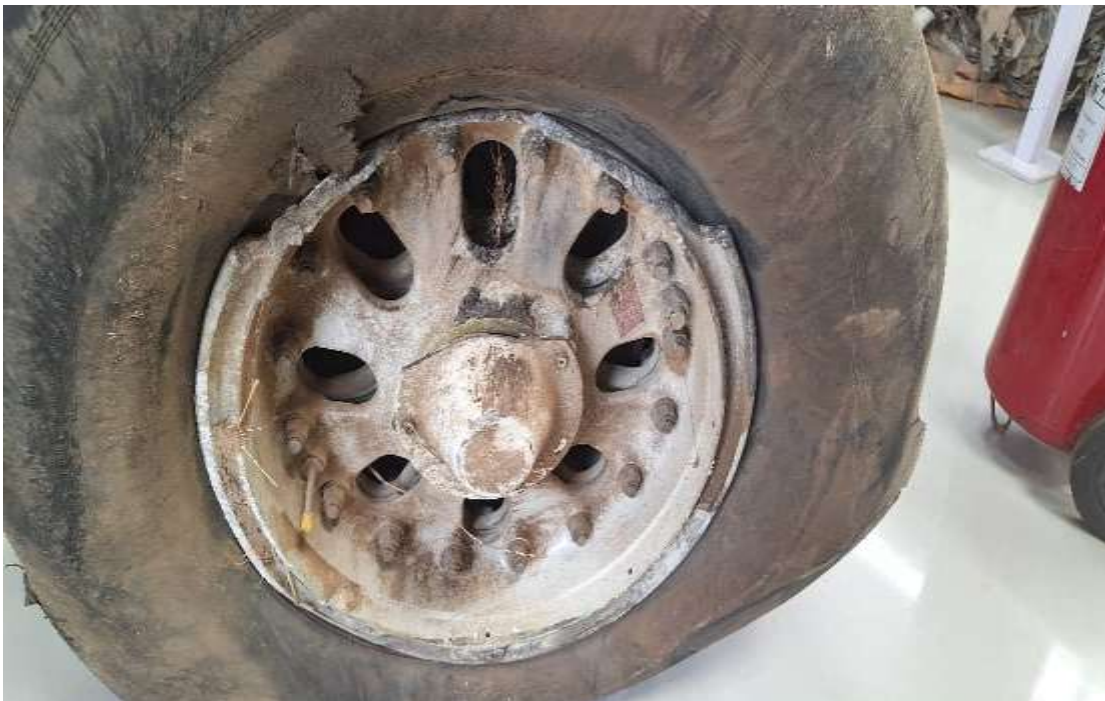
**Figure 10:** Damaged No.3 Main Wheel Assembly

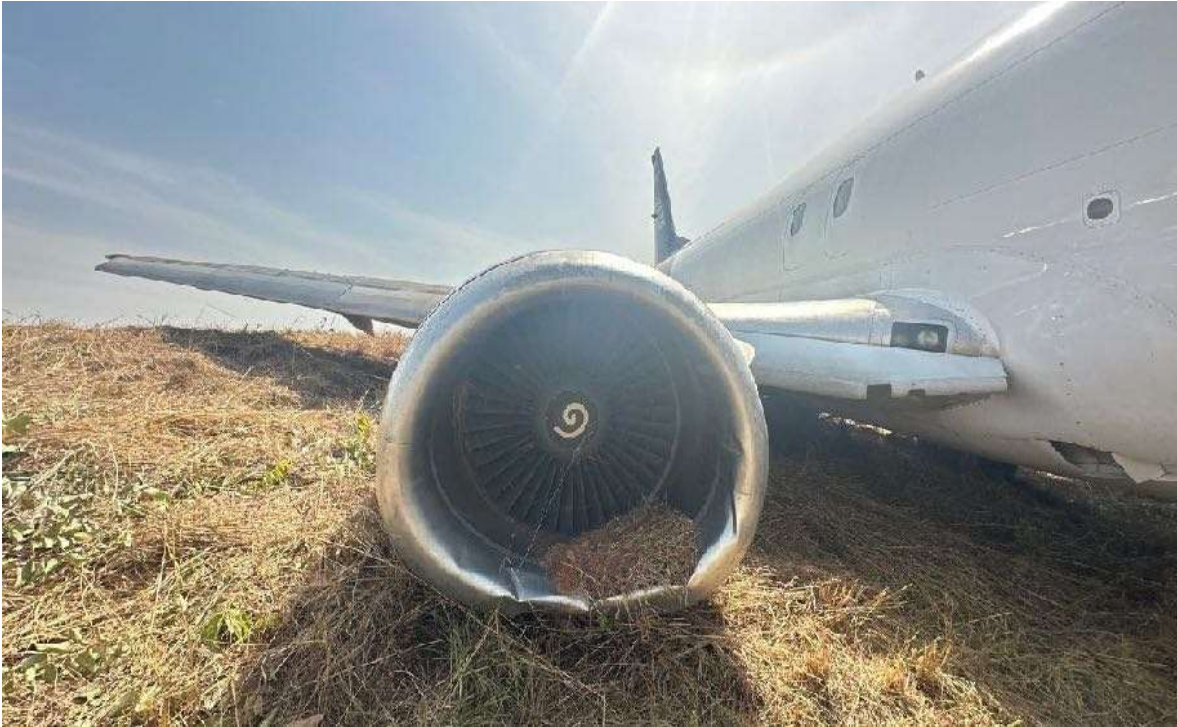
**Figure 11:** Dents/damage on the No.2 Engine Cowl

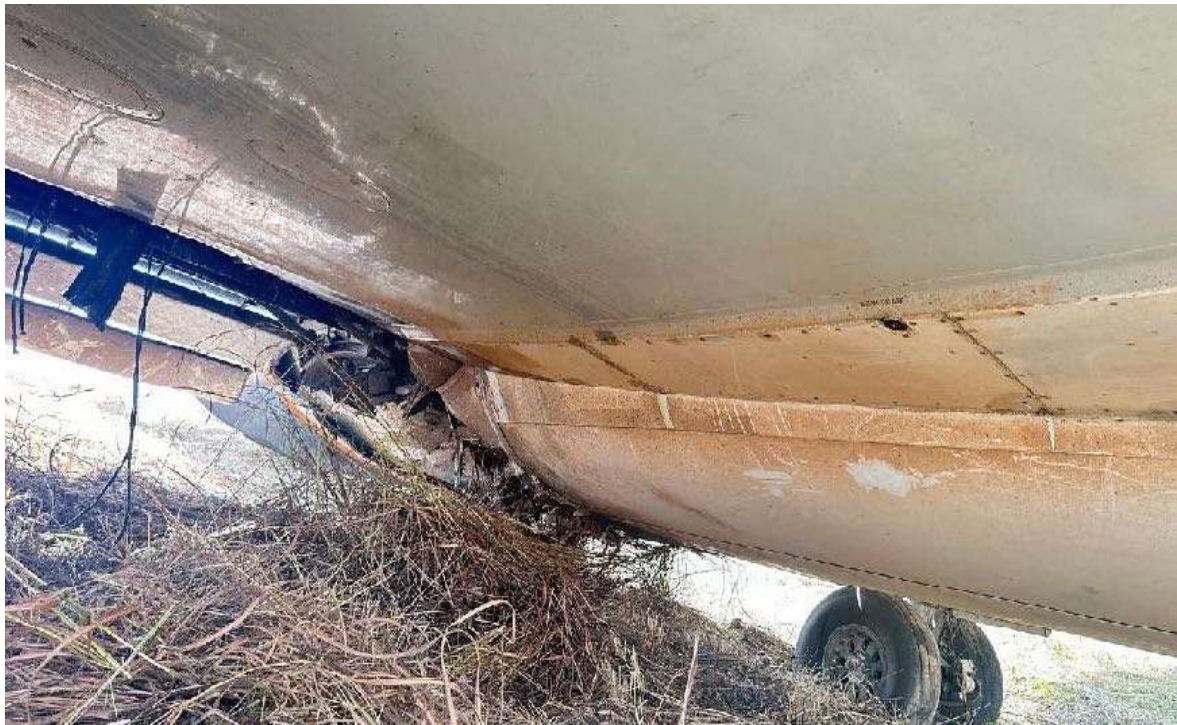
**Figure 12:** Damage to the lower section of the right-wing

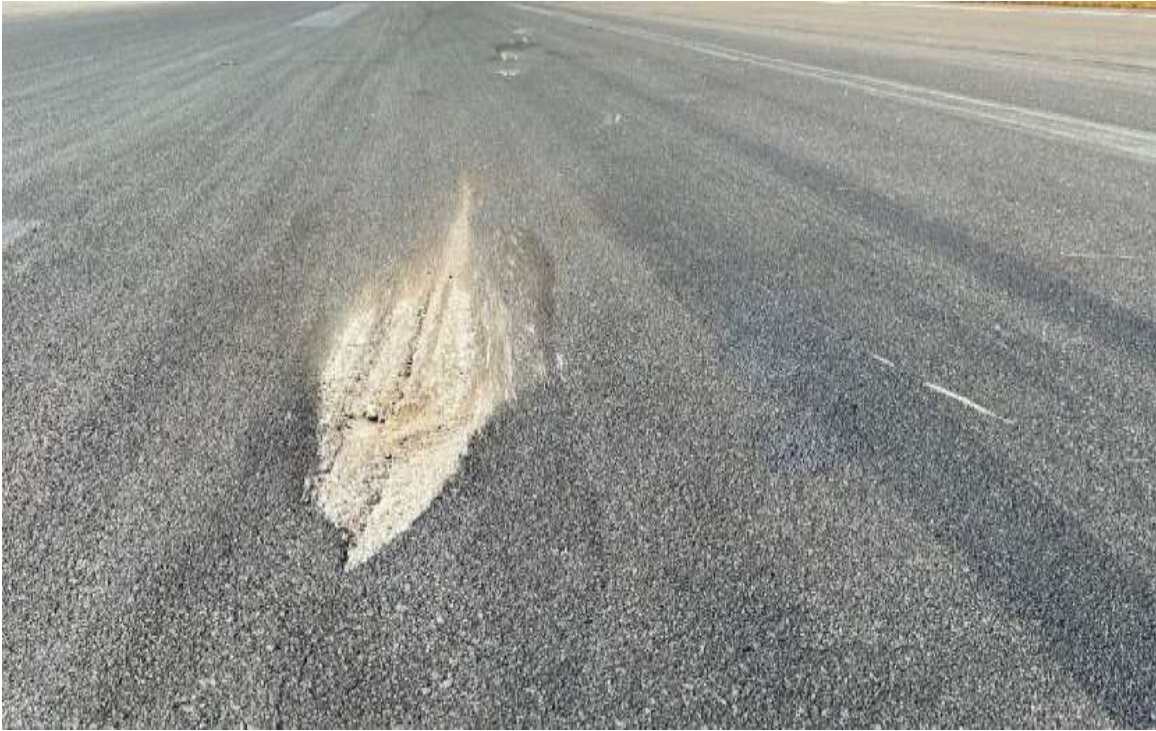
**Figure 13:** Scratch marks on runway surface

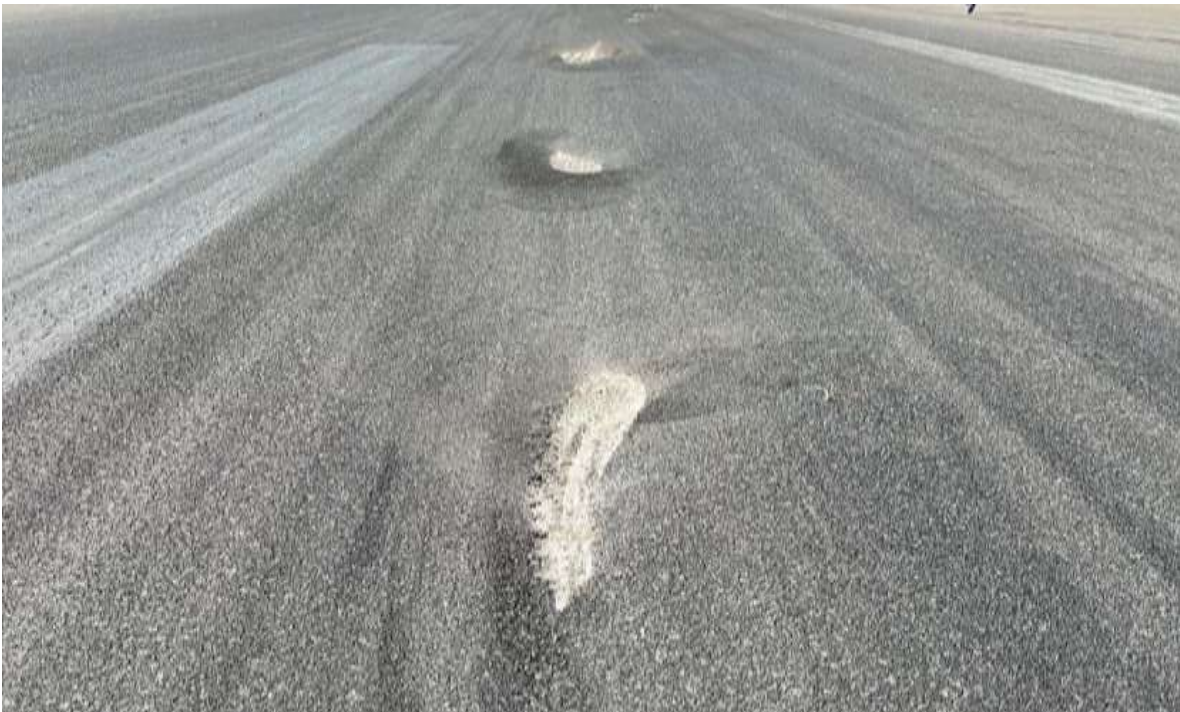
**Figure 14:** Multiple scratch marks on the runway surface
