AIRCRAFT ACCIDENT REPORT

SAHCO-MAL/2021/11/21/F

Nigerian Safety Investigation Bureau

Final Report on the Incident involving a ground collision between a Lavatory Service Truck with fleet number 9/5 operated by Skyway Aviation Handling Company Plc (SAHCO) and a parked Boeing 737-300 aircraft with nationality and registration marks 5N-DAB operated by Max Air Limited which occurred at Nnamdi Azikiwe International Airport Abuja on 21 November 2021.

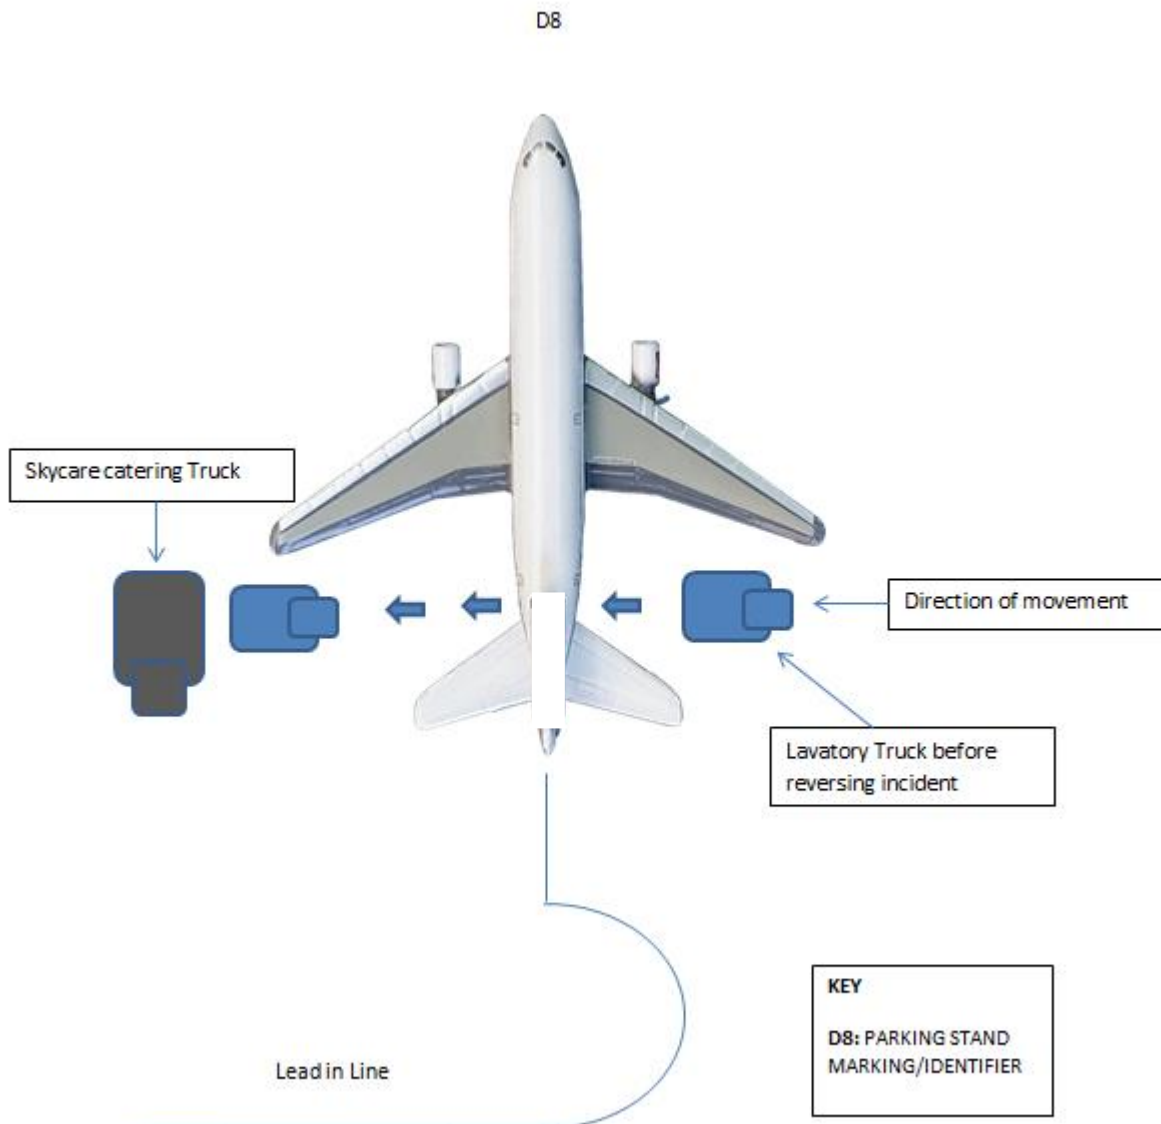
As the GSE driver attempted to reposition the Lavatory Service Truck, it moved (in reverse), passed underneath the rear bulkhead section of 5N-DAB, and continued moving until it eventually hit and was stopped by the Skycare Catering Services Truck on the left side of the Aircraft. The 5N-DAB, lavatory, and catering service trucks suffered various damage.

Figure 1: Sketch of the impact sequence.

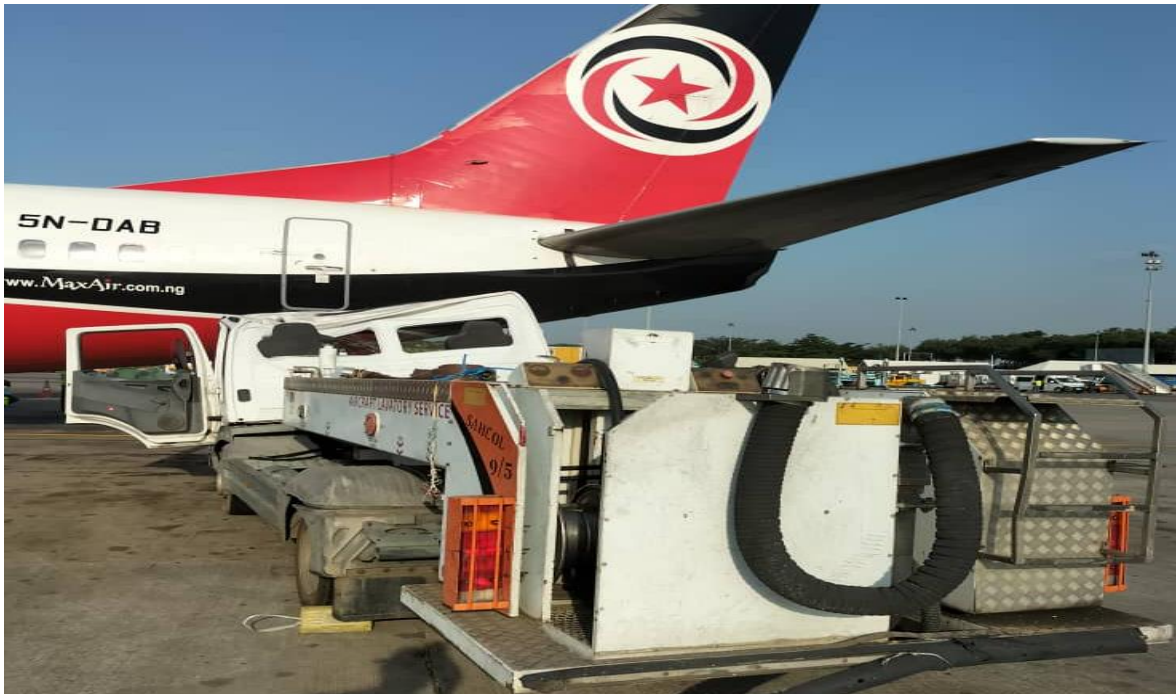
Figure 2: The aircraft and lavatory service truck after the occurrence.

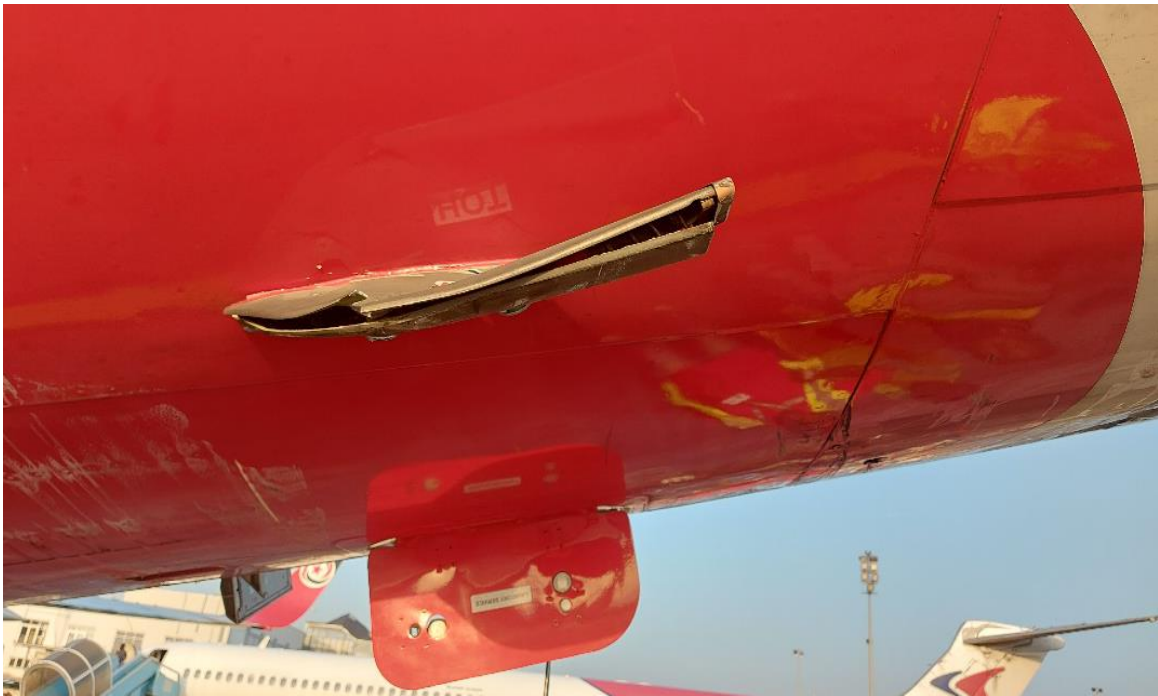
1. Three holes on the Aft section of the fuselage unpressurised area
2. Dents on the pressure bulkhead area

Figure 3: Dent around the rear pressure bulkhead area.

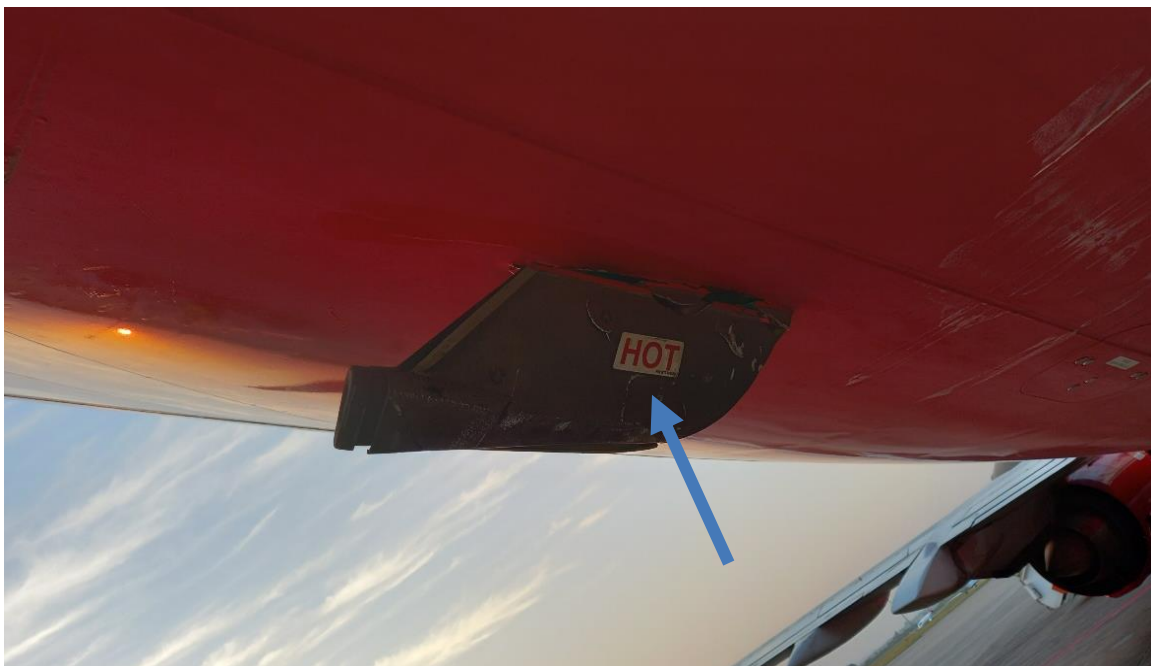
3. Broken rear outflow valve.
4. Broken lavatory service truck door
5. Broken drain valve handle and a damaged rear galley drain mast.

Figure 4: Damaged rear galley drains mast.

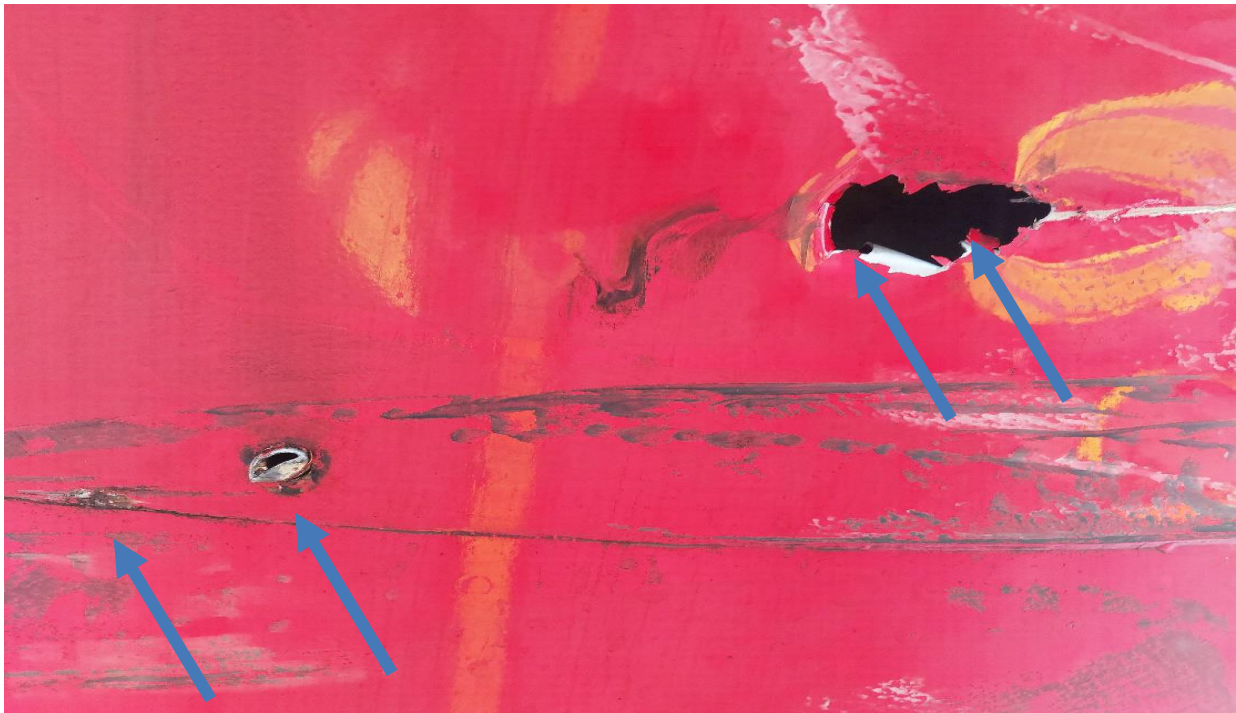
Figure 5: Three holes on the aft of the fuselage unpressurised area.

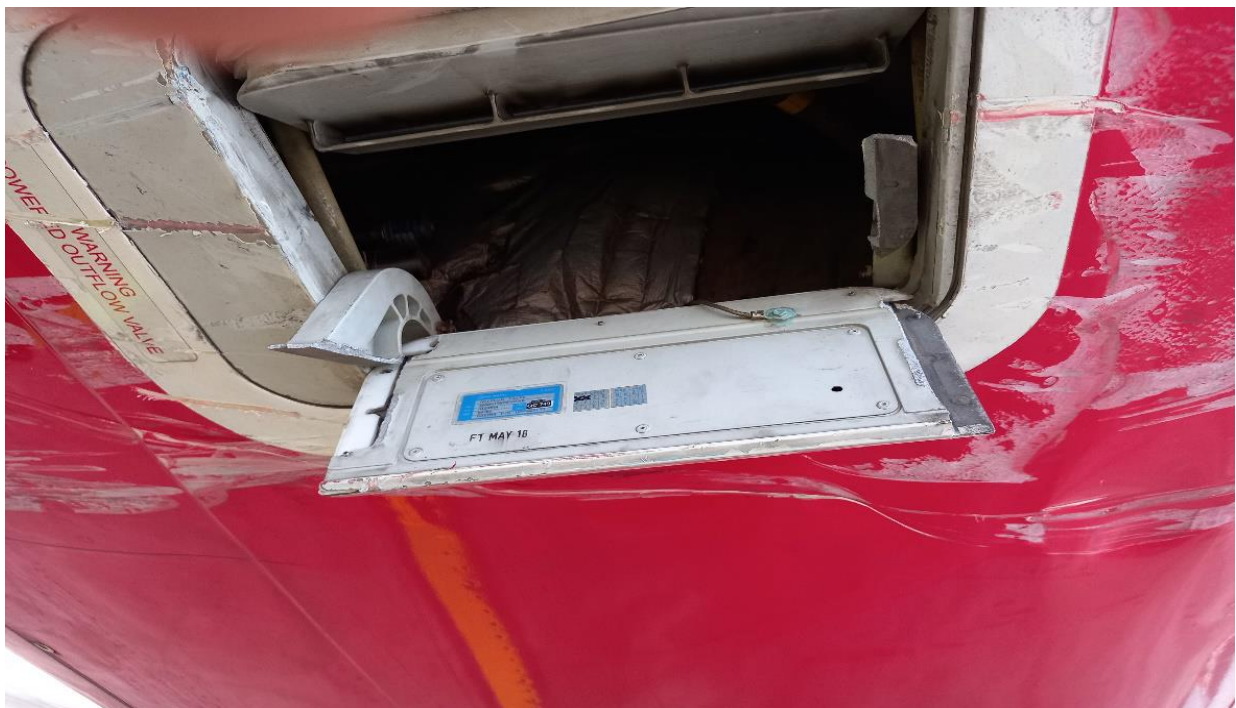
Figure 6: Broken outflow valve.

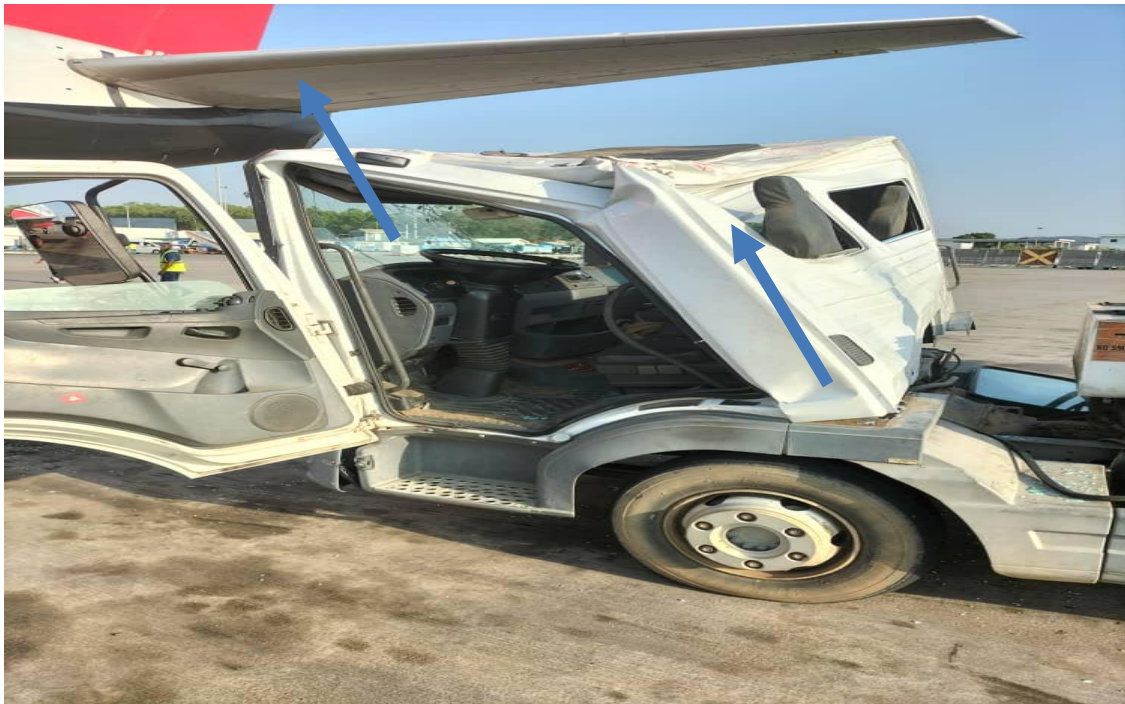
1. The SAHCO lavatory service truck head was substantially damaged.
2. The Skycare Catering Service truck was slightly damaged.

Figure 7: Damaged lavatory service truck after the incident.

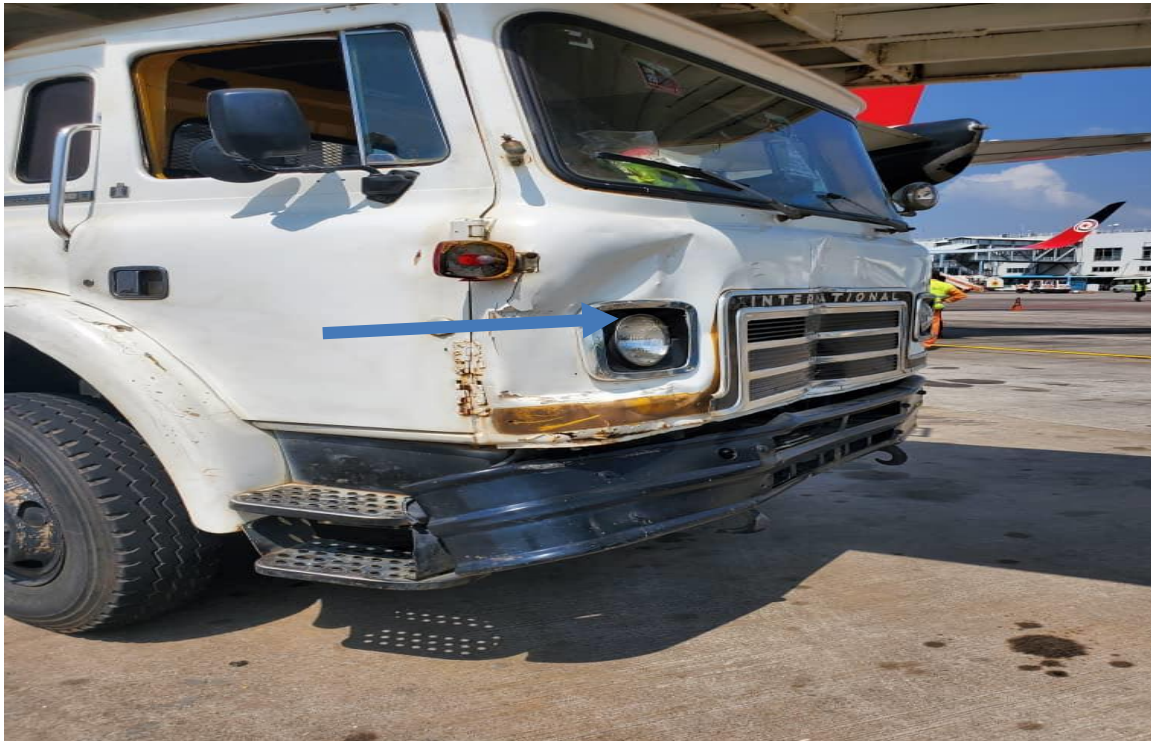
Figure 8: Dent on the catering service truck.
