# AIRCRAFT ACCIDENT REPORT

SAHCO/AAL/2022/02/03/F

**Final Report on ground collision between a conveyor belt TUG660 truck with fleet number 49/9 operated by Skyway Aviation Handling Company (SAHCO) Plc and a parked Boeing 737-800 aircraft with nationality and registration marks 5N-MJQ owned and operated by Arik Air Limited which occurred at Nnamdi Azikiwe International Airport Abuja on 3 February 2022.**

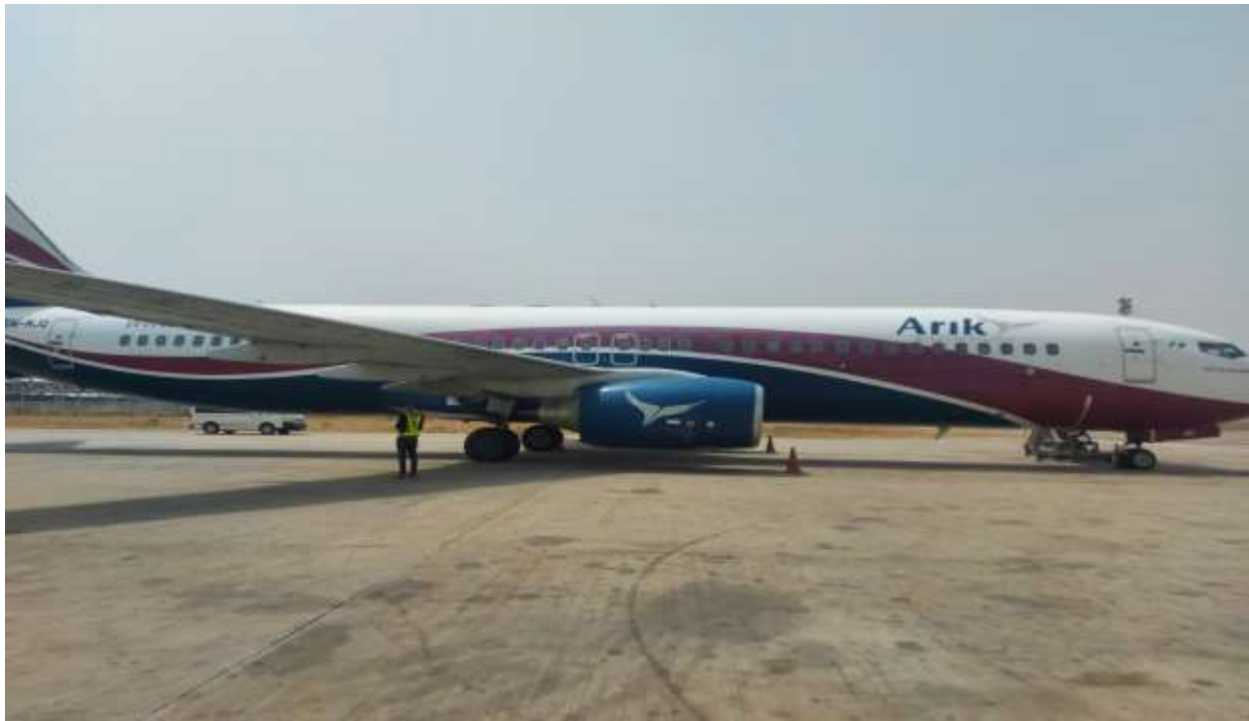
The aircraft was mainly in one piece; one of the right-hand VHF antennae was broken, and the fuselage of the aircraft was punctured.

**Figure 1:** Parked Arik Air Boeing 737-700 after the occurrence

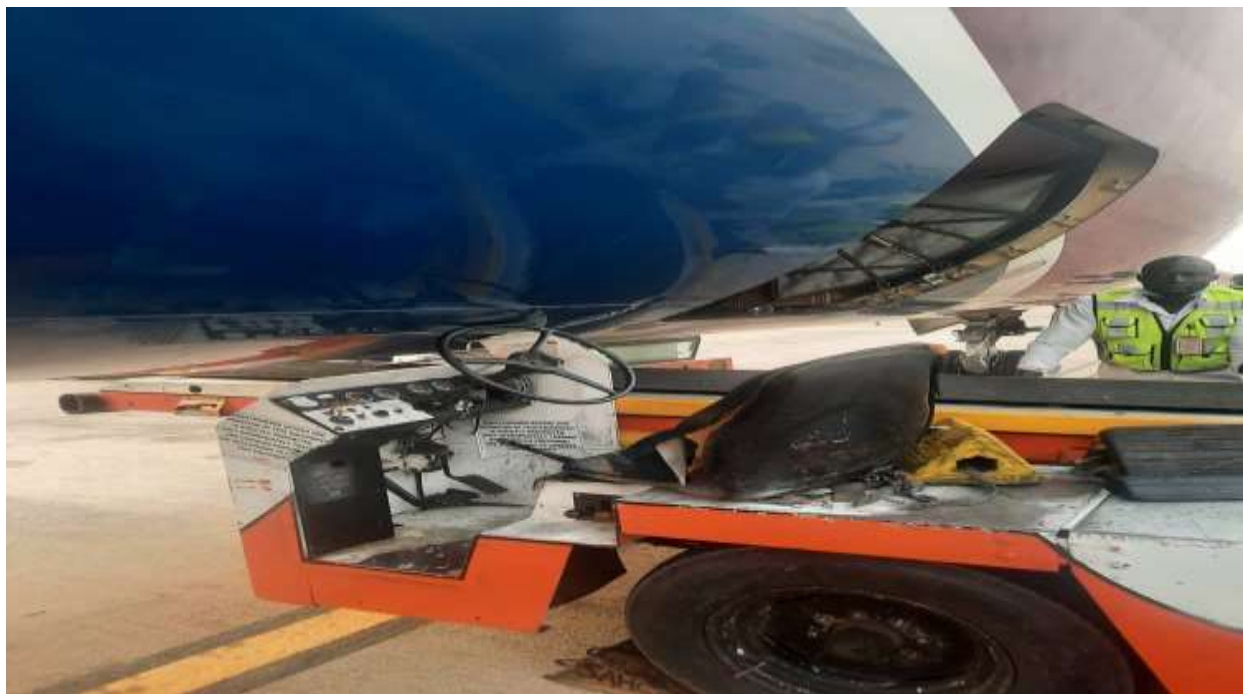
**Figure 2:** The conveyor belt truck still under the aircraft after the occurrence

4. The GSE operator steadily pressed the brake pedal and suddenly noticed that his foot went flat, and the truck would not stop.
5. The truck went right under the aircraft and stopped due to the impact.

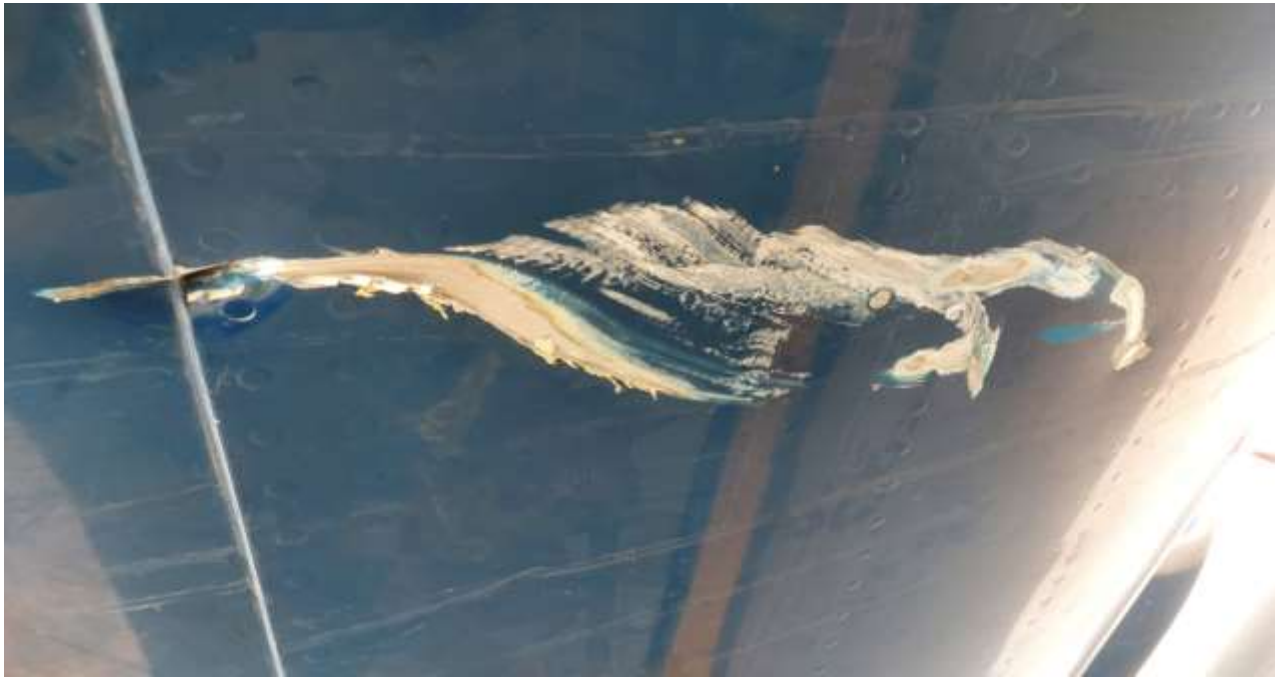
- i. The right-hand VHF antennae was damaged
- ii. Punctured fuselage underneath the aircraft towards the forward cargo hold

**Figure 3:** Puncture to the fuselage of the Arik air aircraft (a pressurised section of the aircraft)

6. The right-hand VHF antennae of 5N-MJQ were destroyed.
7. 5N-MJQ forward cargo hold was torn and ripped open.
8. The conveyor belt truck sustained minor damage.

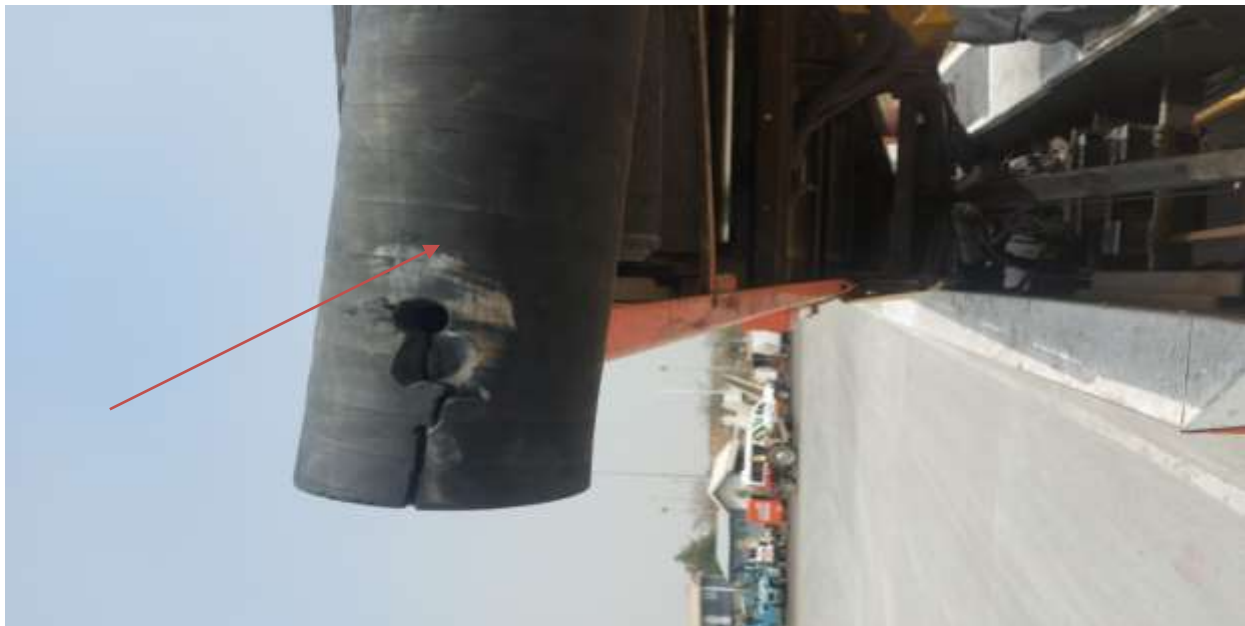
**Figure 4:** Point of the conveyor belt that hit the aircraft

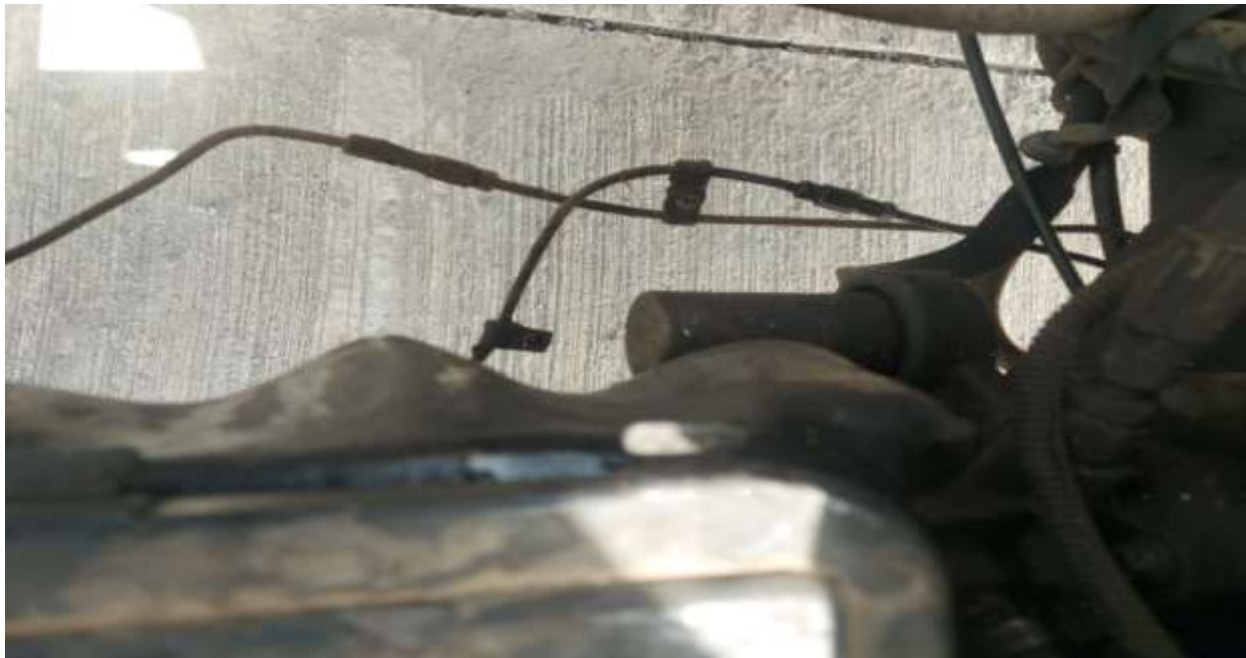
**Figure 5:** Brake assembly of the conveyor belt truck

During the post-occurrence inspection and diagnosis by the SACHO engineers, it was discovered that the brake proportion valve was the source of hydraulic fluid leakage. The brake component of the TUG 660 belt loader comprises a brake master, hydro booster, brake pipes, brake proportioning valve, brake callipers, brake pads, brake discs, brake drum, brake linings, and wheel cylinders. The brake system is set up with brake discs in the front and brake drums in the rear.

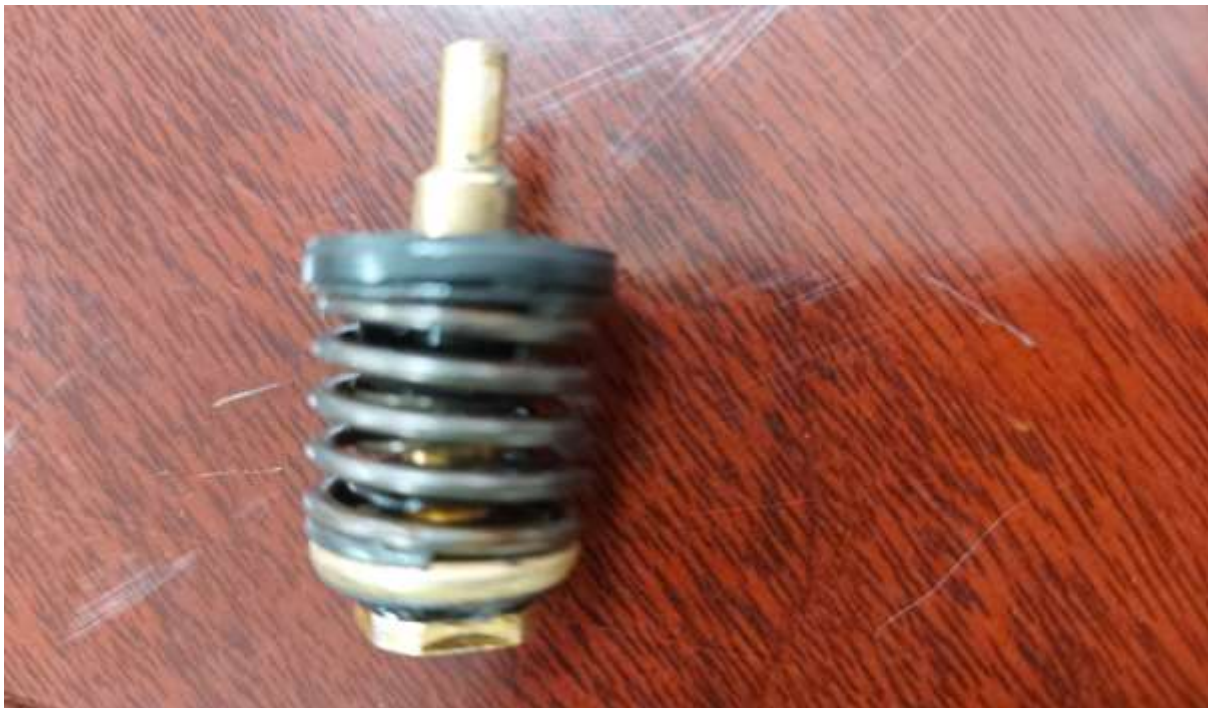
**Figure 5:** Brake proportioning valve of the truck where the leakage was traced to

Recall that on 26 December 2021, the brake of the TUG 660 Truck was reported on the SAHCO Equipment Operator's Report (SAH/E&M/EOR/001) to be ineffective as described in the SAHCO Job Card (SAH/E&M/002). The work to be done was to check the brake system and correct the fault; whenever the fluid ran low, it was topped up to make the brakes effective. However, having been working on another aircraft before being redirected to the Arik aircraft, the brake fluid would have been exhausted due to leakage from the proportioning valve, leading to the brake failure.

Failure of the brake proportioning valve resulting from wear and tear.

If SAHCO plc had undertaken periodic checks for component wear and tear, failing components could have been detected and replaced.

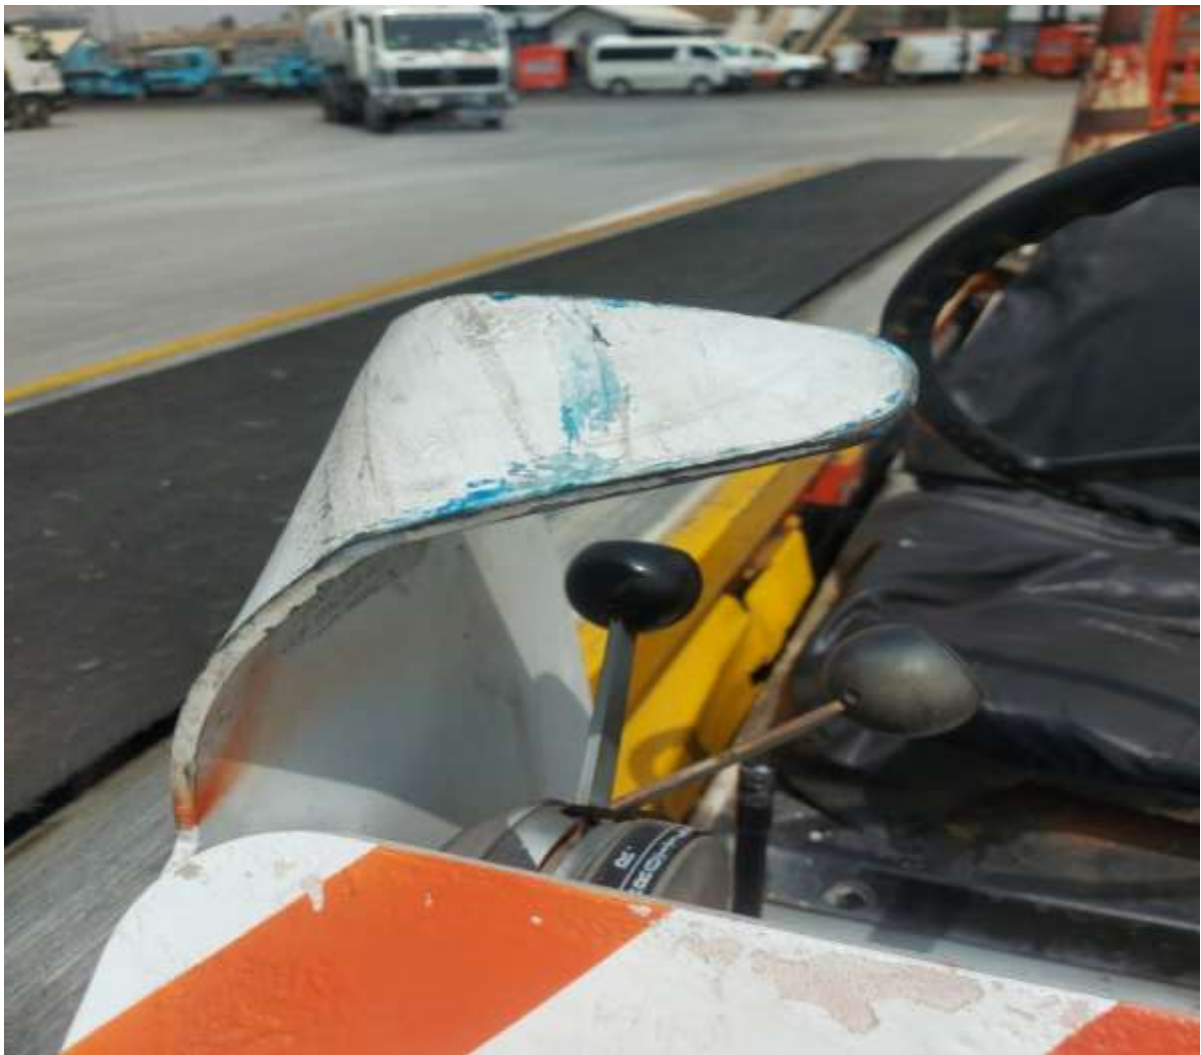
The head protector of TUG 660 was damaged.

**Figure 6:** Head protector of the conveyor belt that punctured the fuselage of the aircraft

The incident was survivable, as the speed on impact was minimal, and the contact between the conveyor belt truck and the aircraft was to the truck's 'head protector'.
