AIRCRAFT ACCIDENT REPORT

SWAT/2015/06/11/F

Accident Investigation Bureau

**Report on the Accident involving a Hawker
Siddeley HS-125-800 XP aircraft owned and operated by
SWAT Technology Limited with nationality and
registration marks N497AG which occurred on Runway
21, Port-Harcourt Airport, Omagwa, Rivers State
On 11th June, 2015**

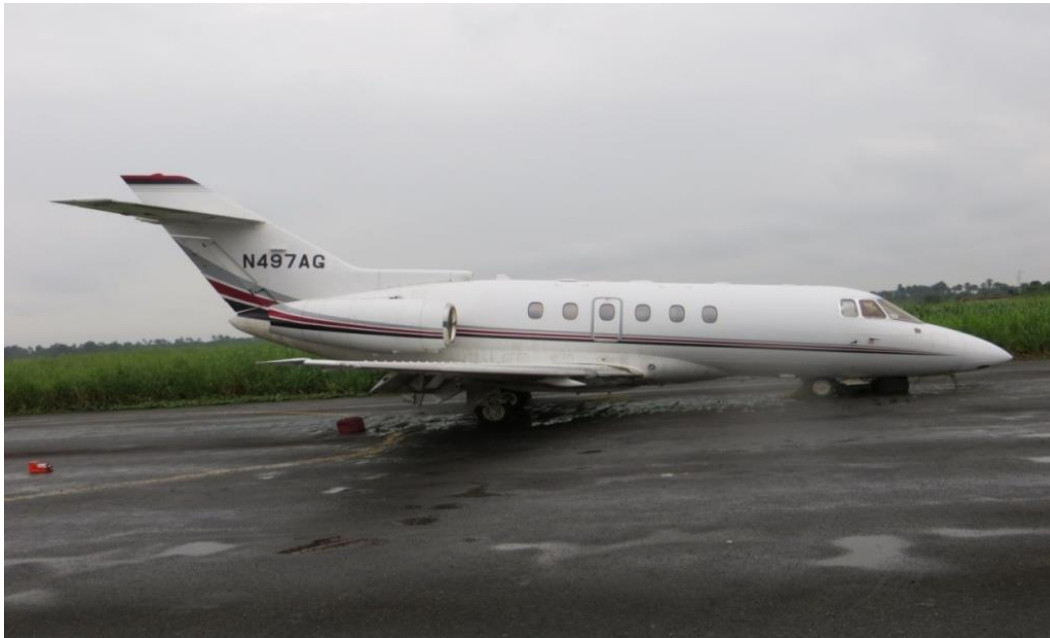
The aircraft was substantially damaged.

Figure 1: Photo of the aircraft after the occurrence

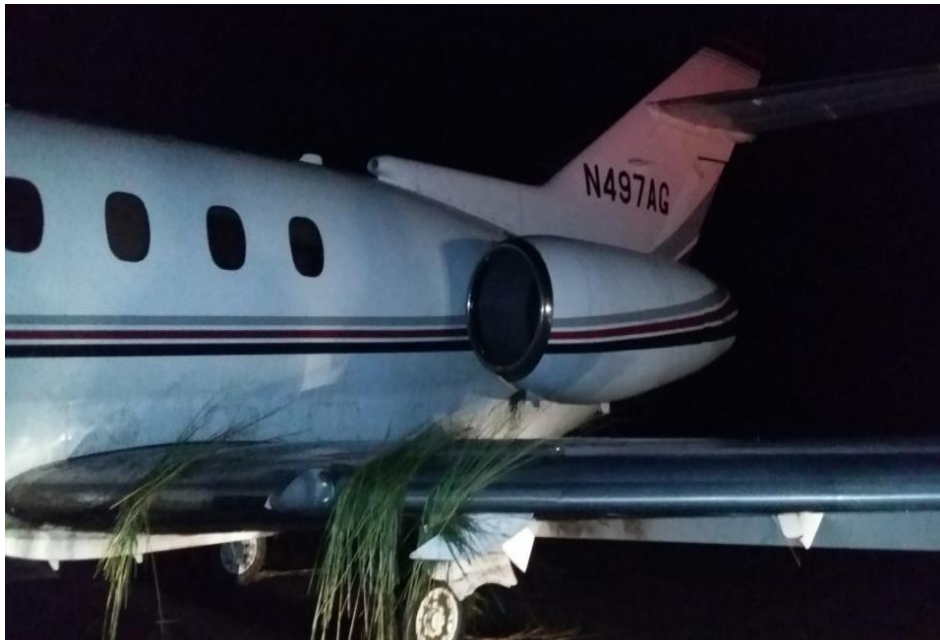
There was collection of grass on the left wing and the left engine generator cooling inlet.

Figure 2: Photo of grass collection on the left wing and generator cooling inlet

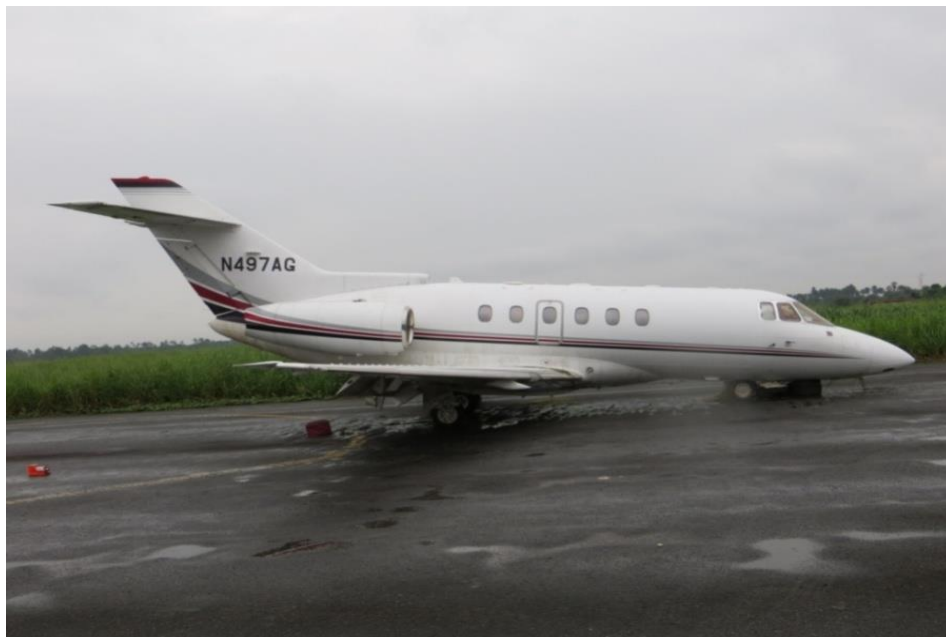
The aircraft touched down at about 1,500 m from the threshold of runway 21 with the left main wheel on the left grass verge and the right main wheel on the runway, travelled a distance of about 300 m in the grass verge before returning to the runway and came to a stop about 2,600 m, with the nose wheel landing gear collapsed.

Figure 3: Photo of the aircraft where it stopped on the runway

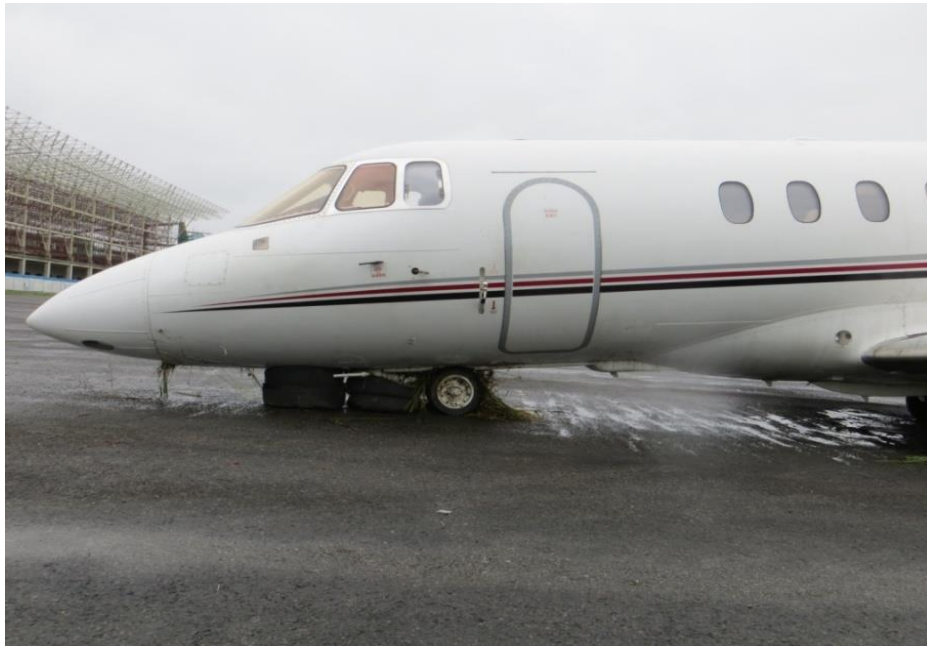
The nose wheel landing gear collapsed, and the aircraft stopped on the runway.

Figure 4: Photo of collapsed nose wheel landing gear

6. At about 1,800 m from the threshold of runway 21, the aircraft returned to the runway and stopped at about 2600 m.
7. The nose wheel gear collapsed.
8. The Airport Rescue and Fire Fighting Services (ARFFS) arrived the crash scene within 2 minutes of the occurrence.
