**PRELIMINARY REPORT ON SERIOUS INCIDENT INVOLVING AIRBUS A330-343 AIRCRAFT OPERATED BY TURKISH AIRLINES INC. WITH NATIONALITY AND REGISTRATION MARKS TC-LOL WHICH OCCURRED ON RUNWAY 21, PORT HARCOURT INTERNATIONAL AIRPORT (DNPO), PORT HARCOURT, RIVERS STATE, NIGERIA ON THE 31ST OF DECEMBER 2019**

<b>Aircraft Accident Report No.:</b>	TURKISH/2019/12/31/D
<b>Registered Owner:</b>	Sky High IV Leasing Designated Activity Company
<b>Registered Operator:</b>	Türk Hava Yollari A.O. (Turkish Airlines Inc.)
<b>Aircraft Type and Model:</b>	Airbus A330-343
<b>Manufacturer:</b>	Airbus Industrie
<b>Year of Manufacture:</b>	2010
<b>Nationality and Registration Marks:</b>	TC-LOL
<b>Serial Number:</b>	1098
<b>Location:</b>	Runway 21, Port Harcourt Intl. Airport, Rivers State, Nigeria.
<b>Date and time:</b>	31st December 2019 at about 03:30 h

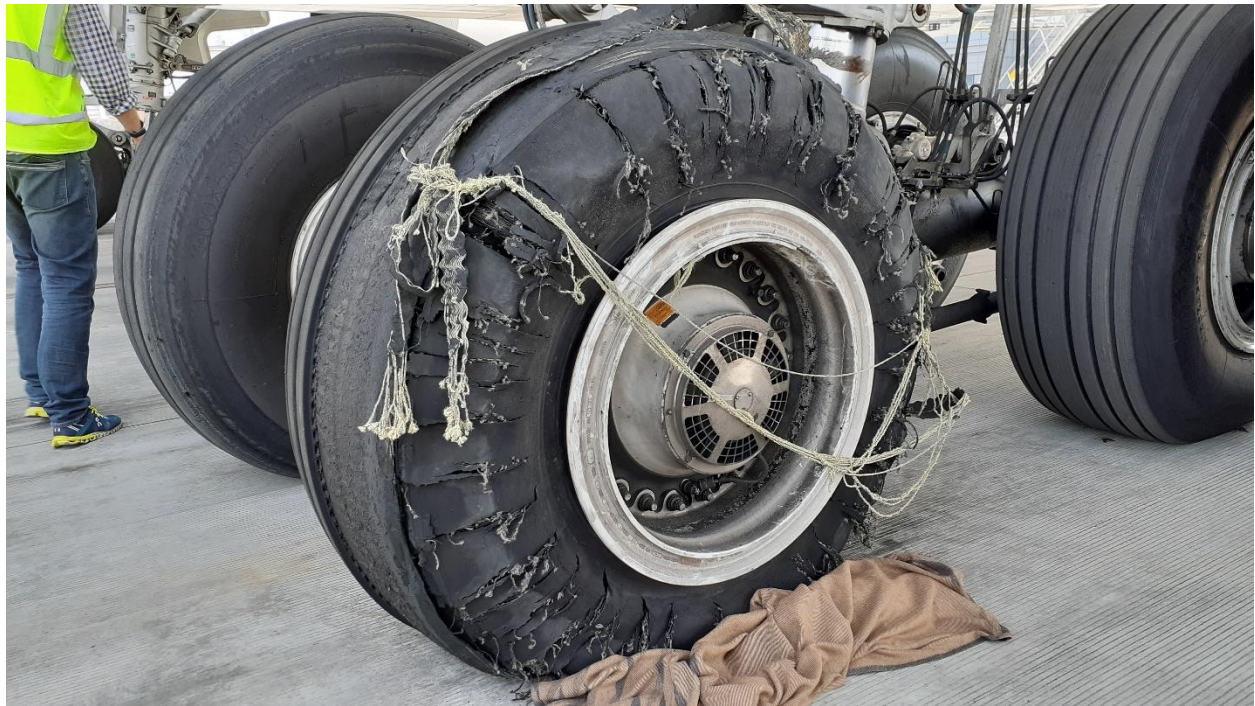
Nos. 3 and 7 main wheel tyres were scuffed. No. 8 Main wheel tyre was found deflated with shredded plies. The right inboard flap was dented on its lower surface. A dent was observed to the internal fan cowl of engine No. 2. Debris from the tyres was found on the runway.

**Figure 2:** Photo of the No. 8 main wheel tyre

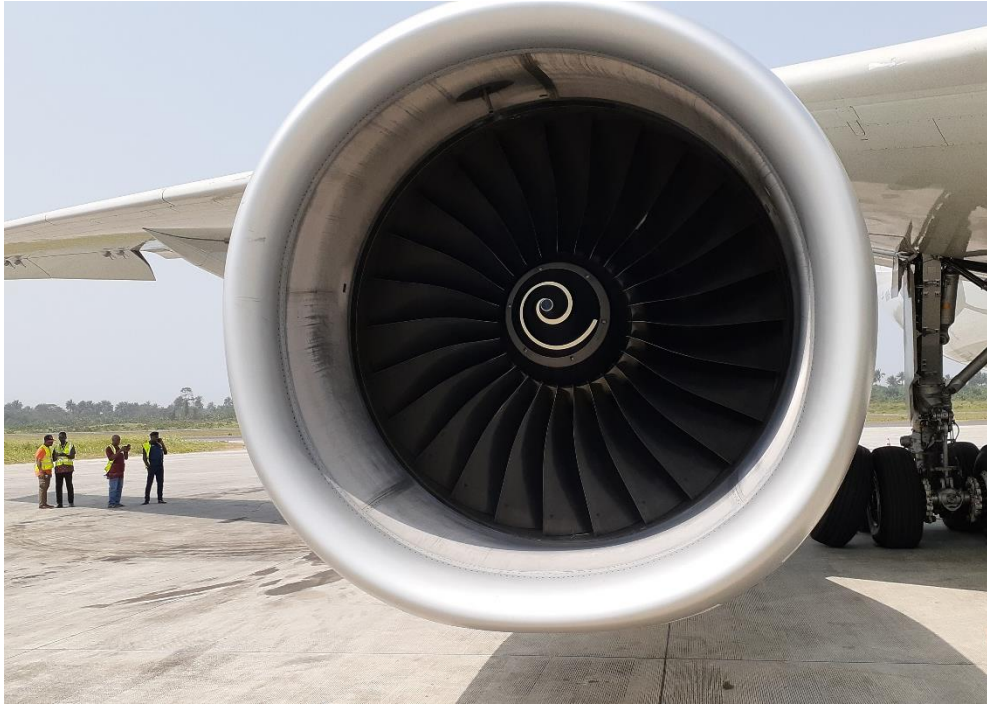
**Figure 3:** Photo of No. 2 engine

1. Examination of the engine condition.
2. Analysis and transcription of the flight recorder files.

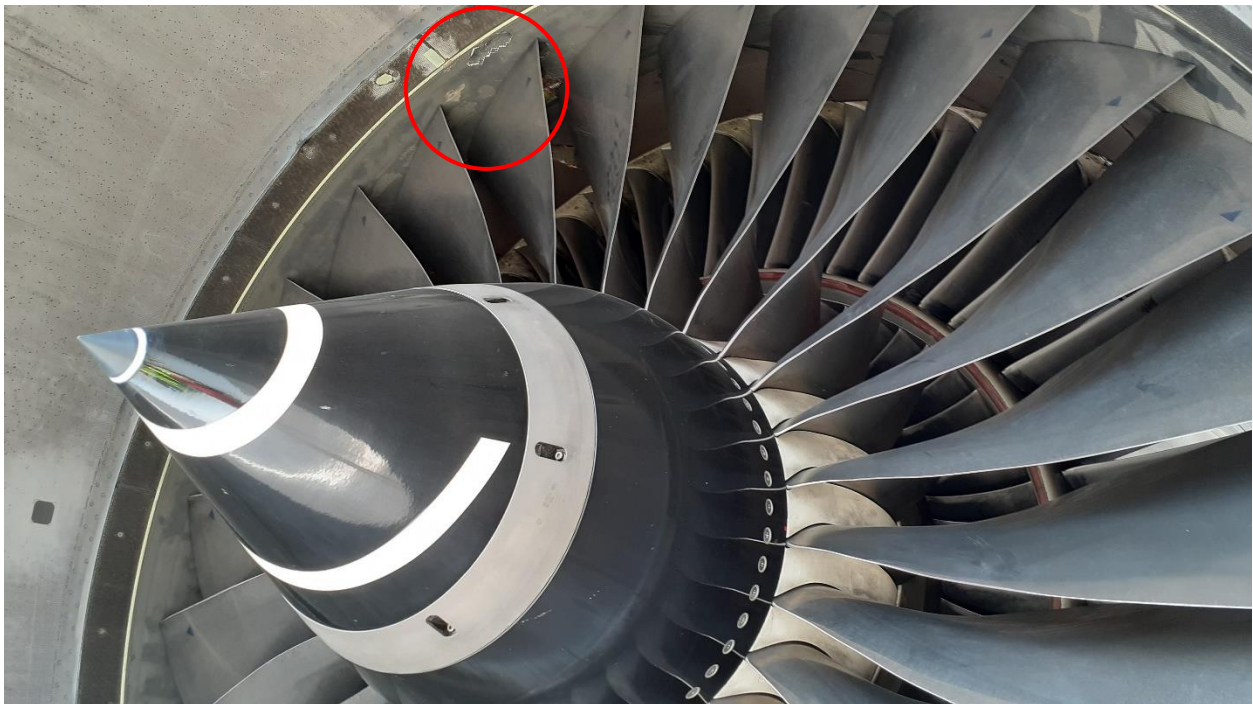
**Figure 4:** A close-up photo of the observed damaged area (circled)

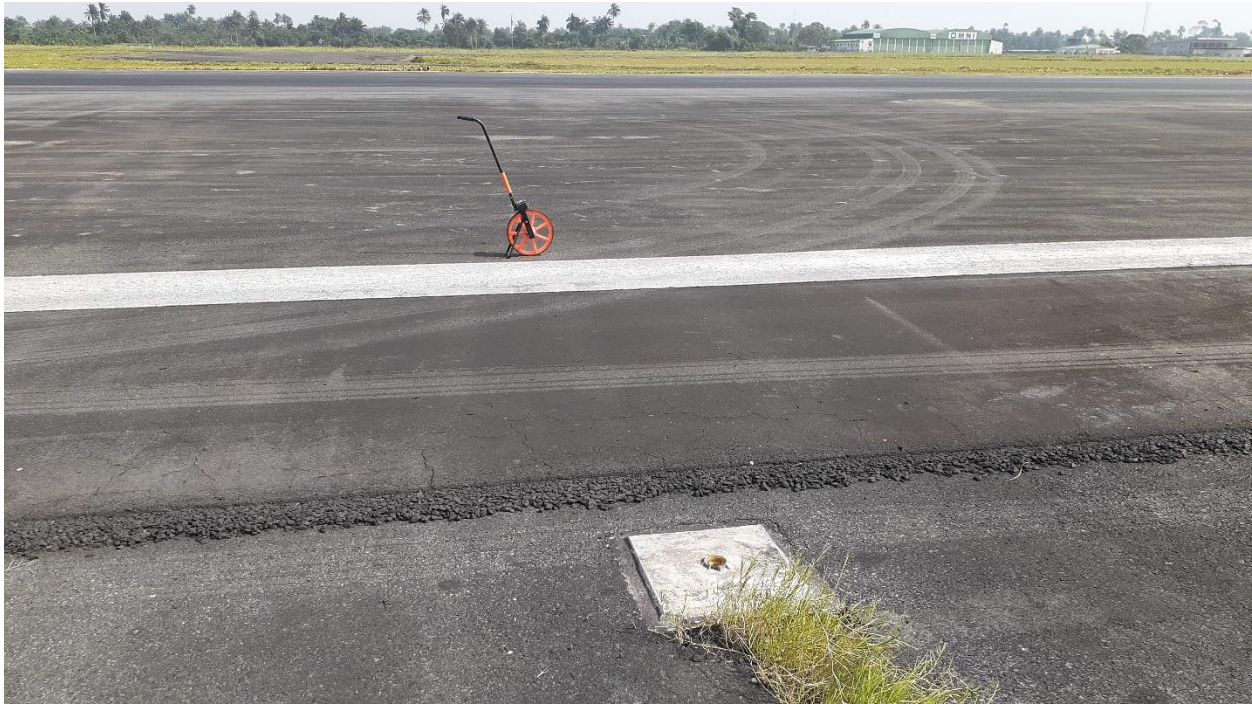
Three runway edge lights were damaged.

**Figure 5:** Photo of one of the damaged runway edge lights

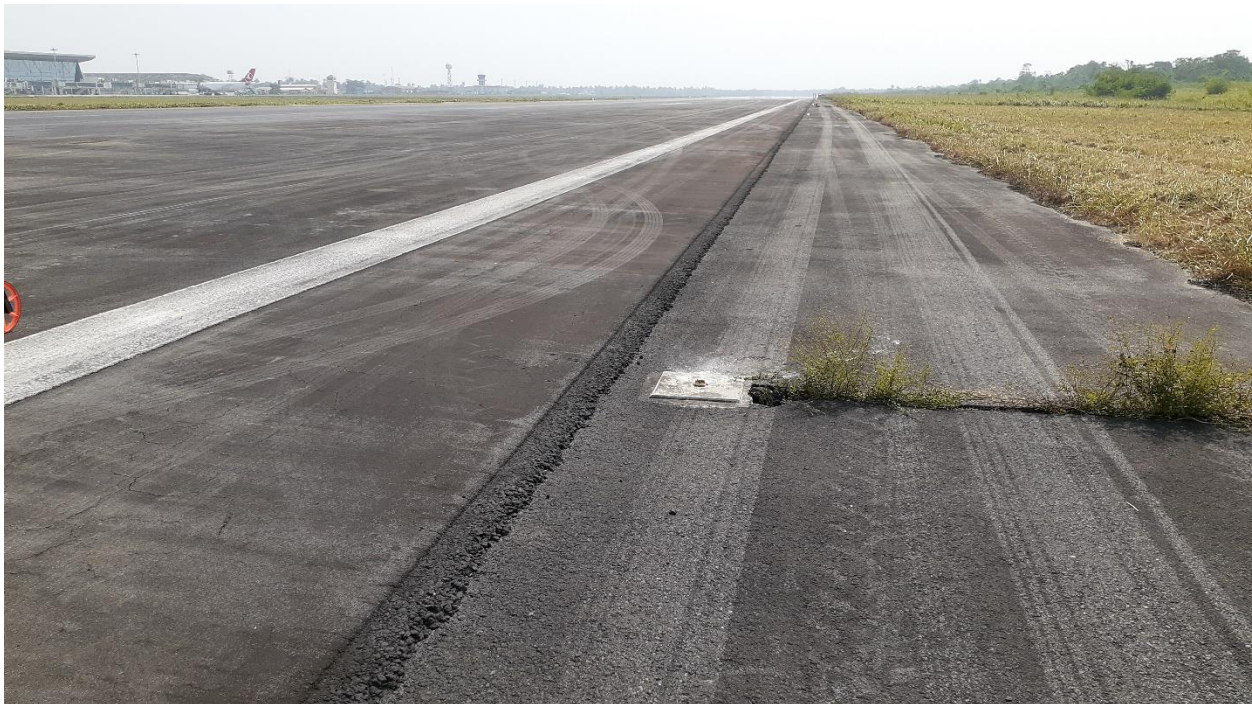
During post-incident inspection, the aircraft tyre marks were found on the runway indicating that the touched down point was right of the runway centreline, at about 612 m from the threshold. The right main wheel crossed the runway edge line onto the runway shoulder at a distance of about 27 m from the touchdown point, impacted and damaged three runway edge lights, and returned to the runway at a distance of about 1,037 m, from the threshold. The tyre marks further indicated that the aircraft returned to the runway centreline at about 1,478 m from the threshold.

**Figure 6:** A photo of the tyre marks from the right main wheel tyres on the runway shoulder
