# AIRCRAFT ACCIDENT REPORT

UNA/2021/11/17/F

**Nigerian Safety Investigation Bureau**

**Final Report on the Serious Incident involving Embraer 145LR aircraft operated by United Nigeria Airlines Limited with nationality and registration marks 5N-BWW, which occurred at about 4000 feet climbing out of Nnamdi Azikiwe International Airport, Abuja, Nigeria on 17 November 2021.**

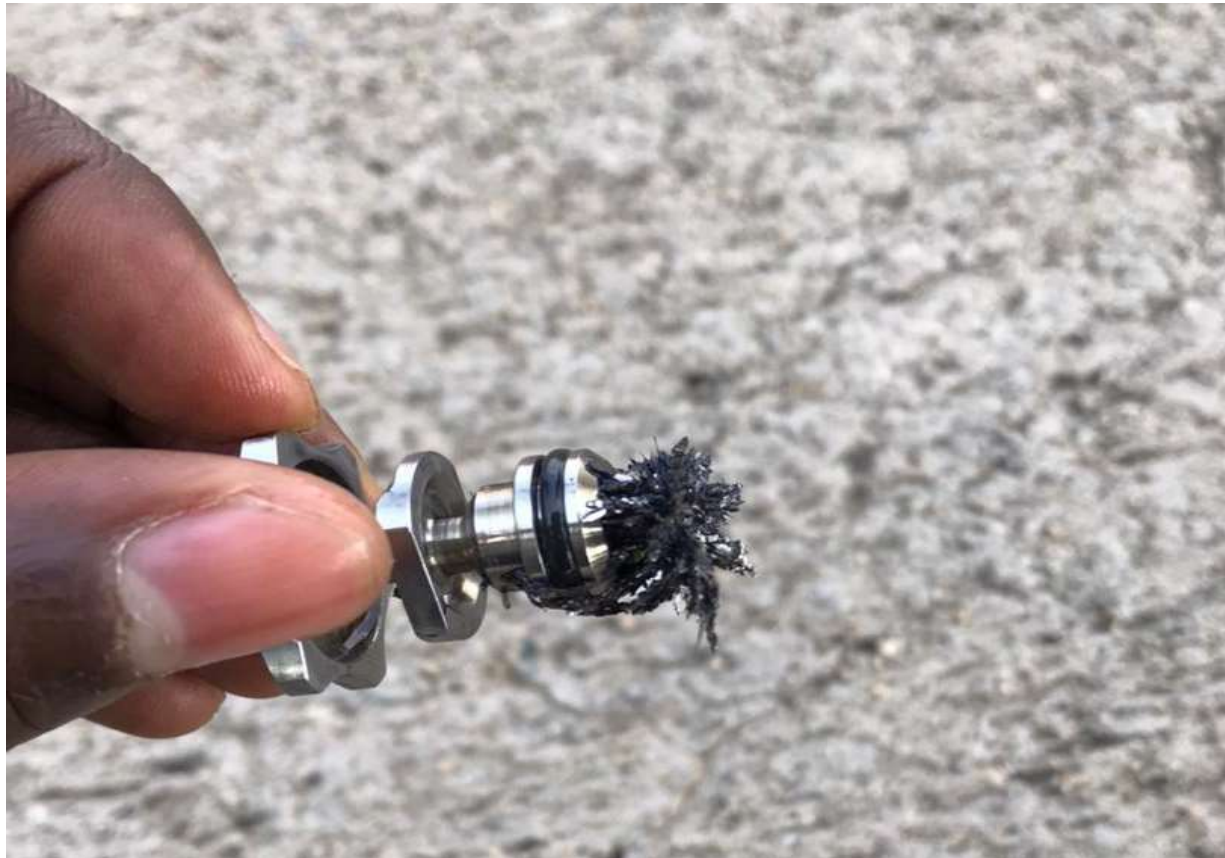
During post-occurrence visual inspection, it discovered that the Engine No.1 magnetic chip detector on the oil tank was covered with metallic chips.

**Figure 1:** Magnetic Plug with chips

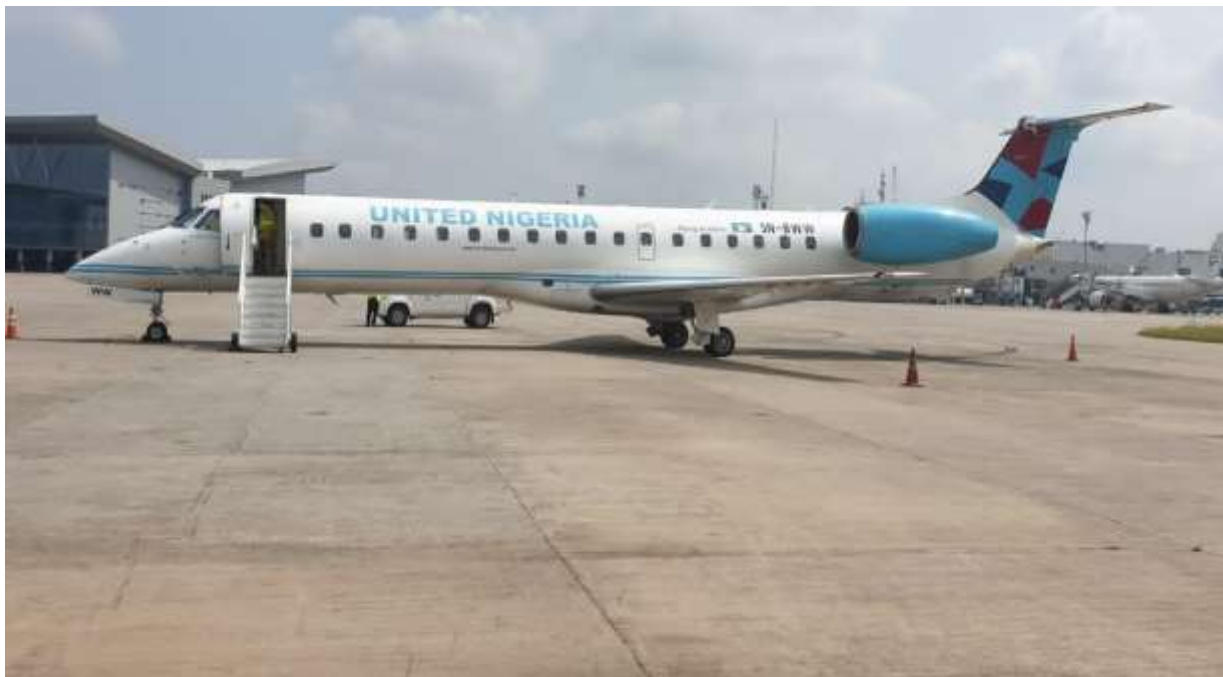
**Figure 2:** The aircraft parked at Apron of Nnamdi Azikiwe International Airport after the incidence

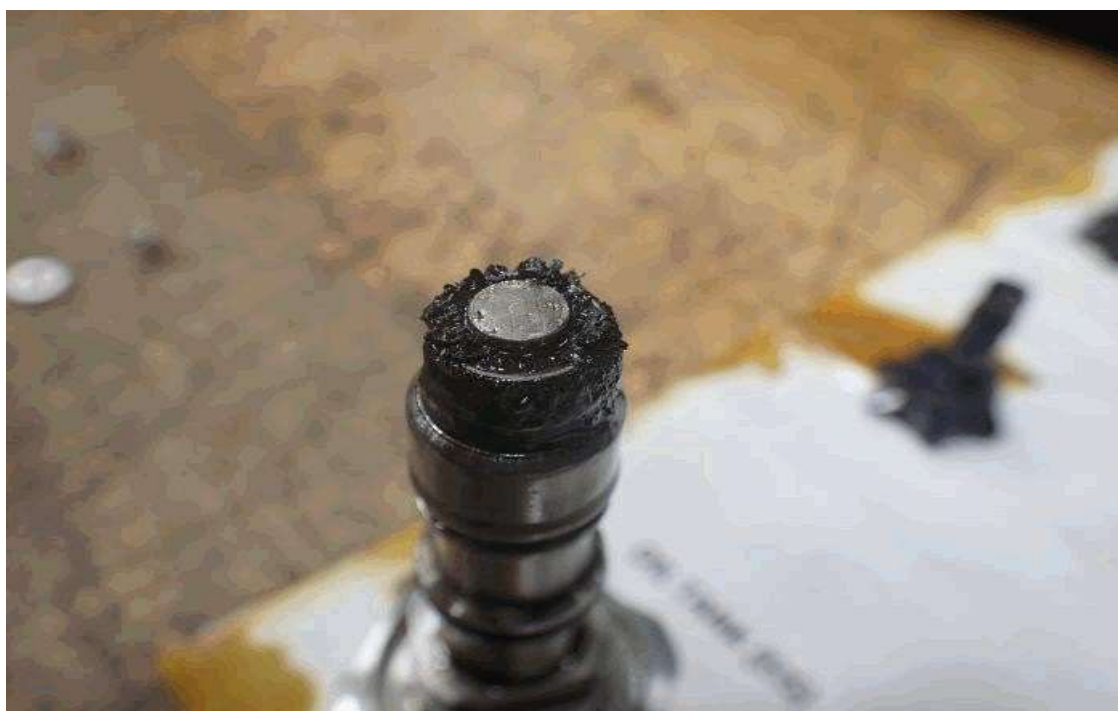
Fig 2: ENGINE CHIP DETECTOR

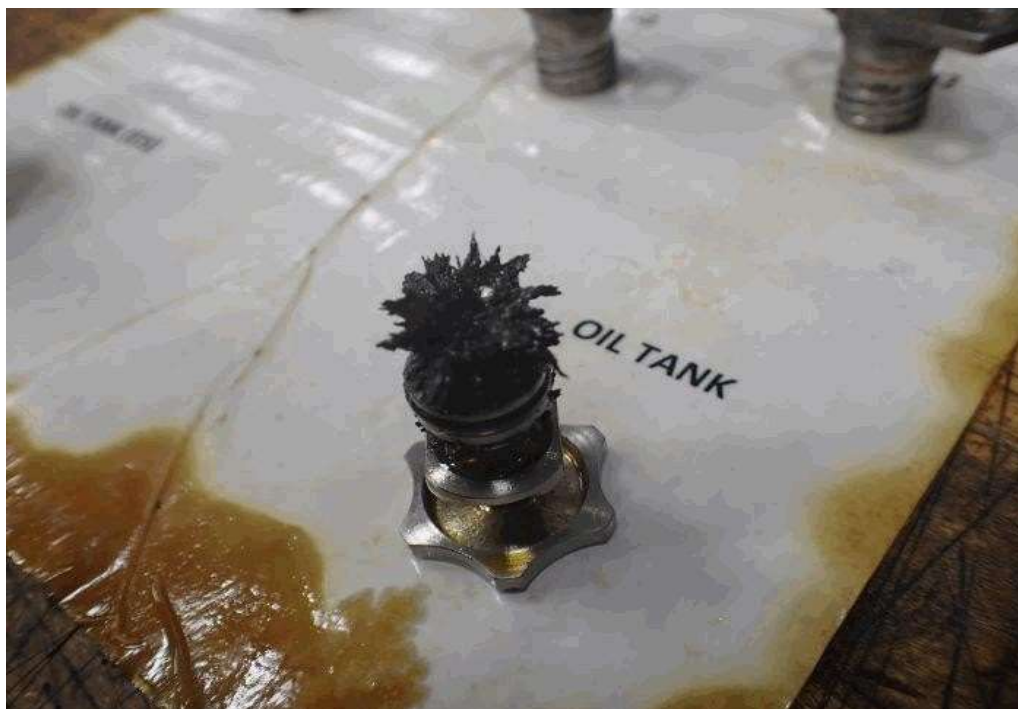
However, on 4 October 2021, the United Nigeria maintenance team informed Rolls Royce that chips were found at the collector plugs during the inspection.

Fig 3: OIL TANK CHIP COLLECTOR

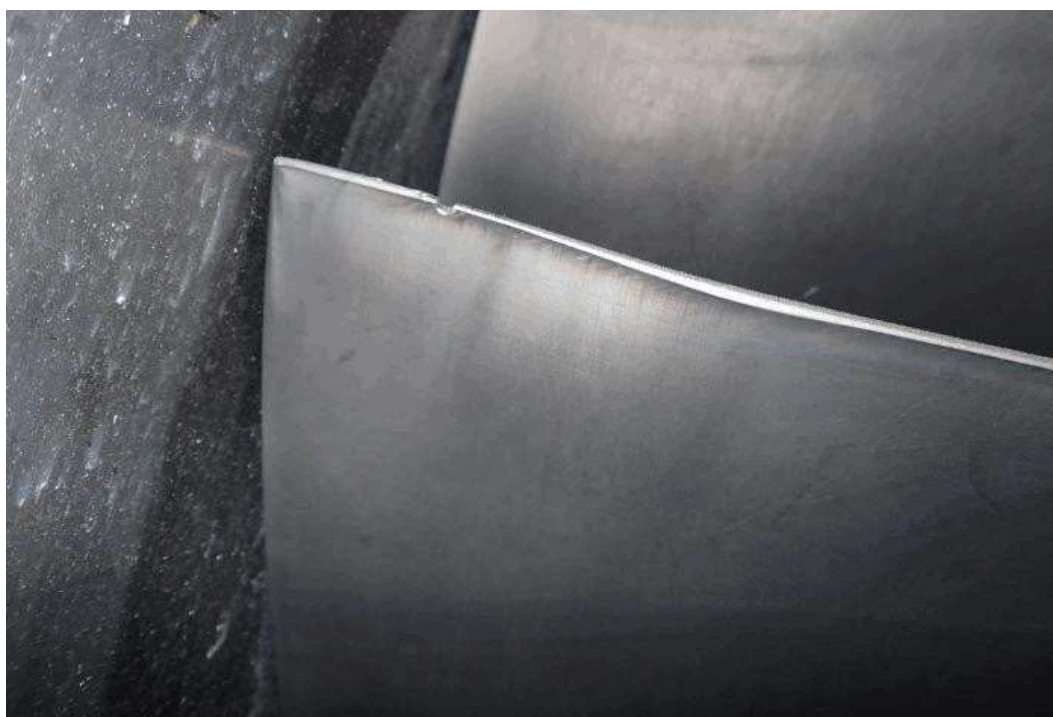
-Two (2) Fan Blades were found with nicks beyond serviceable limits.

Fig 4: FAN BLADE - DETAIL

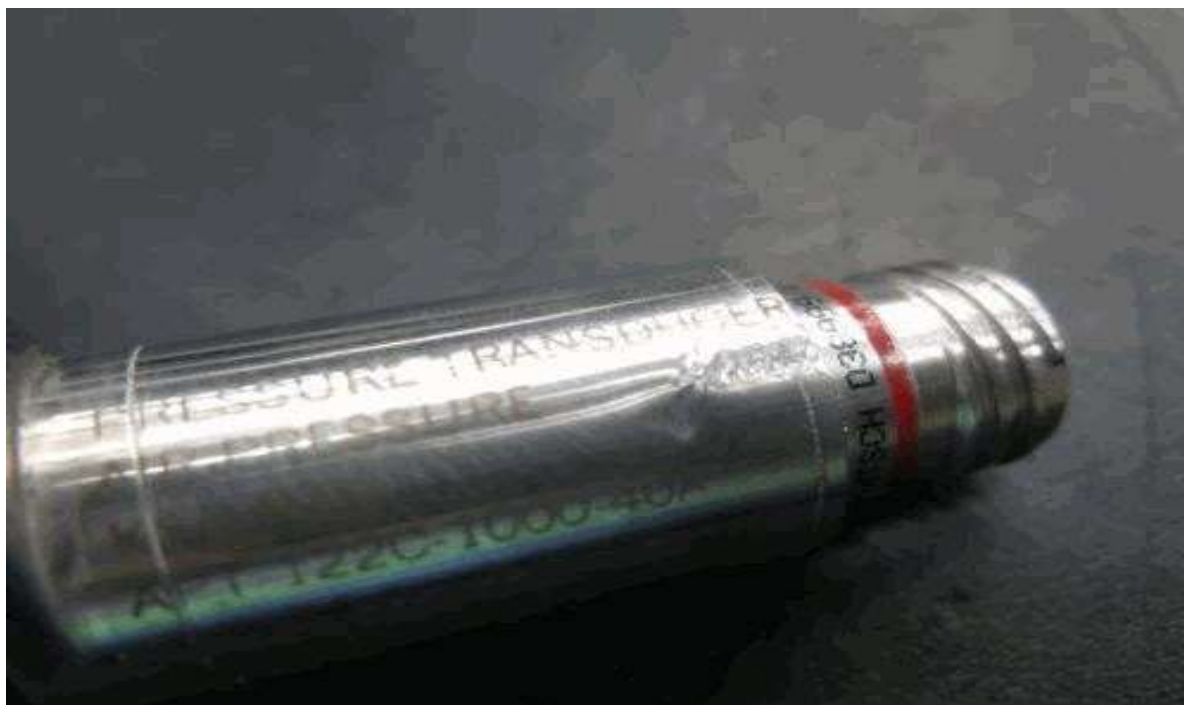
Fig 5: P2.5 SENSOR - OVERVIEW

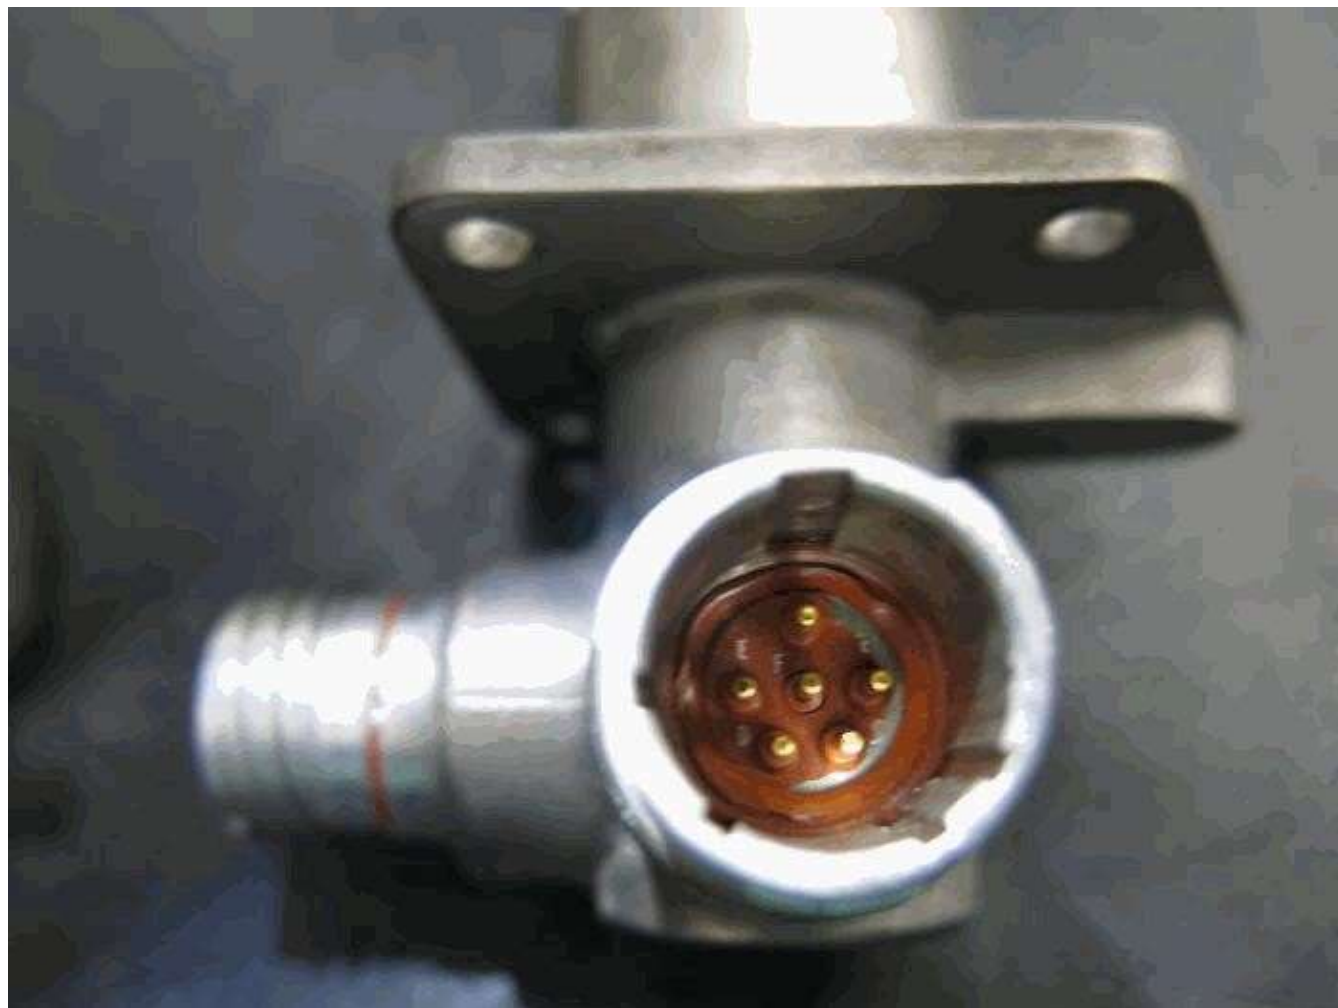
Fig 6: TOTAL TEMPERATURE SENSOR - DETAIL

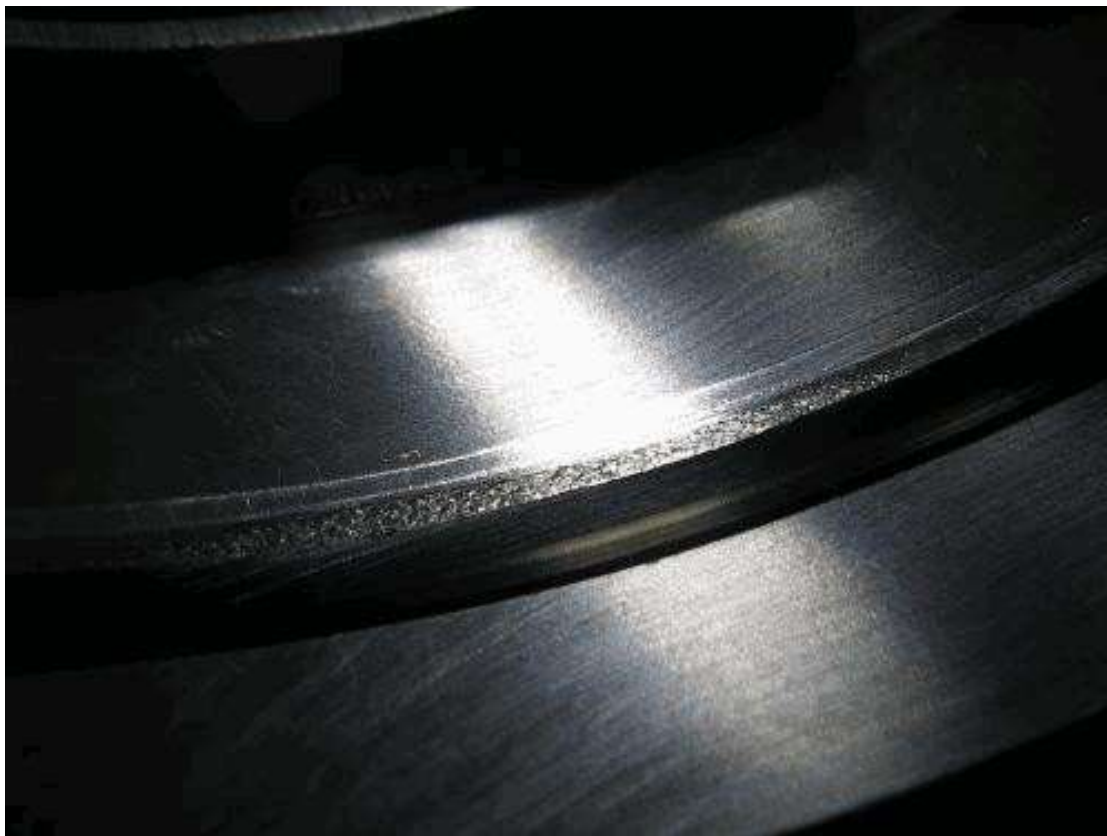
Fig 7: FRONT SUMP HOUSING (FRETTING) - DETAIL

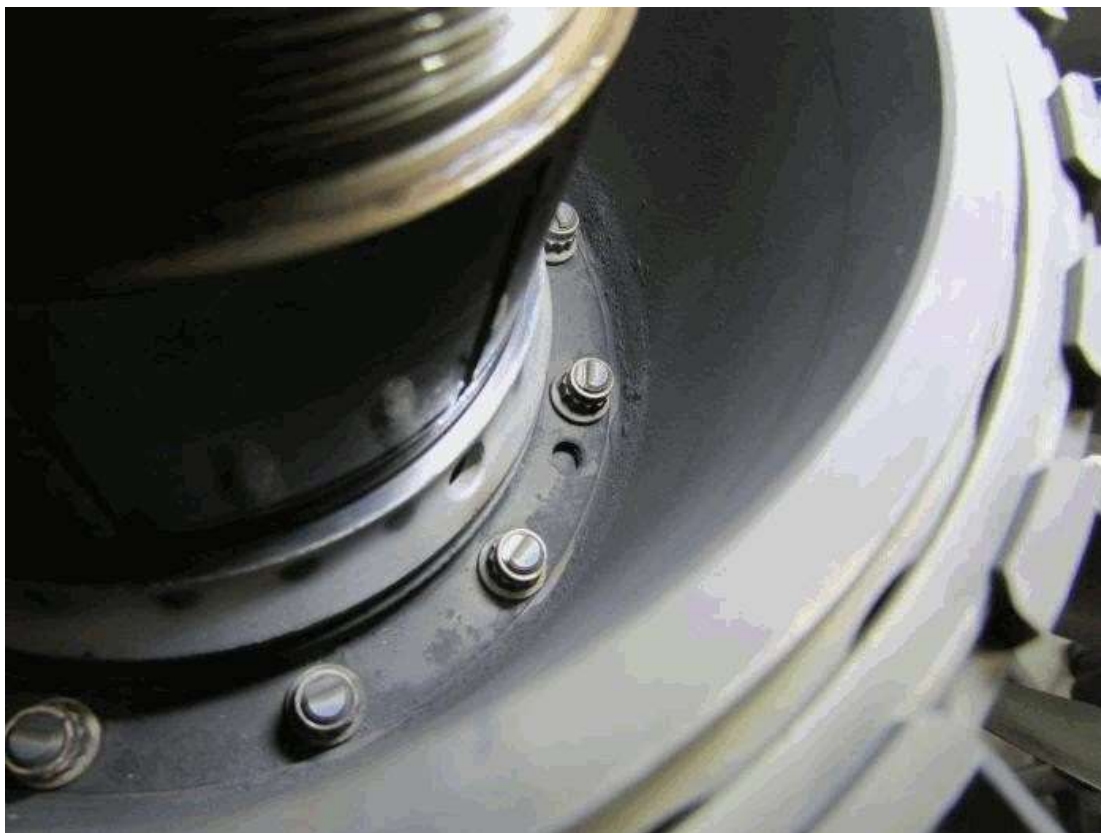
Fig 8: HIGH-PRESSURE COMPRESSOR STUB SHAFT - DETAIL

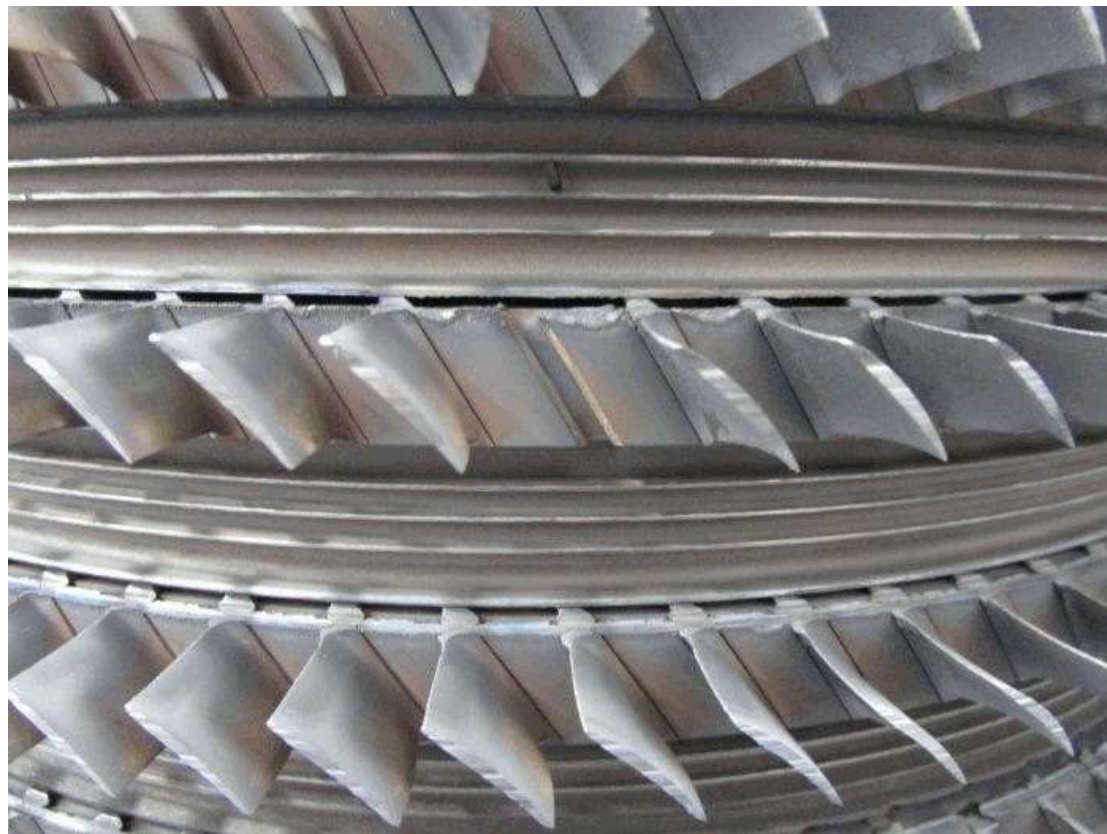
Fig 9: HIGH-PRESSURE COMPRESSOR WHEEL - DETAIL

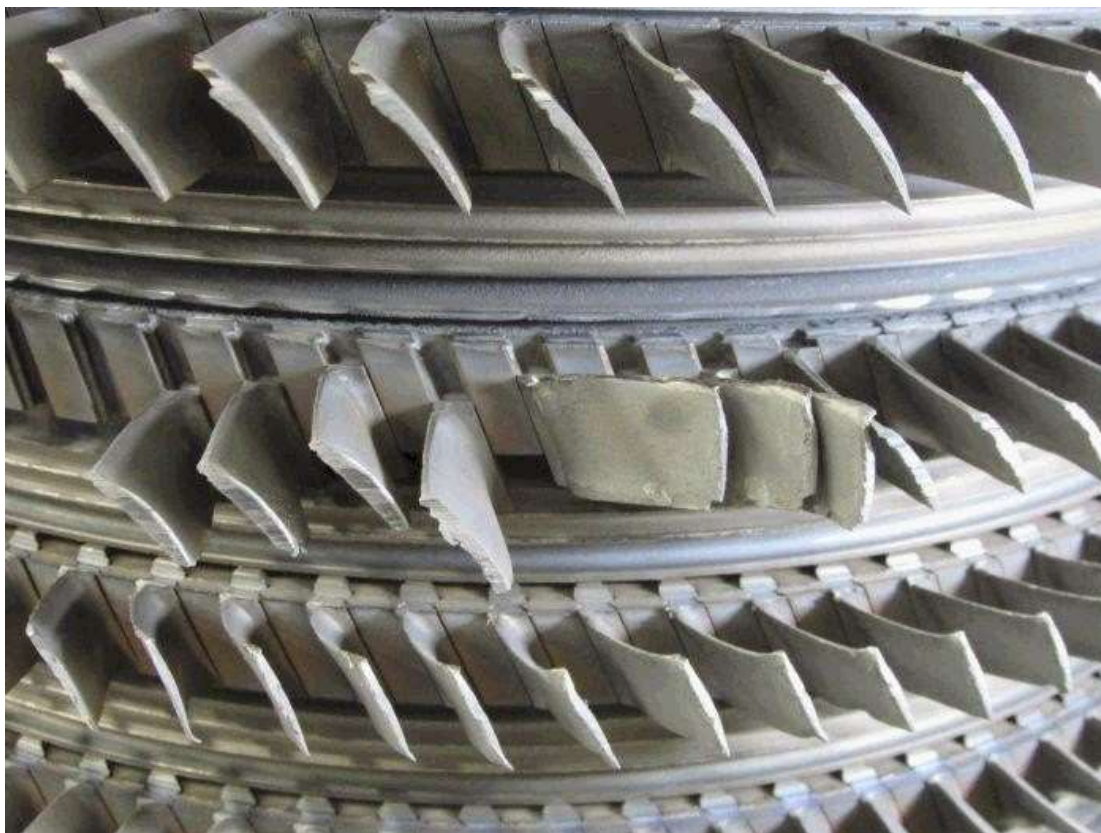
Fig 10: HIGH-PRESSURE COMPRESSOR BLADES

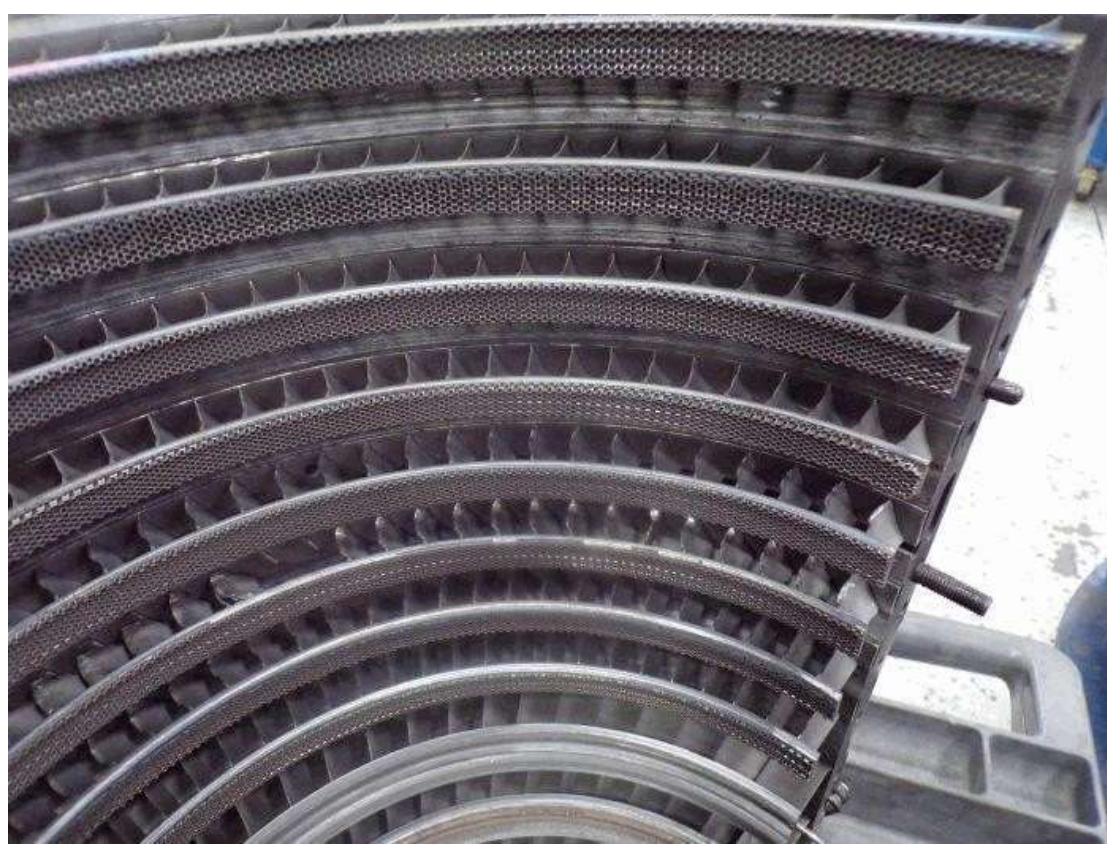
Fig 11: HIGH-PRESSURE COMPRESSOR VANES

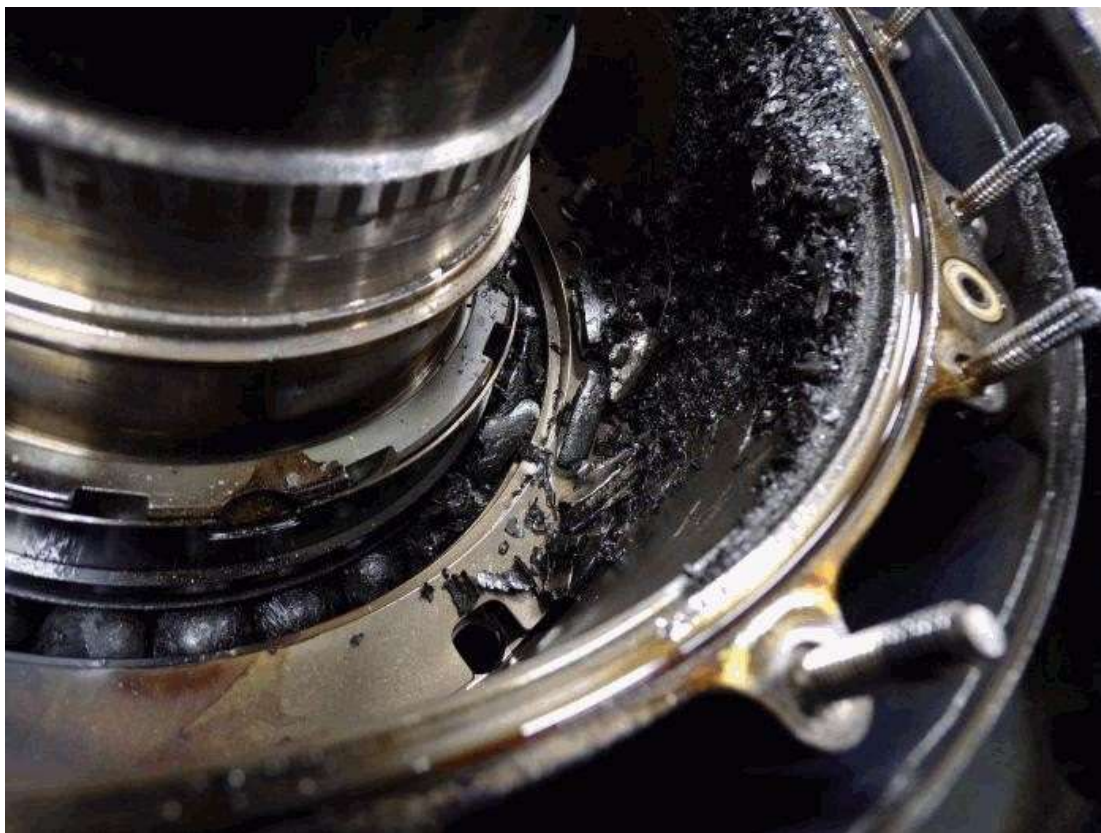
Fig 12: CENTERSUMP - DETAIL

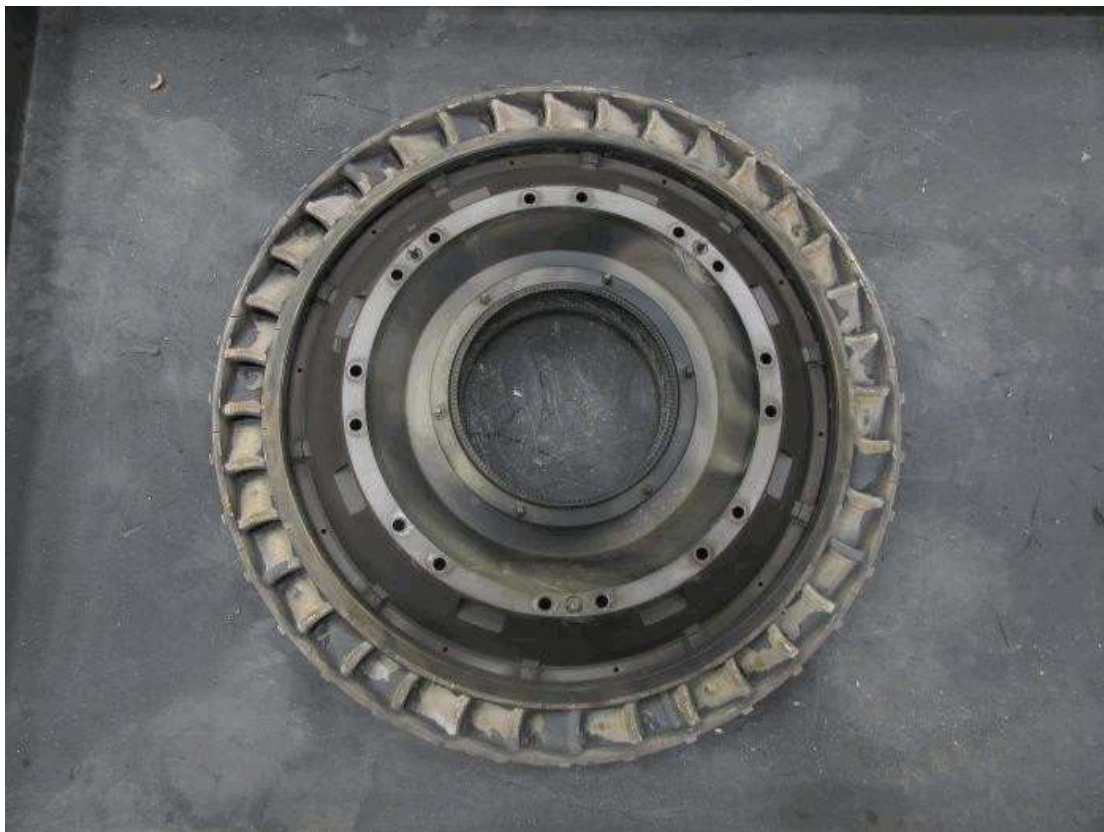
- Two (2) 1st Stage HPT Vanes were found with erosion beyond serviceable limits.

Fig 13: 1ST STAGE HIGH-PRESSURE TURBINE VANES - OVERVIEW

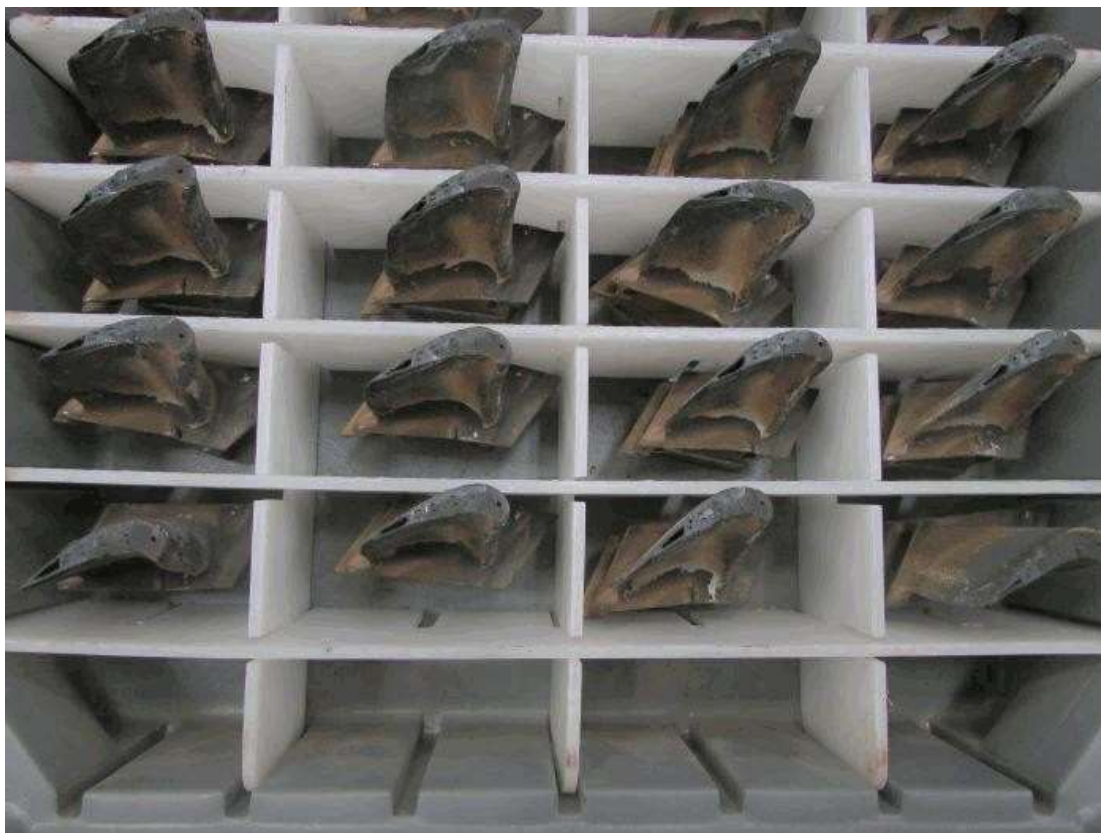
Fig 14: 1ST STAGE HIGH-PRESSURE TURBINE BLADES - DETAIL

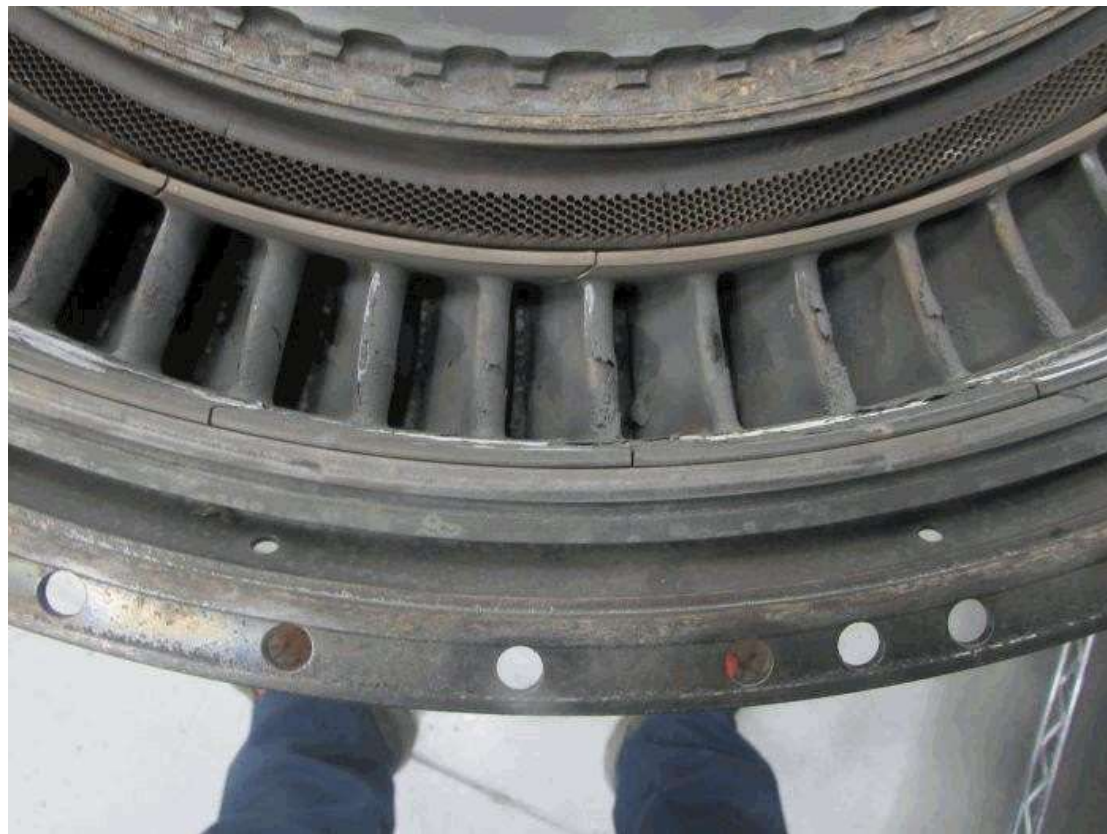
Fig 15: 2ND STAGE HIGH-PRESSURE TURBINE VANES - DETAIL

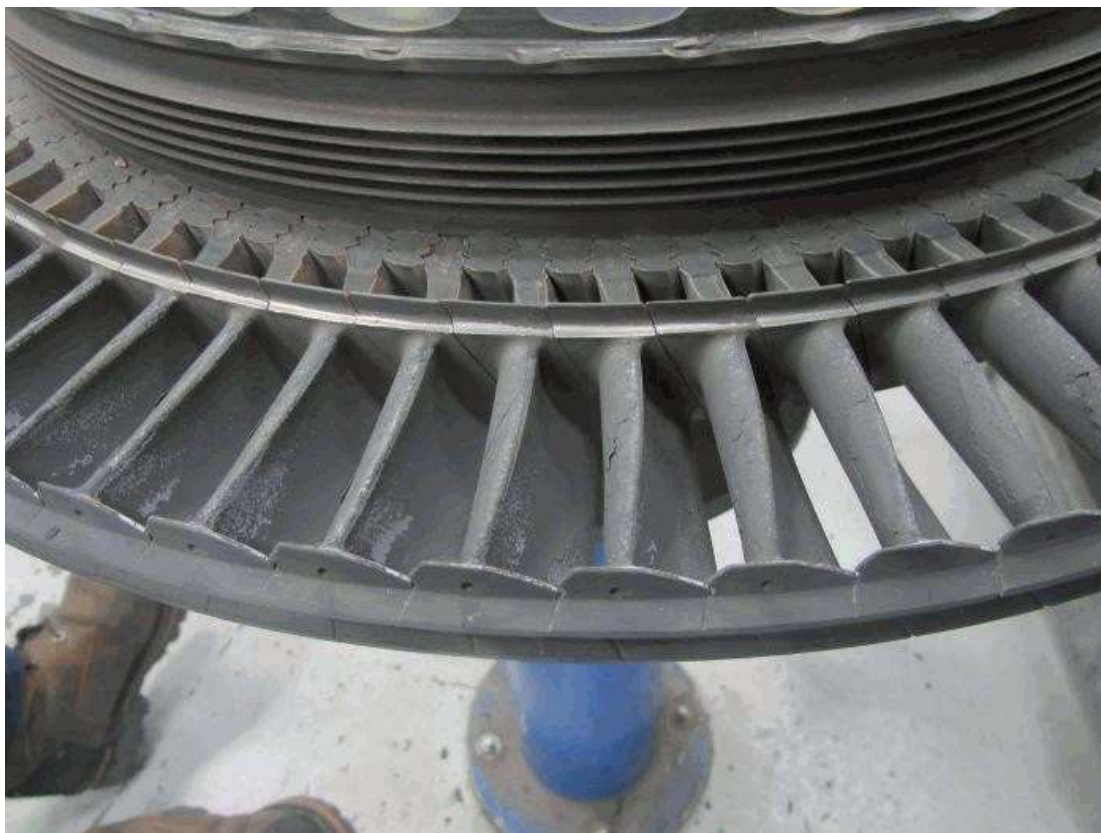
Fig 16: 2ND STAGE HIGH-PRESSURE TURBINE BLADES - DETAIL

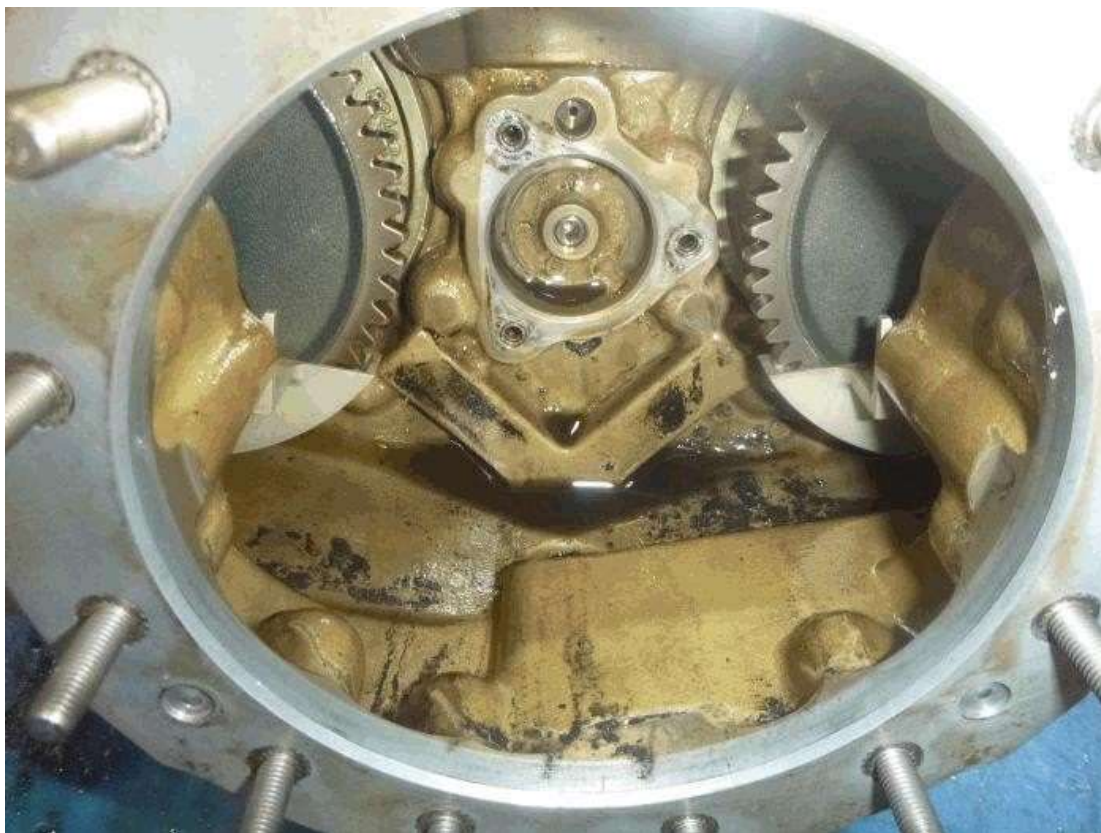
Fig 18: ACCESSORY DRIVE GEARBOX (CONTAMINATION) - DETAIL
