AIRCRAFT ACCIDENT REPORT

WESTLINK/2014/08/11/F

Accident Investigation Bureau

**Final Report on the Accident involving Westlink
Airlines Limited Piper Aztec23-250 Aircraft with
Registration Number 5N-BGZ which occurred at
Matseri Village, Bunza Local Government Area of Kebbi
State, Nigeria on 11th August 2014**

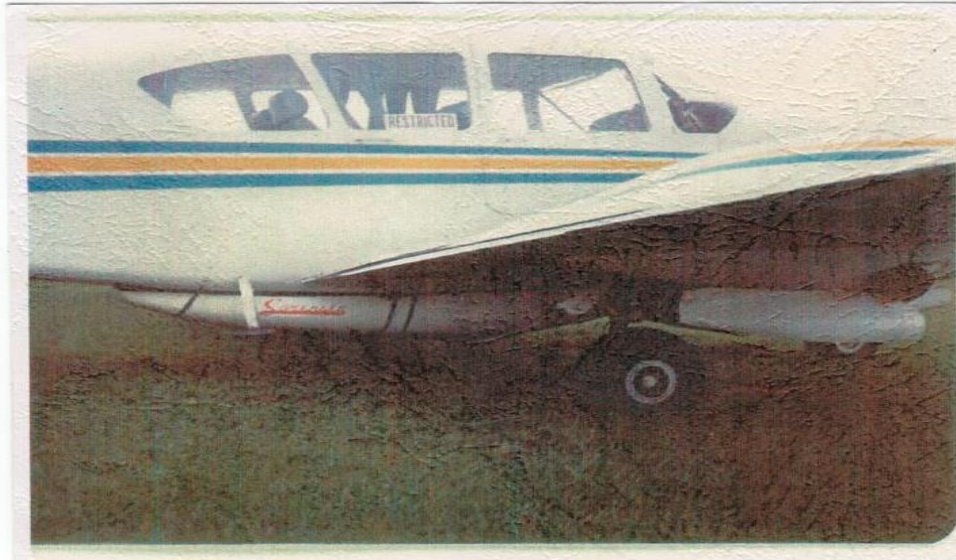
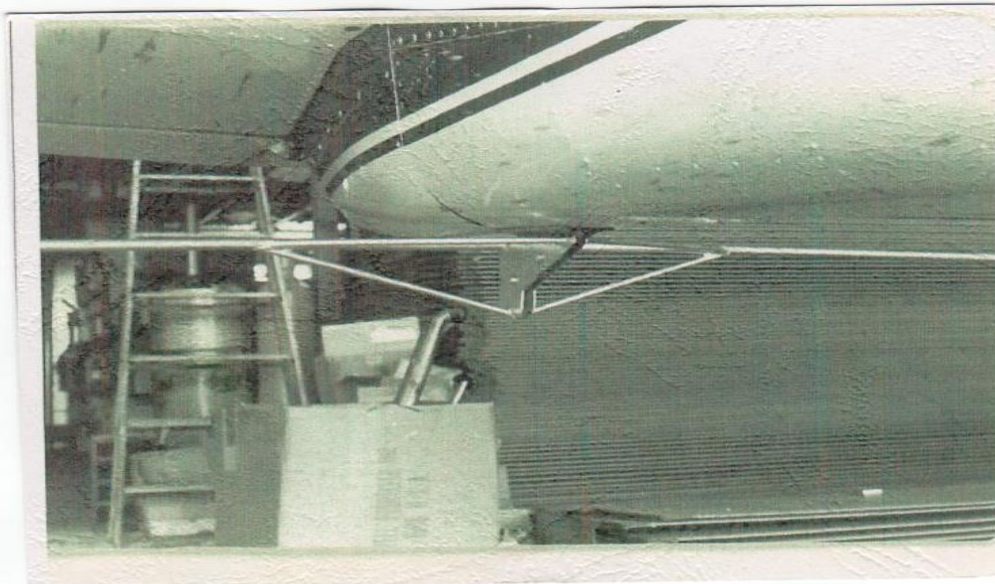
operation. The modification involves the installation of a 440 litre capacity Sorensen tank and a spray boom under the belly of the aircraft. The modification was carried out by Sky Power Express Airways Ltd at their maintenance facility in Kaduna International Airport on 11th December, 2006 with an NCAA approval number "NCAA/AD.1098AT/BGZ/001" dated 30th April, 2007. **See Appendix E.** A tail boom was also installed but was not covered in the documentation.

Figure 1: The Tank and Spray Boom

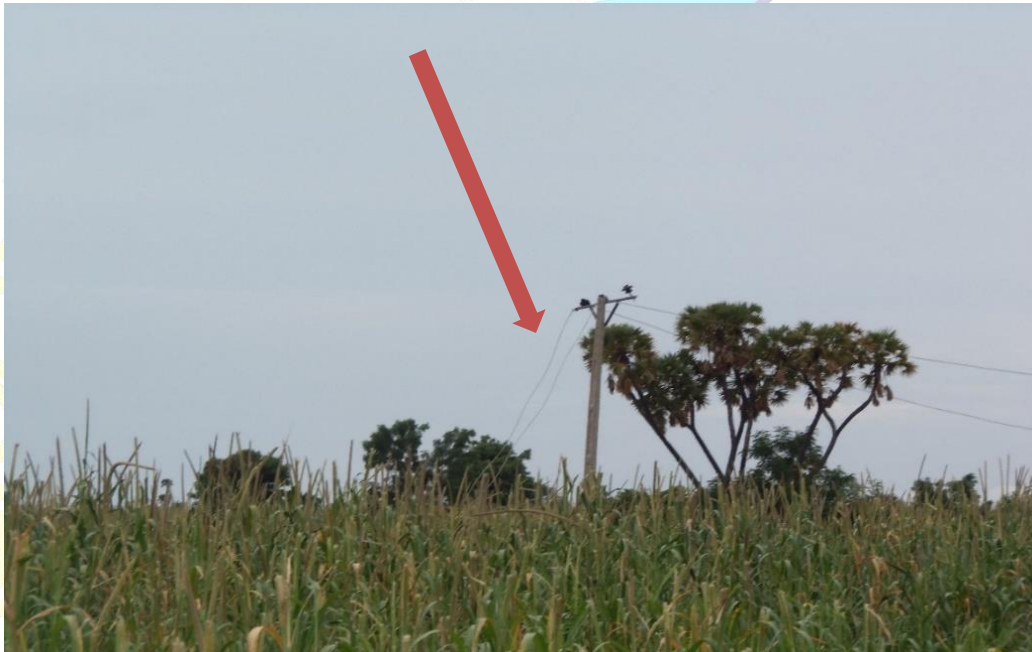
The accident site is a flat piece of farm land with a few scattered trees, full grown millet and maize stalks of an average height of 2.0m. A power line crosses the farmland (East-West) almost perpendicular to the flight path.

The aircraft impacted the power line in a nose up attitude. The power line sheared off the left side horizontal stabilizer from its attachment point, the aircraft rolled to the

Figure 2: Power lines Snapped off across aircraft flight path

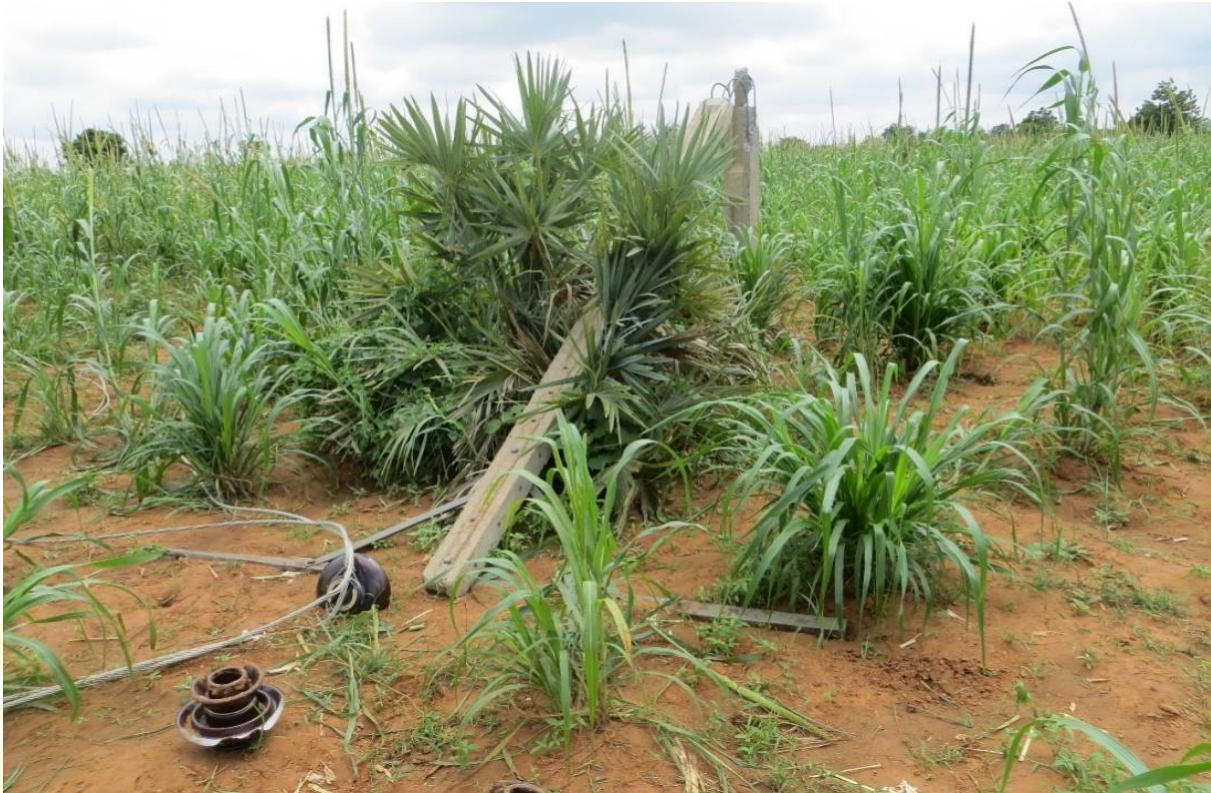
Figure 3: Electricity Distribution Concrete Pole brought down when the aircraft collided with the Power lines.

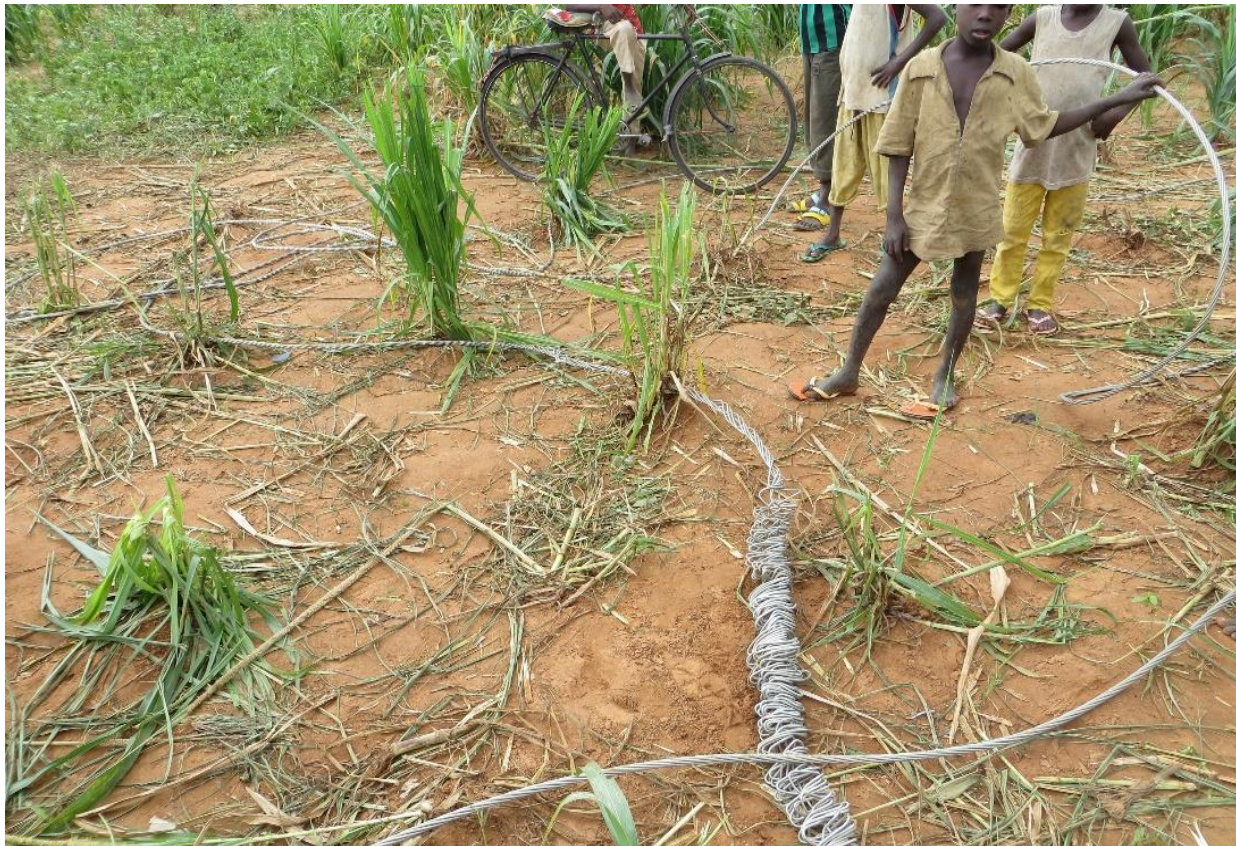
Figure 4: Snapped Electricity Cables

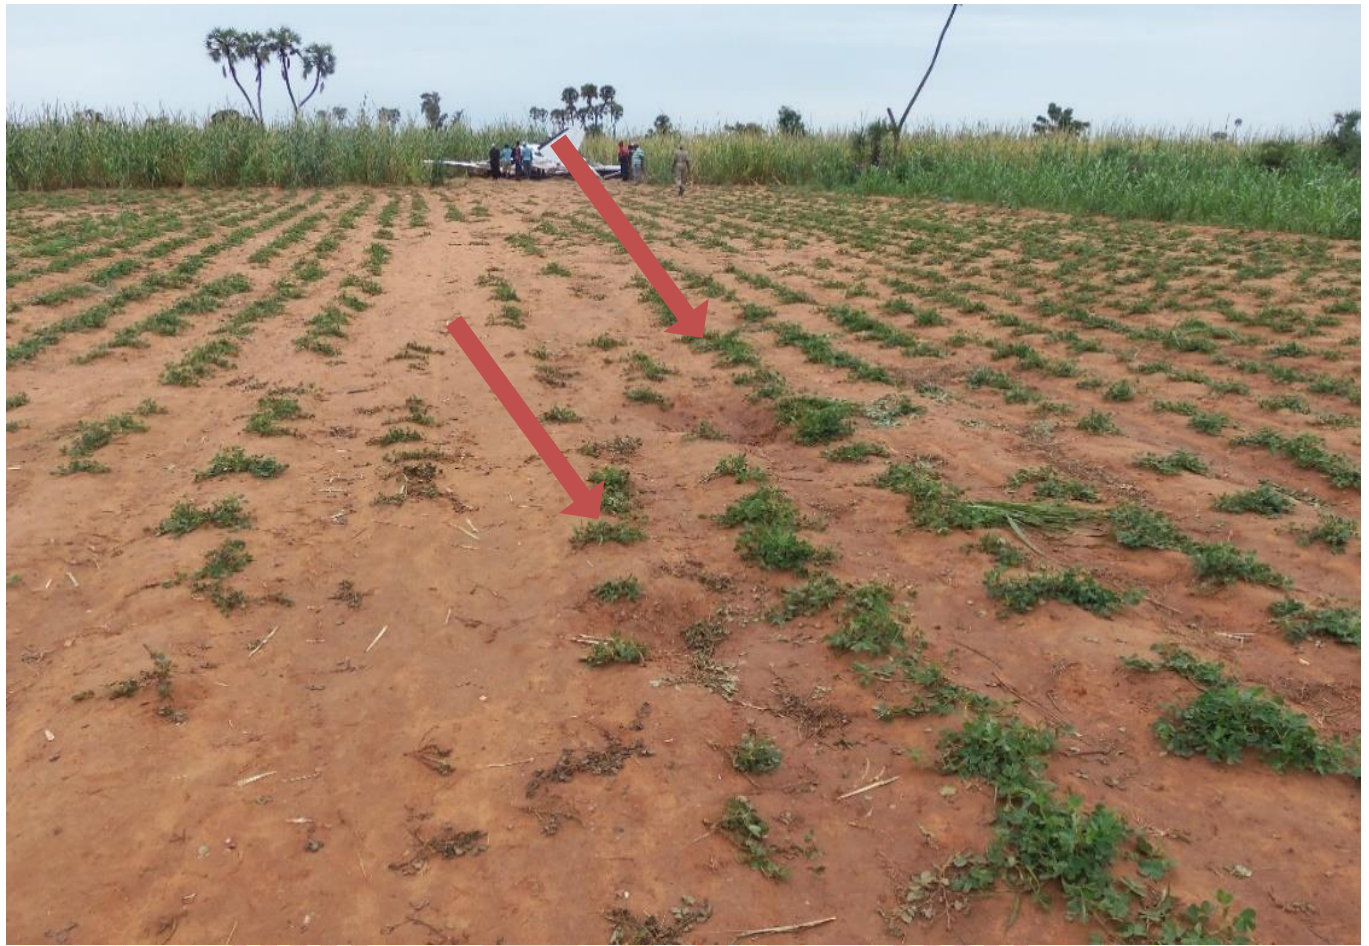
Figure 5: Ground Impact Marks made by the Aircraft at the Crash Site

The Sorensen tank and spray booms installed under the belly of the aircraft were crushed and detached from their strap and attachment points. The wreckage trail and impact marks at the crash site were distorted by rainfall and locals.

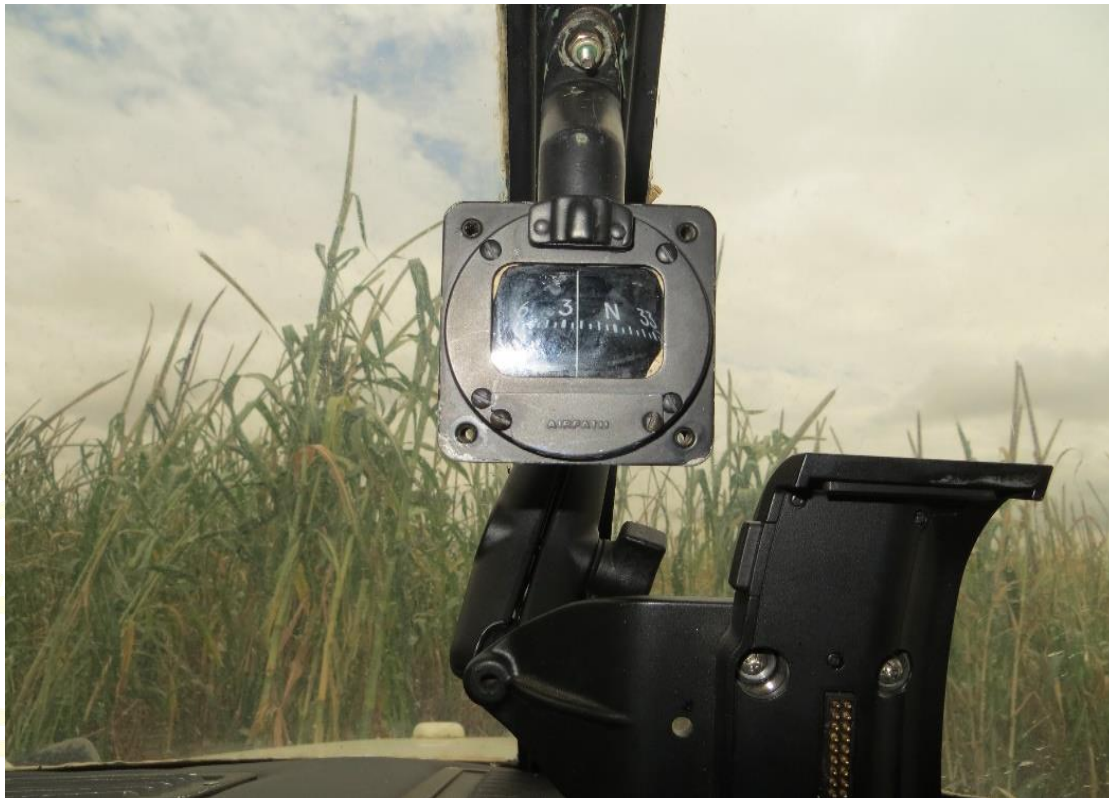
right, impacted the ground, skidded a few meters and finally came to rest on a heading 023° magnetic as seen from the compass in the cockpit.

Figure 6: Compass Magnetic Heading showing the resting position of the wreckage.

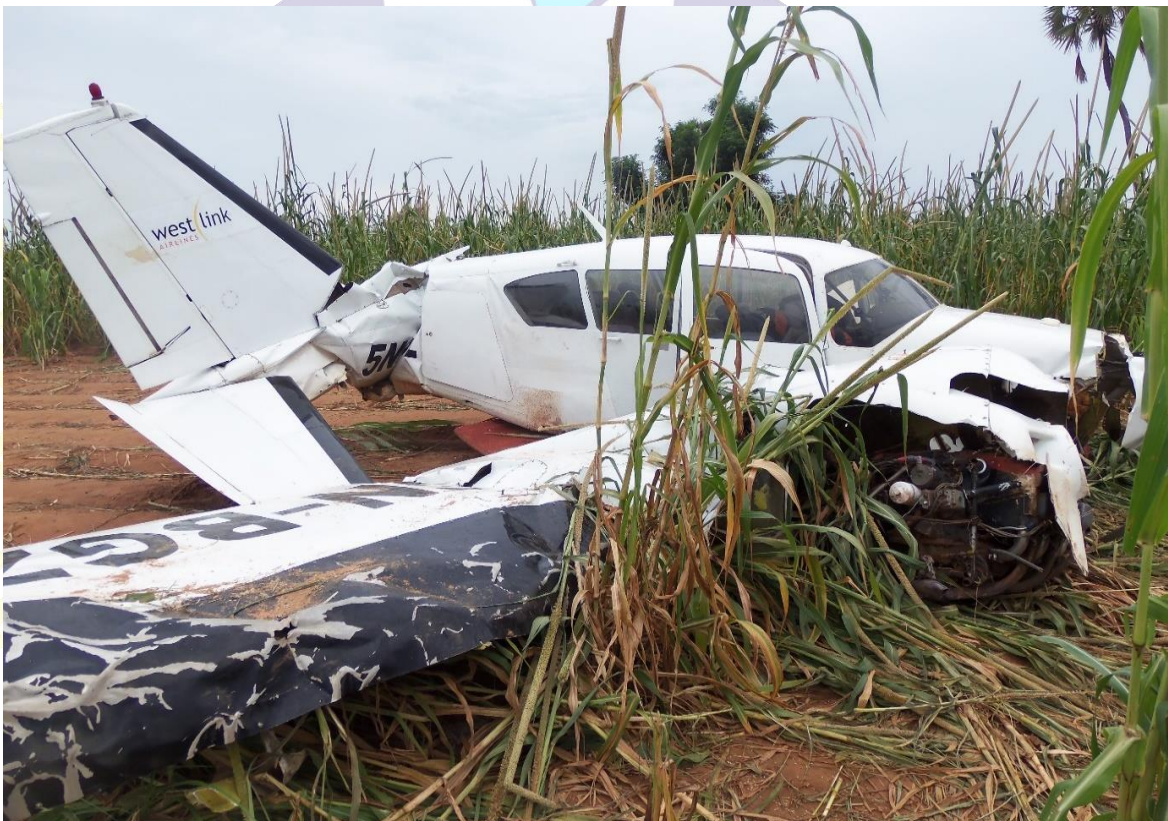
The aircraft radome was crushed, the right engine was crushed, and dislodged from its attachment points. The right leading edge protection device was ripped open. The tail end section of the fuselage suffered a bending stress to the right, with the left side horizontal stabilizer sheared off at its attachment point. The left section of the aircraft was relatively intact, with a slight damage to the engine cowling and the propeller tips.

Figure 7: Side View of the Aircraft wreckage
