Preliminary Report on the Incident involving a Boeing 737-300 aircraft operated by Max Air Limited with nationality and registration marks 5N-ADB, which occurred at Lamido Aliyu Mustapha International Airport (DNYO) Yola, Nigeria on 21 July 2024

Operator:	Max Air Limited, Nigeria
Aircraft type and model:	Boeing 737-36Q
Manufacturer:	The Boeing Company, USA
Year of manufacture:	1999
Nationality and registration marks:	5N-ADB
Serial number:	30333
Location:	Lamido Aliyu Mustapha International Airport (DNYO) Yola, Runway 35
Date and Time:	21 July 2024 at about 17:57 h (All times in this report are local time, equivalent to UTC+1 unless otherwise stated)

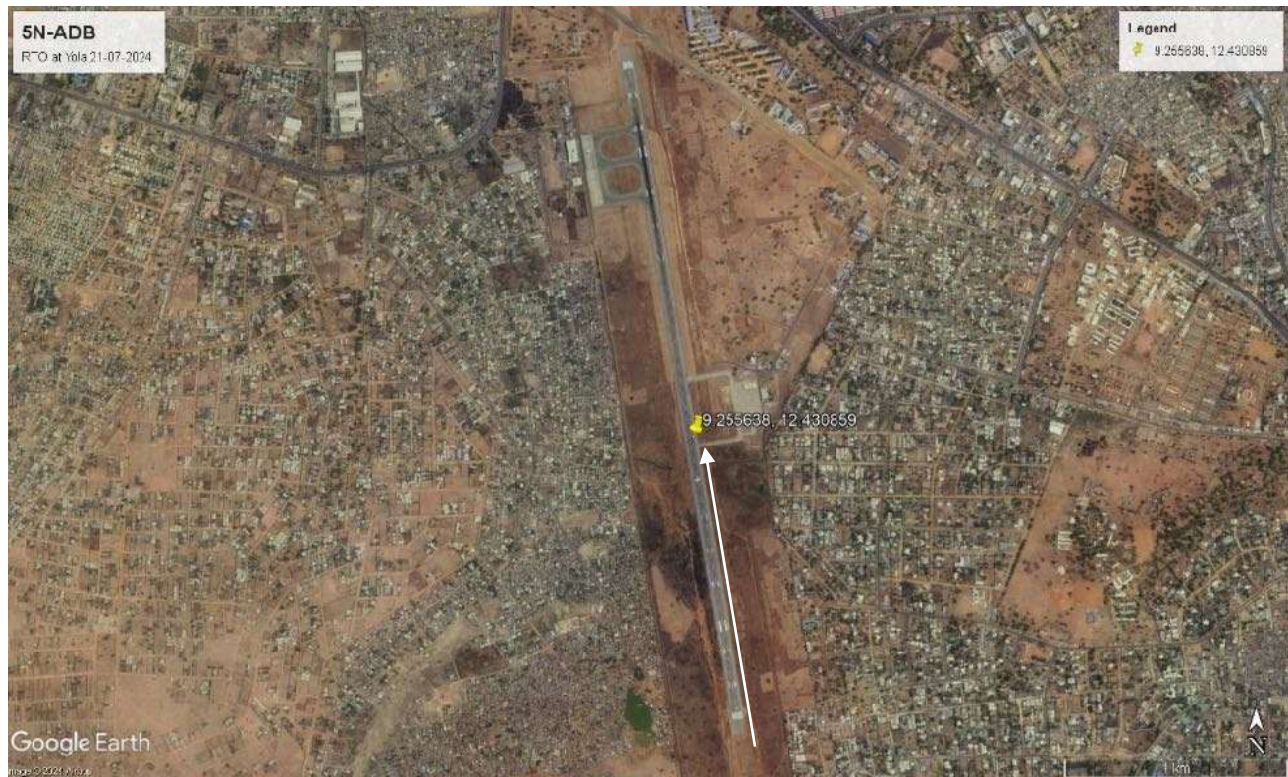
At 17:57 h, NGL 1649 was cleared for take-off Runway 35, with the prevailing wind as 270° at 07 kts. During the take-off roll, the flight crew observed that the auto-throttle disconnected, and the PF then set the take-off thrust manually before re-engaging the auto-throttle. The crew also observed that the desired engine thrust settings were not attained instantly. The PM then called out the aircraft speed, 90 kts. Thereafter, the aircraft buffeted at above 100 kts. A bang was heard, followed by a landing gear disagree annunciation for the Right Main Landing Gear. According to the PF, the thrust levers were then retarded at about 126 kt IAS (Indicated Air Speed) as part of Rejected Take-Off (RTO) procedure. The PM scanned the instruments and called out "stop, stop, right gear" and then proceeded to call out "speed brakes" as the speed brake lever was observed to be not fully actuated. The aircraft came to a stop 300 m from the end of the runway.

Figure 1: Point at which thrust levers were retarded (arrow shows direction of motion)

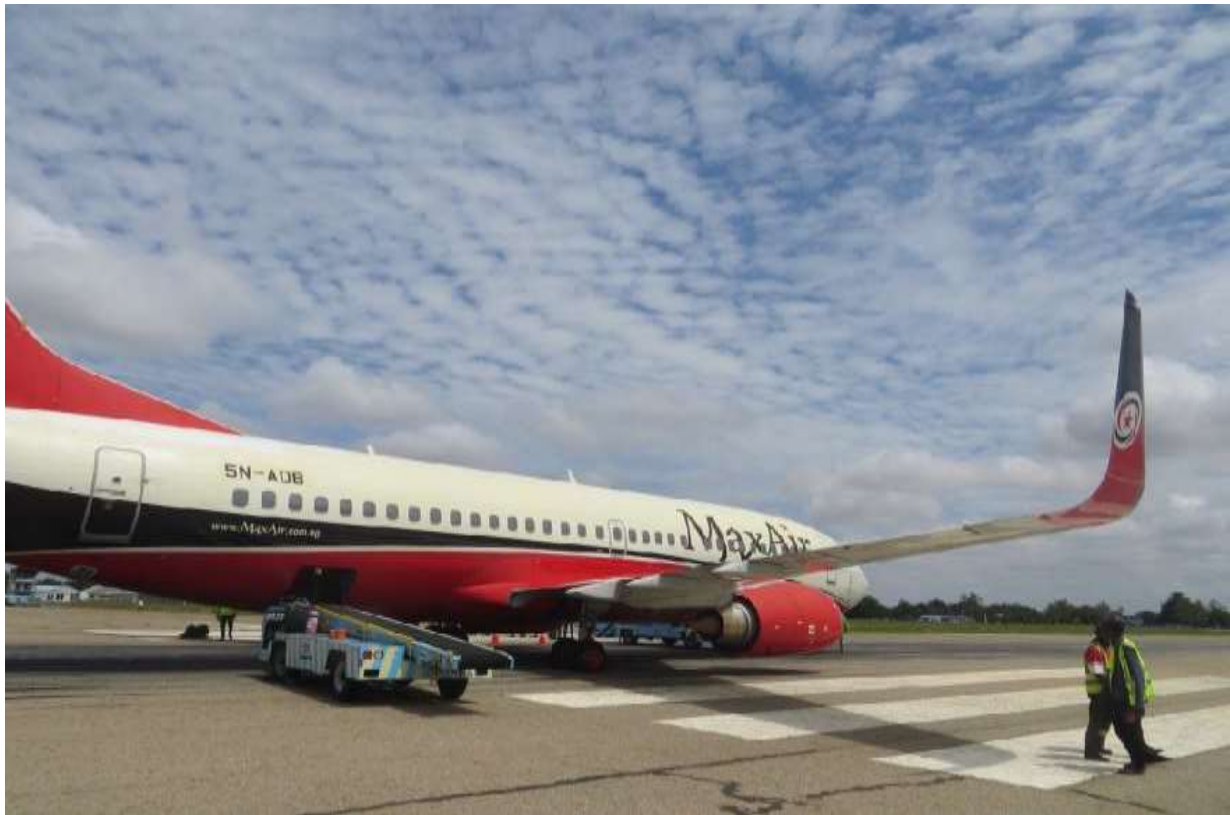
The aircraft was slightly damaged.

Figure 2: 5N-ADB post-occurrence at DNYO

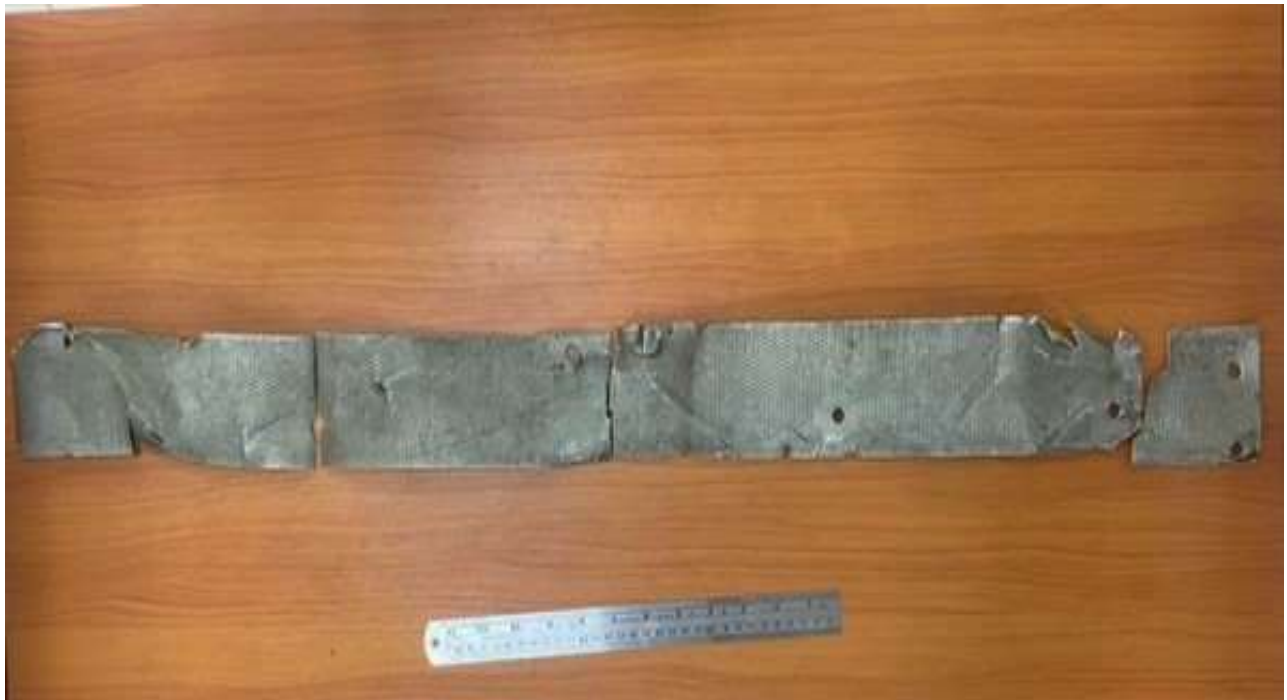
At 17:06 h, NGL 1648 landed on Runway 17 DNYO. The PF observed bird activity, and during the backtrack, the PM observed foreign object debris (FOD) on the runway, around the Nigerian Airforce Apron, almost on the runway centre line. The flight crew reported to the tower.

A staff member of the Nigerian Airspace Management Agency (NAMA) was dispatched to the reported position, and perforated metallic sheets were retrieved; a Boeing 737 operated by Air Peace Limited subsequently took off from Runway 17.

Foreign Object Debris were recovered from the runway after 5N-ADB Landed.

Figure 3: Foreign Object Debris recovered from the runway (ruler to show scale)

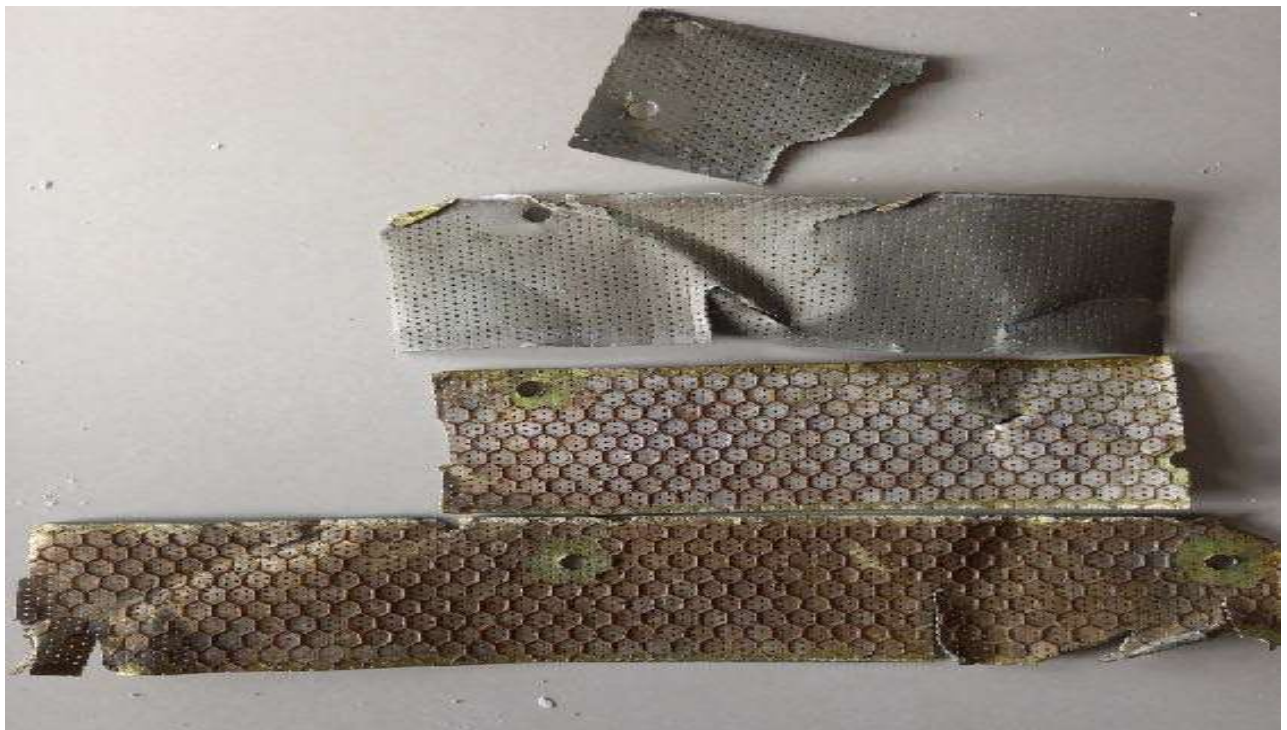
Figure 4: Alternate view of the FOD

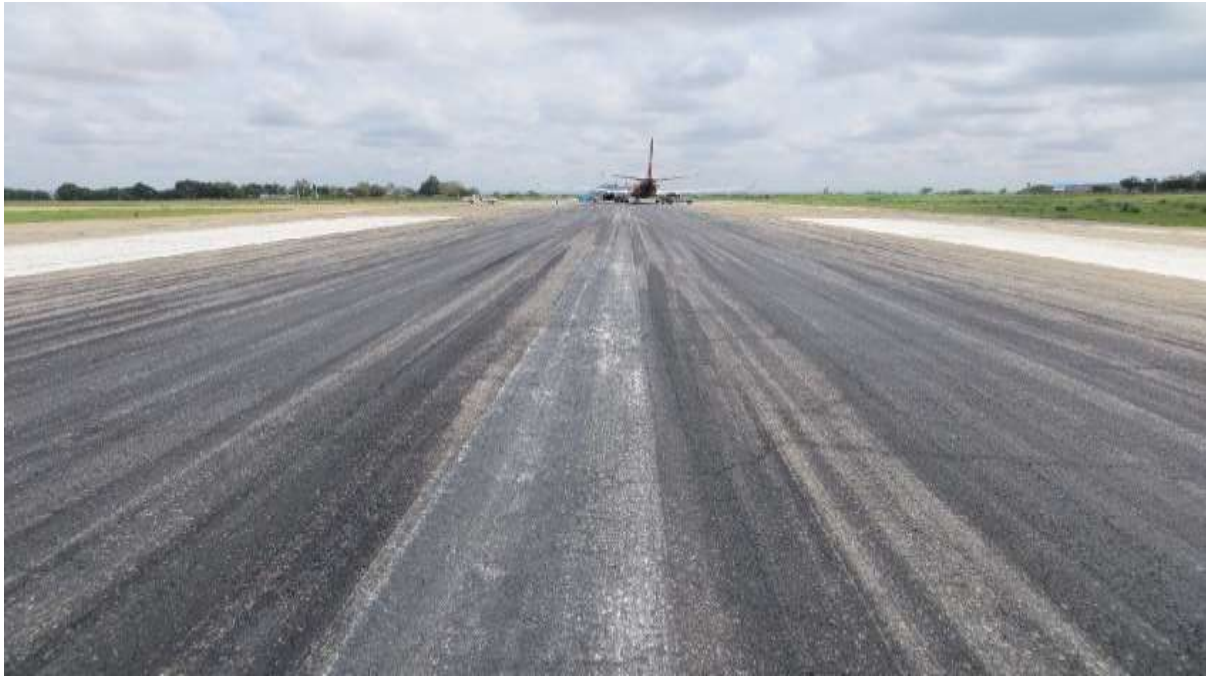
Figure 5: Rubberised deposits on the runway at DNYO

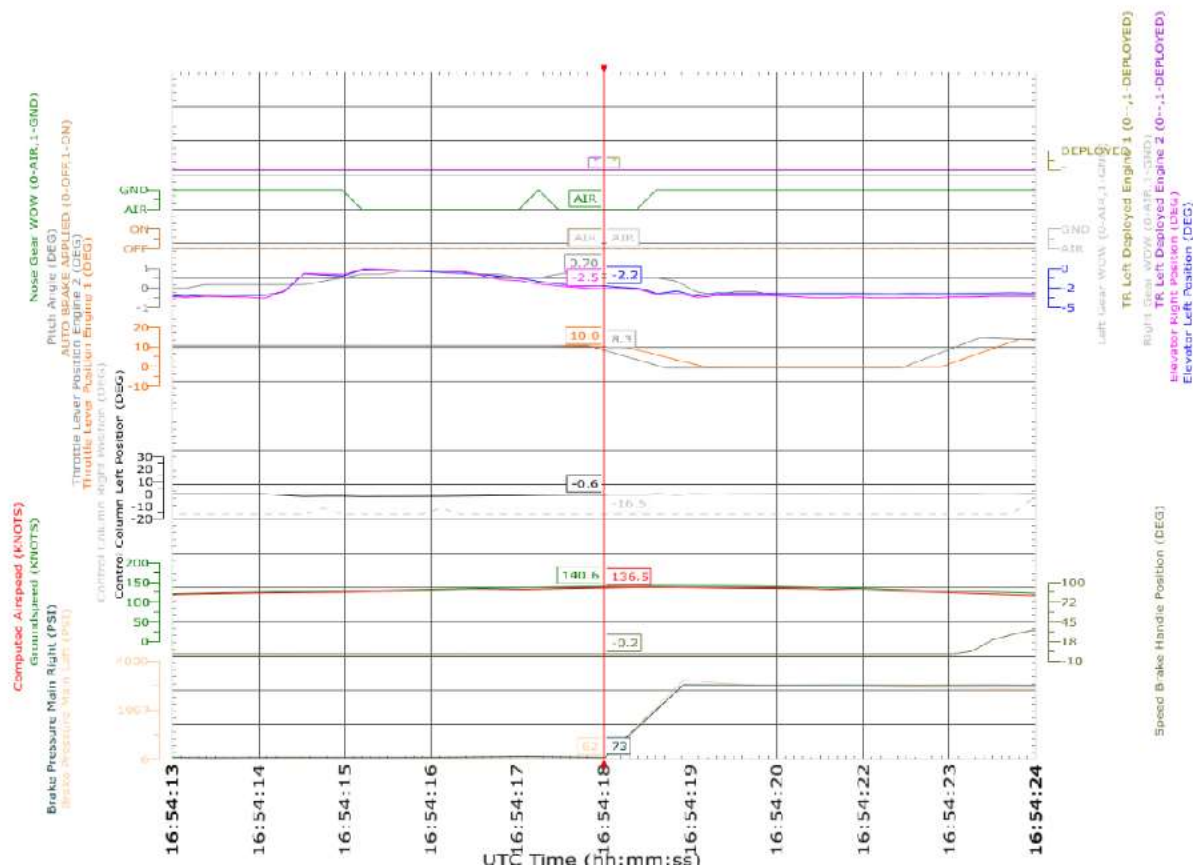
Figure 6: A representative plot from the FDR (at the point of initiation of RTO)

Flight data indicated that there was a disagreement on the Right Main Landing Gear indication at 122 kts CAS (Computed Air Speed), and the thrust levers were retarded 5 s after at 136 kts CAS. The brakes were applied, and thrust reversers were deployed.

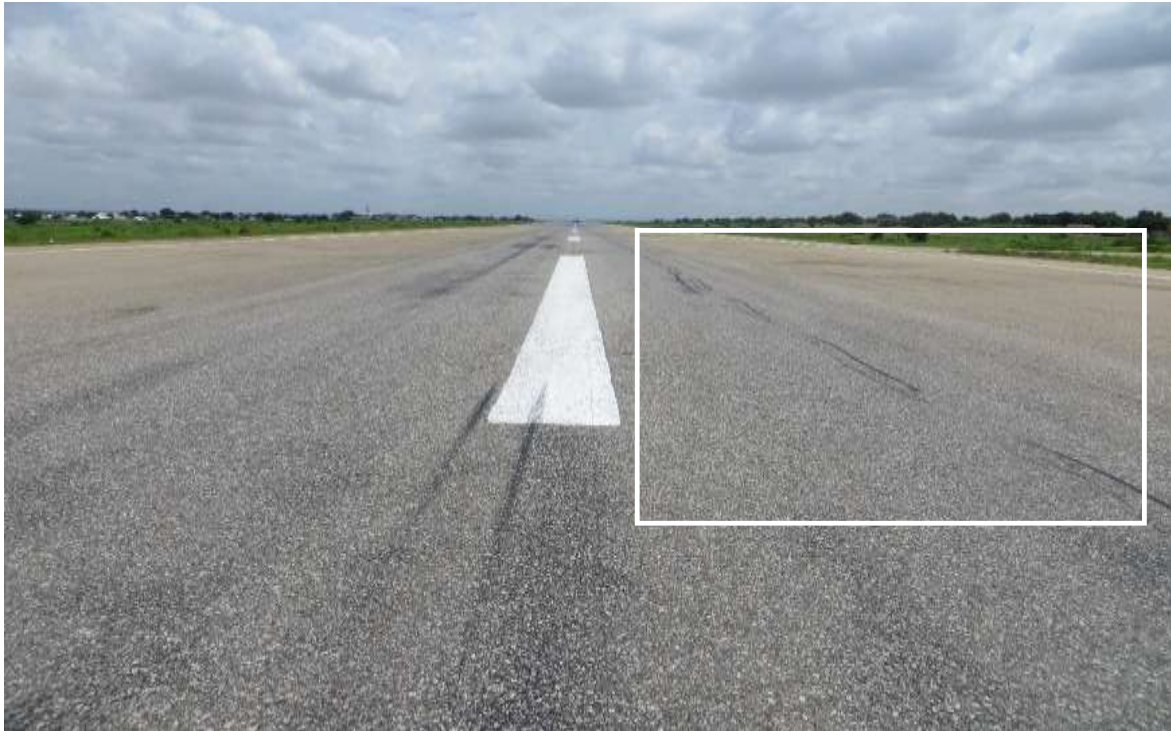
Physical evidence suggests that Number 3 Main Wheel tyre (the inboard tyre on the Right Main Landing Gear, MLG) failed about 1000 m from the Runway 35 threshold then, Number

4 Main Wheel tyre burst. Number 1 and 2 Main Wheel tyres deflated as the aircraft came to a stop. The aircraft stopped 300 m short of the threshold of Runway 35.

Figure 7: Witness marks indicating Tyre No. 3 failure

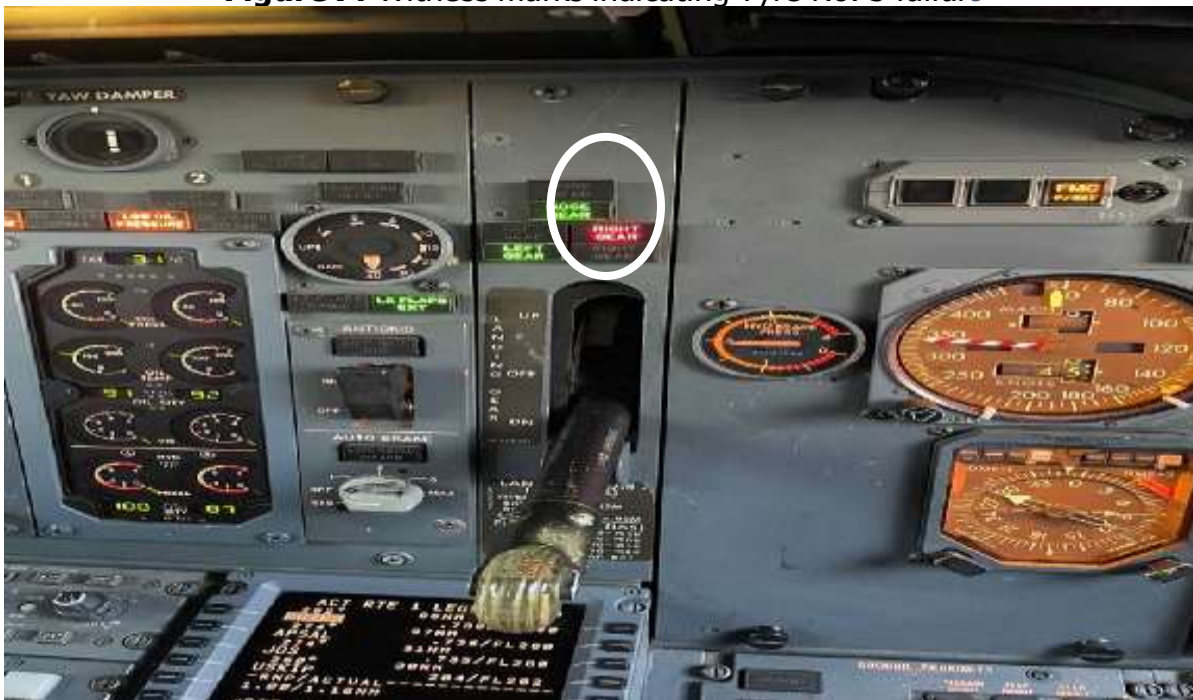
Figure 8: Landing gear indications in the cockpit

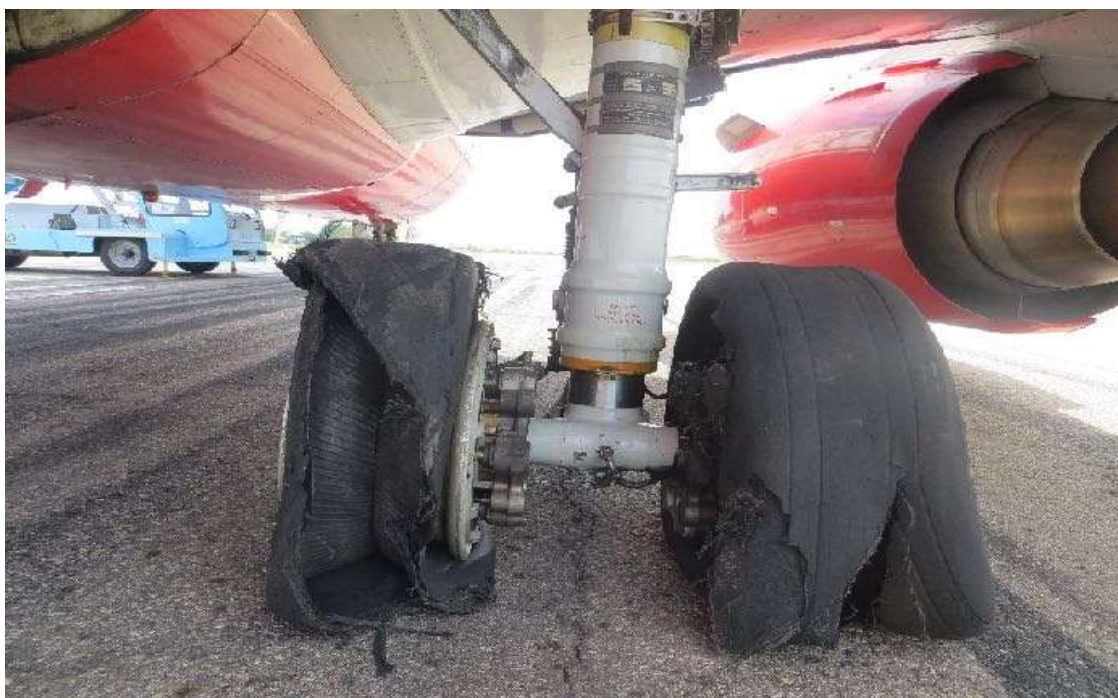
1. Number 3 Main Wheel tyre failed;
2. Number 4 Main Wheel tyre burst;
3. Number 1 and 2 Main Wheel tyres were deflated;
4. Binding of brake assembly Number 1 and 2;
5. The right MLG shock strut door was broken.

Figure 9: Failed Tyres No. 3 and No. 4

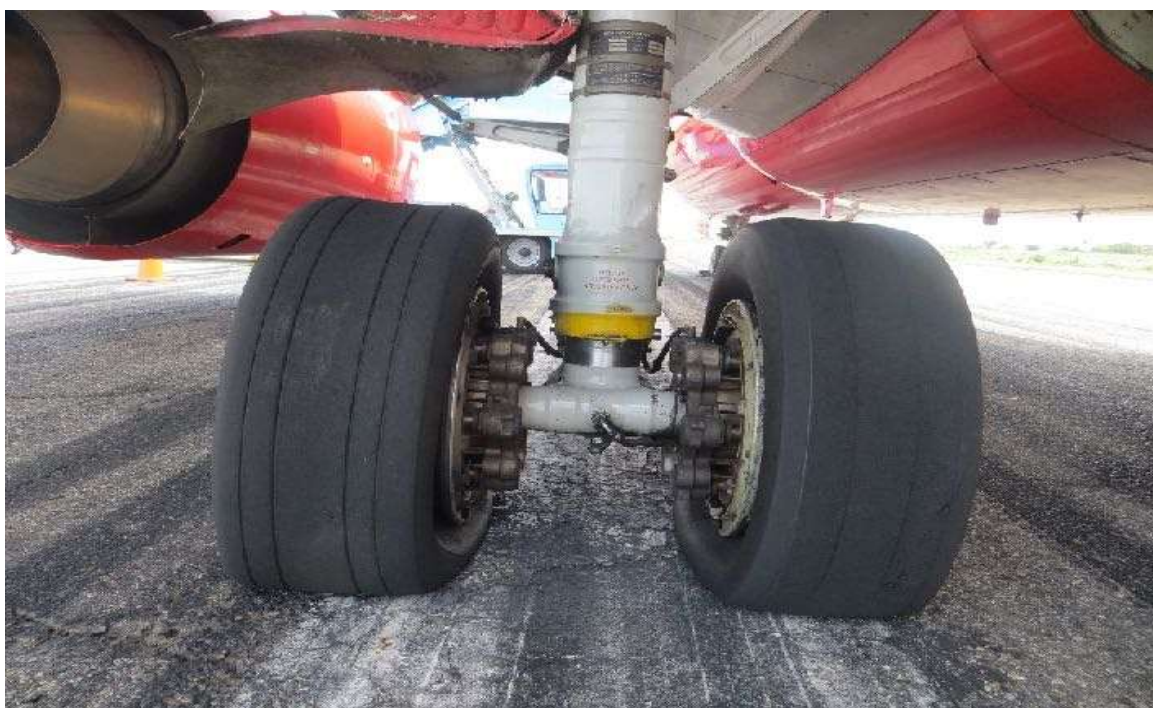
Figure 10: Deflated tyres No. 1 and No. 2

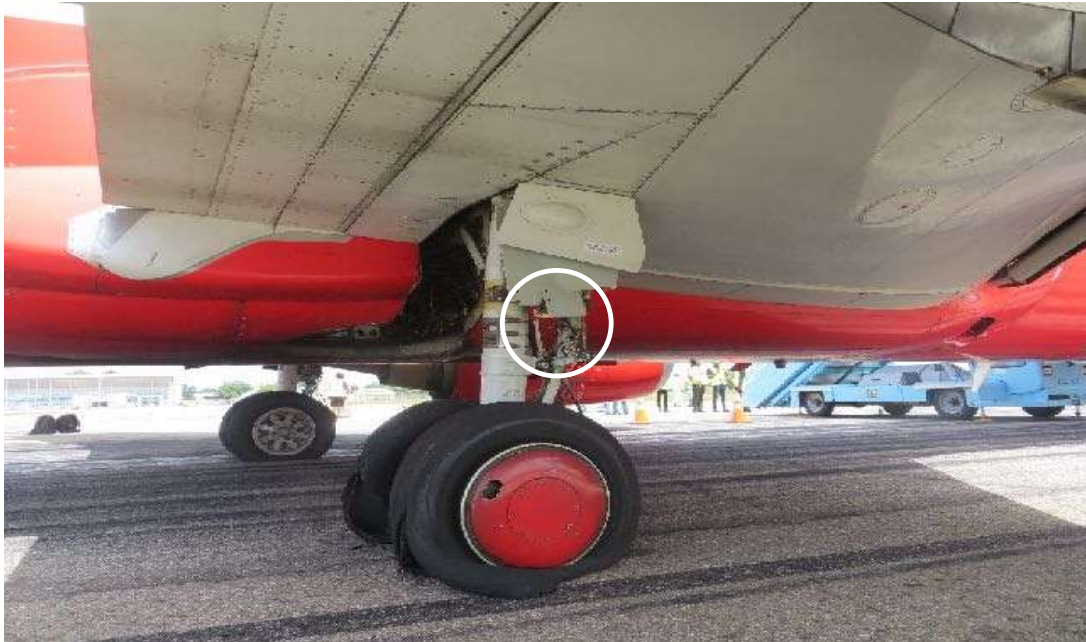
Figure 11: Torn section of Right MLG shock strut door

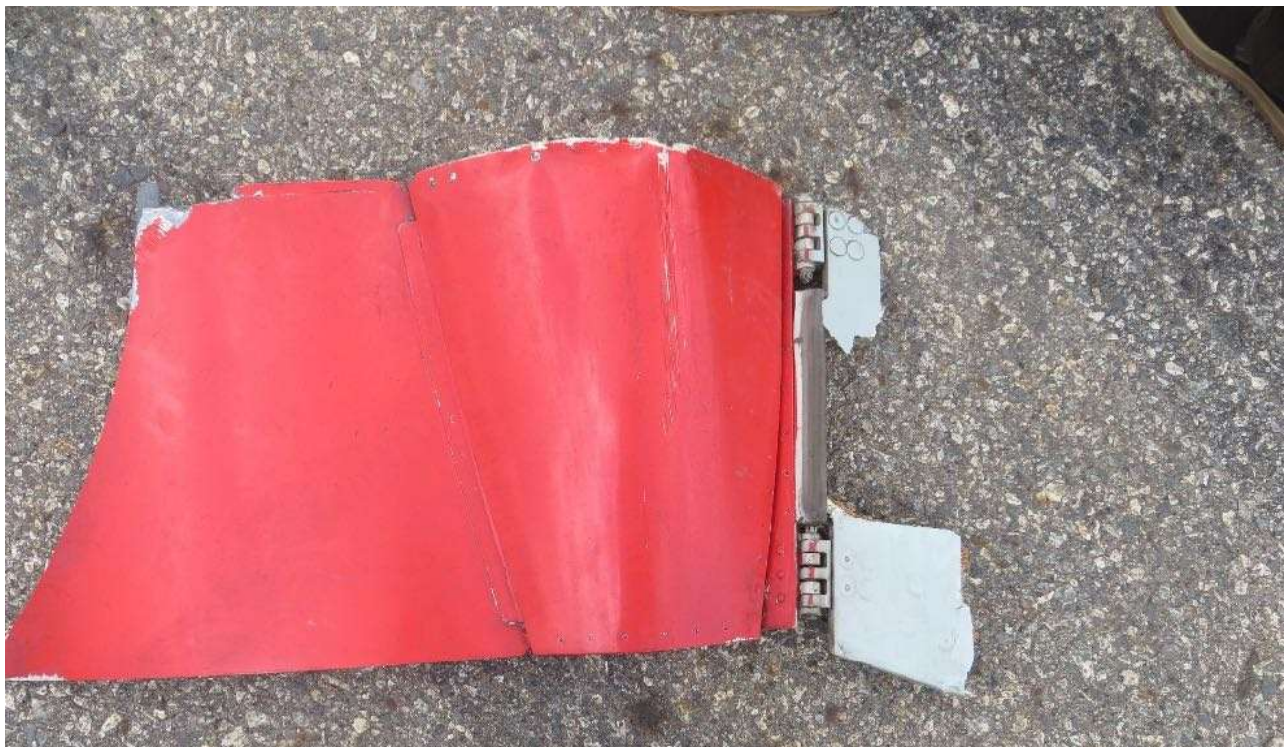
Figure 12: Detached piece of the R MLG shock strut door

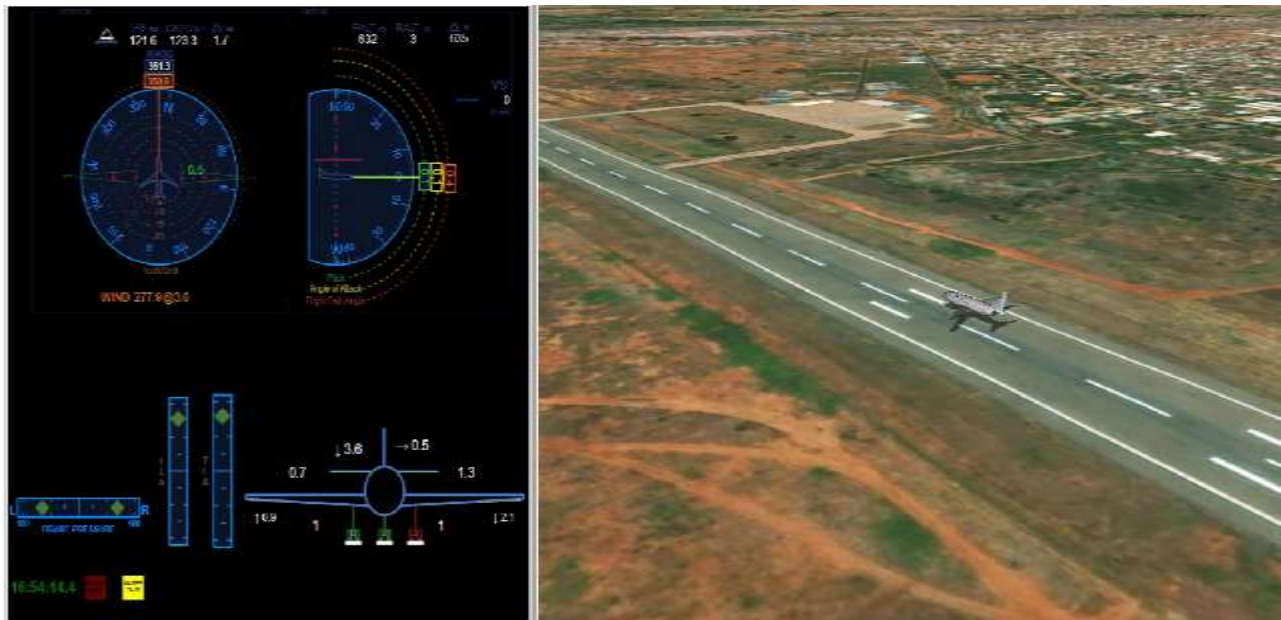
Figure 13: Right MLG disagree

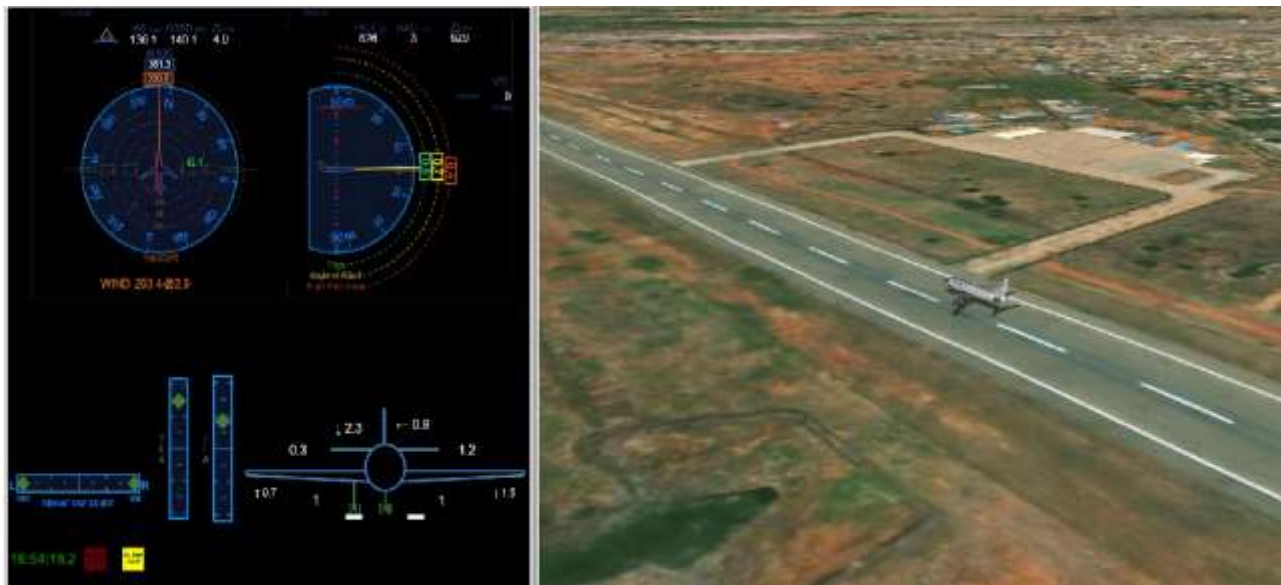
Figure 14: Commencement of RTO

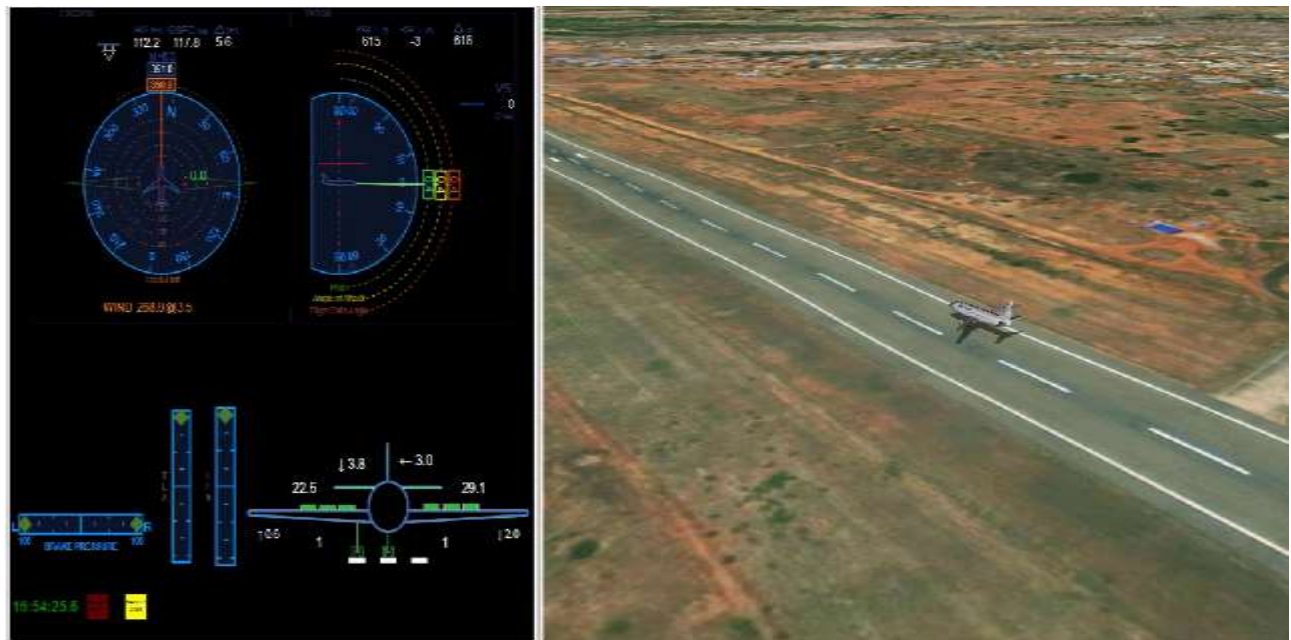
Figure 15: Deployment of reversers, brakes and speed brakes
