MARINE ACCIDENT REPORT

Marine/2024/08/11/P/002

Nigerian Safety Investigation Bureau

Report of an accident involving a wooden canoe which occurred along River Rima by Dundaye Village, Wamakko Local Government Area (LGA), Sokoto State on 11 August 2024.

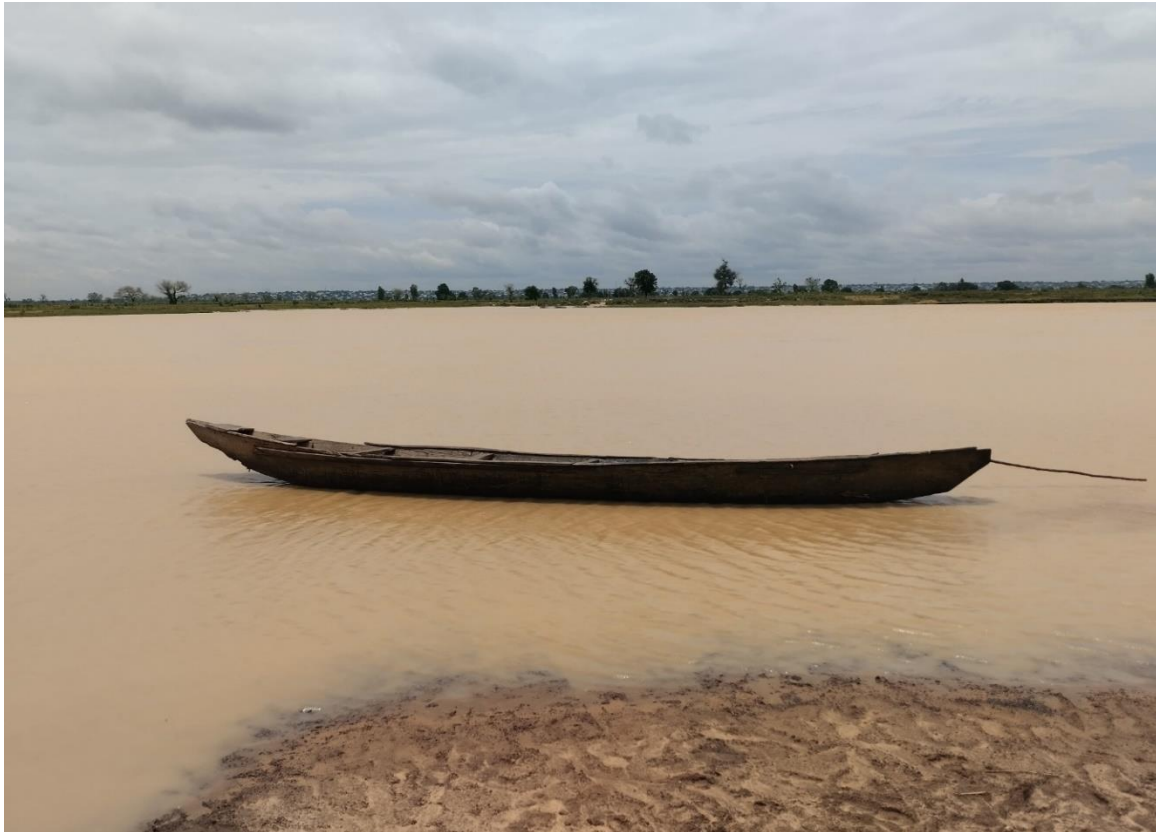
Figure 1: The accident Wooden Canoe

The Canoe was recovered without any damage, and normal operations continued immediately after the occurrence.

Provisions for life jackets and other safety gear were not made on the Canoe.

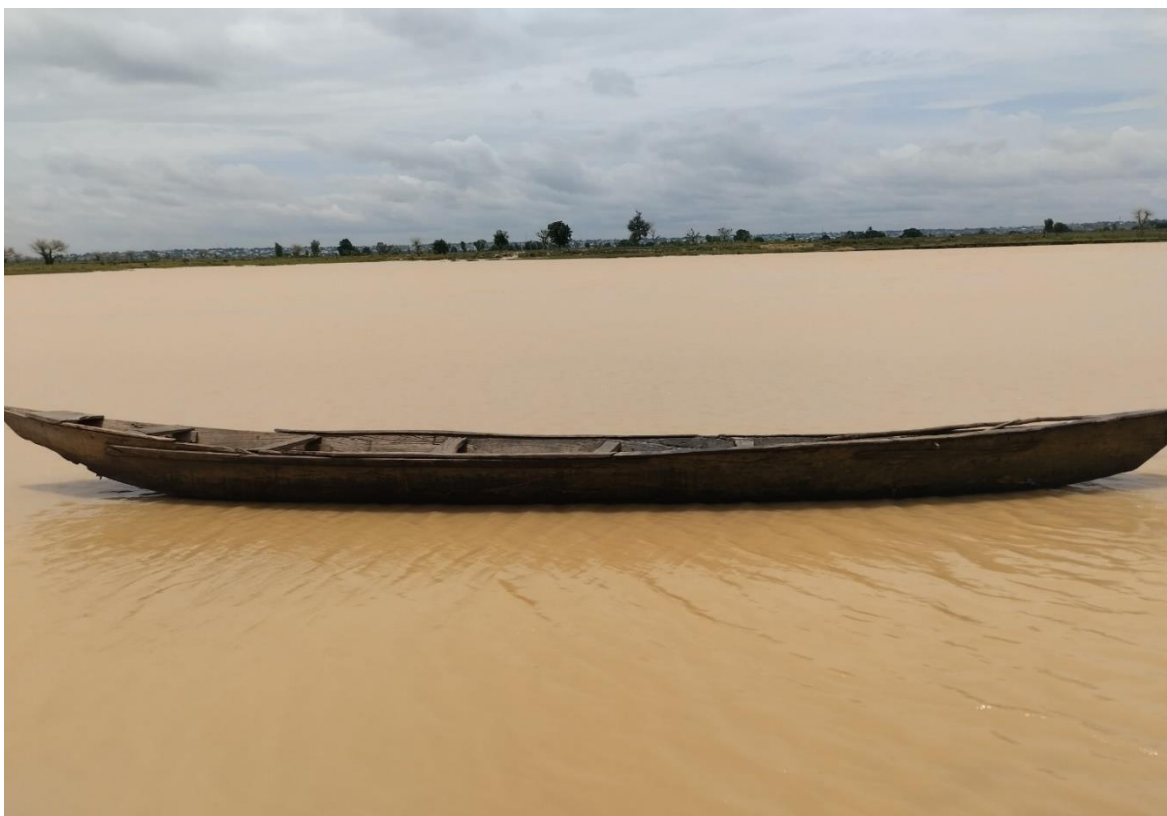
Figure 2: A view of the shore from the location of the accident
