AIRCRAFT ACCIDENT REPORT ATL/2023/07/10/F

Nigerian Safety Investigation Bureau

Final report on the serious incident involving a Hawker 800XP aircraft operated by Aero Tak Limited with nationality and registration marks 5N-JEF which occurred at Nnamdi Azikiwe International Airport Abuja, Nigeria on 10 July 2023.

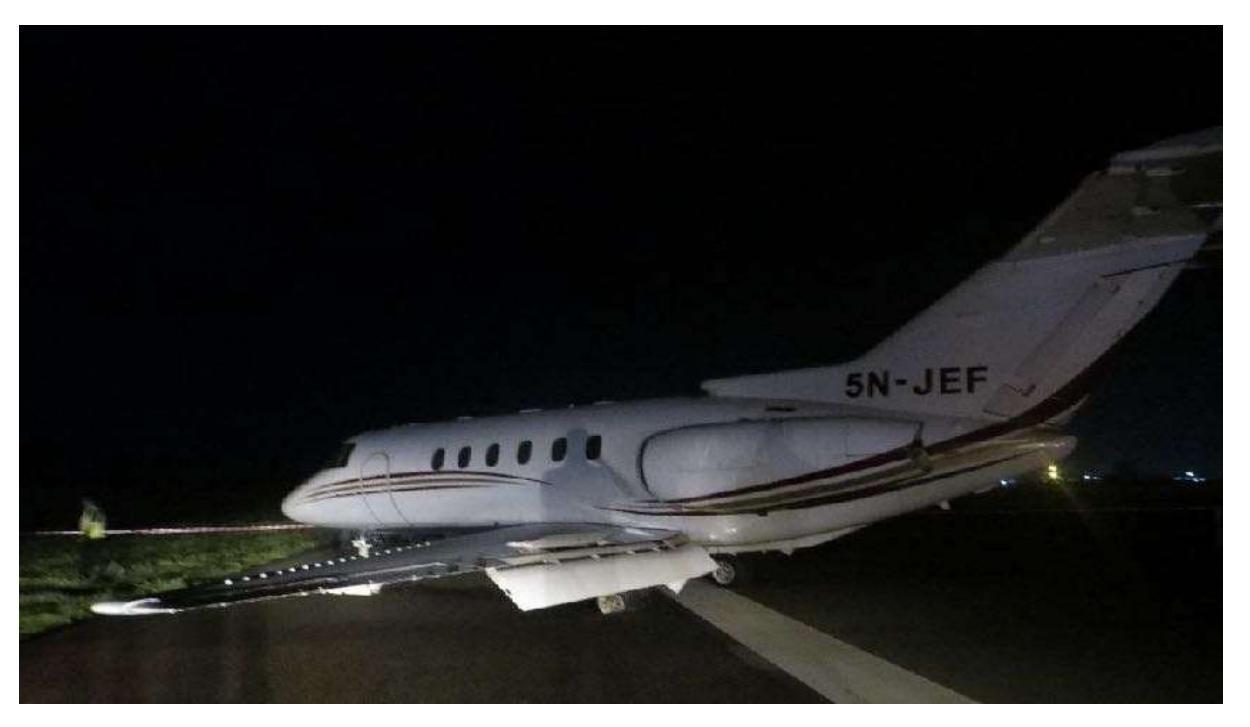
Figure 1

Figure 1: 5N-JEF on the runway post-occurrence

On landing runway 22, 5N-JEF veered to the left of the centre line at around link A2 and excursed unto the left paved runway shoulder, beyond the runway edge lights, at around 94 m from link A3. It then re-entered the active runway 186 m from the exit point as it veered to the right. 5N-JEF stopped making a 140° turn to a magnetic heading north.

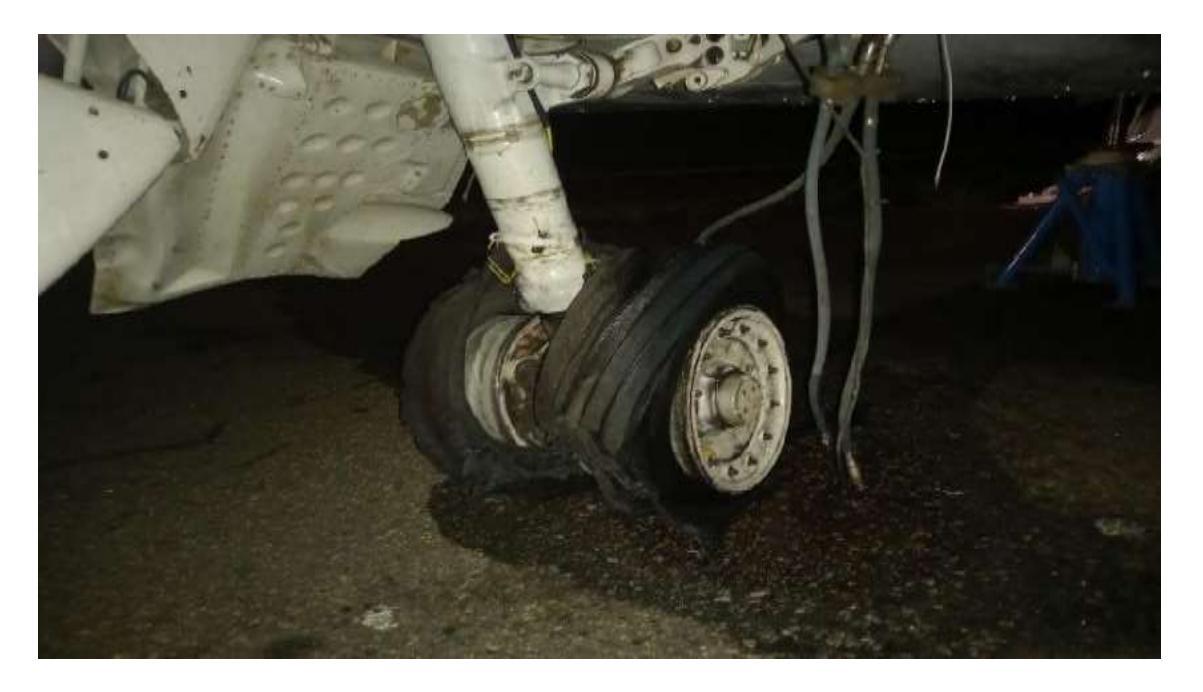
- 1. Damaged wheel assemblies of the left Main Landing Gear (MLG).
- 2. Severed hydraulic lines of the left MLG.
- 3. Hydraulic oil leakage below the left MLG.
- 4. Abrasion on the number 3 (right main wheel) tyre.
- 5. Abrasion on the number 1 nose landing gear tyre.

Figure 2: Damaged wheel assembly of the left Main Landing Gear (MLG) with severed hydraulic lines

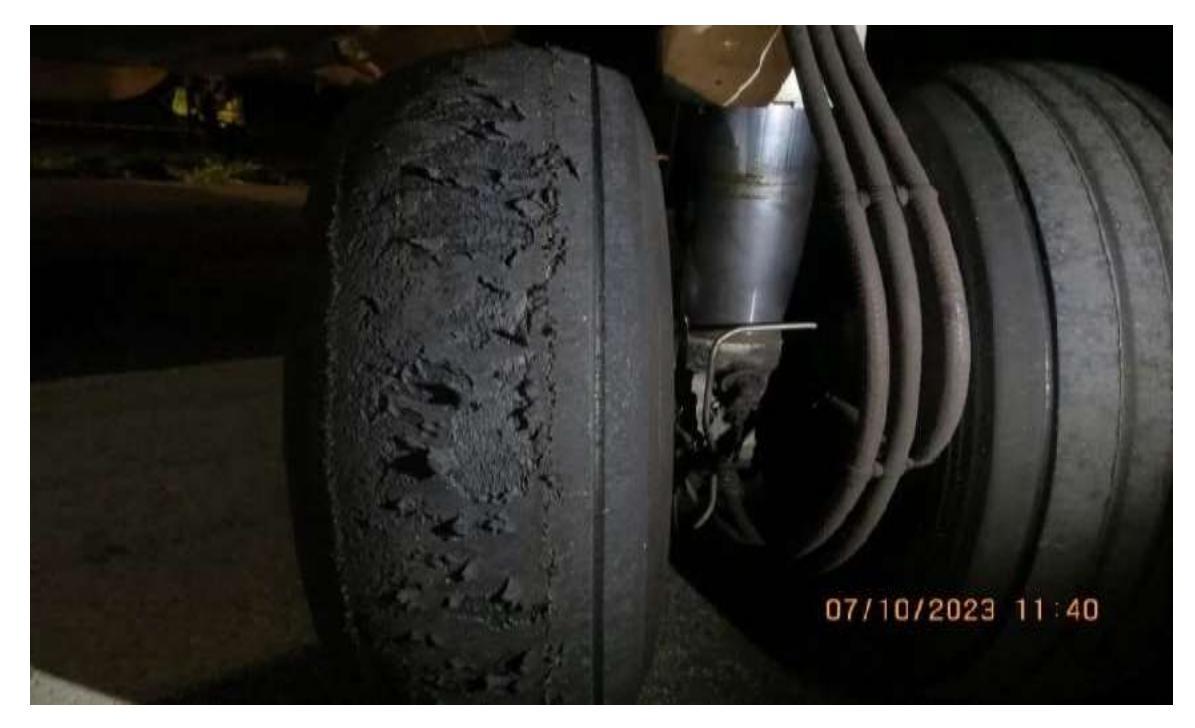
Figure 3: Abrasion on the number 3 (right main wheel) tyre

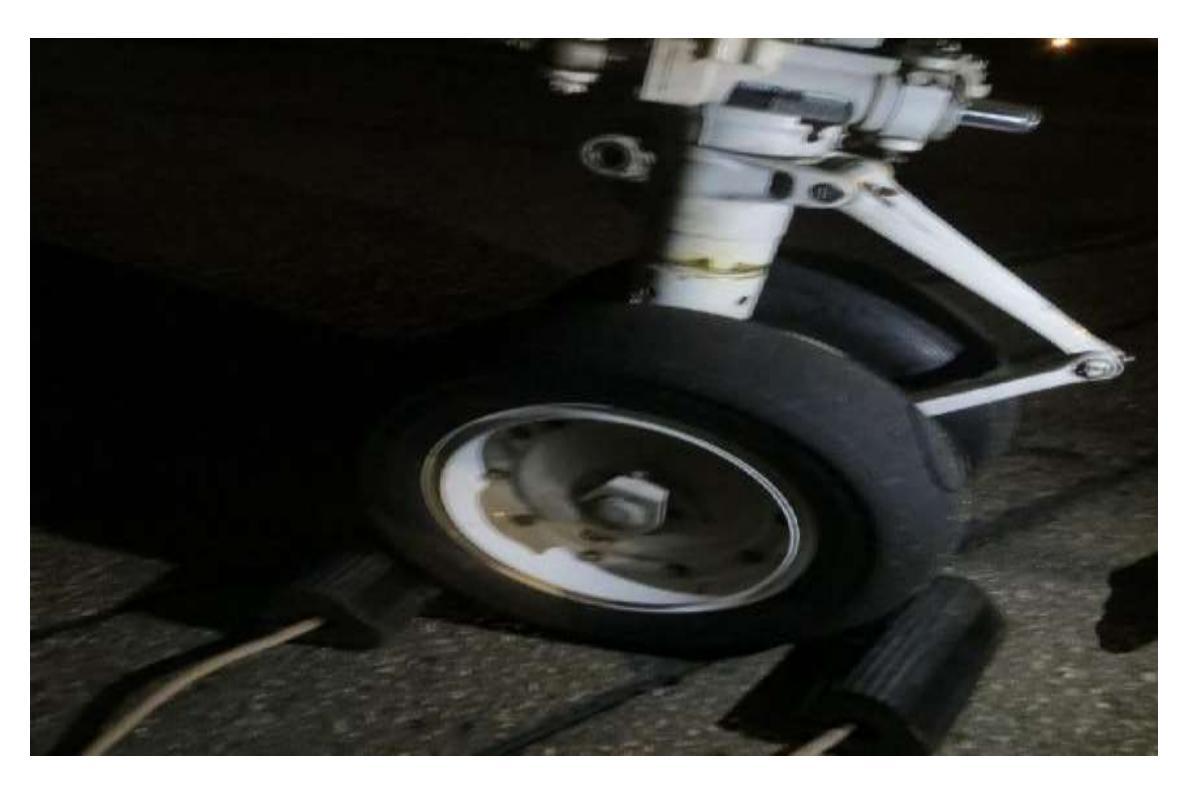
Figure 4: Abraded number 1 Nose wheel tyre
