# AIRCRAFT ACCIDENT REPORT

IAC/2014/03/27/F

**Report on the Serious Incident involving a Diamond  
DA-40 aircraft with Nationality and Registration Marks  
5N-BRM owned and operated by International  
Aviation College which occurred on Runway 23, Ilorin  
International Airport  
On 27th of March, 2014**

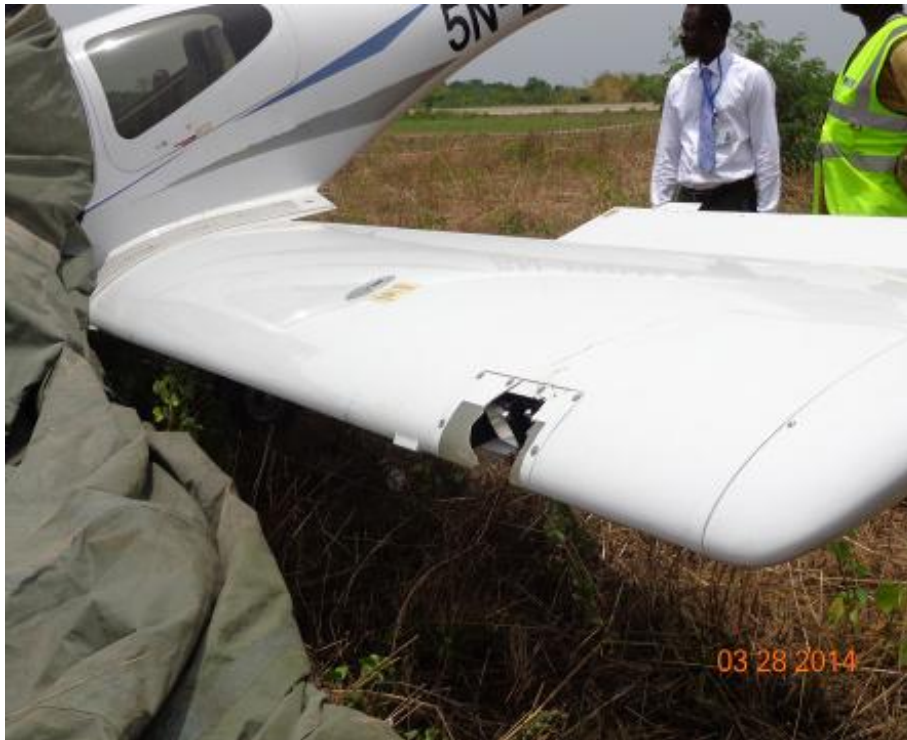
The aircraft veered left off the centreline runway 23 into the bush, impacted a shrub which broke the landing light, sheared the nose landing gear and damaged its propeller blades, before coming to a stop at about 325 feet from the edge of the runway. The cockpit structure was intact.

**Figure 1:** Photo of damaged landing light on port wing

7. The aircraft veered off to the left of runway 23 with high speed into the grass area from the runway edge.
8. The aircraft left landing light was broken.

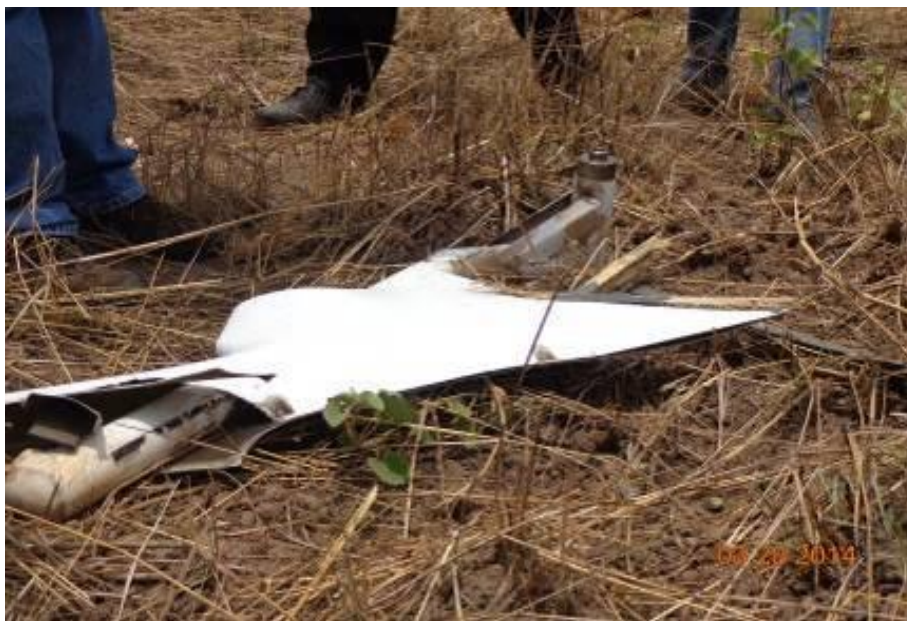
**Figure 2:** Photo of sheared-off Nose Landing Gear

9. The propeller blades were damaged.
10. The nose landing gear sheared off.
11. The ATC activated the crash alarm after the crash.
12. The ARFFS responded promptly to the crash alarm.

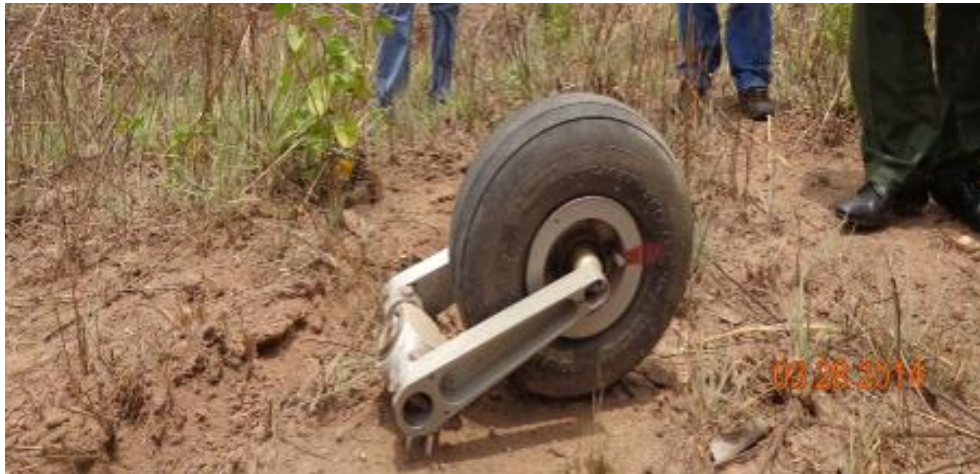
**Figure 3:** Photo of the broken nose wheel

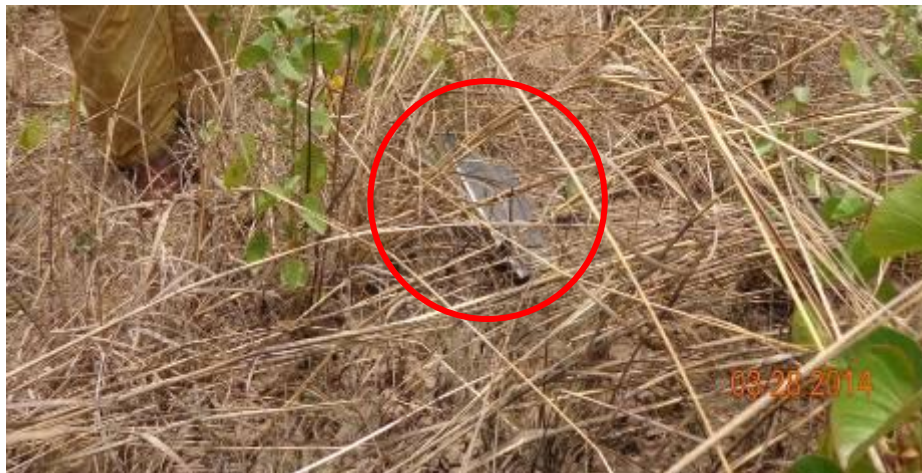
**Figure 4:** Photo of a propeller blade fragment

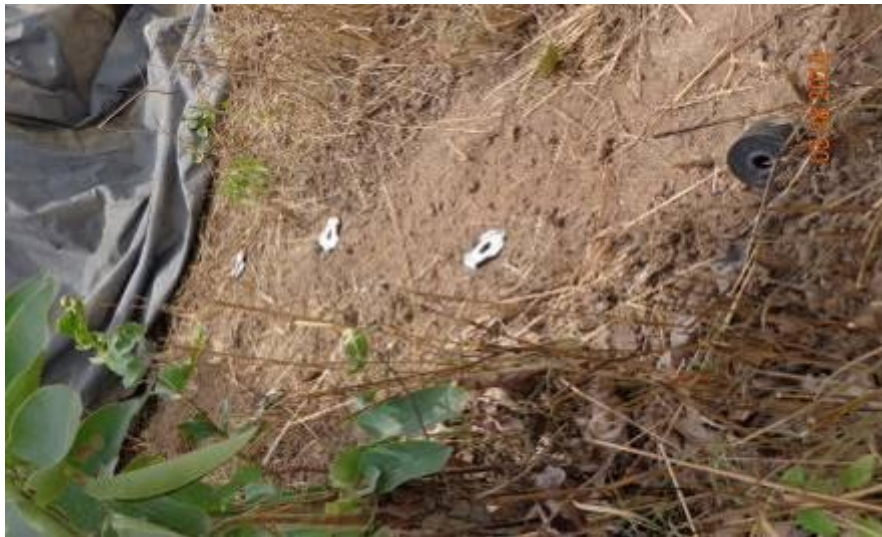
**Figure 5:** Photo of the debris trail

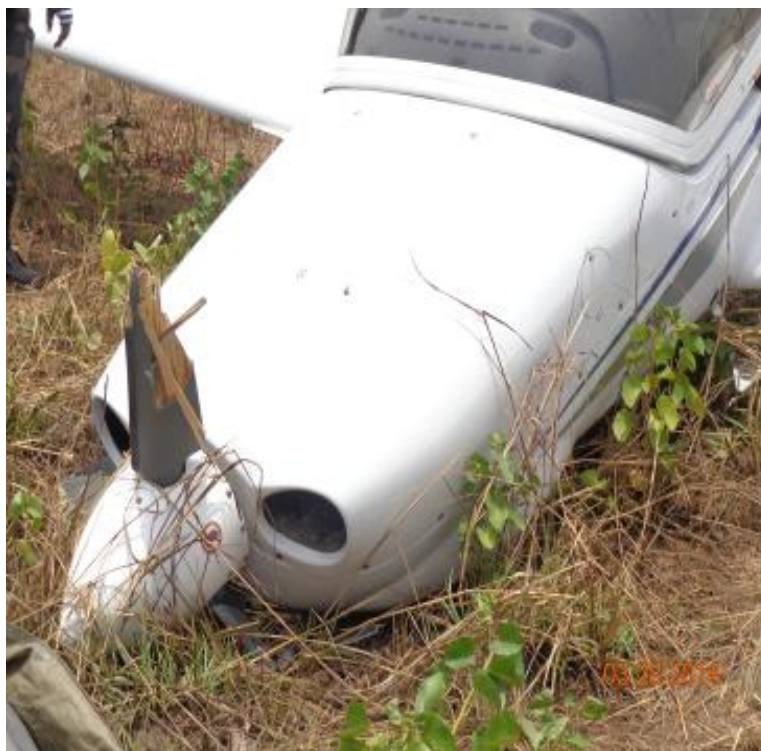
**Figure 6:** Photo of the aircraft's forward fuselage and broken propeller blades
