## **AIRCRAFT ACCIDENT REPORT**

**AIB/SAHCOL/2008/01/15/F**

**Report on the Serious Incident involving  
A BAGGAGE TRACTOR (DOUGLAS)  
Towing Tug NO. 55/2 and parked  
Aircraft B737-200 at D-43 Avio-bridge on the Ramp  
at Murtala Muhammed International Airport  
Ikeja, Lagos  
Nigeria  
On 15 January 2008**

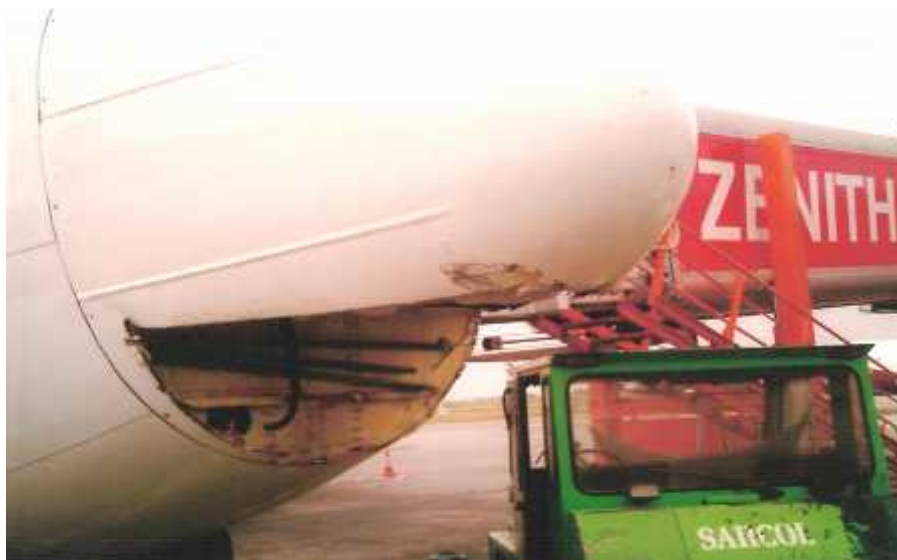
The lower part of the aircraft's radome was crushed as the tow tug rammed into it, exposing the weather radar antenna. The tow bar which was originally positioned perpendicular to the aircraft nose gear was turned beyond 90 degrees with its wheel inscribing an arc on the ramp's concrete surface. The torque links of the aircraft nose landing gear was rotated beyond the marked limit thereby breaking the turning locks as seen on the ground. The windscreen of the tow tug was shattered, upper right frame dented, and a headlight broken. One of the safety cones demarcating the safety zone of the aircraft was also displaced.

Fig.1 Tow tug damage to the lower Radome

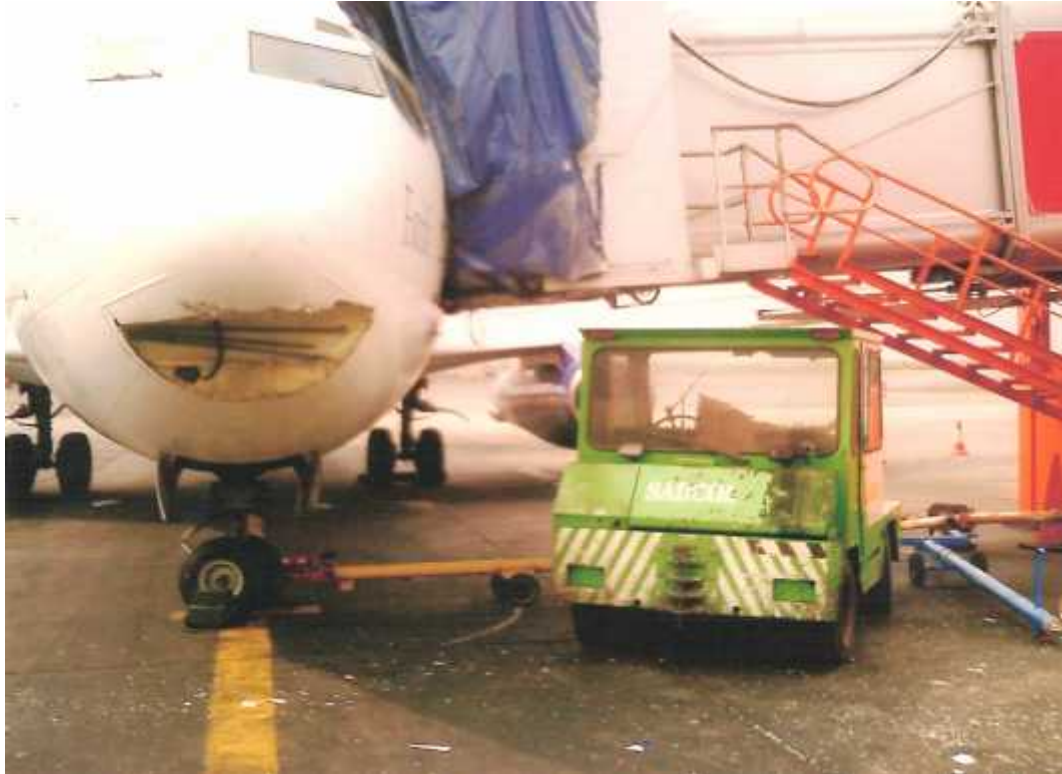
Fig.2 Exposed portion of the lower radome with the tow bar that turned the nose wheel beyond its limit

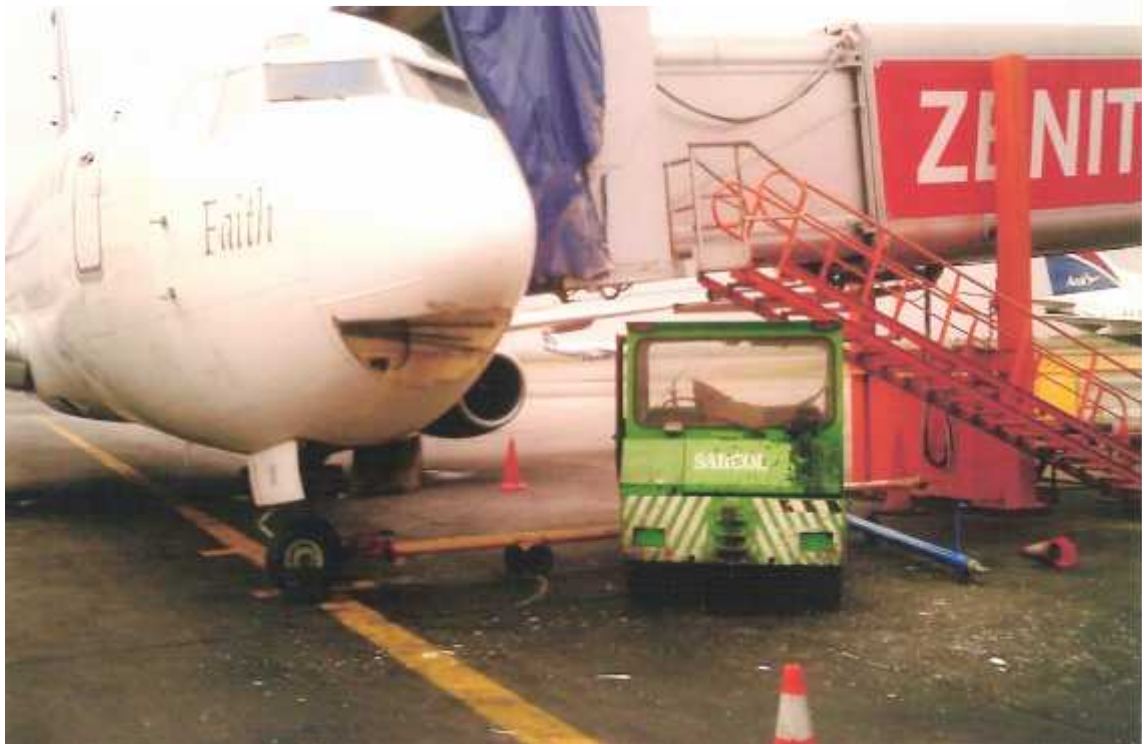
Fig.3 Nose gear turned beyond 90° exceeding the turning limit

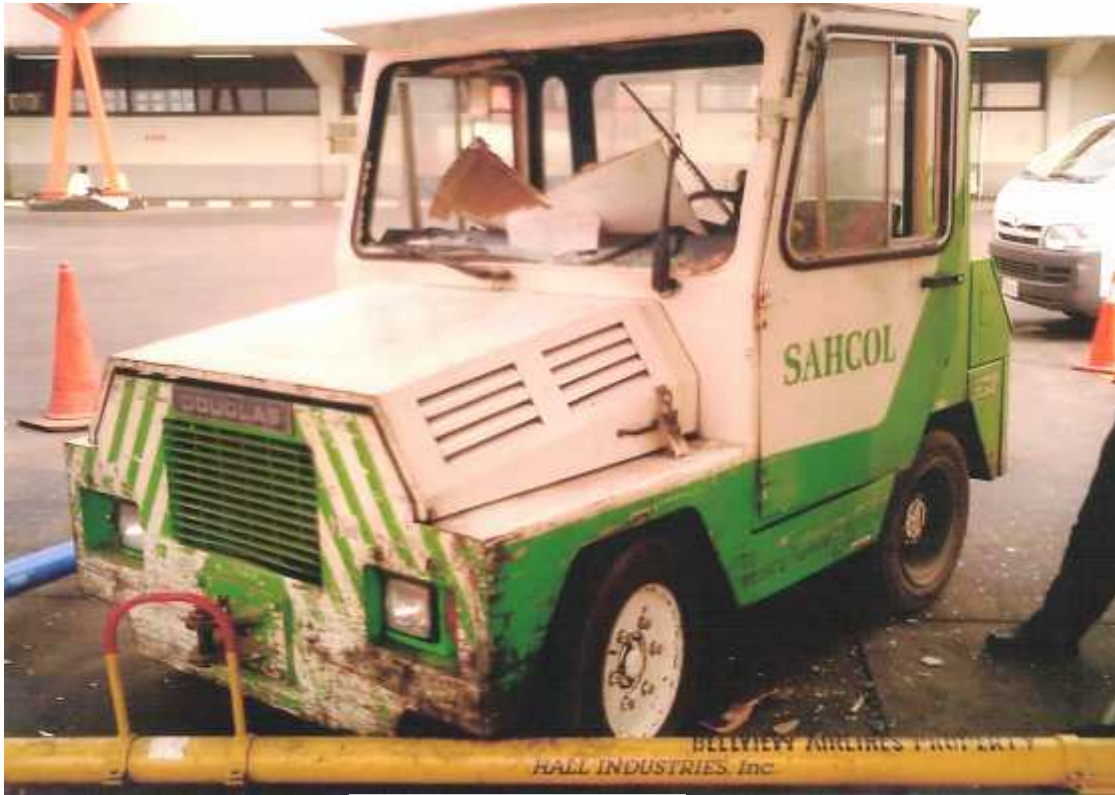
Fig. 4 The Tow Tug

The brake system of the tow tug was tested on the scene by competent personnel and was found to be defective.

Federal Airports Authority of Nigeria (FAAN) should implement the policy and procedure for monitoring the maintenance activities of vehicles and equipment used by ground handling operators. Quarterly and random checks should also be carried out on these vehicles and equipment.

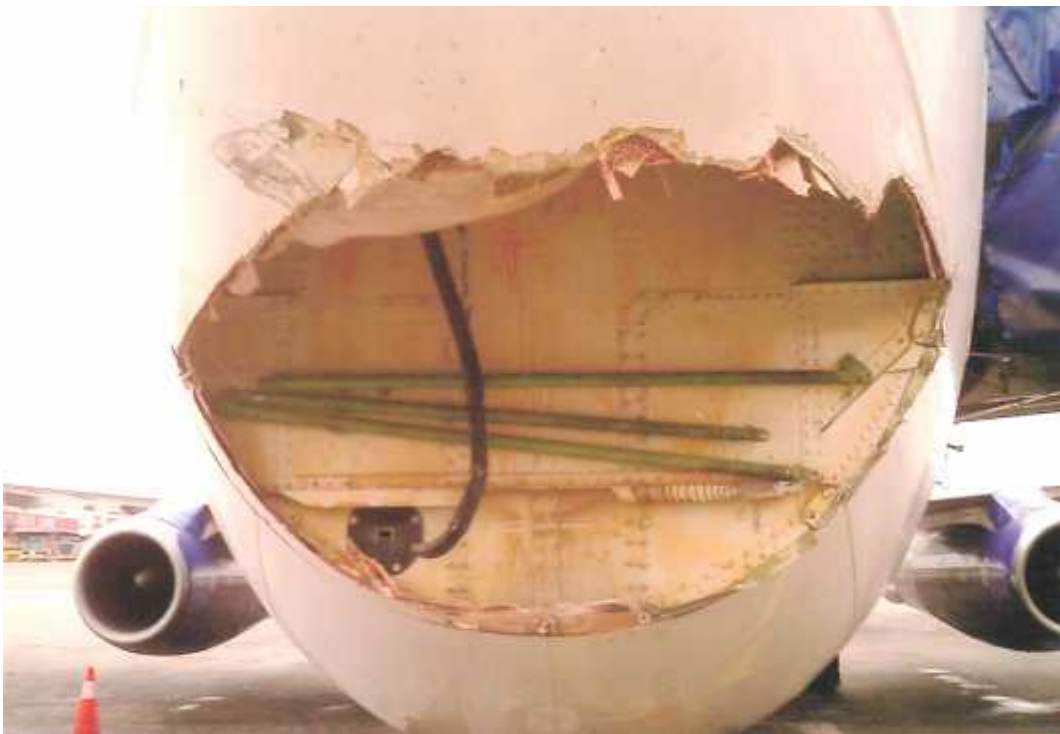
Fig.5 Exposed weather radar antenna at the lower part of the radome

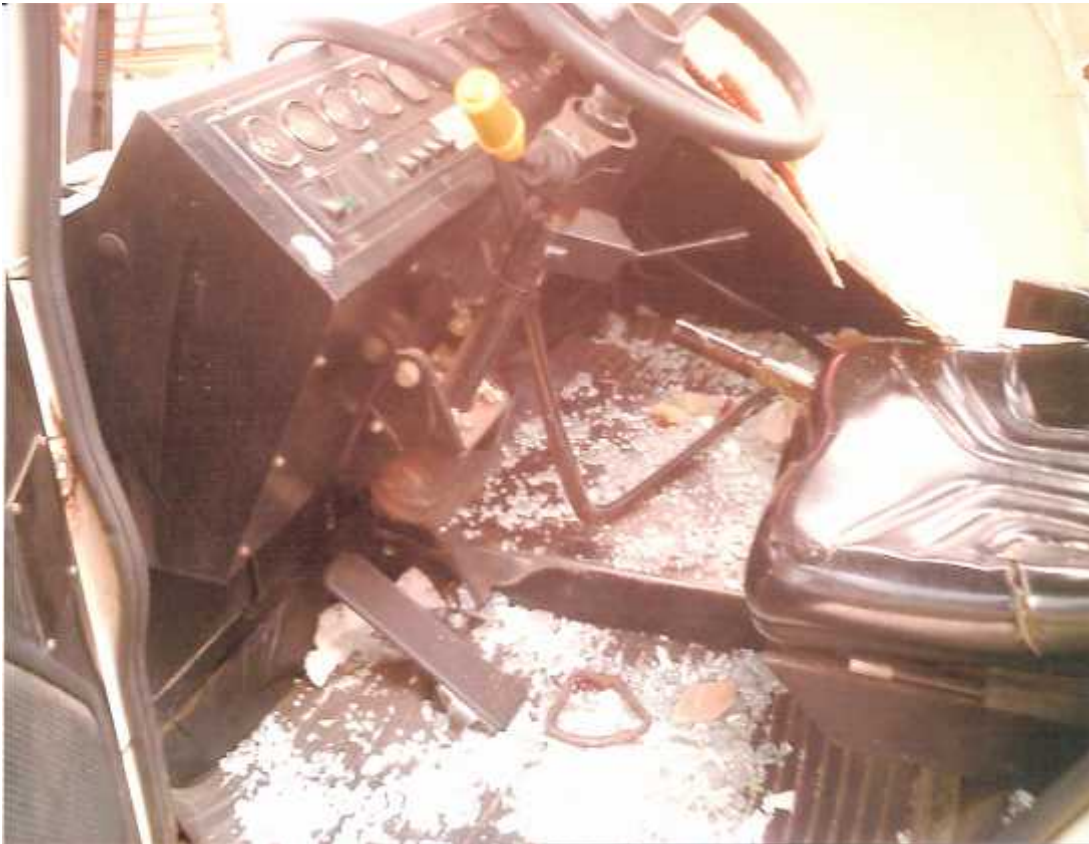
The windscreen of the tow tug was shattered and a head light broken.

Fig.6 Shattered wind screen of the tow tug
